Project 1358013

Squamish Lillooet Regional District  
1350 Aster St  
Pemberton, BC, V0N 2L0

## **Whitecap Berm Emergency Geotechnical Assessment**

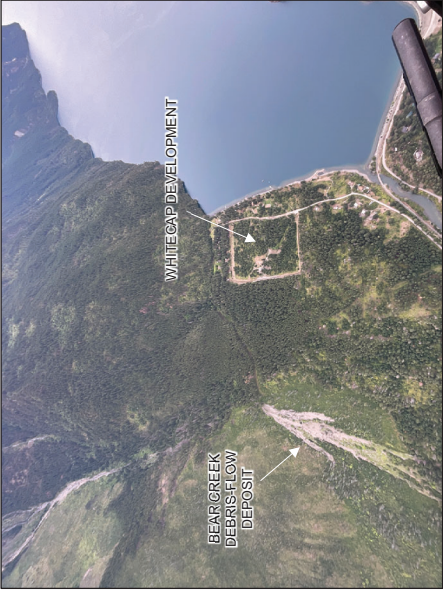
Photo 1. Overview of the Bear/Pete's fan area and lower watershed.

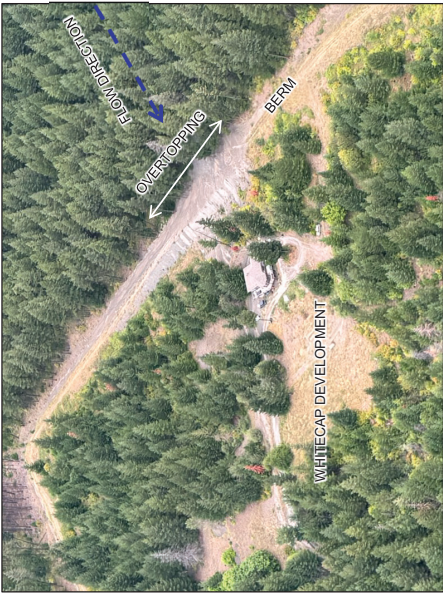
- A debris flow originating from Pete's Creek overtopped an approximately 70 m section of the eastern berm directly upslope of the 8332 Seton Portage Road residence, immediately south of the previous overtopping locations. Some of the flow was conveyed north along the eastern and northern berm perimeter ditch (Photo 5).

- The overtopping location appeared to coincide with a localized low point (dip) in the berm crest of approximately 0.5 to 1 m relative to the berm grade along an approximately 100 m section of berm upslope of the residence.

Photo 2. Berm overtopping location from debris flow on Pete's Creek.

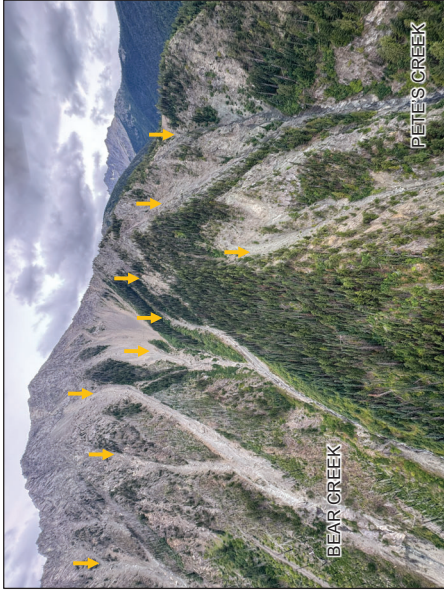
- From the helicopter, the Pete's Creek debris flow appeared to have initiated from two or three tributaries in the upper watershed at an elevation of approximately 1,600 m (Photo 3, 4). BGC did not observe a single, large initiating source, such as a landslide scar, and interprets the debris flow was likely triggered through in-channel sediment entrainment during high runoff. BGC observed that most of the Pete's Creek mainstem scoured to bedrock in the watershed, with water flowing in the tributary at the time of inspection, indicating limited remaining sediment supply along the mainstem. Some sediment sources remain in the upper watershed, but appear to be more limited than observed in the Bear Creek watershed, described below.

- Similar to Pete's Creek, BGC did not observe a single large initiating source in the Bear Creek watershed from the helicopter overflight, rather, fresh debris-flow tracks on the three main tributaries and multiple sub-tributaries (Photo 3). Unlike Pete's Creek, the Bear Creek watershed contains numerous, extensive debris sources associated with material accumulated within tributaries and talus cones. BGC observed a few isolated locations that may have been scoured to bedrock, but most of the debris tracks and surrounding slopes appeared to retain substantial remaining debris supply.

Photo 3. Upper Bear/Pete's watershed. Yellow arrows indicate debris-flow initiation locations with fresh debris tracks.

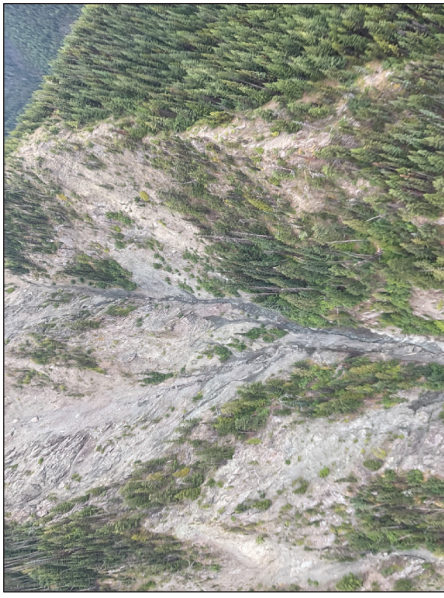
Photo 4. Close-up of the upper tributaries in the Pete's Creek watershed where the debris flow initiated.

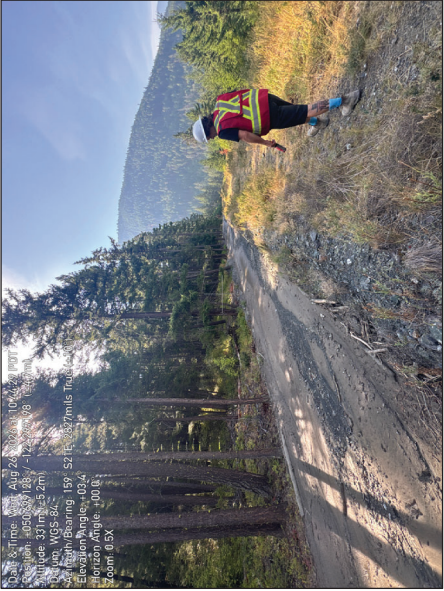
Photo 5. On eastern berm looking south at debris conveyed to the north by the perimeter ditch.

- Removing debris impounded behind the berm and in the ditch to restore capacity, consistent with the criteria set out in the O&M manual (SLRD, December 15, 2001).

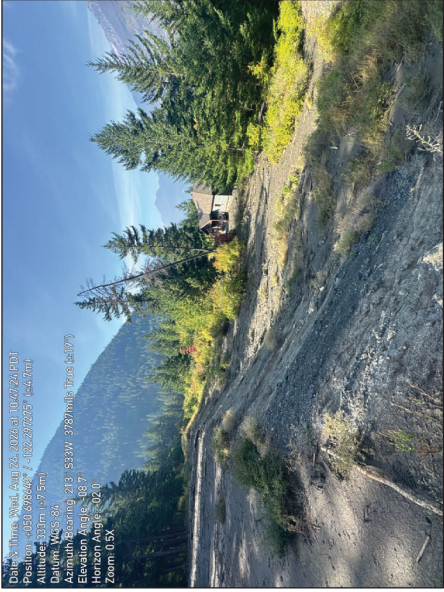
Photo 6. Looking south along downstream berm crest at overtopping location. Occupied residence approx. 30 m downslope of berm.

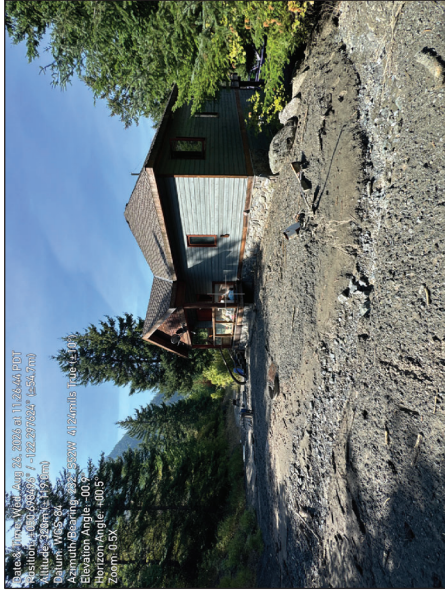
- Flows that overtopped the berm deposited on the upslope and northern sides of the 8332 Seton Portage Road residence, and continued downslope along the driveway and a gully to Seton Portage Road (Figure 02). Deposit depths around the residence varied but appeared to be approximately 0.3 m to 0.5 m deep (Photo 7). Debris that overtopped the berm did not enter the residence as the structure is elevated above the surrounding pad grade. However, debris pooled between the building and the pad cut into the original fan surface, which limited the ability of water and debris to drain away from the residence.

Photo 7. Upslope side of occupied residence at 8332 Seton Portage Road surrounded by debris.

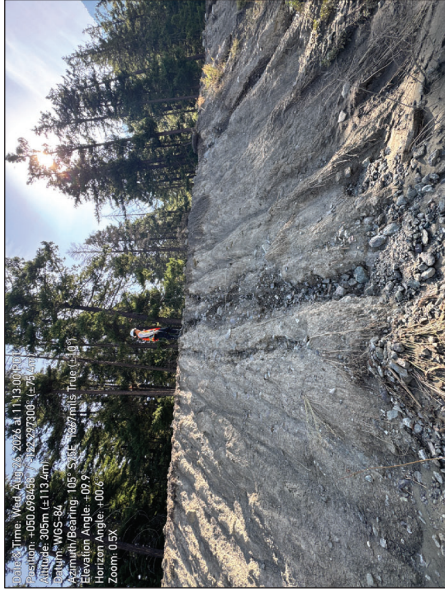
- Flows that overtopped the berm caused erosion and gullying at approximately four locations on the downhill slope of the berm (Photo 8). Gullies were up to approximately 1 m wide and scoured up to approximately 0.5 m into the berm crest and slope.

Photo 8. At berm toe looking east at erosional gullies along downhill face of berm at overtopping location.

- Repairing the downhill face of the berm by scraping loose debris from the berm face, filling the erosional gullies with compacted coarse granular material sourced from the debris-flow deposit, and restoring the downhill face to a maximum slope of 1.5H:1V.
