# BRITISH COLUMBIA MINISTRY OF FORESTS: POST-WILDFIRE NATURAL HAZARD RISK ANALYSIS

## LEVEL 2 RECONNAISSANCE REPORT – C40983 PEAR LAKE FIRE

| <b>FIRE NUMBER/STATUS:</b><br>C40983 Pear Lake Fire classified as under control as of September 14, 2026 | | <b>FIRE YEAR:</b><br>2026 | <b>DATE OF FIELD REVIEWS:</b> n/a<br><b>DATE OF REPORT:</b> October 8, 2026 |
| <b>AUTHOR:</b> Sarah Crookshanks, M.Sc., P. Geo., Geomorphologist, Kootenay Boundary Region, South Area | | | |

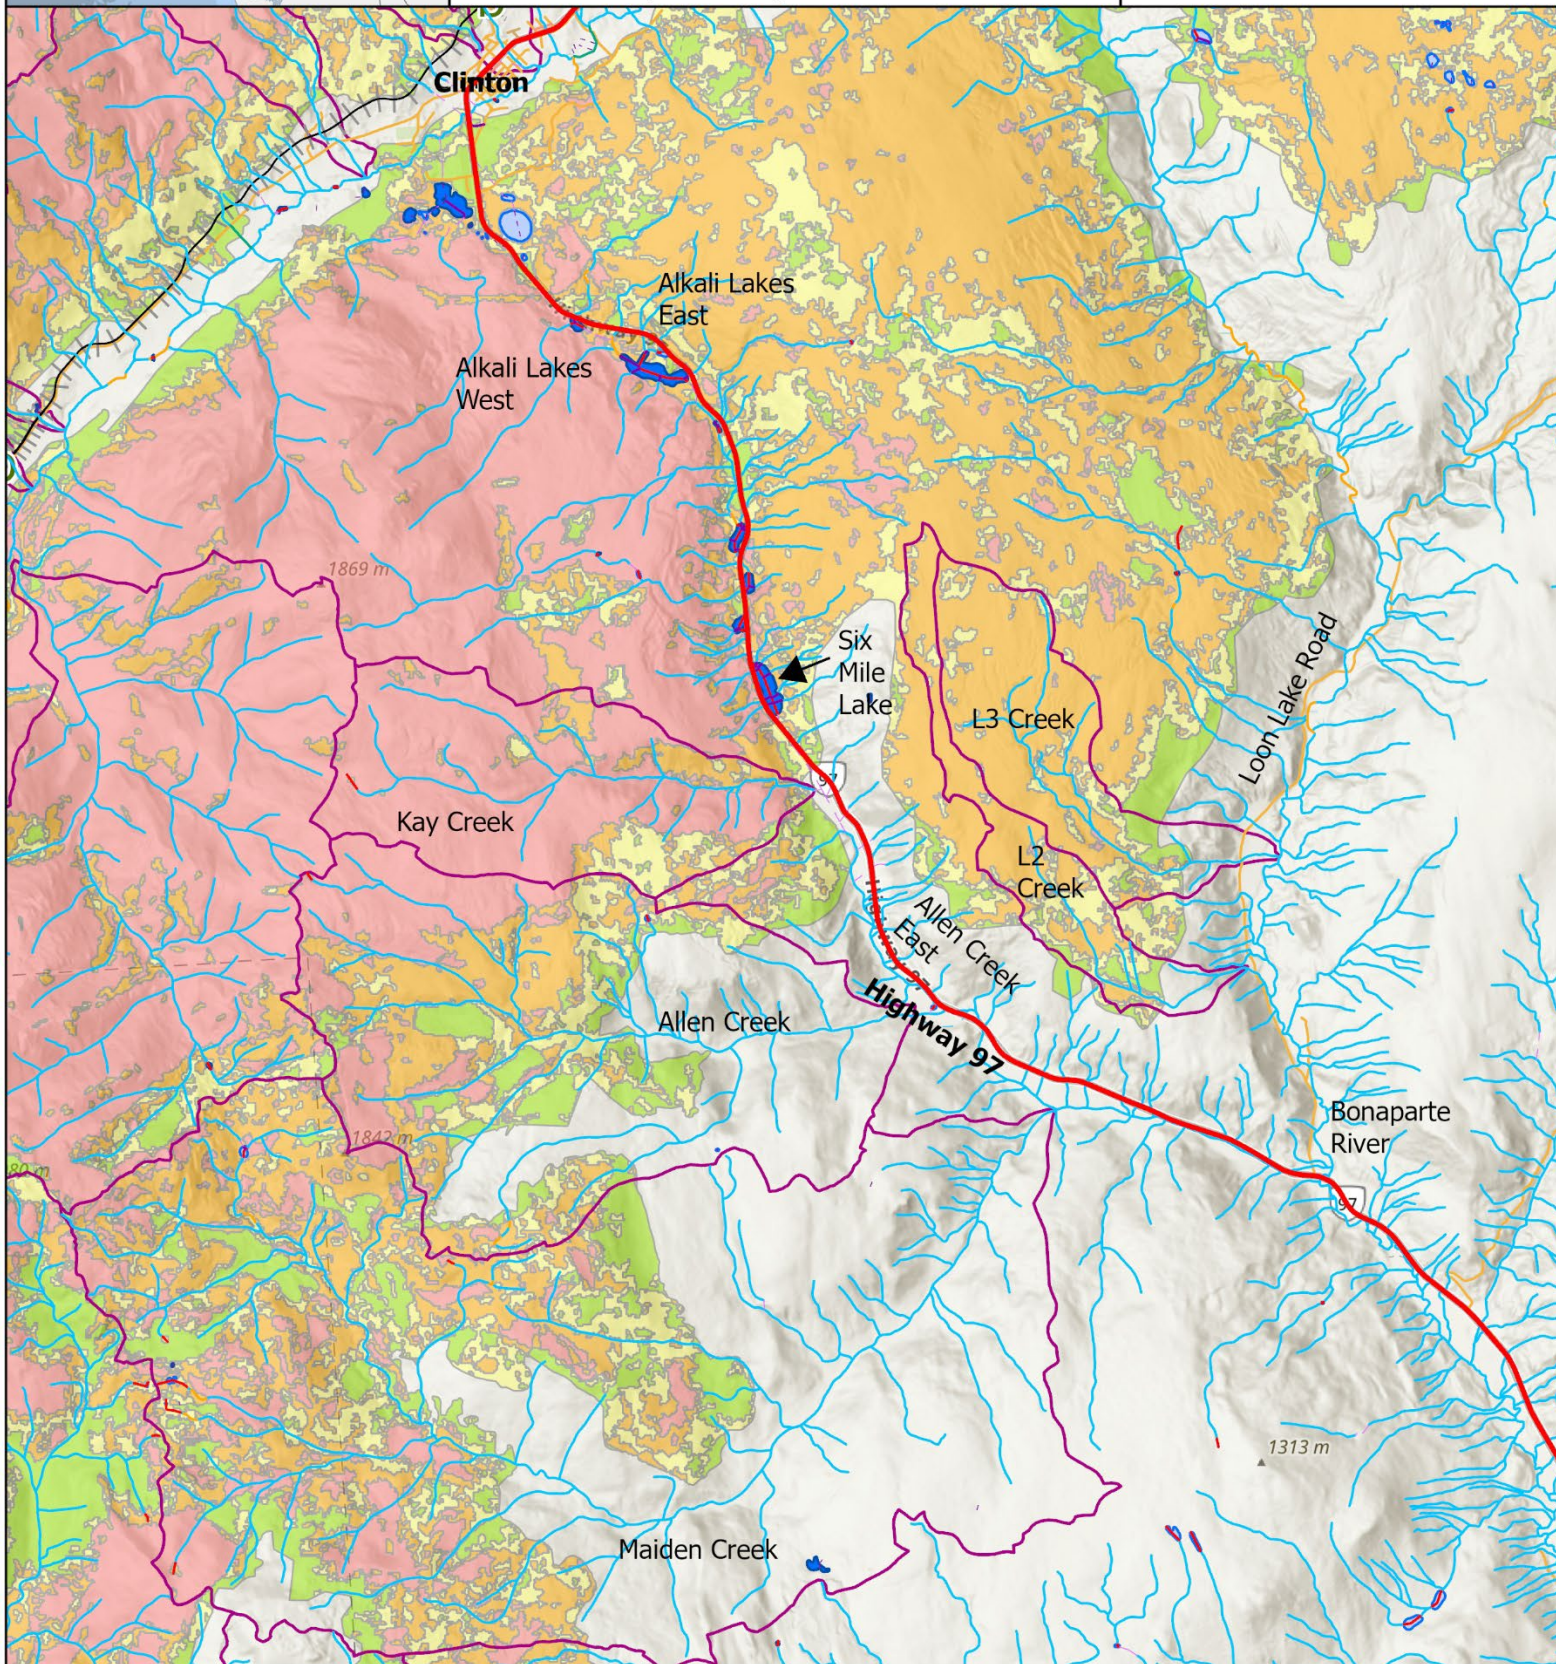
# C40983 Pear Lake Fire Post Wildfire Natural Hazard Risk Assessment Map 1 Southeast

to moderate severity. The sparsely forested and grassland plateau west of Loon Lake Road has now been reburned by the Pear Lake Fire. The two largest drainages along this slope (L2 and L3 Creeks on Map 1) were burned mostly at moderate severity, while the headwater areas of the remaining draws burned at mostly moderate severity.
