**Pierre A. Friele, MSc, PGeo**  
P.O. Box 612  
1021 Raven Drive  
Squamish, BC  
V8B-0A5  
Ph. (604) 898-4770

August 30, 2013

**Re:** Catalina Creek debris flow, August 30, 2013.

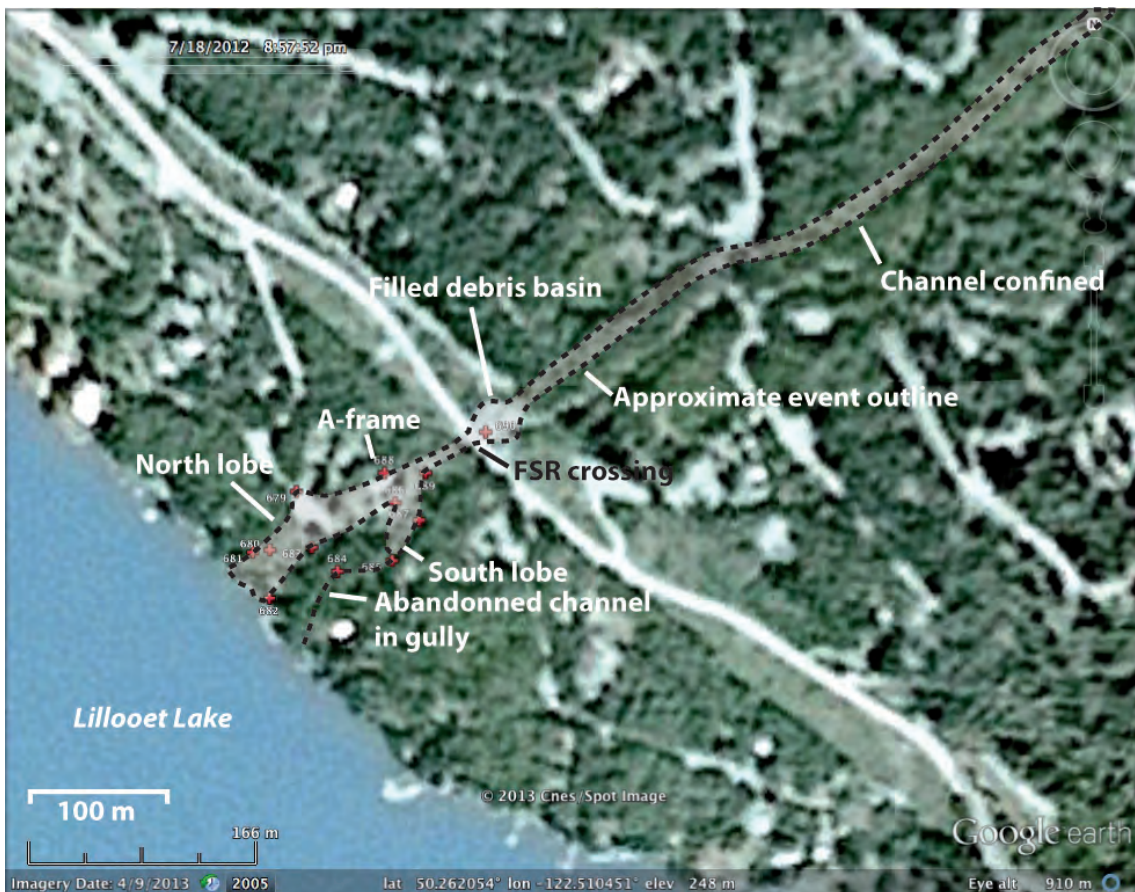
**Figure 1.** Approximate outline of the August 30 2013 debris flow, Catalina Creek.

On reaching the apex of the debris cone, the debris flow remained confined along the ~900 m length of channel downstream to the debris basin just upslope of the FSR crossing, perhaps depositing 7-15 m<sup>3</sup>/m along this length (6000-14000 m<sup>3</sup>); it filled the debris basin (1000 m<sup>3</sup>); deposited 4-5 m of debris on the FSR (300-500 m<sup>3</sup>); then carried on down the channel depositing a large lobe (750-1000 m<sup>3</sup>) on the south bank, plugging the channel at a footbridge crossing; and avulsed north, overrunning the boat launch and reaching the beach. The north lobe swept over the driveway of the A-frame house, pushed a small pickup truck into the lake, and destroyed a boat rack full of boats. In the deposition zone of the north lobe, the debris is on average 1-2 m thick along the margins and <1 m thick along the centre of the track, with a volume of perhaps 2000-6000 m<sup>3</sup>.

Based on these observations, the total debris deposition below the apex could be on the order of 10,000-25,000 m<sup>3</sup> in volume, a Class 4 debris flow (Table 1). The material was a bouldery slurry, with a 30-40% clast content of cobble to medium boulder, with maximum clast size up to 2-3 m b-axis.

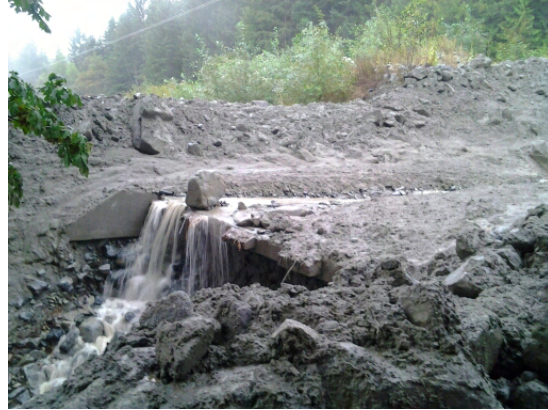
The FSR bridge was inspected (Photo 5). Only a portion of the deck and abutment wingwalls were visible on the downstream side of the bridge. The bridge opening was plugged, the deck overtopped, the guard rails destroyed and the wingwalls appeared somewhat undermined. Despite this impact, the bridge appeared not to have shifted.

**Photo 5.** View NW at the downstream edge of the FSR bridge before cleanup. Seija Halonen photo.

Once the channel upstream and downstream of the bridge opening, and the opening itself, are fully cleared of debris, a proper engineering inspection of the bridge will be required prior to allowing regular traffic, especially larger vehicles, to resume.

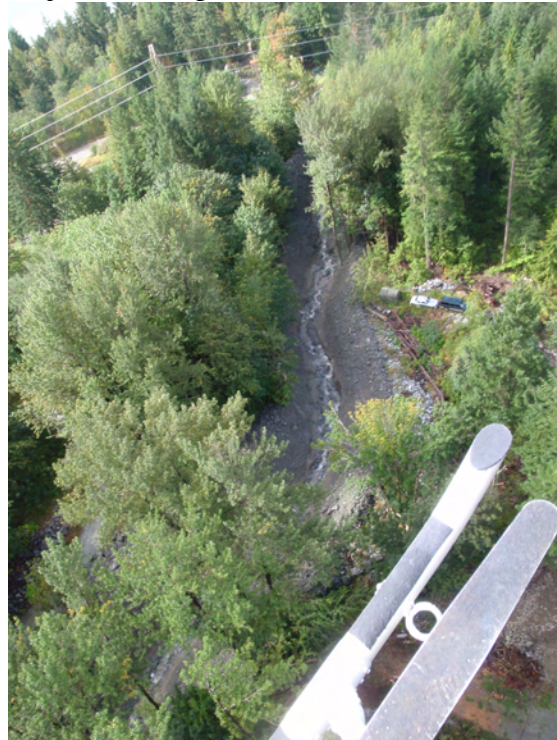
**Photo 7.** Aerial oblique SW view of channel upstream of FSR. In this area the debris flow remained confined.
