MINISTRY OF FORESTS, LANDS AND NATURAL RESOURCE OPERATIONS INFORMATION NOTE

Date: October 24th, 2016
File: 17275-20

ISSUE: 2016 Mount Currie Rock Fall and Local Instabilities

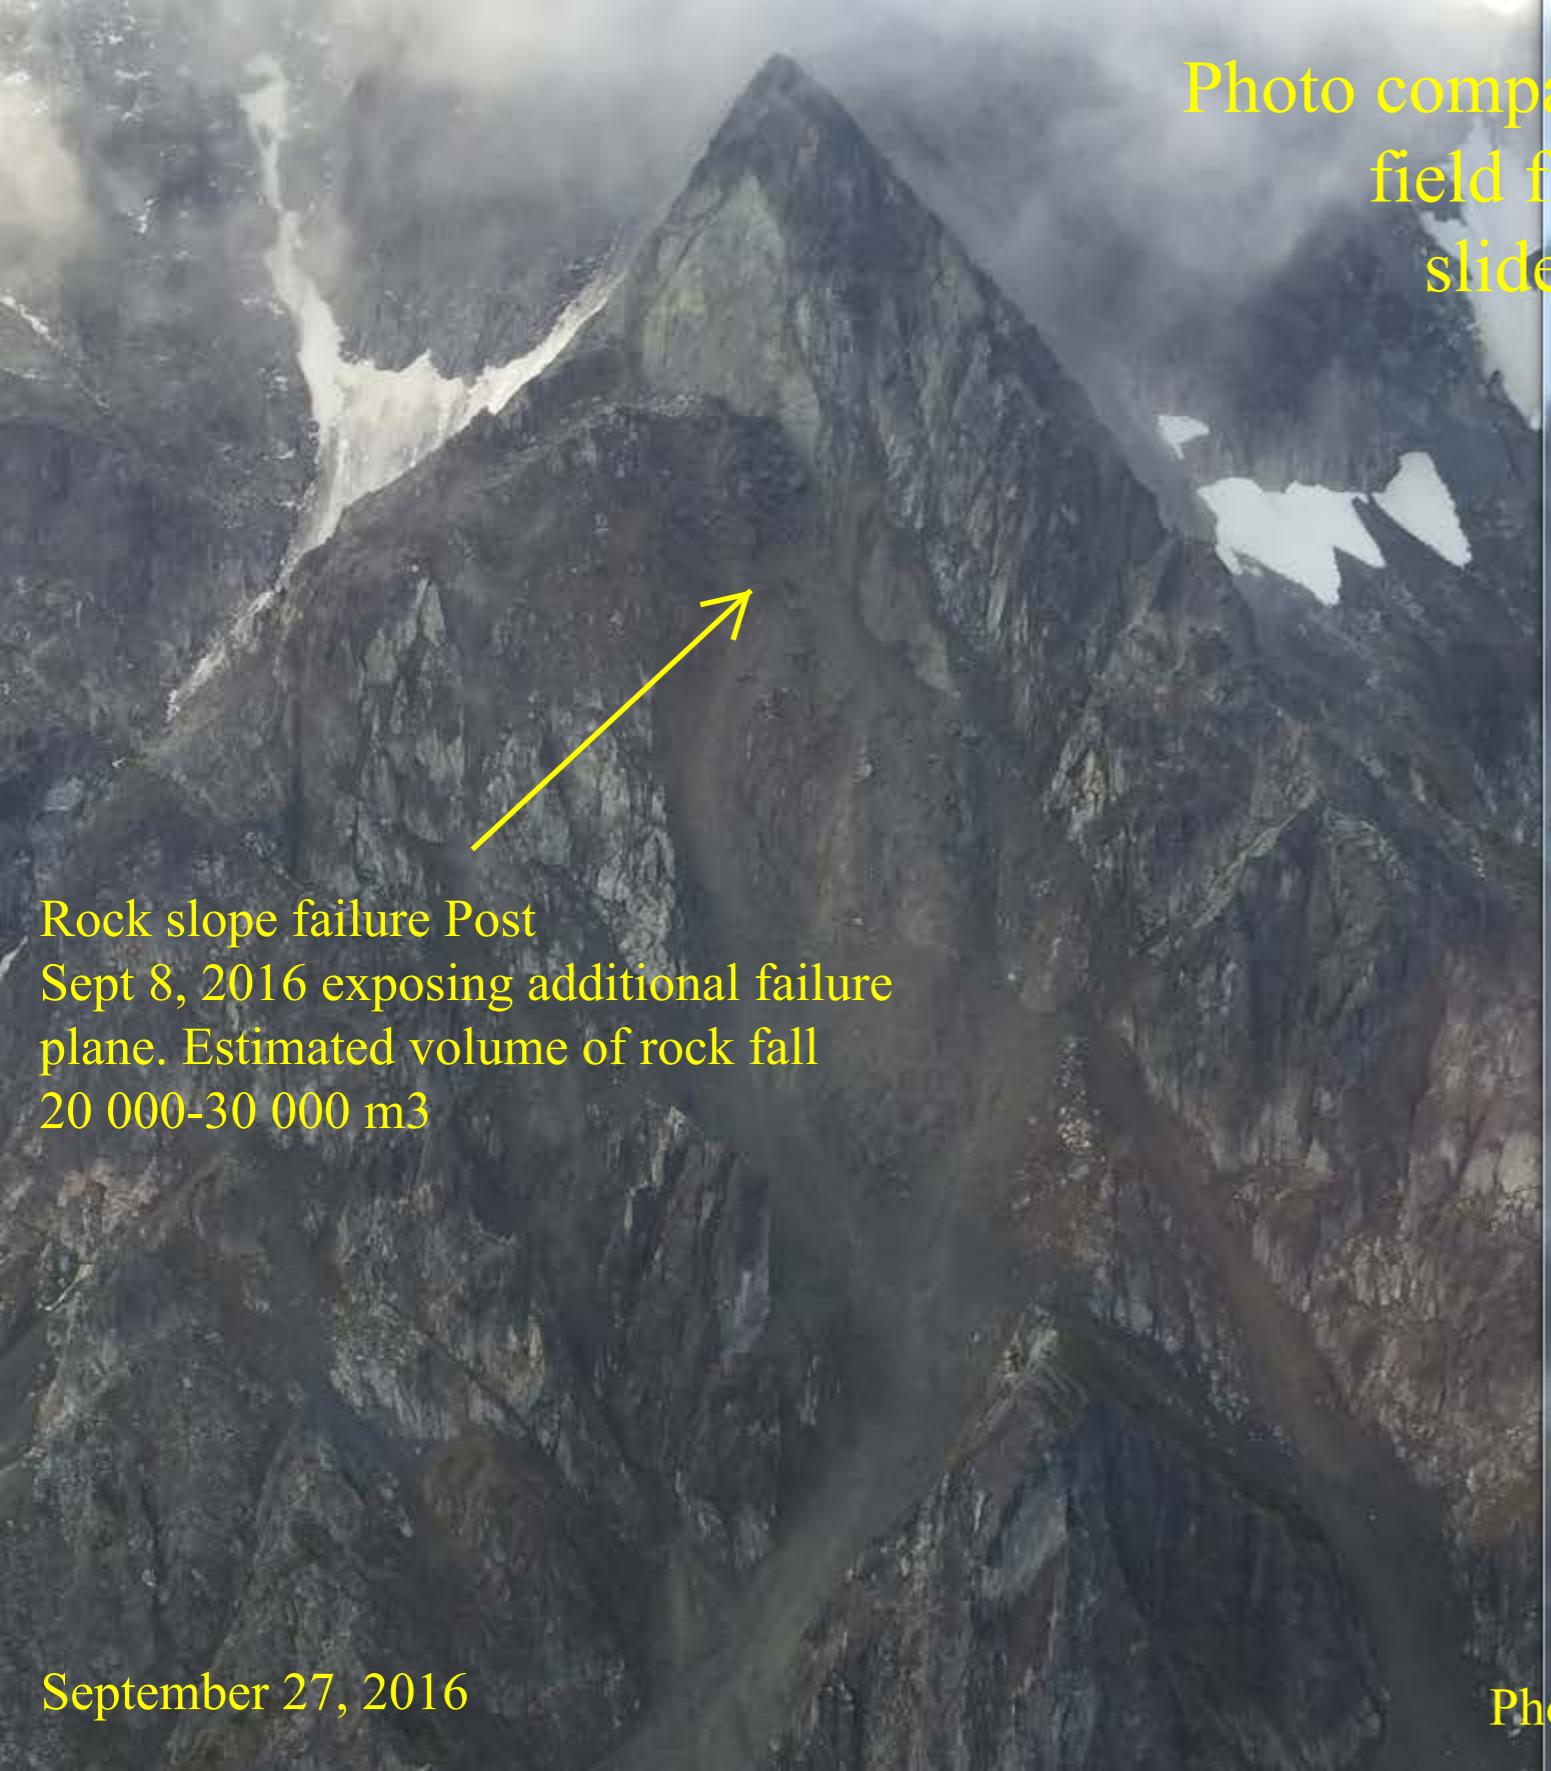
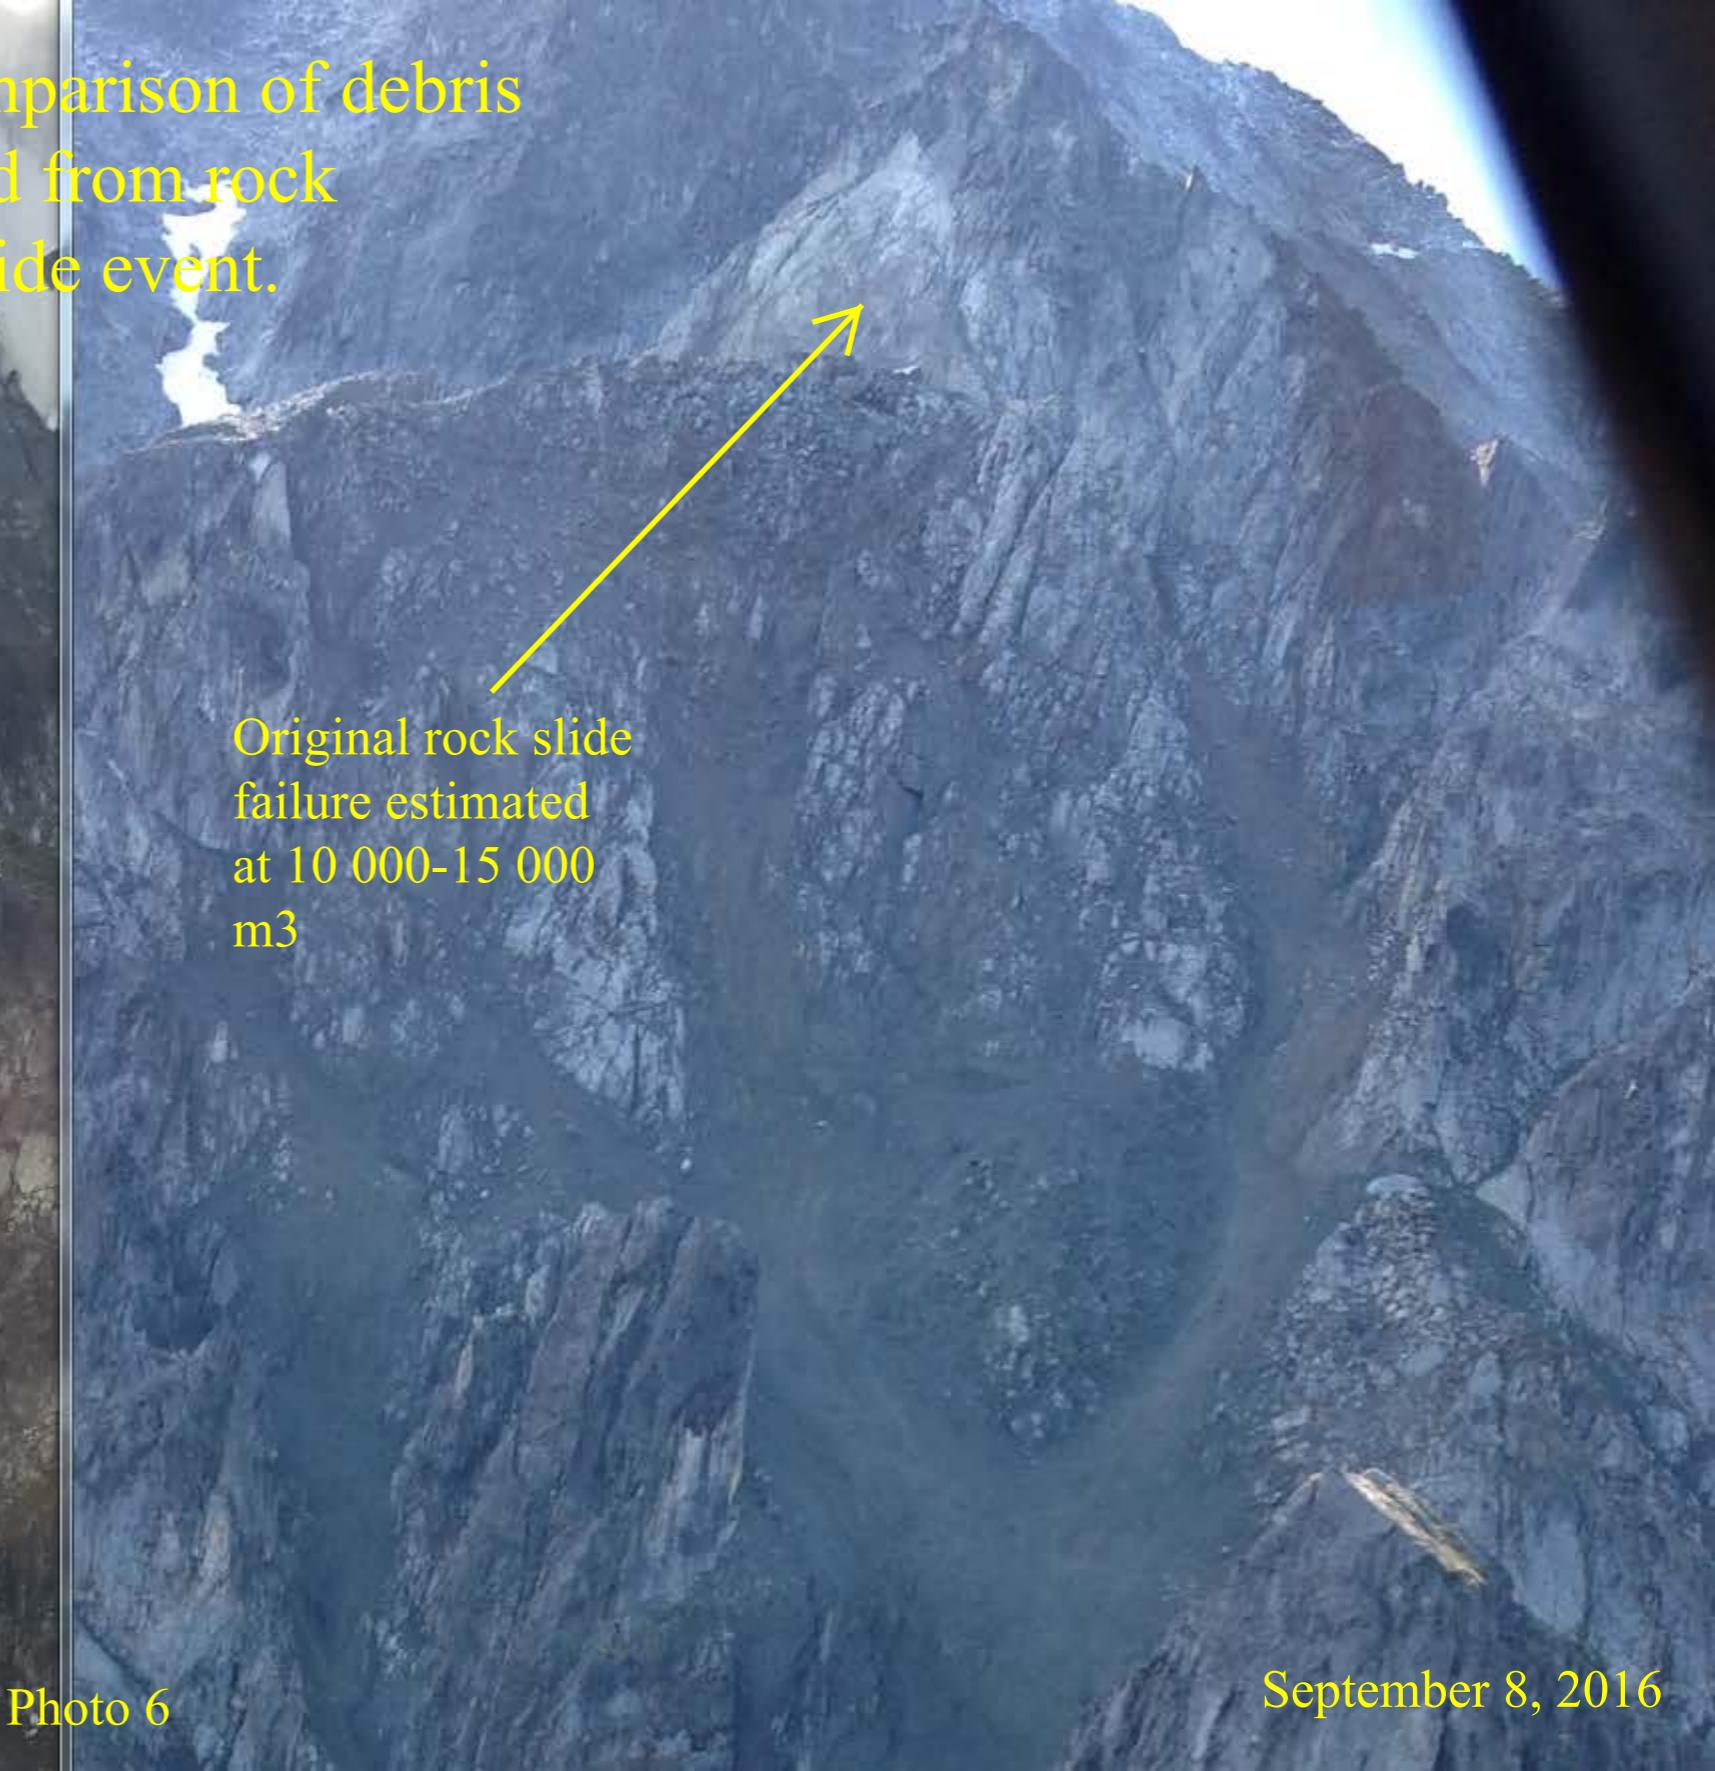
Photo 6

Photos 4 and 5 shows the location of the rock fall noted during the September 8th flight. Photos 6 and 7 show different perspectives of the same rockfall area but compares photos taken on the 8th and 27th of September. During this 19 day period a significant amount of rock has fallen on the west side of the failure exposing a larger uniform failure plane in the background. Estimated volumes from this additional rock fall are in the range of 20,000-30,000m³. It is expected more of this rock deposition from the September 8th event will continue to fall and slide from this area during the fall rains, and freeze/thaw activity. Continued failures and rock falls along this plane will expose a larger area of unsupported bedrock. Although the rock falls of the recent size do not pose a risk to valley residents, the exposure of larger volumes of unsupported bedrock potentially could result in rock fall events that do pose risk to valley residents.

Photo 8 shows the rock behind the failure head scarp being highly fractured with near vertical jointing. Determining a future failure plane will be critical as base support is being lost with continuing failures occurring as noted from September 8th to the 27th events. As failures at the base of the current slide continue to occur during the fall and into 2017 from the bench seen in photo 6, base support to the head scarp area will be lost, and the potential for larger failures increases

Photo comparison of debris
field from rock
slide event.

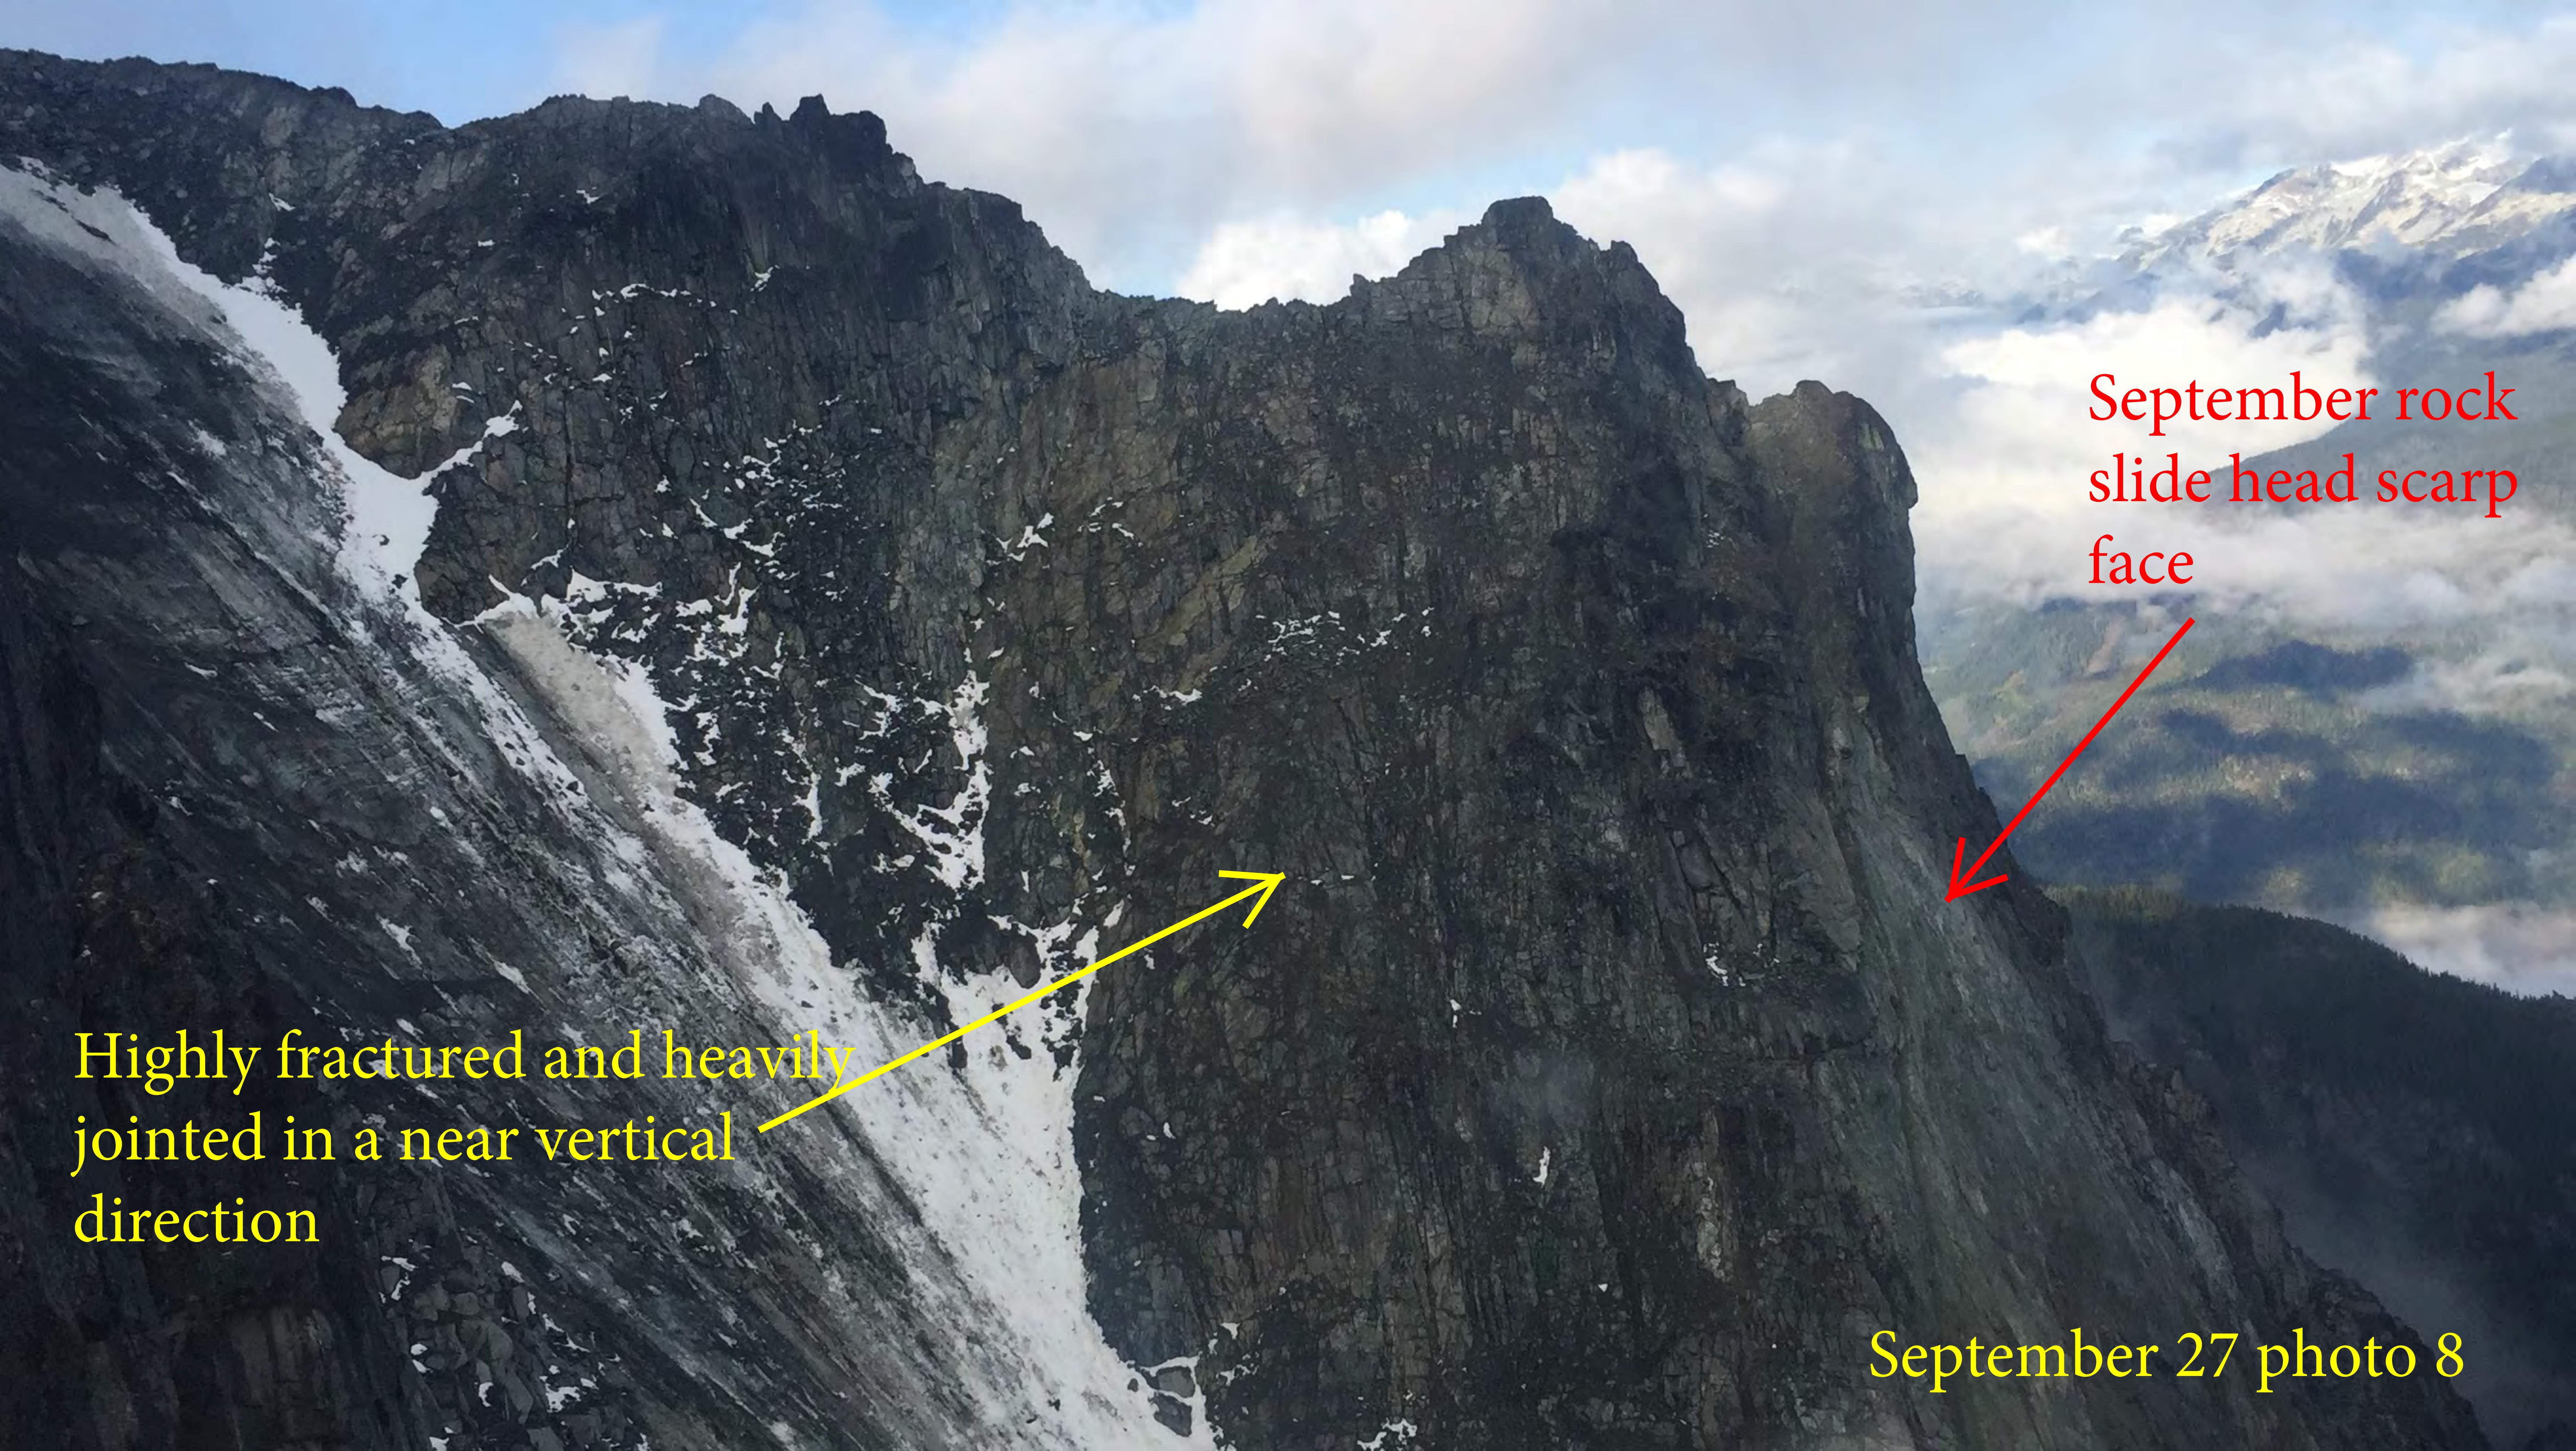
September 27 photo 8

The potential for failures larger than 100,000m³ are possible given the highly fractured and vertical jointing in the bedrock behind the failure surface shown in photo 8. It is currently unknown if these will fail in small volumes or in a single large rock avalanche. As the headscarp becomes larger with continuing rock falls, the potential for larger volume failures also increases as a result of base support being lost.

Highly fractured and heavily
jointed in a near vertical
direction

September rock
slide head scarp
face

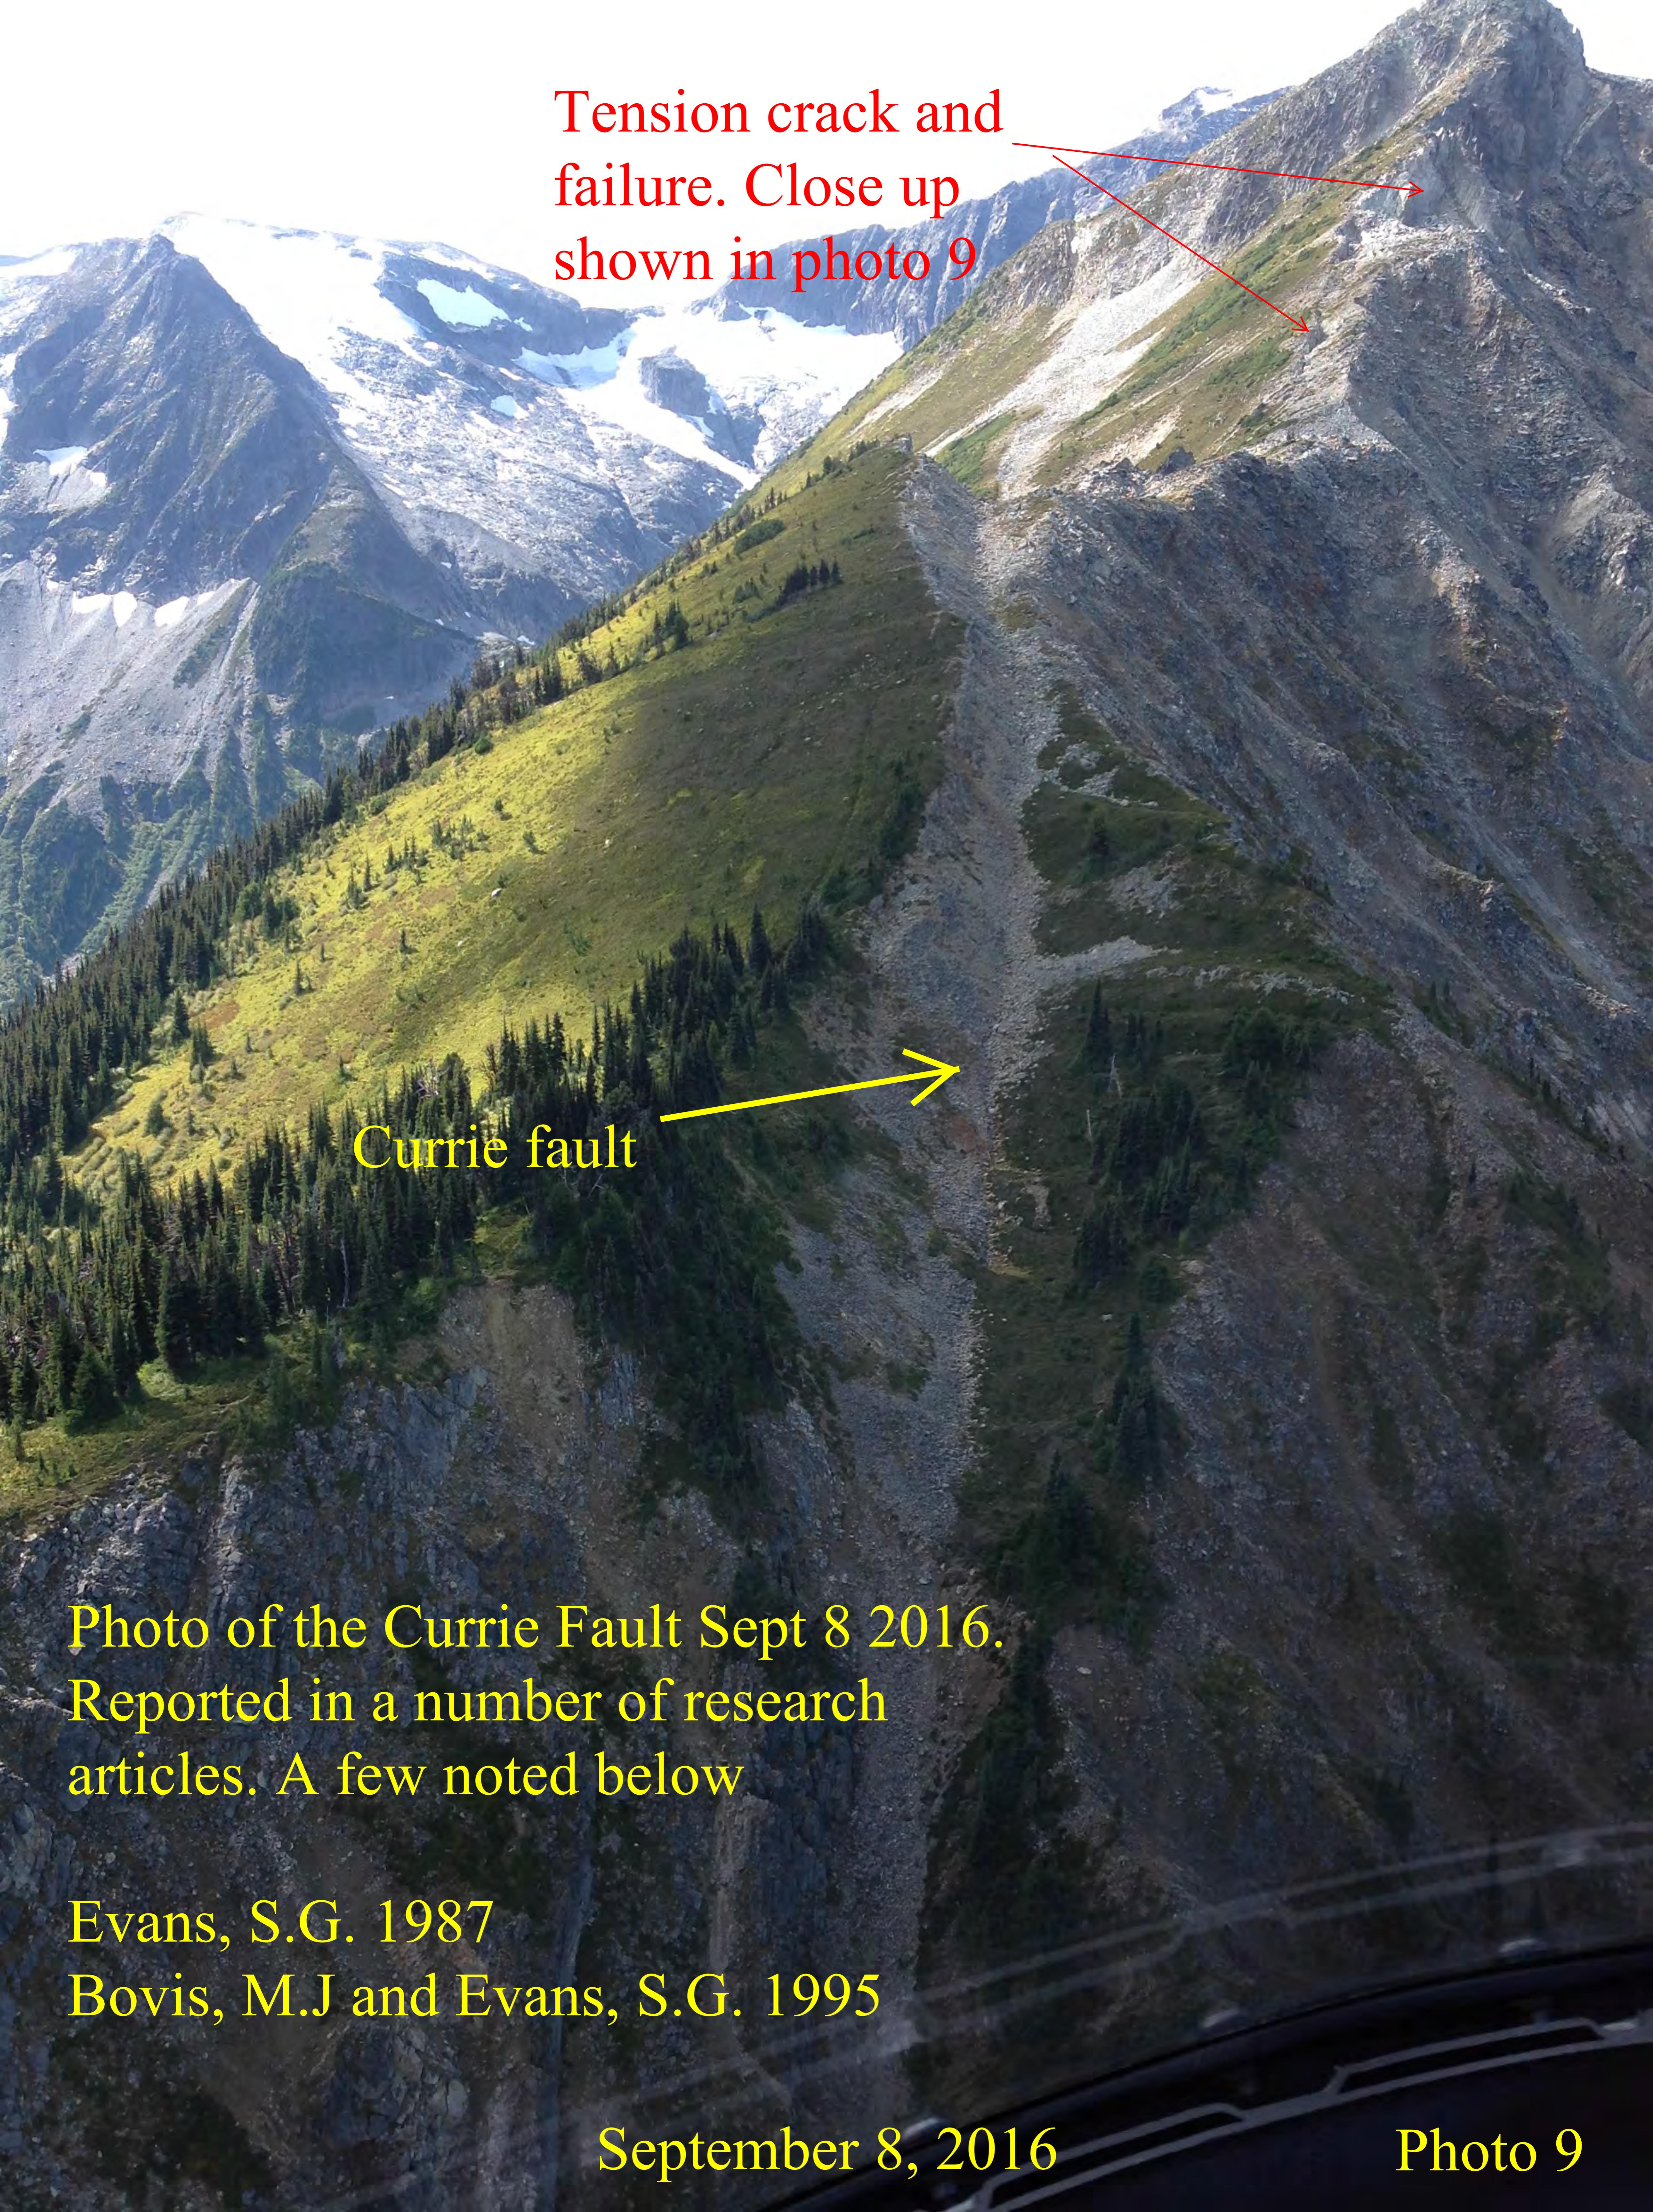
Photo 9

The potential for similar sizable events exists for other locations along the Mount Currie Ridge. From 1987 to 1991, Bovis and Evans (1995)² measured significant movement along a linear scarp located on the Mount Currie Ridge approximately 2 km to the northeast of the current rockfall. They interpreted the movement to be due to gravitational forces (i.e. the slope is unstable and is slowly moving due to gravity). Photos 9 and 10 show the Currie linear scarp and a tension crack with a head

Tension crack and
failure. Close up
shown in photo 9

Currie fault

Photo of the Currie Fault Sept 8 2016.
Reported in a number of research
articles. A few noted below

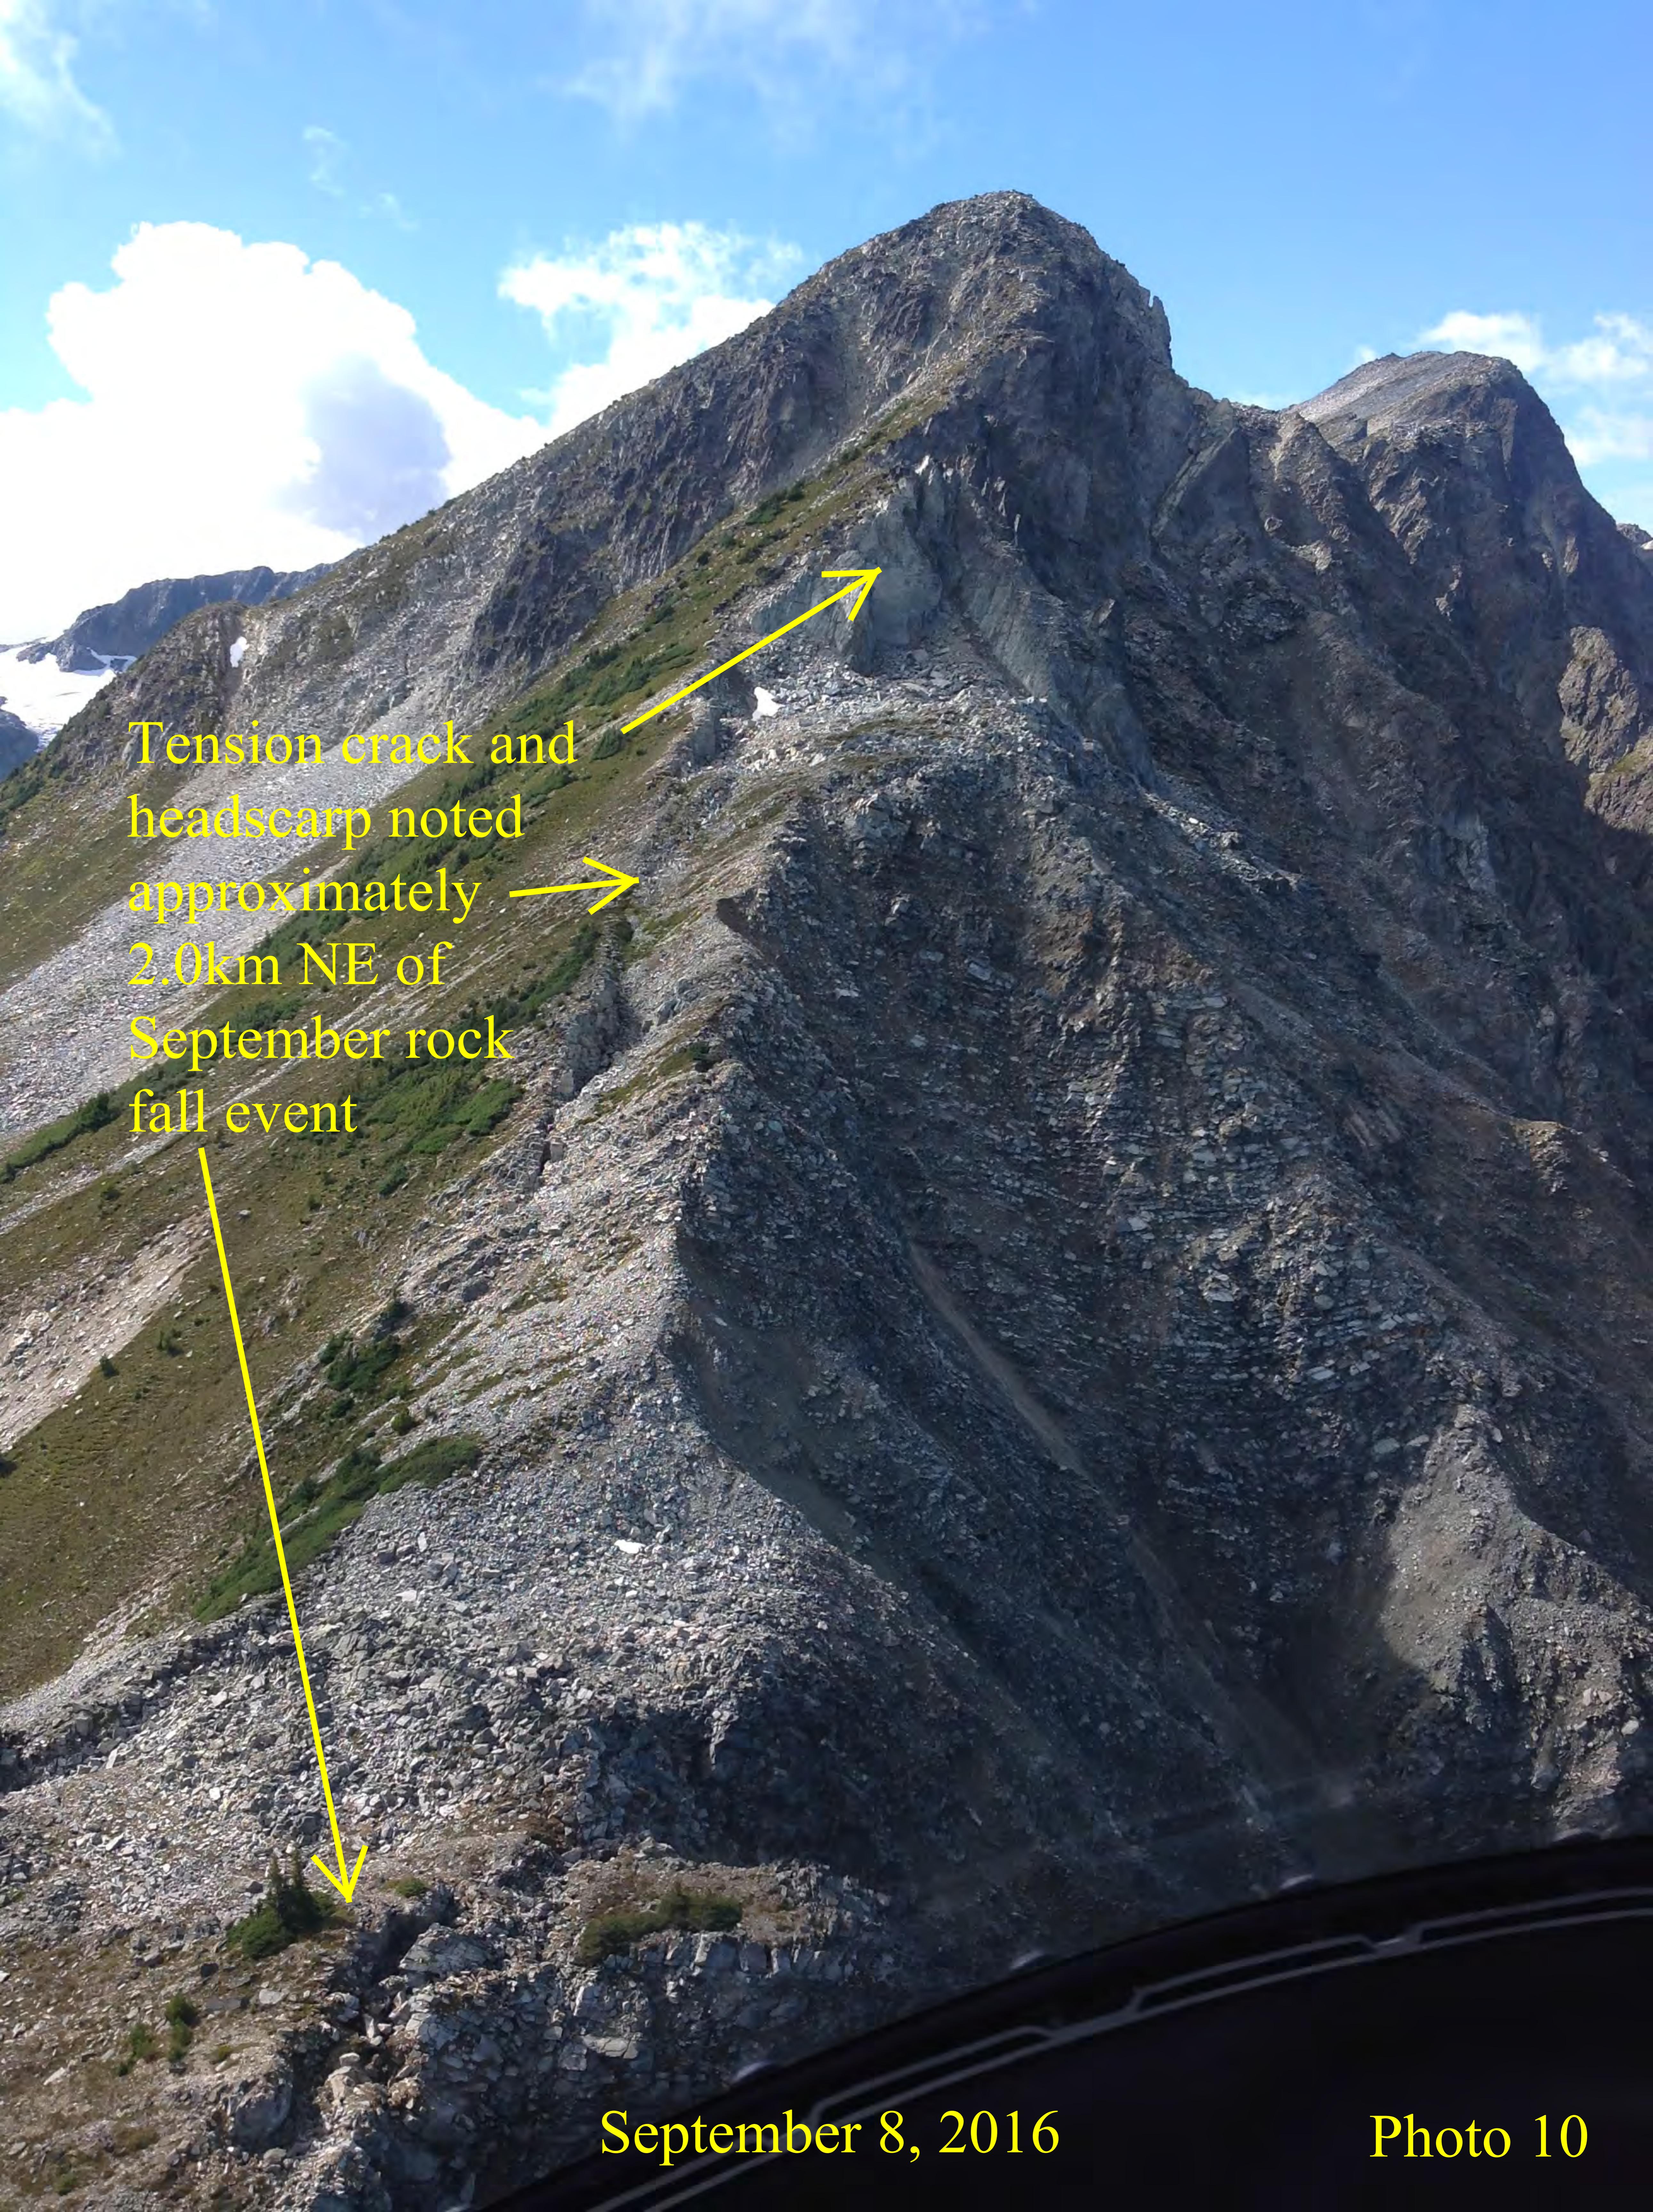
Photo 10

Tension crack and
headscarp noted
approximately →
2.0km NE of
September rock
fall event

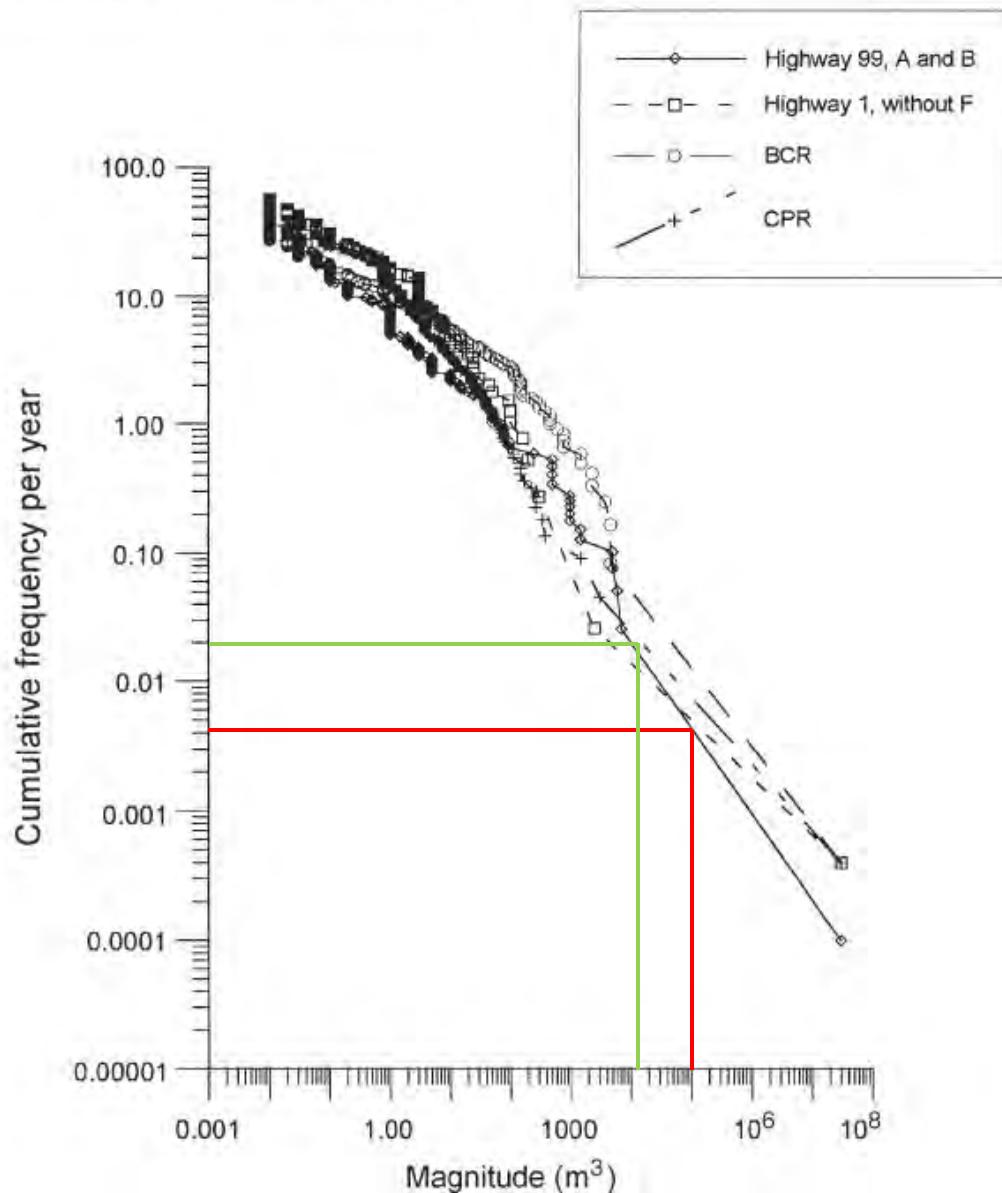
A report completed by Hungr (1999)⁴ was used to determine the probability of a rock fall with a magnitude of 10,000 m^3 and 100,000 m^3 . Hungr's report was utilized as it was completed in this geographic area to represent the frequency and magnitude of rock fall events that would reach Highway 99. Additional data from Highway 1, CP Rail and BC Rail were plotted by Hungr which correlated well with Highway 99 events. Our estimates indicate large rock falls are probable along this ridge at a frequency between 250 and 1250 years for the respective volumes noted above. This is illustrated on photo 11.

Dr Hungr's magnitude frequency relationship for transportation corridors in SW BC (Can Geotech J 36: 224-238 (1999))

Hwy 99- a 10k cubic metre event should reach the highway every 0.02 years (50 years).

Therefore, study area being 20% of Highway 99 length a 10K m³ event would be expected every 250 years (50/0.2) in this area, based on probabilities.

Hwy 99- a 100k cubic metre event should reach the highway every 0.004 years (250 years).

Therefore, study area being 20% of Highway 99 length a 100K m³ event would be expected every 1250 years (250/0.2) in this area, based on probabilities.

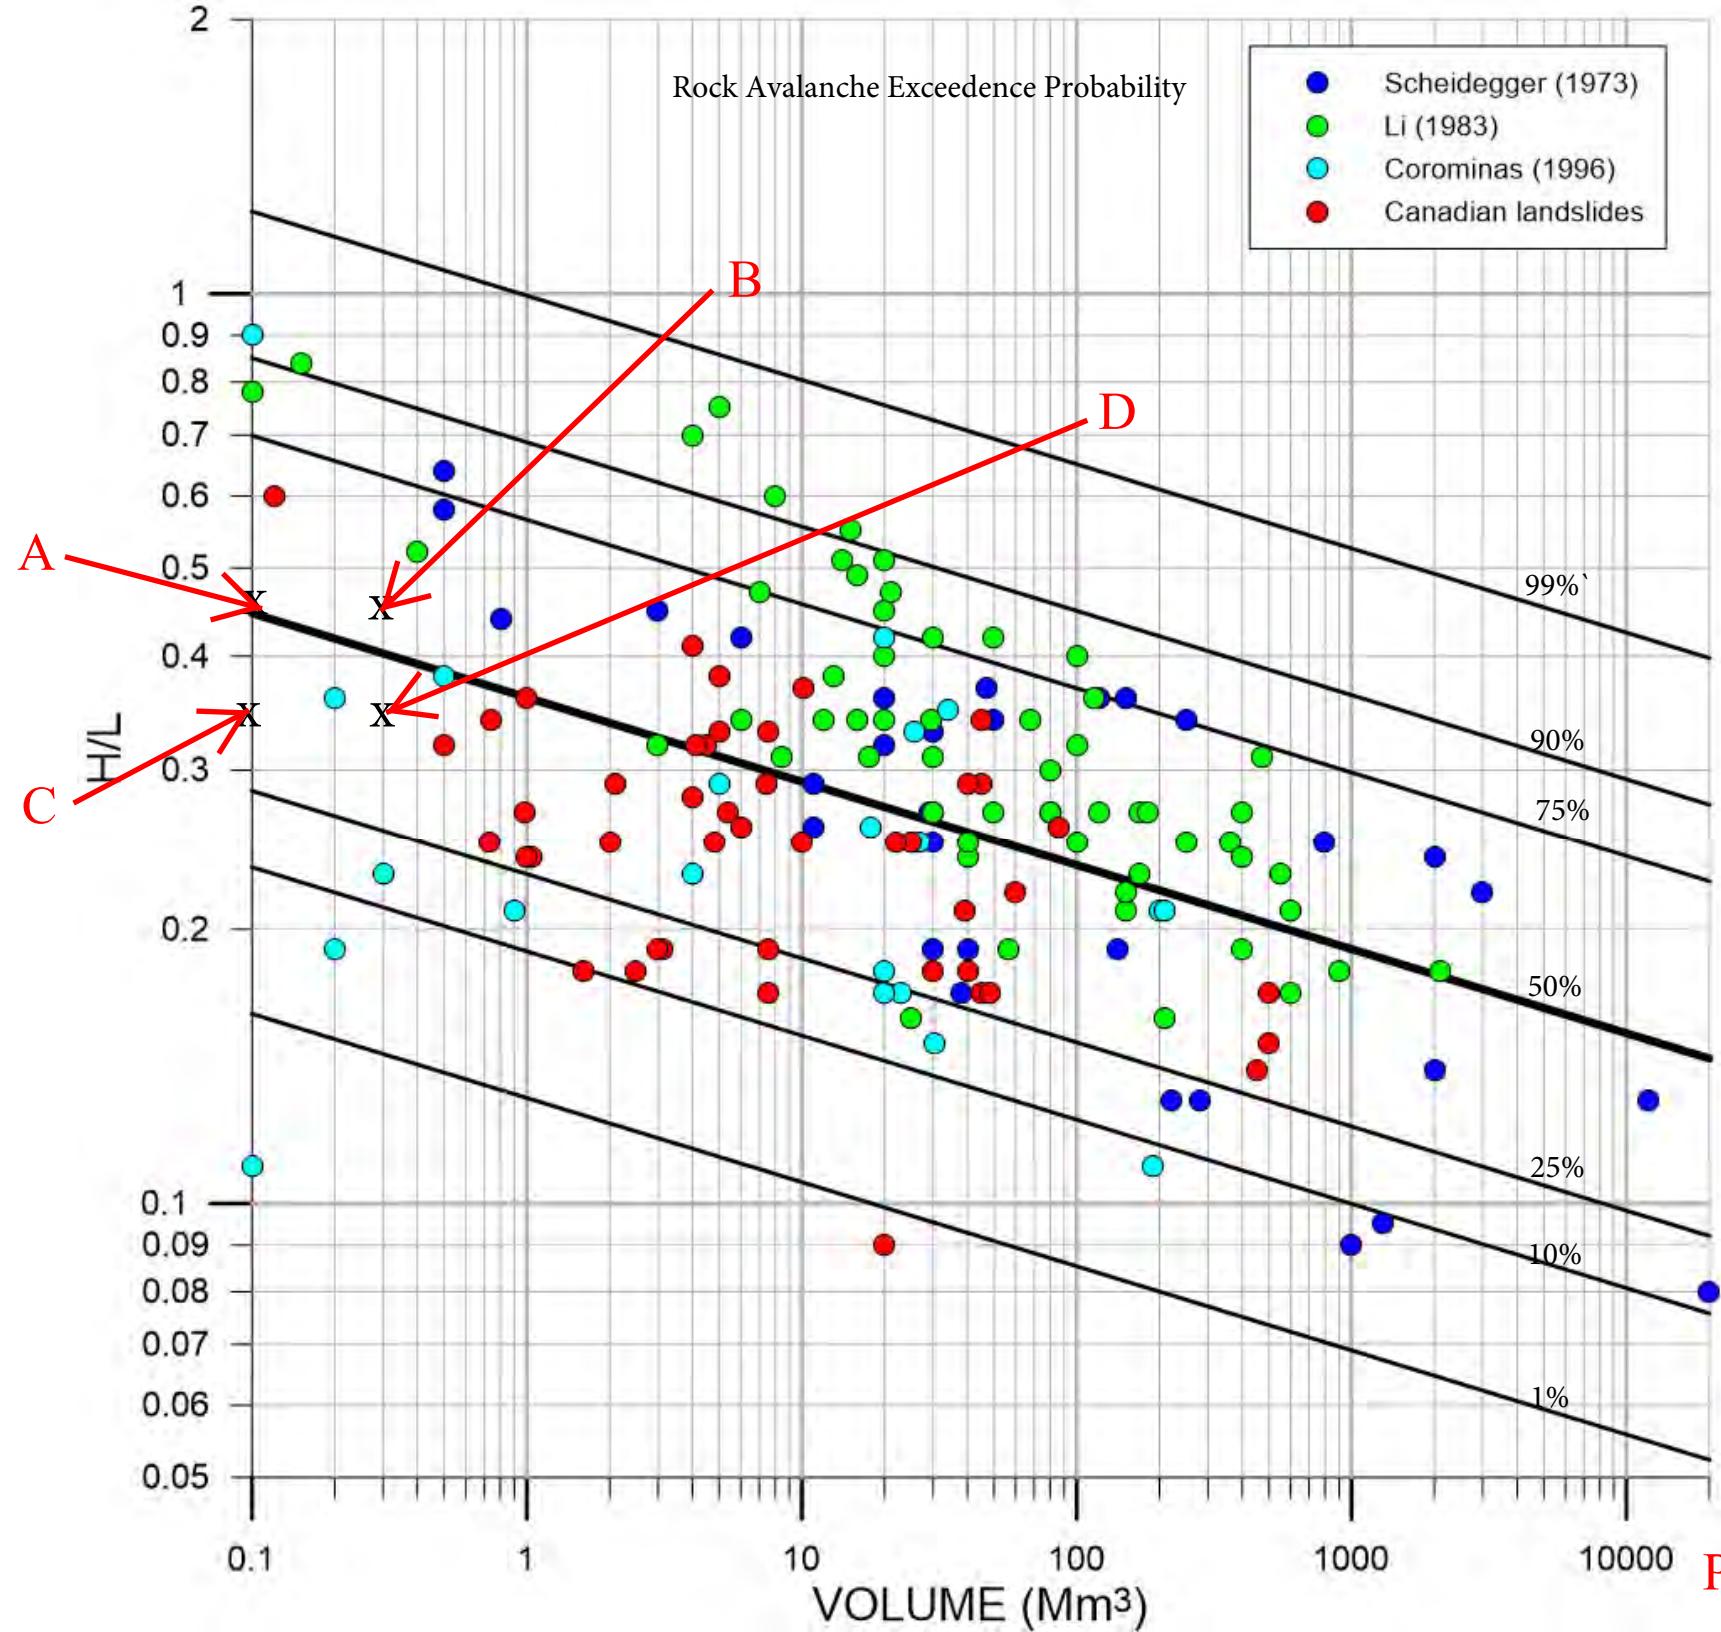
In a similar fashion we looked at the possibility of such events reaching the valley bottom and looked for the probability of an event of reaching the Green River and Lillooet River. In each instance, we assumed a rock failure of 100,000 m^3 and 300,000 m^3 which are conceivable given the "strongly foliated quartz diorites of Lower Jurassic age"⁵ and its competency. Photo 12 shows the probability of a 100,000 m^3 (Points A and C) denoted by X and 300,000 m^3 (Points B and D) rock avalanche reaching both the Green River and Lillooet River. The Green River reach is identified with points A and B. The Lillooet River reach is shown with point C and D.

The probability of a rock avalanche reaching the Green River was estimated to be in the vicinity of 50% and 60% respectively for a 100,000 m^3 (Point A) and a 300,000 m^3 (Point B) event. Similarly, the probability for a rock avalanche reaching the Lillooet River is in the vicinity of 35% and 42% respectively for a 100,000 m^3 (Point C) and 300,000 m^3 (Point D) event.
