Place Glacier Hazard Assessment Report

Debris Flood and Flow Hazards

October 16, 2025

Squamish-Lillooet Regional District

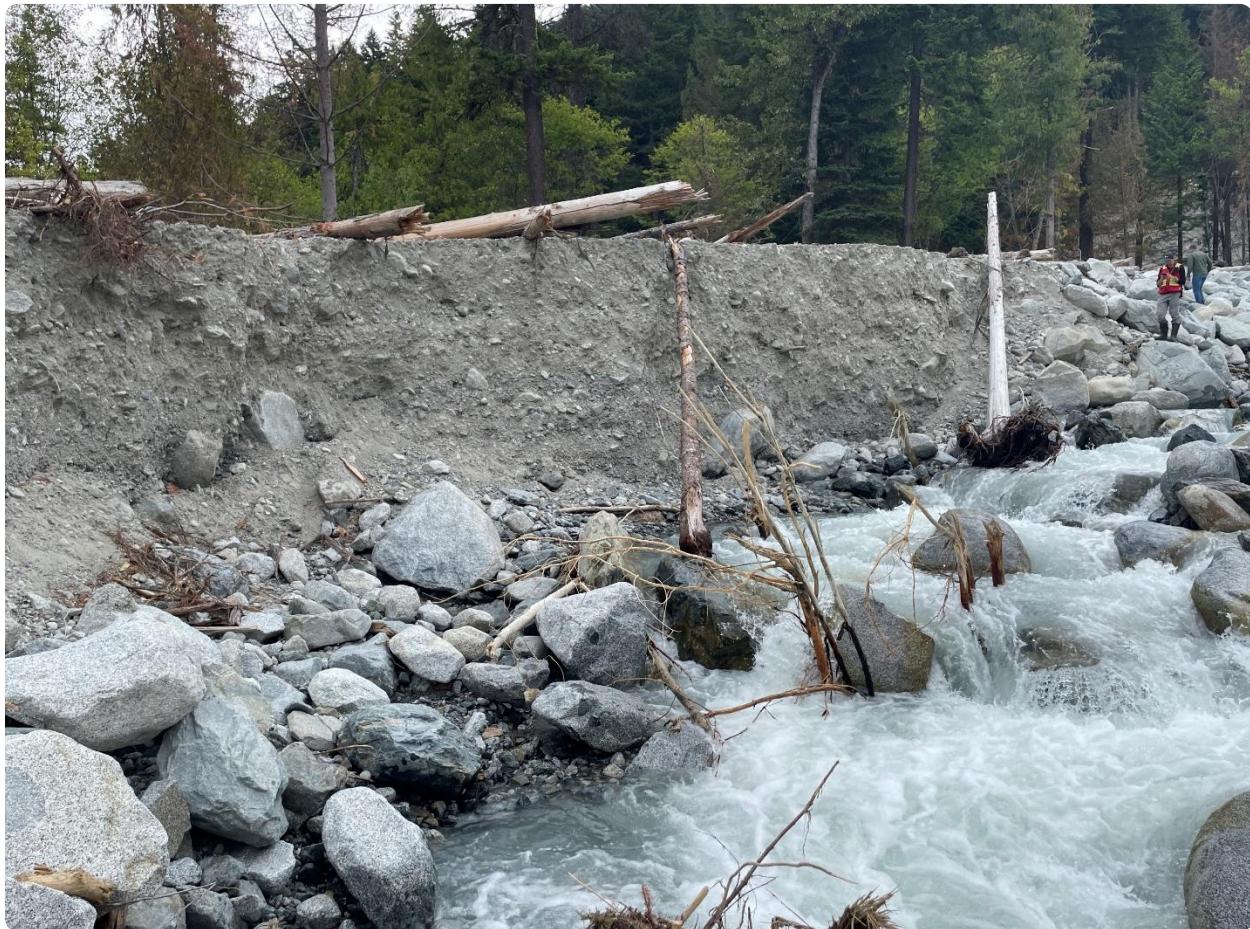
The ground-based debris flow hazard assessment found that the 2024 emergency response works had been damaged as a result of the 2025 Outburst Event. Within the steep mountainous section near the upstream extent of the 2024 emergency response works, sections of the embankment riprap had failed and the embankment had retreated back 2 to 3 m. At the location where the channel avulsed in 2024 only 2 to 3 m of crest width remain (Figure 2-5). Scouring of the bed occurred and the channel has incised down into the deposited 2024 sediments leaving the toe of the bank riprap undercut and perched in some locations.

Figure 2-5. Riprap Failure & Embankment Retreat – Looking Upstream (June 8, 2025)

As a result of the 2025 Outburst Event, the re-established embankment and riprap at the site where re-direction of Place Creek flow away from Poole Creek to Gates Lake occurred in 2024 has been damaged. Continued exposure of this damaged portion of embankment to glacial outburst events may result in further erosion and eventual breach of the embankment causing flow to route back towards Gates Lake (avulsion). Repairing the 2024 emergency works would provide temporary mitigation from a potential avulsion in response to a glacial outburst event similar in magnitude to the 2025 Outburst Event; however, it is unknown whether it could provide mitigation from a larger outburst event similar in magnitude to the 2024 Outburst Event. A conceptual design and opinion of probable cost has been prepared for the re-establishment of damaged 2024 Emergency Works along Place Creek in response to the 2025 Outburst Event. As glacial lake outburst events are anticipated to occur on an annual basis it is recommended that a more robust, longer-term option be considered. If a longer-term option cannot be implemented prior to the anticipated 2026 glacial lake outburst (historically between June and July) it is recommended that the emergency works be re-established no later than May 2026.

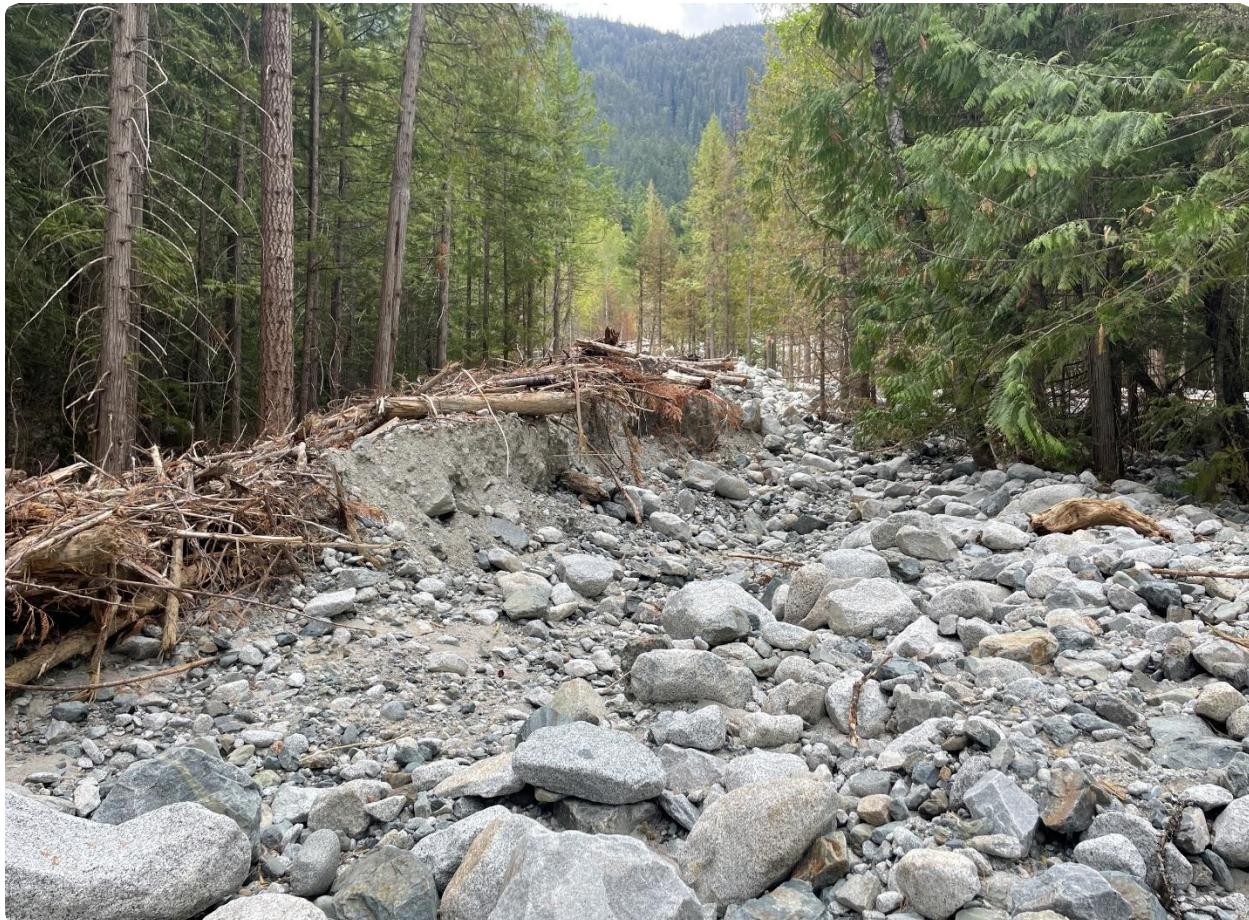
Figure 2-6. Erosion at Downstream Extent – Looking Upstream (June 8, 2025)

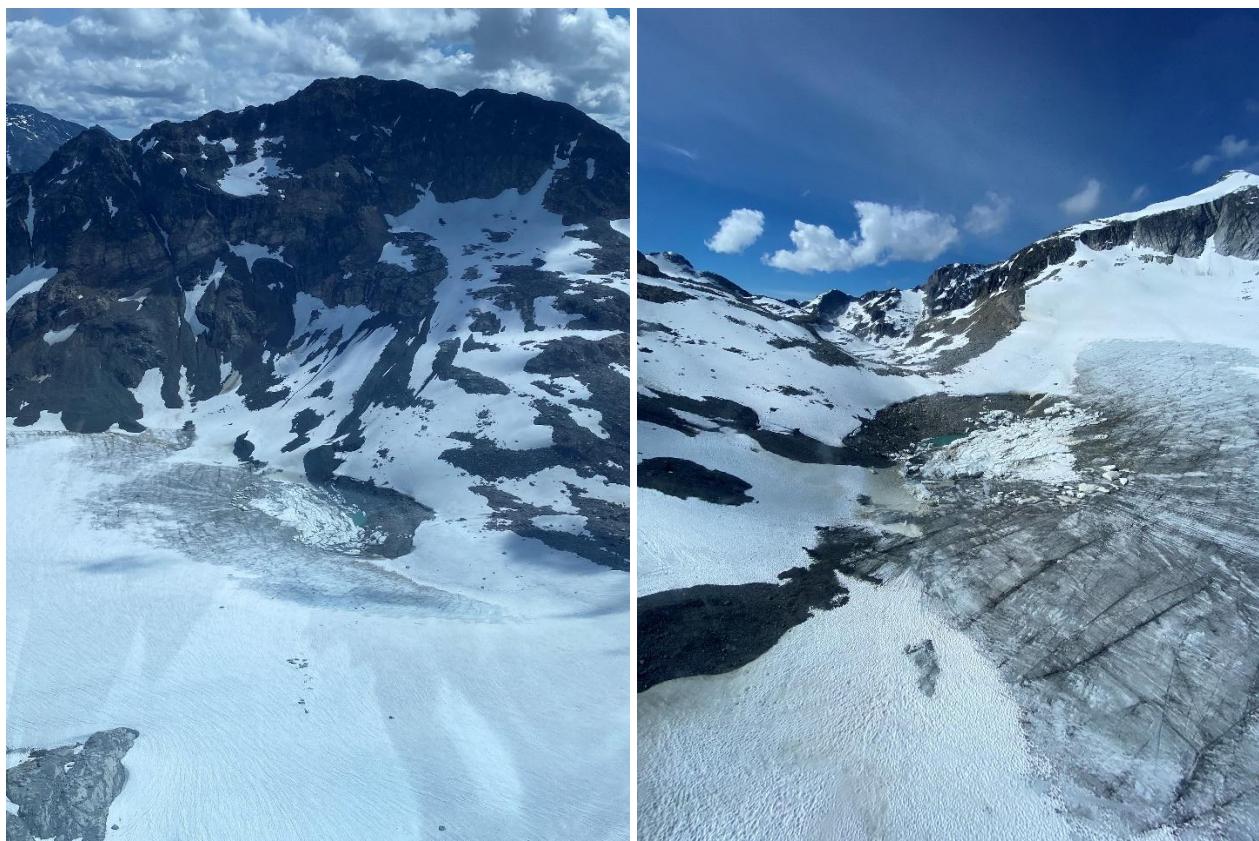
Based on the observed condition of Place Glacier (i.e., the extent and inferred volume of ice remaining), it is anticipated the upper lake area will continue to impound water again over time and pose a similar threat in the future. The rate of this is unknown at this time and was not ascertained during this assessment.

Figure 3-3. (Left) Viewing north at the upper cirque lake (supraglacial lake). (Right) Viewing east at the same lake for varied perspective. Some standing water was observed in the lakebed.

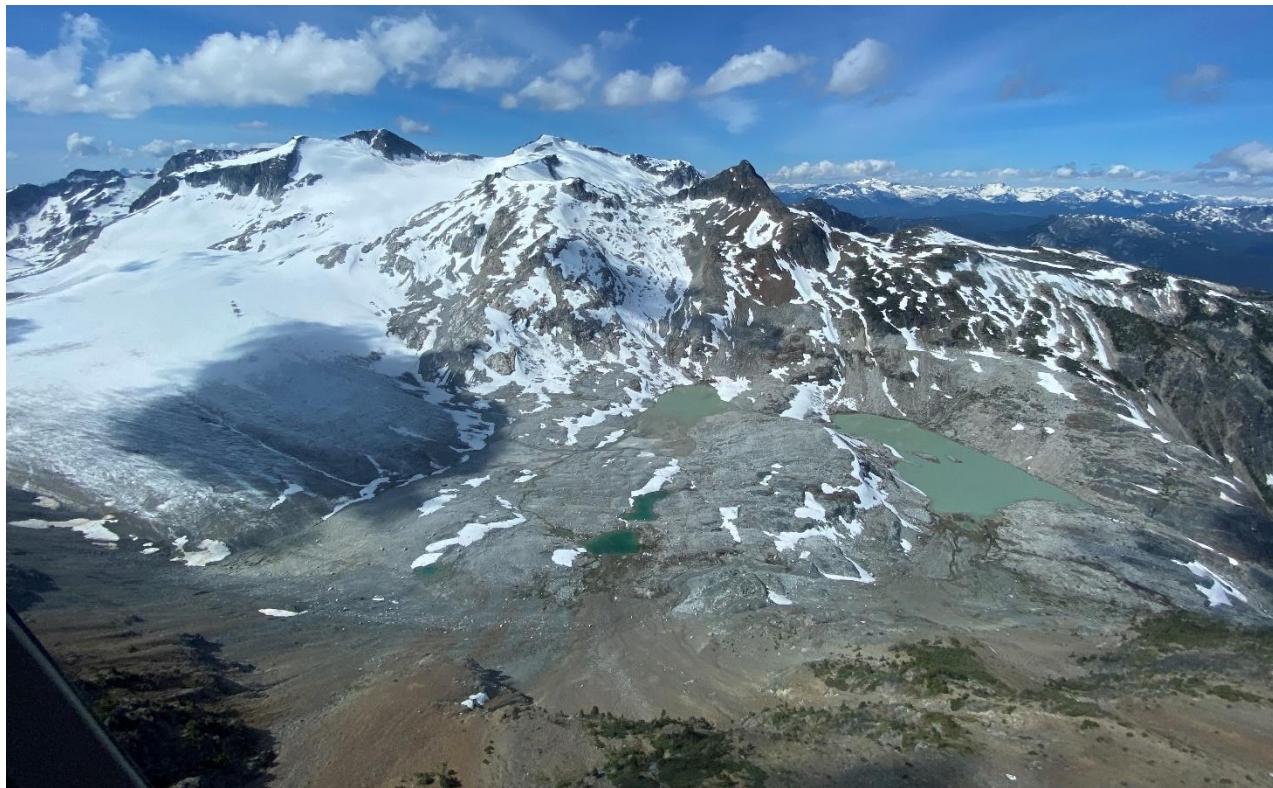
Some localized faults and areas of poor bedrock quality were identified in the steep bedrock slopes and buttresses in the upper cirque. Slope stability along the upper elevation bedrock slopes was inferred to be variable with most areas being deemed susceptible to continued mass wasting. No evidence that would indicate an imminent threat to public safety was observed (e.g., a landslide event that may enter the lower cirque lakes and initiate an outburst flood).

Figure 3-4. Viewing south-southwest at distal limb of the glacier and steep slopes above the lower cirque lakes. (Note: the supraglacial lake (source of the outburst event) is just out of frame to the photo left).

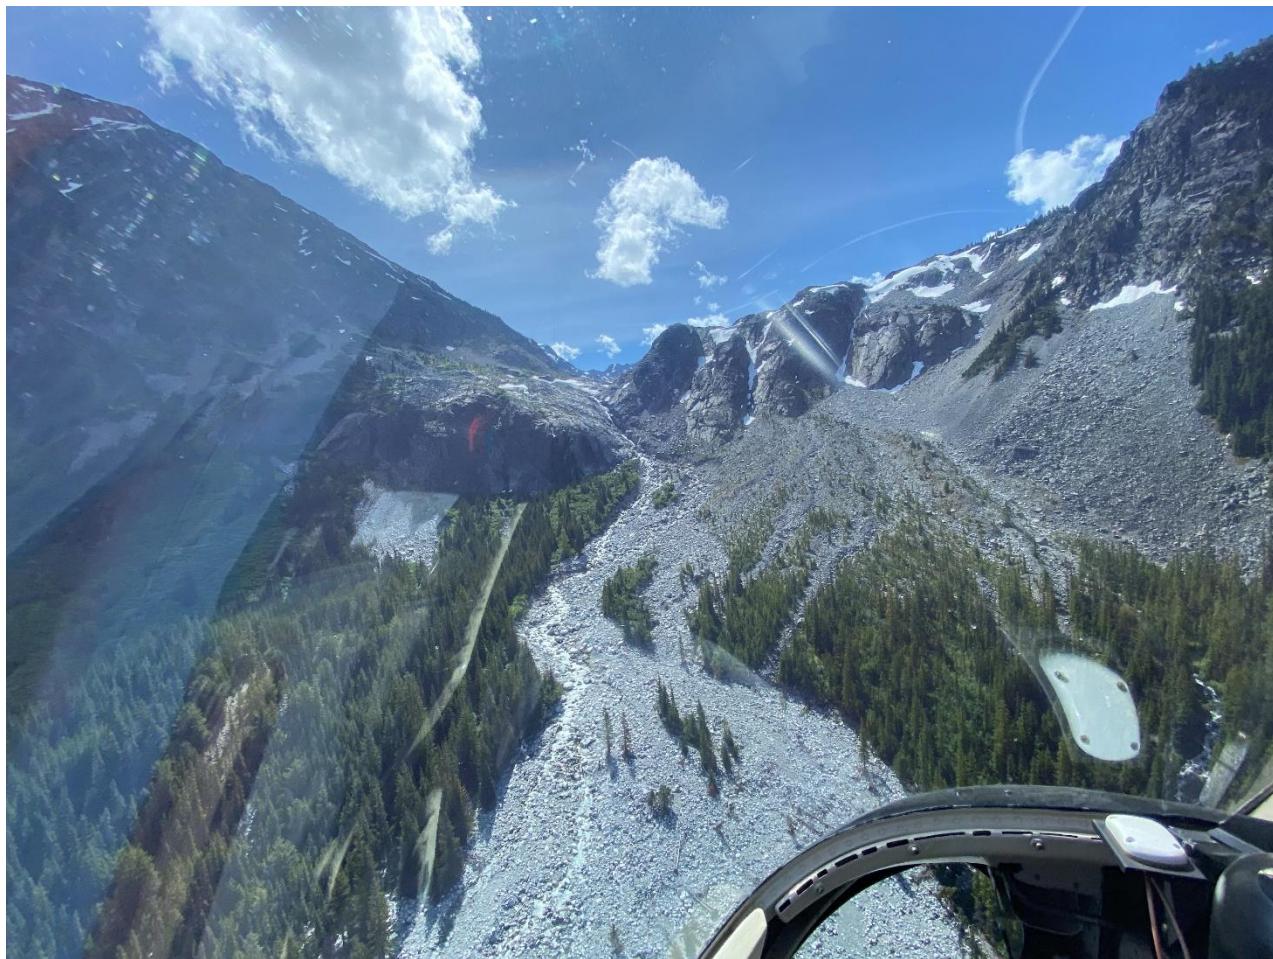
outburst event. This will contribute to stream bulking and consequently elevates debris flood and landslide (debris flow) hazard down gradient.

Figure 3-5. View of the outlet of cirque lakes. Evidence of debris flows were identified here.

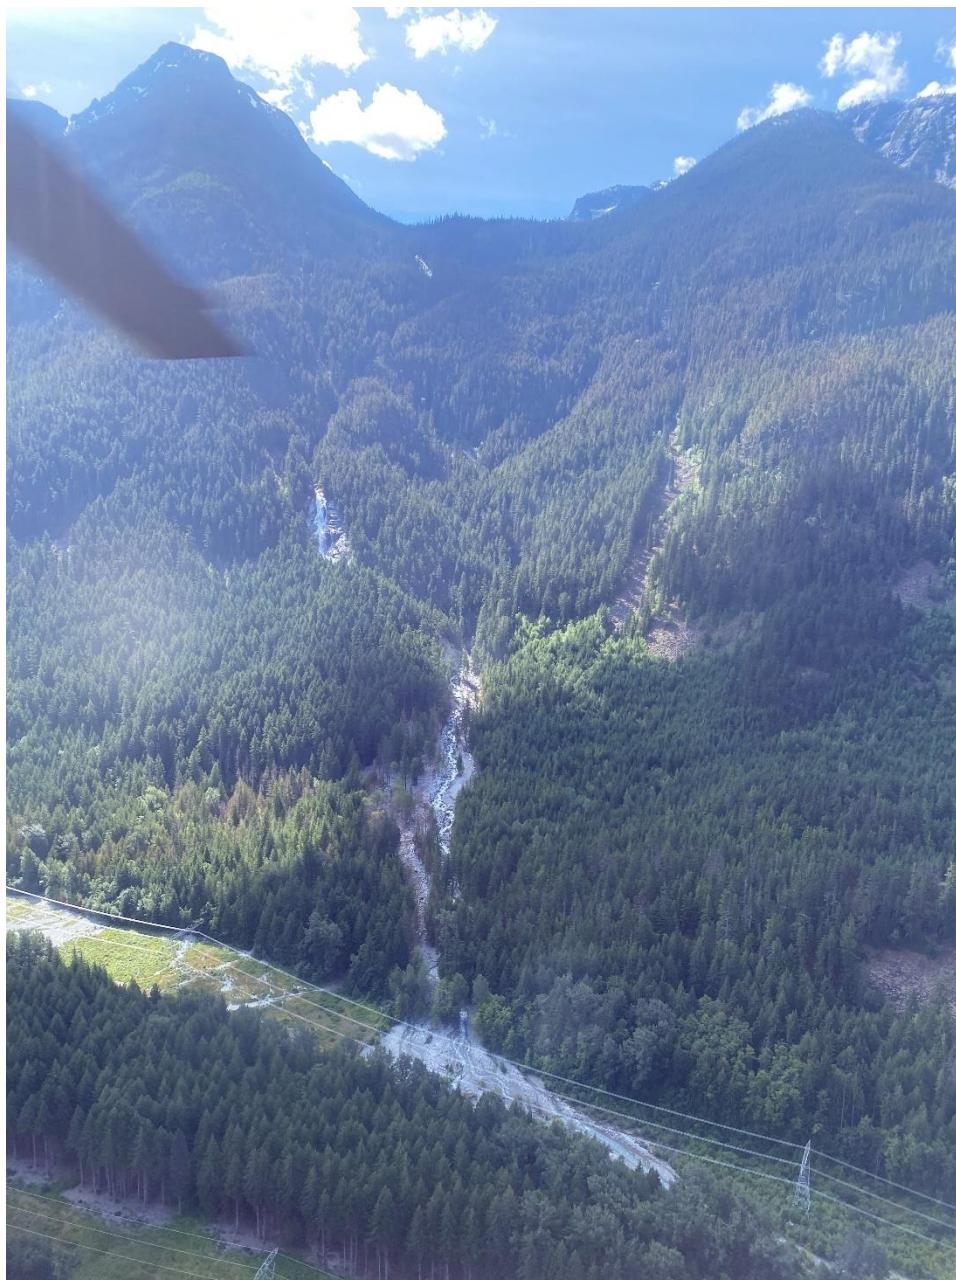
At the time of the assessment, flow from Place Creek was directed south to Poole Creek; however, evidence of recent stream flow and flooding – both overland flows and channelized flows - were observed along the BC Hydro right-of-way towards Gates Lake. The flow along these areas of the right-of-way appeared ephemeral, and where water was observed, it appeared stagnant at the time of the assessment.

Figure 3-6. Overview of flood deposits in lower reach of Place Creek. Flow can be observed flowing south (image right) towards Poole Creek.

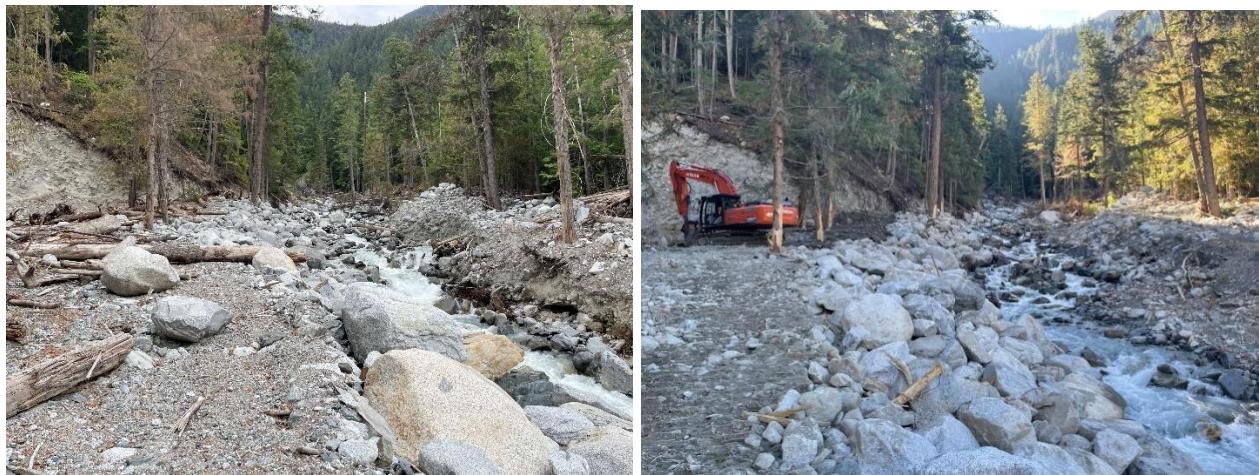
At the furthest upstream extent of the 2024 emergency response works the channel had scoured and incised down into the sediments deposited during the 2024 outburst event which had resulted in undermining of the right bank riprap toe in localised areas. In these areas the riprap was perched above the channel bed and unstable (Figure 3-10); however, the majority of the riprap was in good condition with tightly interlocked stones, minimal voids and little evidence of slumping or displacement – a comparison of 2025 to 2024 conditions is provided in Figure 3-9. The unprotected left bank of the channel experienced erosion and retreat resulting in near vertical 2 to 5 m high bank slopes (Figure 3-11).

Figure 3-9 Looking upstream at upstream extent of 2024 emergency recovery works. Left image is 2025 and right image is 2024.

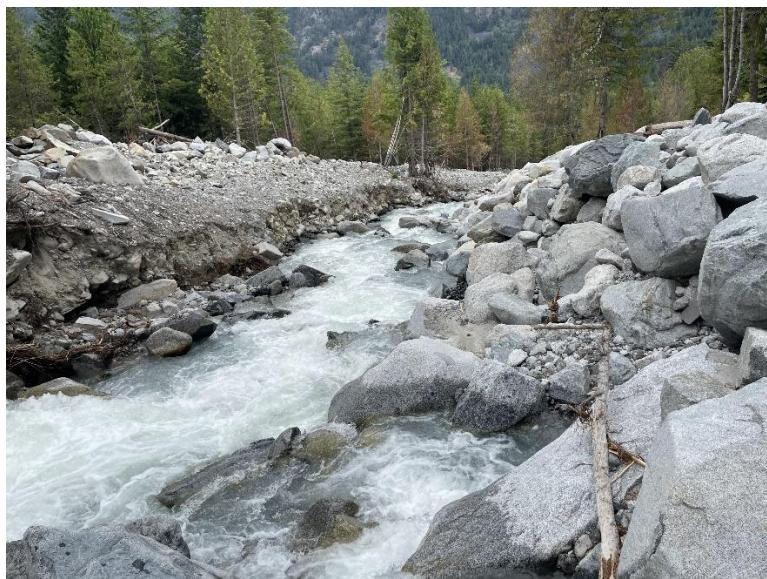
Figure 3-11 Looking downstream at scoured and incised channel and eroded left bank from upstream extent of 2024 emergency response works.

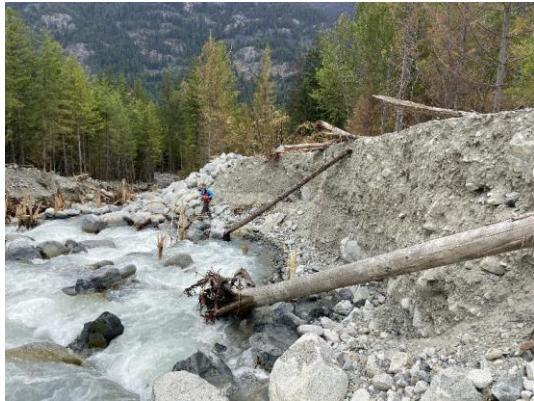
These channel conditions continued downstream for approximately 80 m. At this location approximately 20 m of the right bank riprap failed and the bank eroded back resulting in a vertical 4 to 5 m high wall (Figure 3-12). Following the 2024 emergency works the crest of the right embankment at this location was approximately 5 m wide before dropping down to the 2024 outburst avulsion channel. The crest width is now 2 to 3 m wide and lacking erosion protection. Further bank retreat at this location could result in an avulsion and routing of flow potentially back along the 2024 outburst event avulsion alignment towards Gates Lake.

Figure 3-12 Looking downstream towards failed riprap and vertical face of eroded embankment

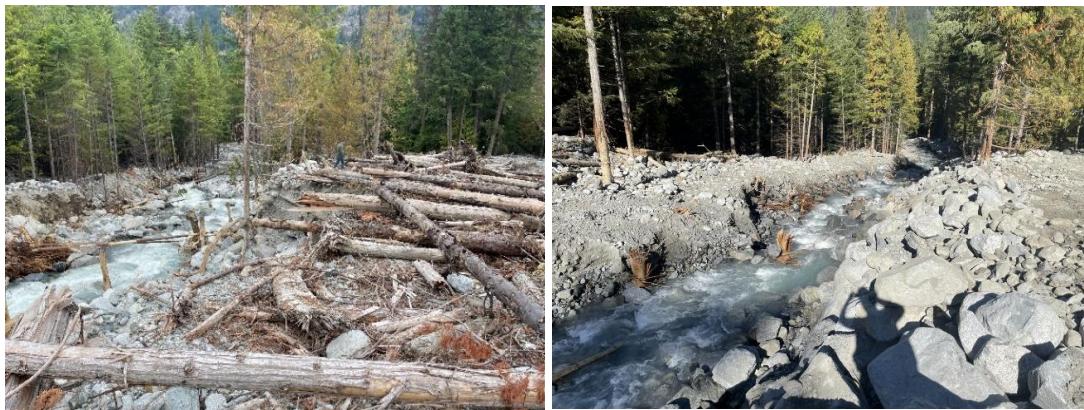
The right bank riprap extending approximately 30 to 40 m downstream from this location was in good condition with tight interlocking of stones and no scouring or undermining of the toe observed. At this location the channel had incised down into the 2024 outburst sediment and exposed a stand of trees. Flow appears to have been deflected by this stand of trees and concentrated along the right bank resulting in failure of the riprap along a 20 m long section of channel (Figure 3-13). At this location the crest width following the 2024 emergency recovery works was approximately 10 m wide before gradually tapering down into the forested mountain terrain. The bank erosion has reduced the crest width to approximately 7 m wide at this location – an avulsion of the channel due to further bank retreat at this location is not anticipated.

Figure 3-13 Looking downstream towards failed riprap

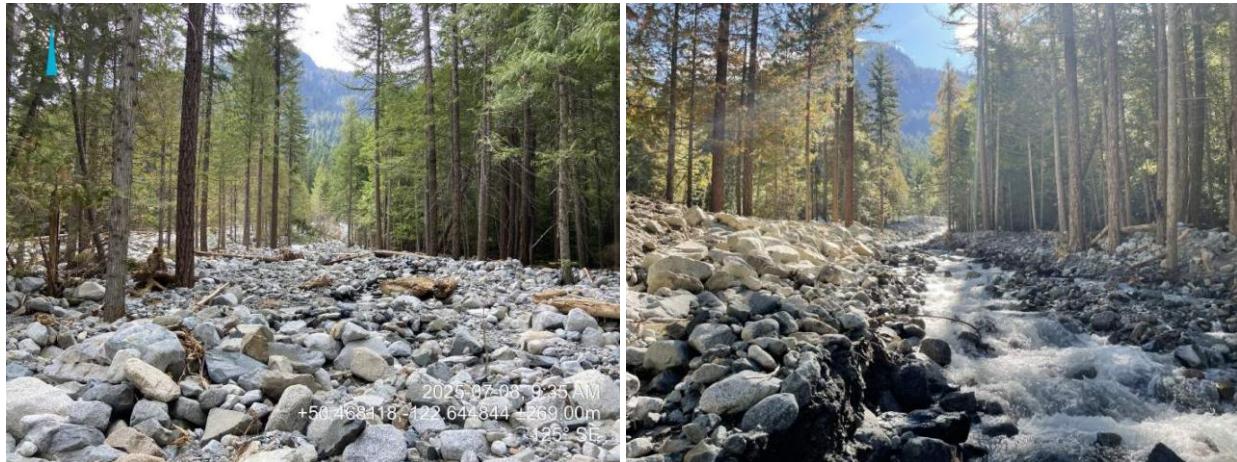
The channel continues downstream from this location a further 40 m with the right bank riprap in good condition and channel incised down into the 2024 outburst sediment. At this location the gradient flattens out and 2025 outburst sediment appears to have deposited, filling the 2024 emergency response channel (Figure 3-14). Flow is now being conveyed through multiple channels incised into the 2025 outburst sediment extending from the left valley wall to the 2024 emergency response east embankment (Figure 3-15).

Figure 3-14 Looking upstream where channel gradient flattens and 2025 outburst sediment has filled the 2024 emergency response channel (left image 2025, right image 2024)

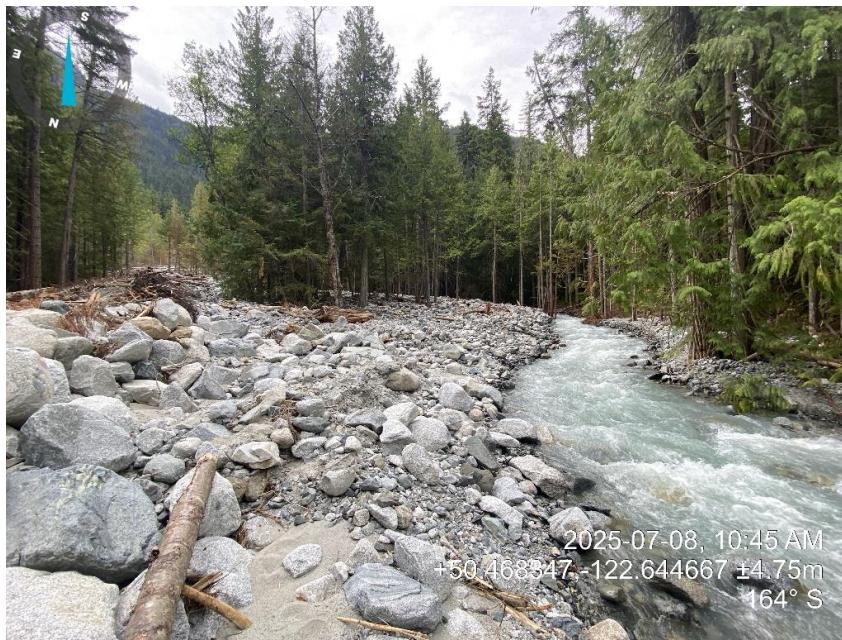
channelization within the deposited sediment along the right riprap embankment indicate that flow during the 2025 outburst event had encroached upon the right embankment (Figure 3-16).

Figure 3-16 Looking upstream at re-channelized flow along the 2024 emergency response channel alignment and deposited sediment and large woody debris along the right riprap embankment

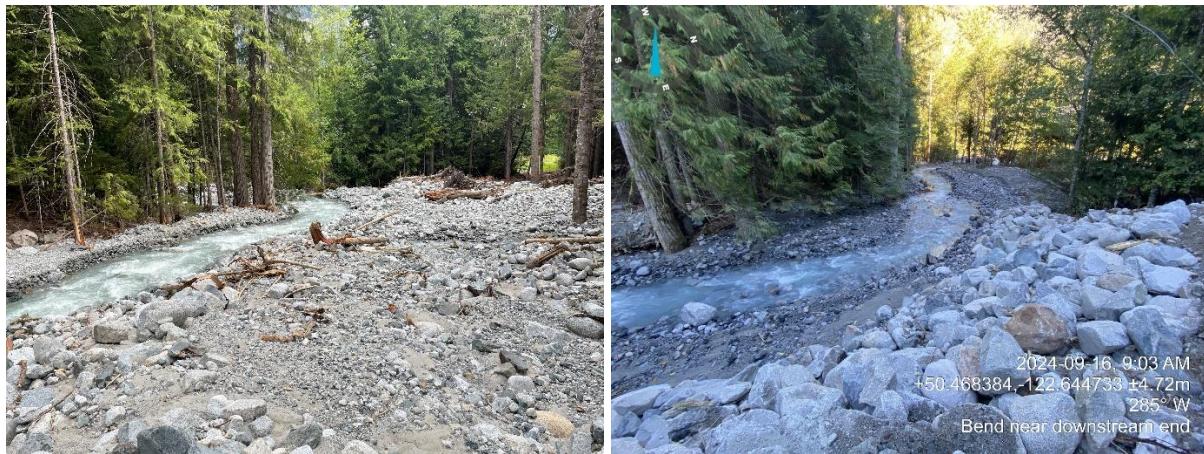
At the downstream terminus of the right embankment riprap flow overtopped the right embankment, evidenced by woody debris and fine sediment deposited along the crest of the embankment and through the adjacent forest, resulting in failure of the riprap and the placed embankment fill (Figure 3-17 and 3-18). At the time of the assessment this area was dry; however, based on deposited fine sediment and woody debris flow appears to have been conveyed 40 m past this failed section of embankment east through the forest towards the Pemberton Plateau but then routed back west and rejoined Place Creek.

Figure 3-17 Looking downstream at terminus of right embankment riprap (left image 2025, right image 2024)

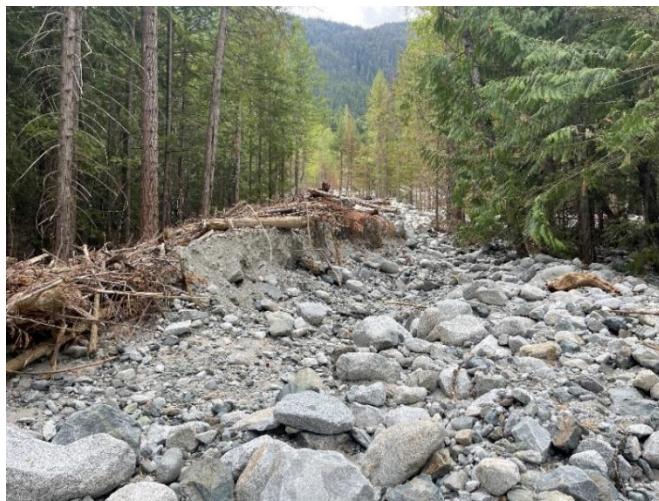
Figure 3-18 Failed portion of right embankment and riprap

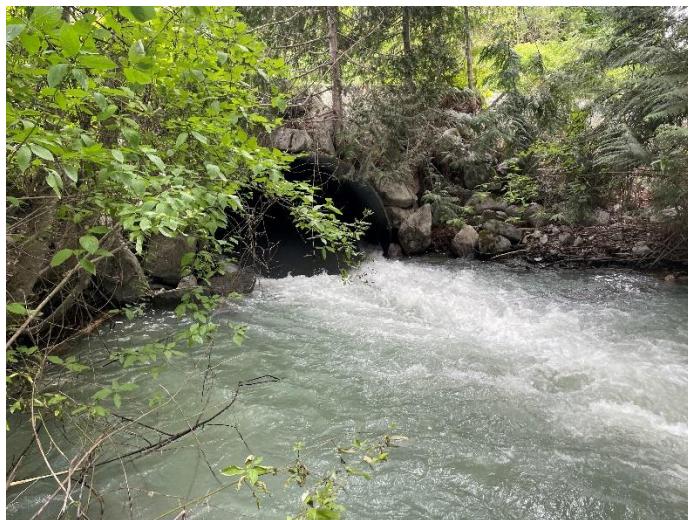
The outlet of the culvert is perched approximately 0.5 m above the channel bed and a scour hole of unknown depth or length has formed immediately downstream of the outlet. 500kg to 1000kg MOTT class riprap is placed along the end slope and adjacent embankment slopes; however, the toe of the riprap has been undermined by scour and the riprap is slumping down into the channel (Figure 3-27).

Figure 3-27 Looking upstream at Poole Creek Road culvert outlet

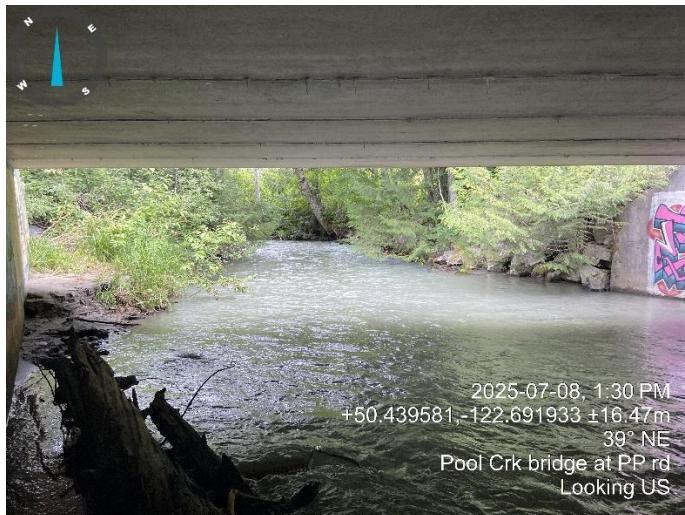
The Pemberton Portage Road bridge crossing of Poole Creek is located approximately 130 m upstream from the Poole Creek confluence with the Birkenhead River. The bridge (girder type unknown) has a span of 11.7 m and a distance from the low chord to the channel bed of 2.7 to 3 m (Figure 3-30).

Figure 3-30 Looking upstream at channel from below Pemberton Portage Road Bridge

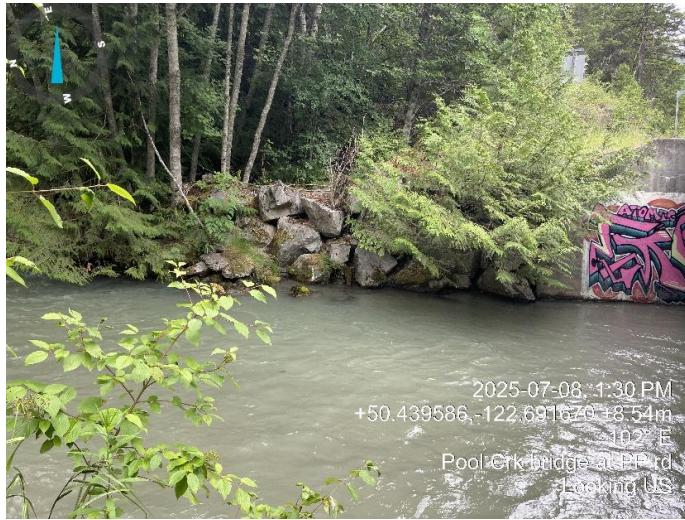
Figure 3-32 Estimated 250-kg MOTT class riprap along upstream left bank of wingwall

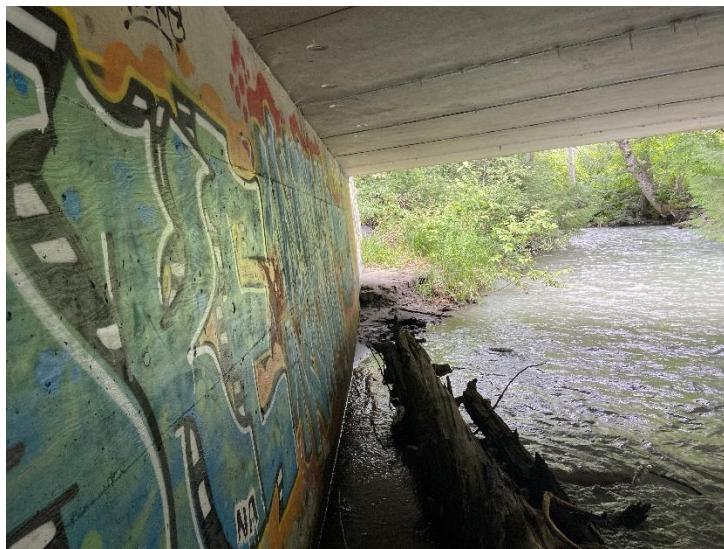
Approximately 0.2 to 0.3 m of sediment deposition was observed along the upstream right bank; however, grassy vegetation had established through it indicating this was likely deposited during the 2024 outburst event (Figure 3-33). SLRD indicated that during the 2025 outburst event there was approximately 1.5 m of clearance from the water surface to the low chord at the downstream face of the bridge.

Figure 3-33 Evidence of sediment deposition along upstream right bank of Pemberton Portage Road Bridge
