**GEOTECHNICAL ASSESSMENT  
Residential Development  
9000 Block, Highway 99, Whistler, BC**

Document Type: Final

Date: September 10, 2025 (Version 1)

Project No.: **K-180335-00**

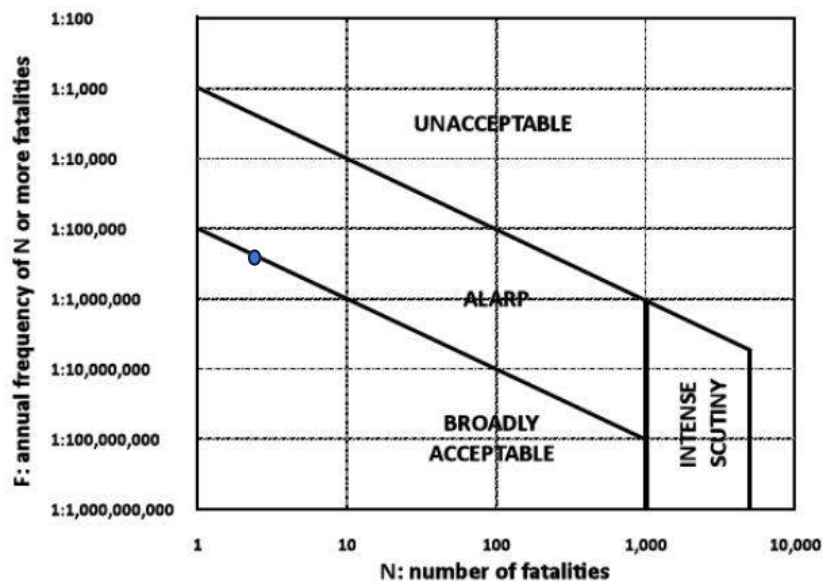
Figure 11-2. Frequency – Number of Fatalities Diagram

Alternatively, the point of 1: 222,000 and N=2 plots within the Broadly Acceptable portion of the F/N Threshold lines for Hong Kong (Number of Fatalities Diagram).

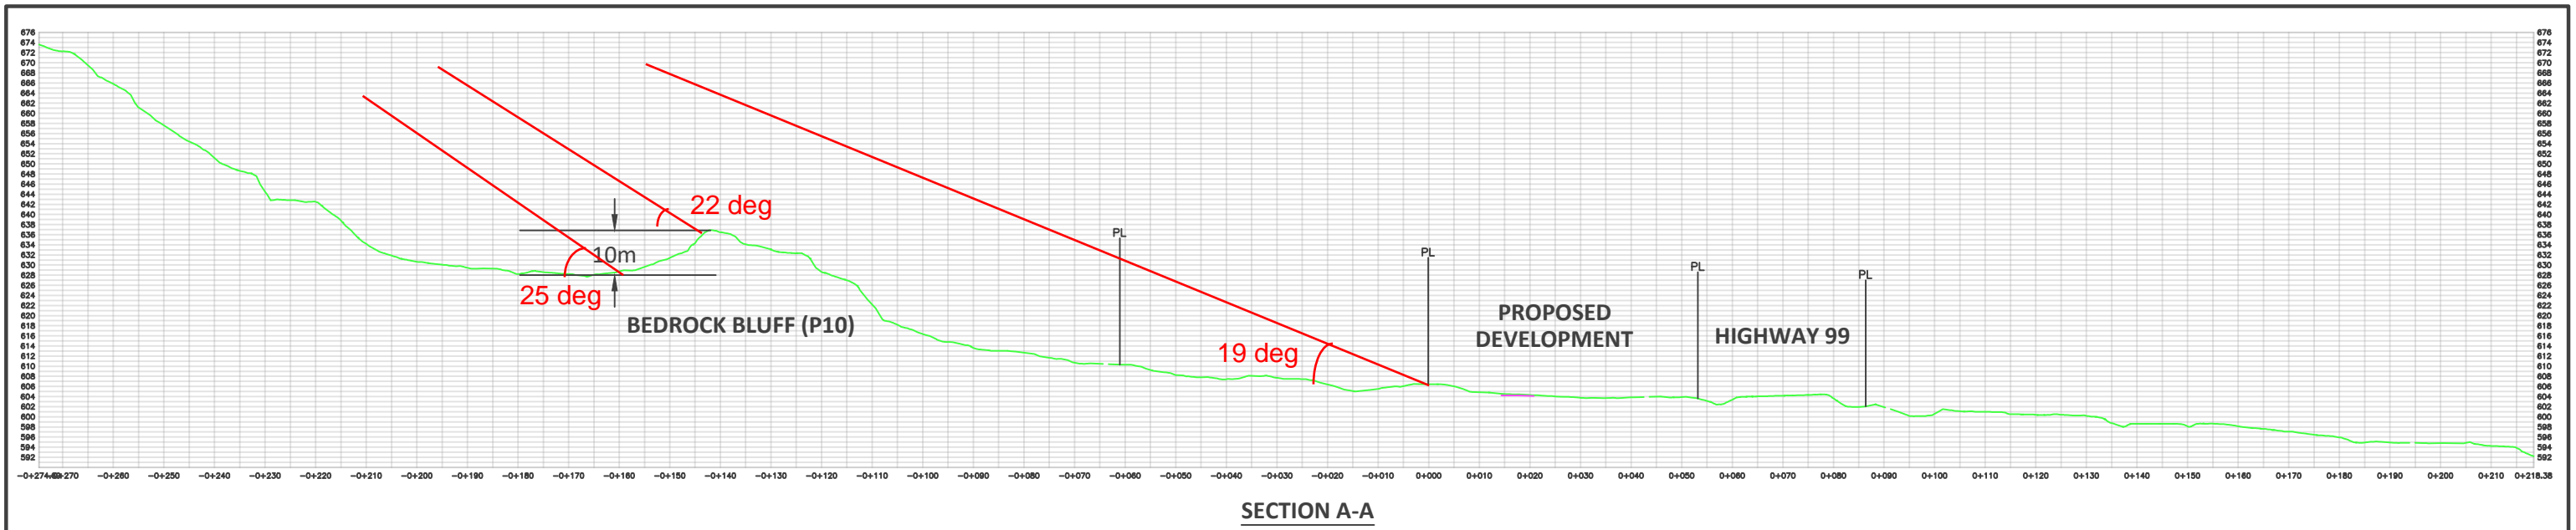
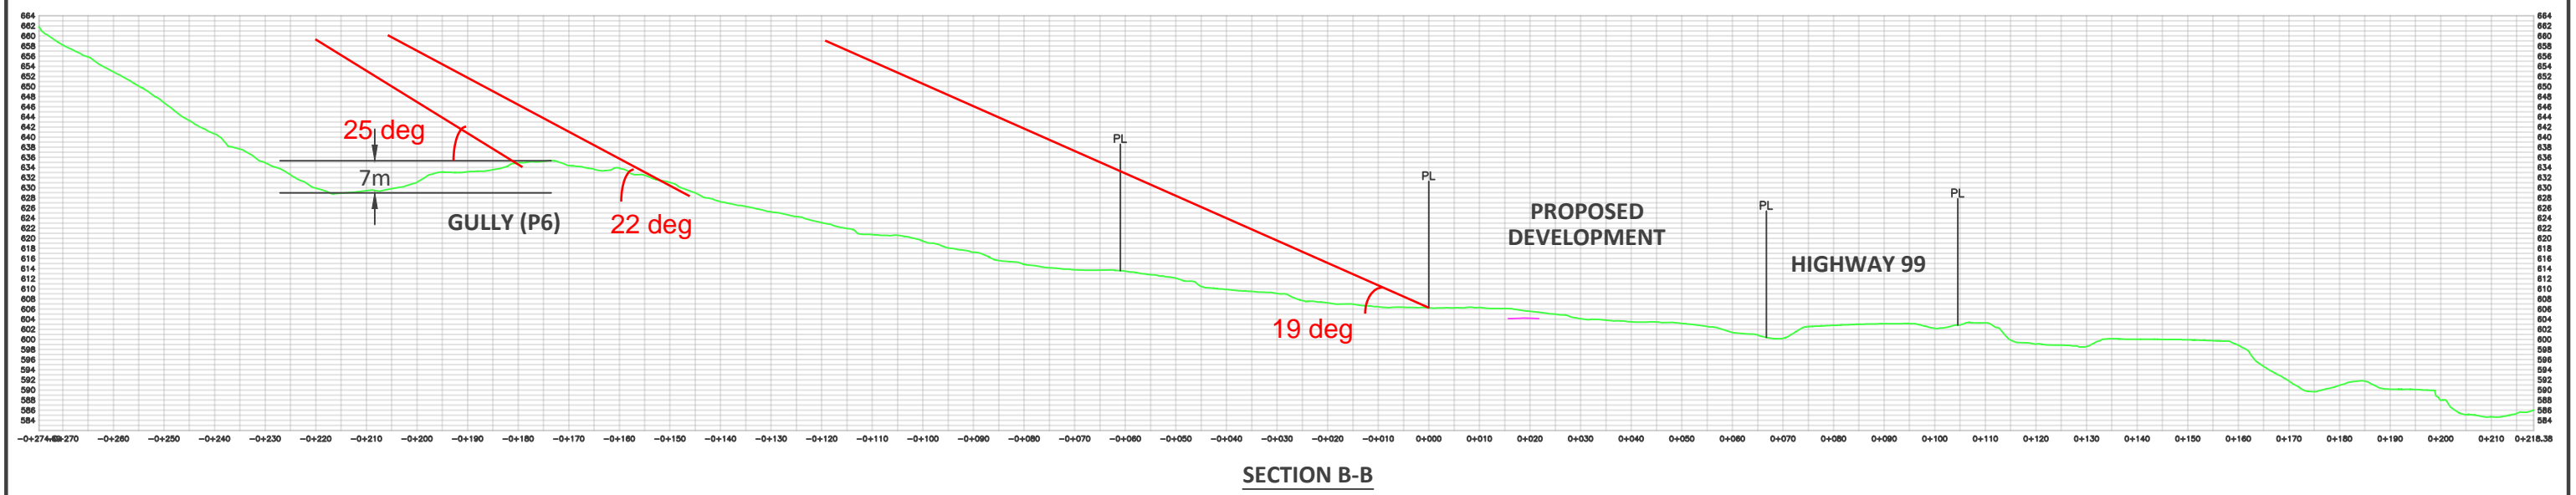
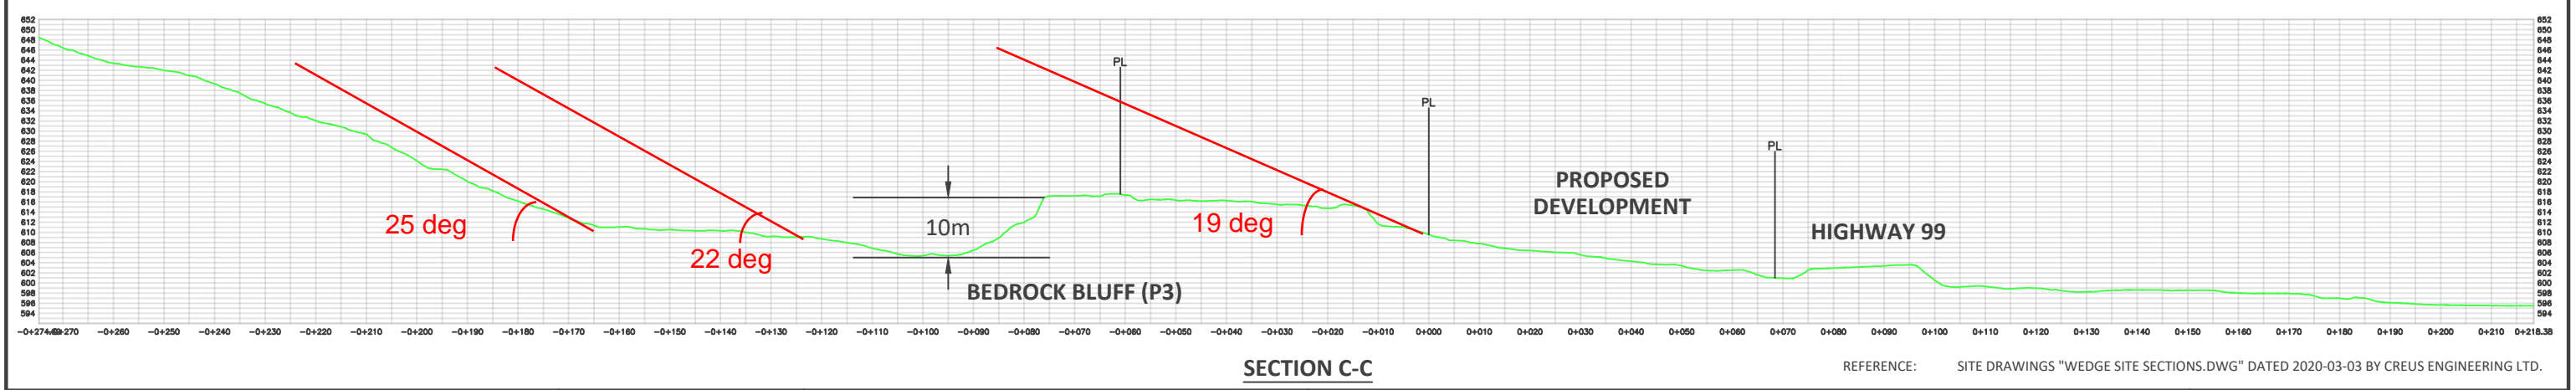
West of the southern portion (see Profile A-A) of the proposed subdivision, the east facing slope steepens to about 6H: 1V for a horizontal distance of about 110m then transitioning to a 1.8H: 1V inclined slope for

West of the central portion of the proposed subdivision (see Profile B-B), the east facing slope steepens to an inclination of about 5H: 1V over a horizontal distance of about 140m then transitioning to an inclination of about 2H: 1V for a horizontal distance of about 20m. Topography then flattens for a distance of about 40m transitioning to a west facing slope inclined at about 2H: 1V for a distance of about 30m.

West of the northern portion of the proposed subdivision (see Profile C-C), the east facing slope steepens to an inclination of about 1.7H: 1V for a horizontal distance of about 15m then transitioning to a level surface for a distance of about 60m. West of the flat lying area there is a steep west facing slope inclined at about 1.3H: 1V for a distance of about 15m. Site reconnaissance of the west facing slope indicates it is generally comprised of very steep to near vertical bedrock bluffs about 10m in height.

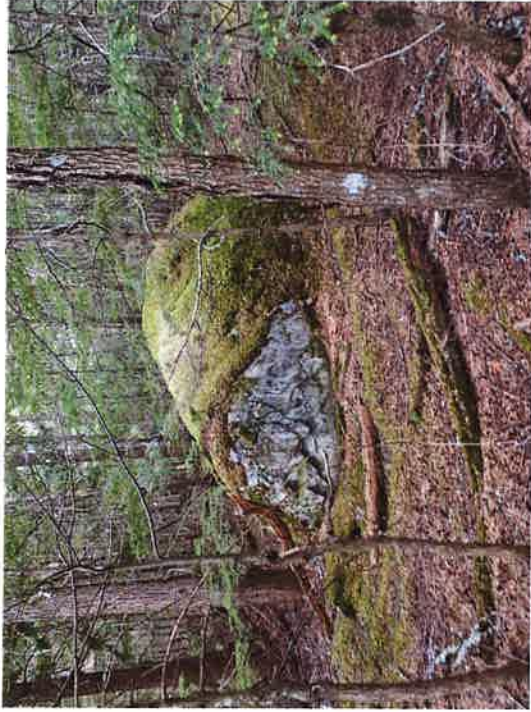
Photo 1 – Large Isolated Rounded Boulder Within Proposed Development Site – Substantial Burial

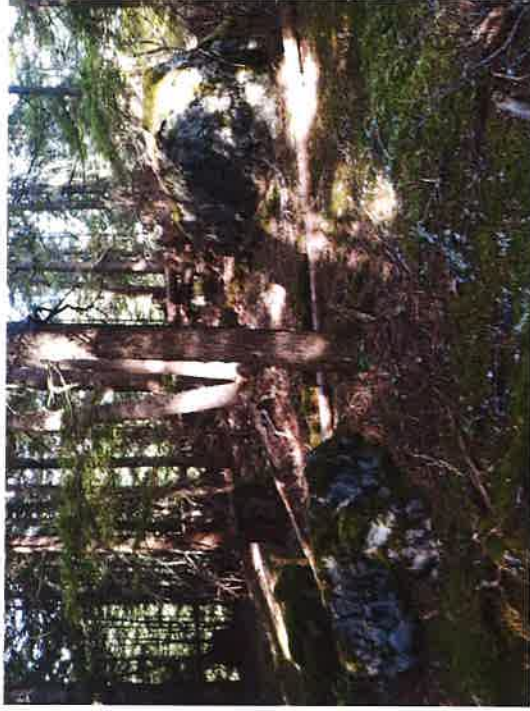
Photo 2 – Large Rounded Boulders Substantially Buried, Above Proposed Development Site – P1

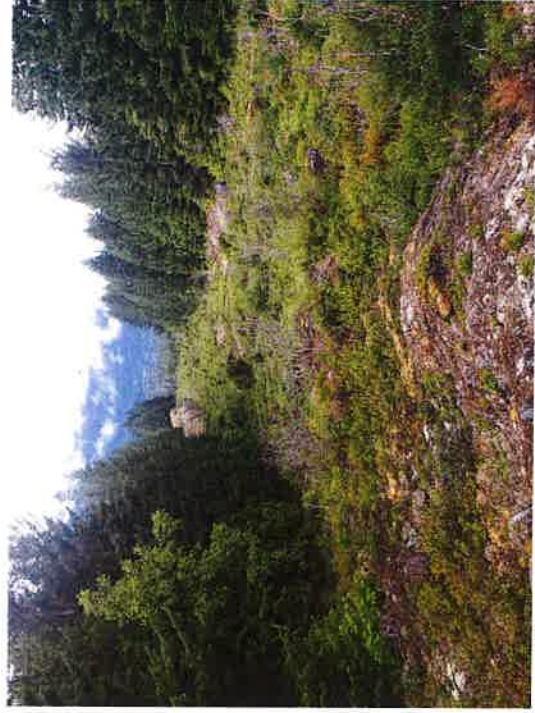
Photo 3 – Looking North BC Hydro Right-of-Way – Bedrock – P2

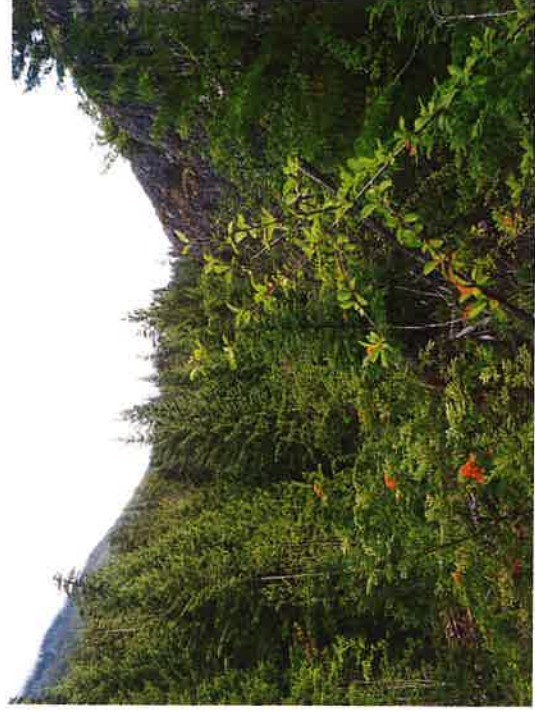
Photo 4 – Near Vertical Bedrock Bluff Facing West (Upslope) about 10m height – P4

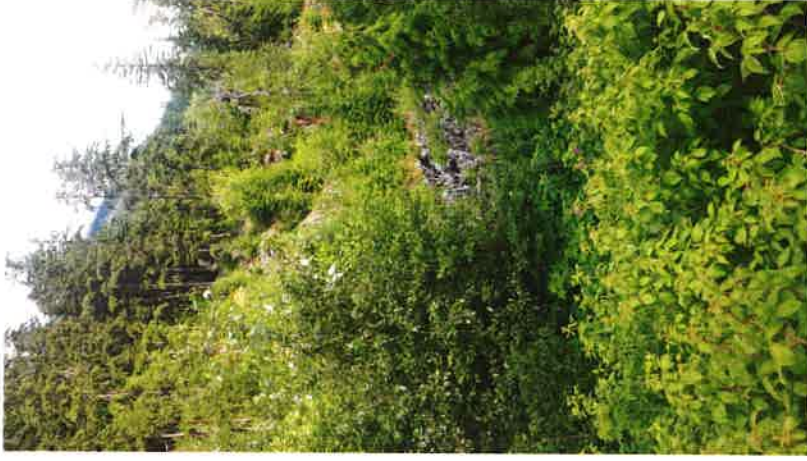
Photo 6 – Gully Oriented North-South – P6

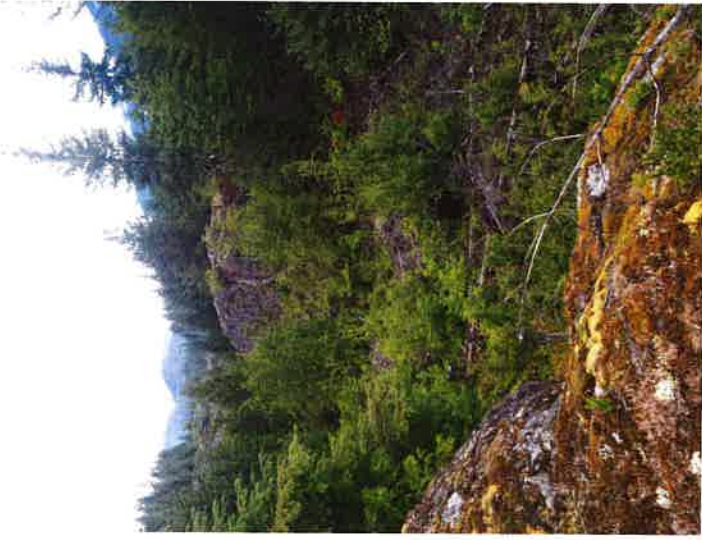
Photo 5 – Bedrock Bluff (Photo 4) From Above

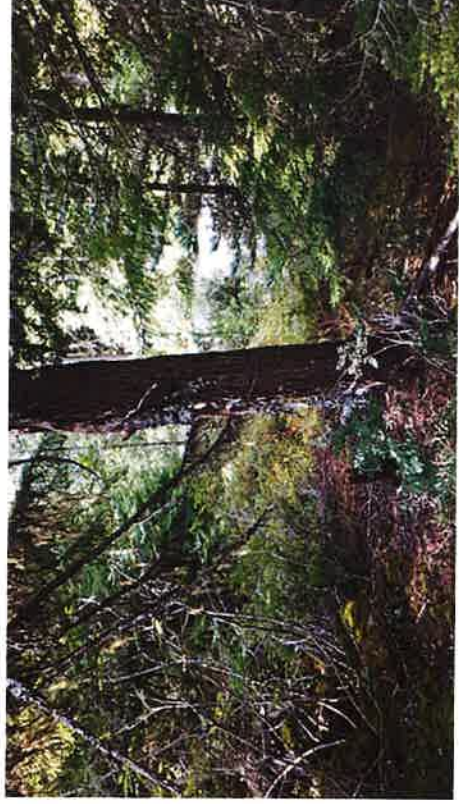
Photo 7 – Top of Bedrock Bluff Facing Upslope – P9

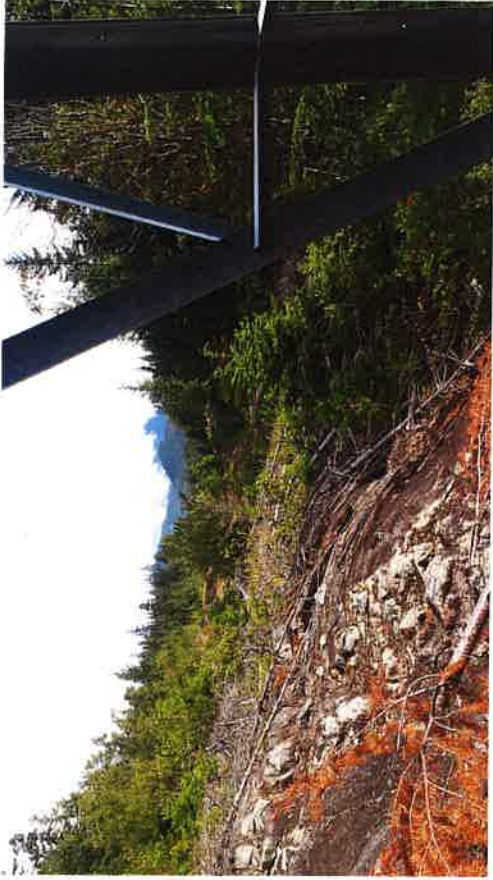
Photo 8 – Bedrock Outcrops in BC Hydro Right-of-way – P11

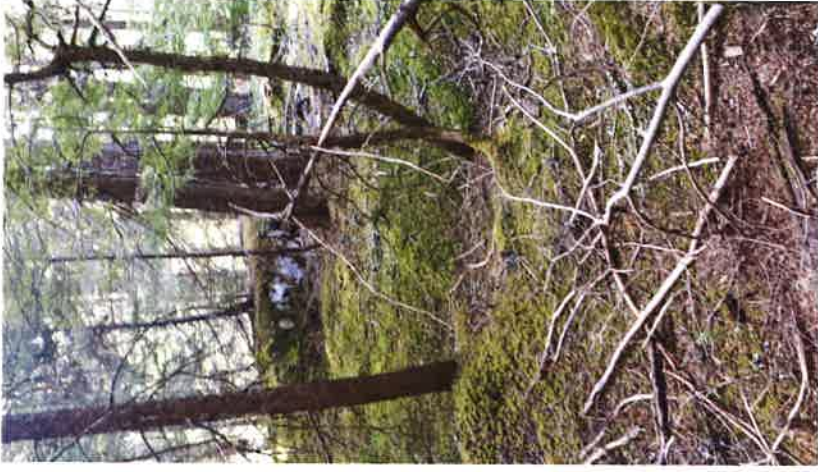
Localized bedrock outcrops were noted within the proposed development in several locations. West of the proposed subdivision bedrock outcrops become more common and dominate the ground surface.

Photo 10 – Bedrock Outcrop Within Proposed Development

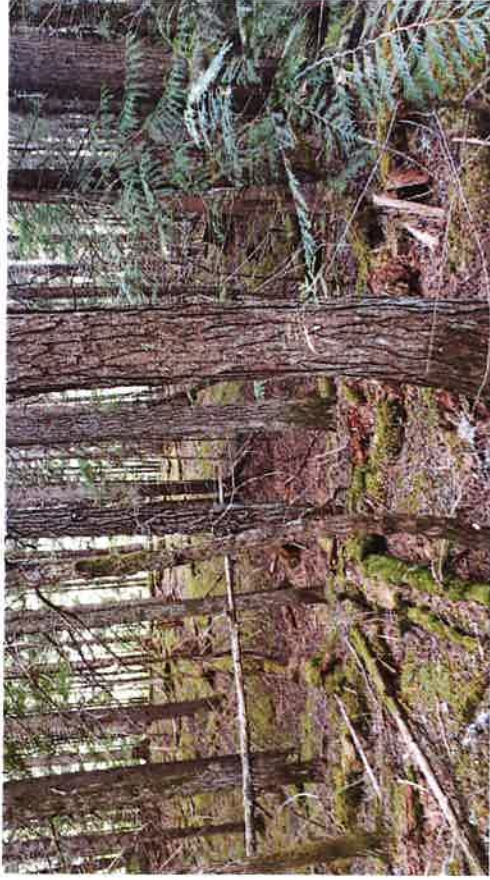
Photo 9 – Flat Lying Surface Within Proposed Development

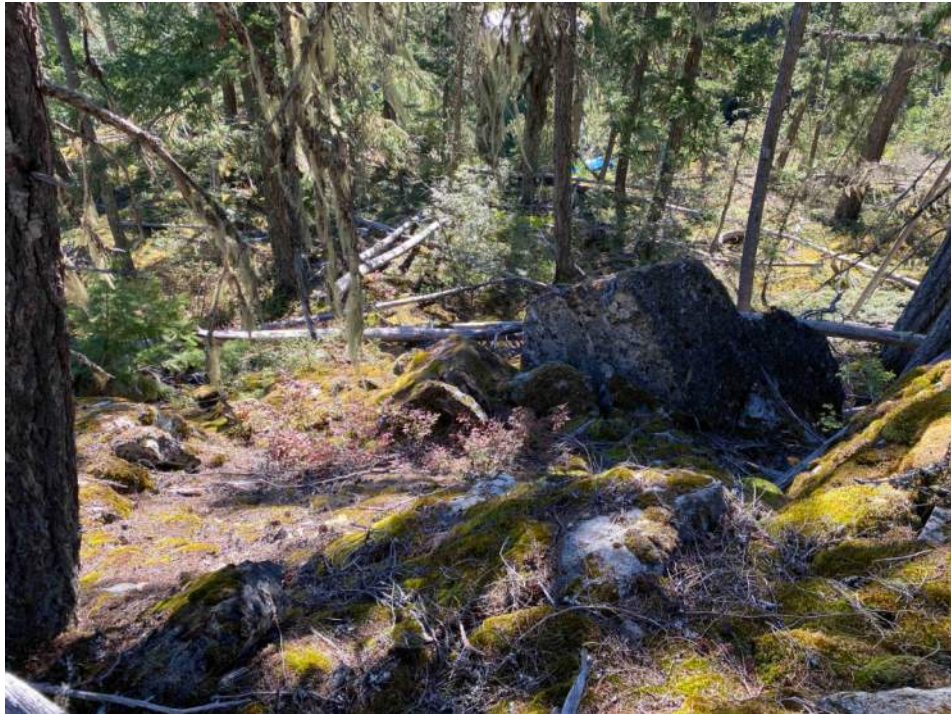
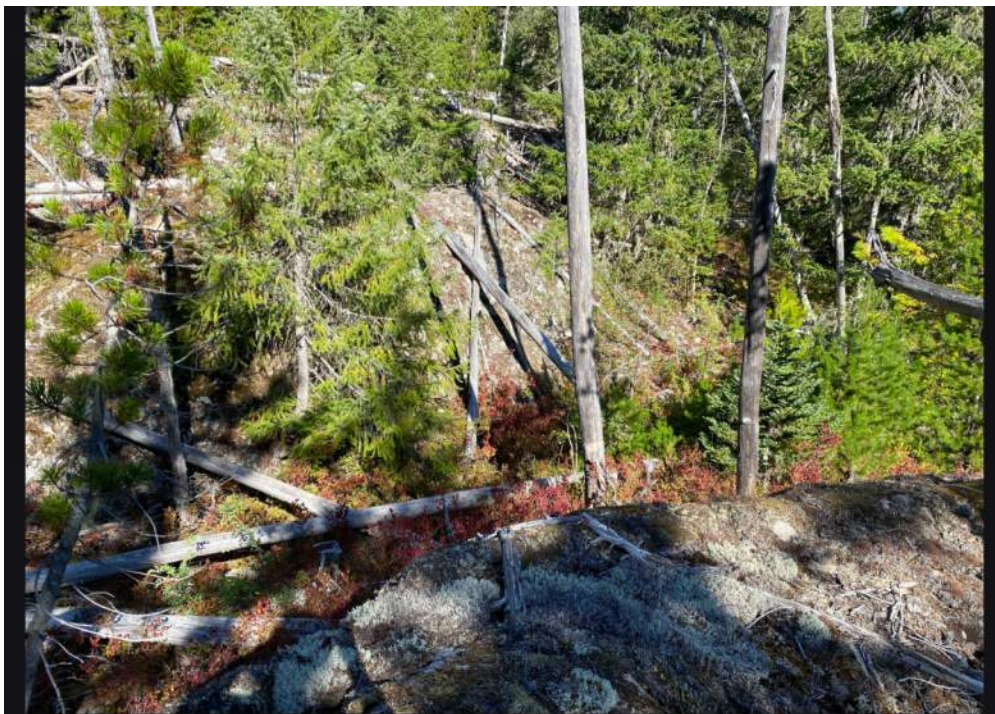
Rockfall sources include the mountain slopes to the west of the proposed development. The closest bedrock bluff which could be a source for rockfall was located about 300m west of the proposed development (Waypoints 1 and 2). The nearest rockfall deposits of rockfall were about 175m west of the proposed development (Waypoint 20). The presence of the west facing bedrock bluffs (Waypoint 18) were considered to form a barrier for rockfall originating to the west and no sources were noted east of

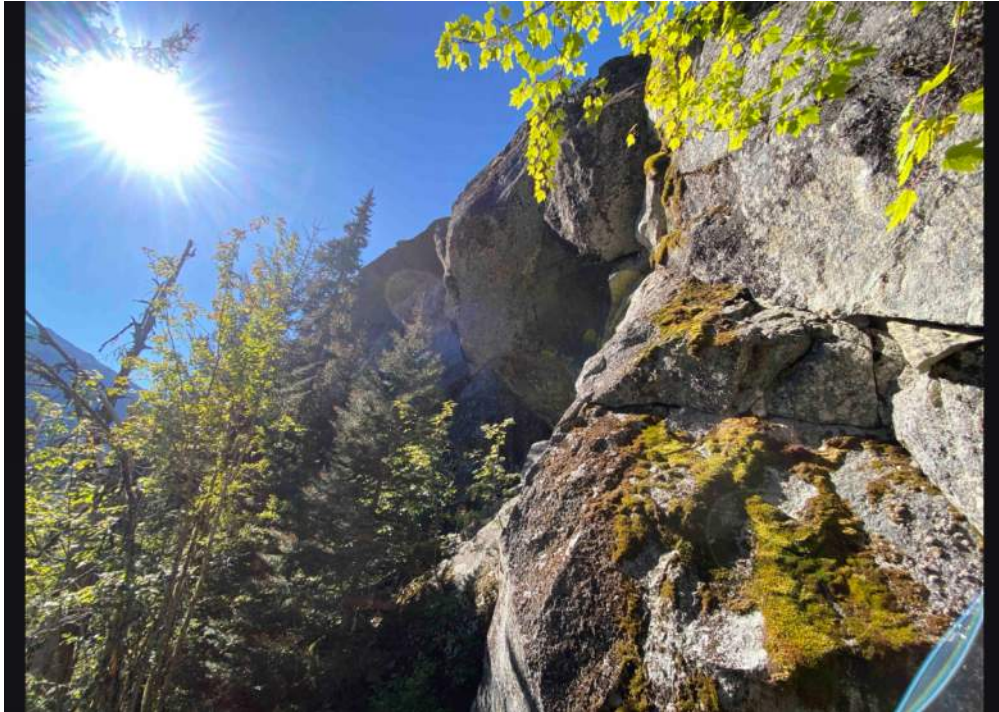
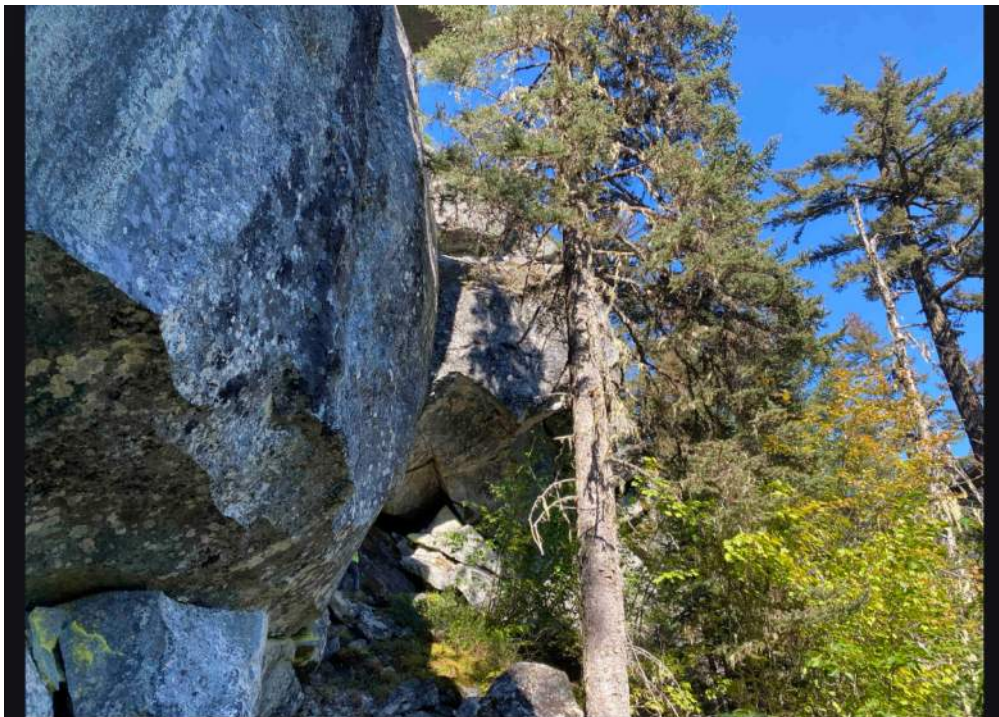
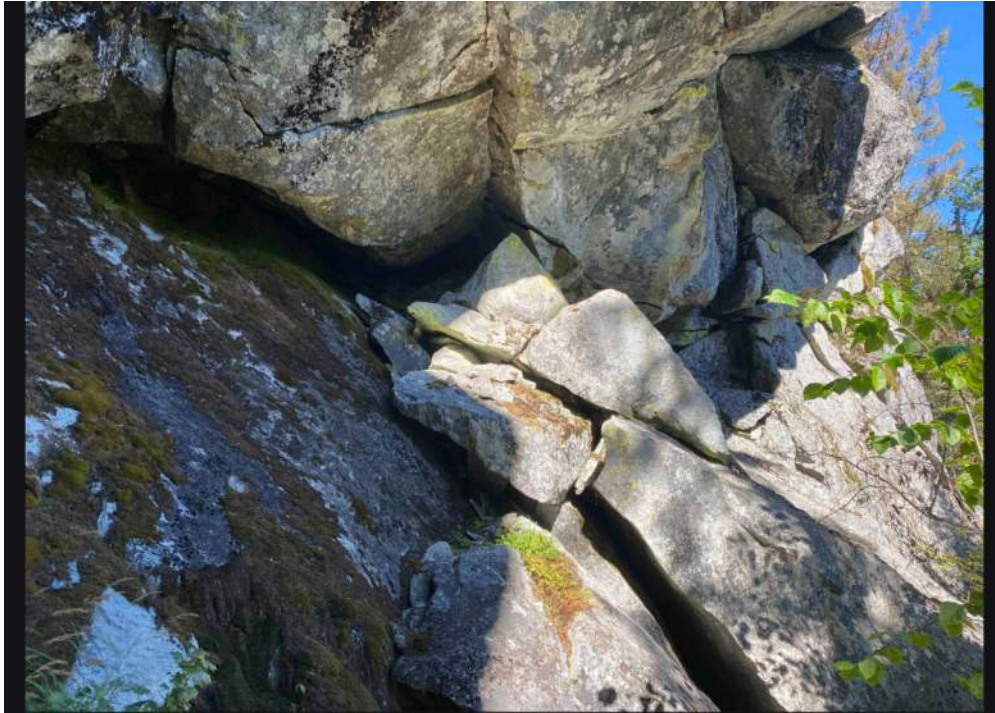
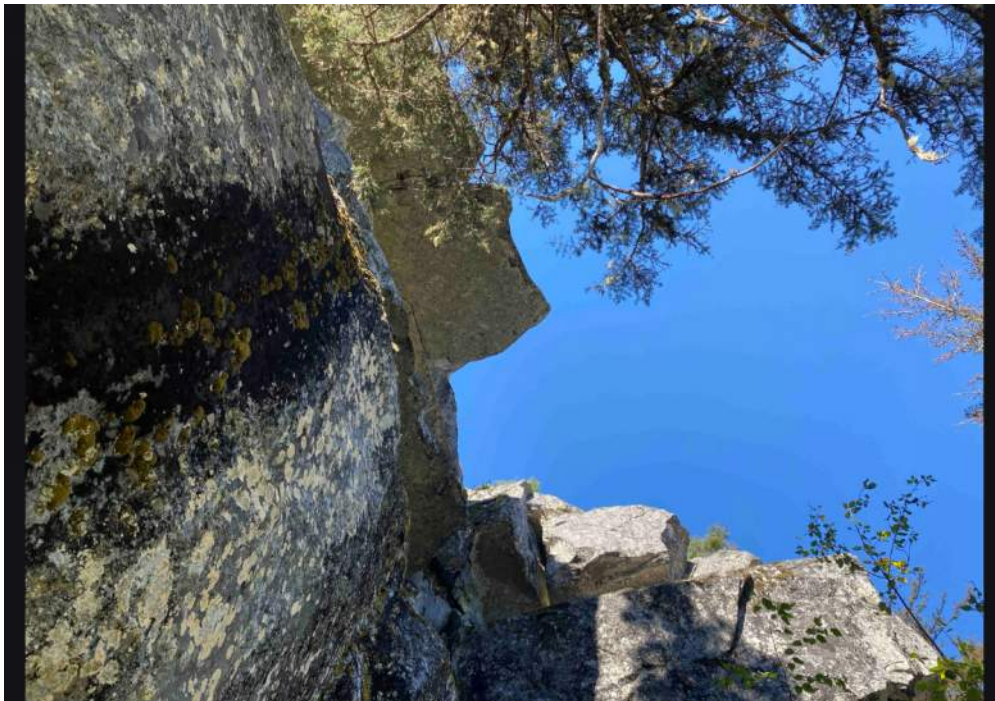
**Photograph 23 – Waypoint 7**

Above the proposed development, it was noted that the slope behind (west) of the lineation was inclined similarly to the slope below (east) of the lineation. A localized area of potential volume bedrock slope failure areas was noted above the proposed development (Waypoint 7). A bench was noted in the area of the lineation within the historic rock avalanche area ending at the southern edge of the source area. This bench is considered to be the northern edge of an earlier rock avalanche within the area above the proposed development, possibly prior to or during the previous glaciation as there was no significant indication of debris below. This opinion is further reinforced by noting the lower slope below the lineation has a very similar inclination as the backslope above and to the rock avalanche source area to the north. In addition, the upper slope above the lineation is in line with lower slope, providing limited source material for a rock avalanche.

The localized potential failure area (Waypoint 7) was about 19°. Based on the above discussion the hazard presented to the proposed subdivision is considered to be very low. A return period of greater than 1:10,000 years has been chosen as no rock avalanche has occurred since the last glaciation.

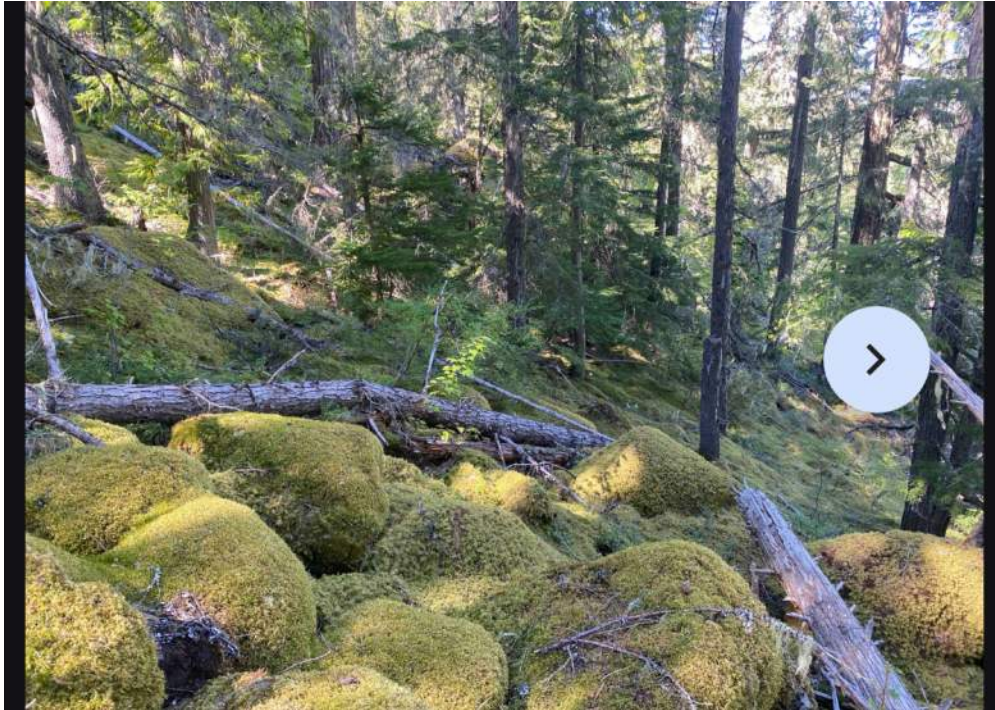
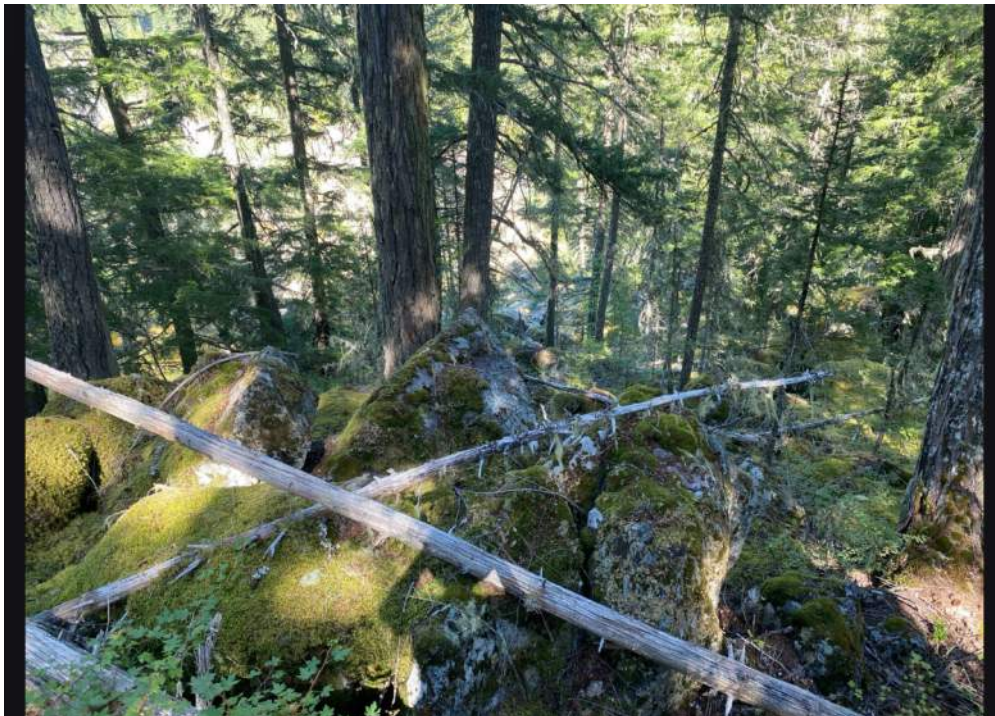
**Photograph 29 – Waypoint 15**

In general, key features identified upslope (west) of the subject property during site reconnaissance included boulder fields, steep bedrock bluffs, potential rockfall source bluffs, and varying areas of vegetation. It should be noted that the nearest blocks beyond the toe of the boulder fields was in the order of about 350m west of the subject property (refer Waypoint 15).

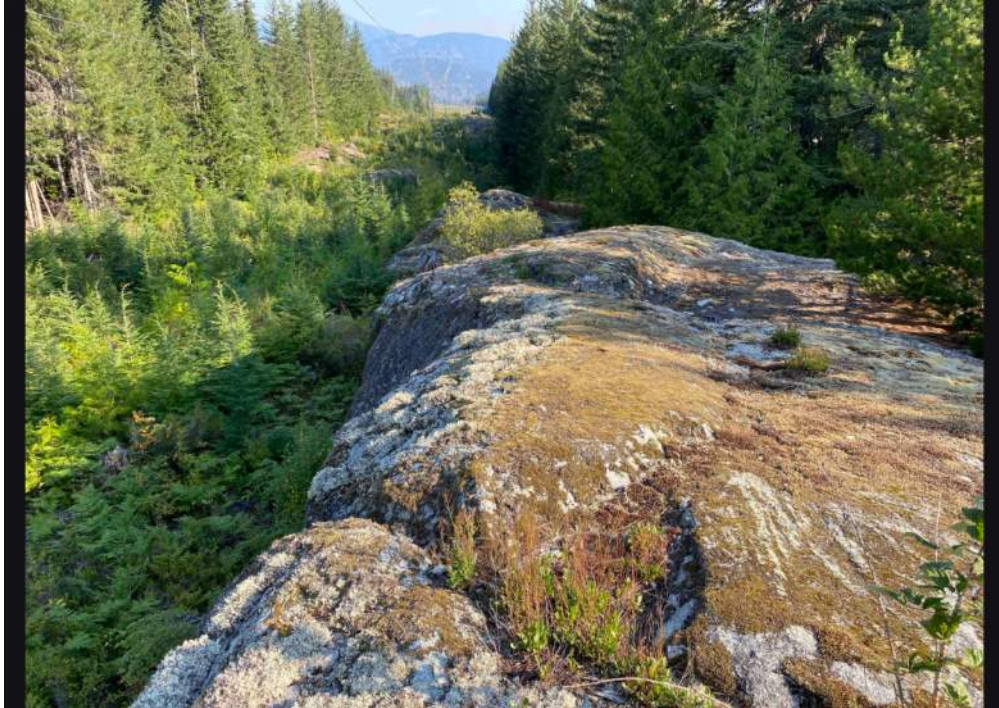
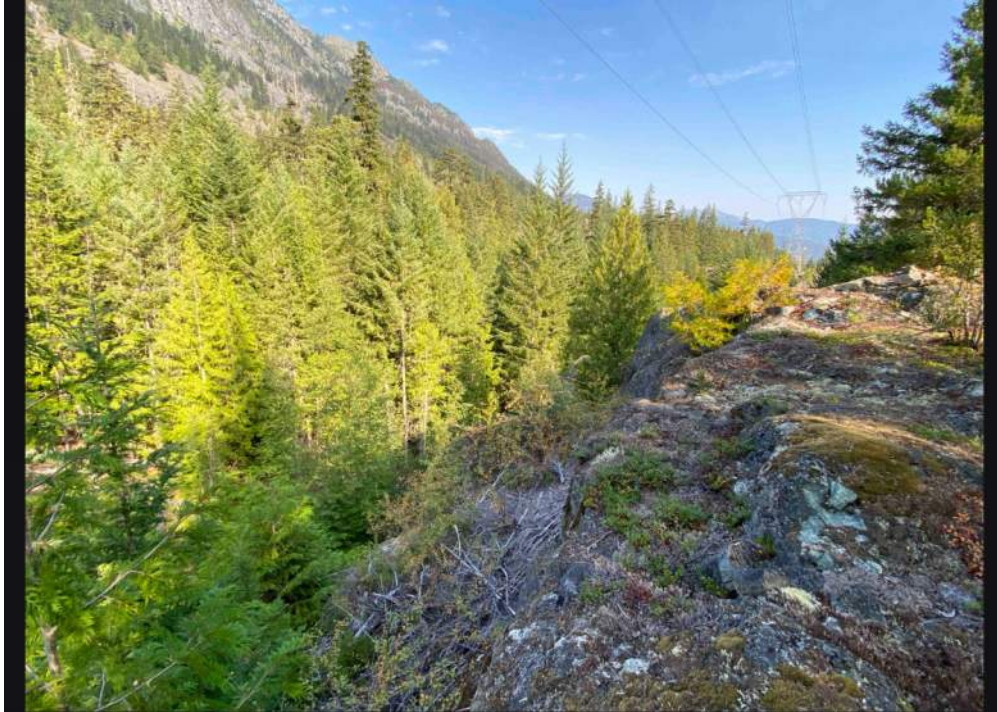
Steep bedrock bluffs, generally west facing and in the order of about 5m height, were noted within close proximity to the western property line (refer Waypoint 16 and 18). These bedrock bluffs typically formed a north-south alignment, with some localized areas in the order of about 15 to 20m height.
