**Re: Debris Flow Hazard within the Cataline Creek Drainage, Lillooet Lake Estates**

**RE: Geotechnical report warns of persistent debris flow hazard on Cataline Creek**

**Re:** Catalina Creek debris flow, August 30, 2013.

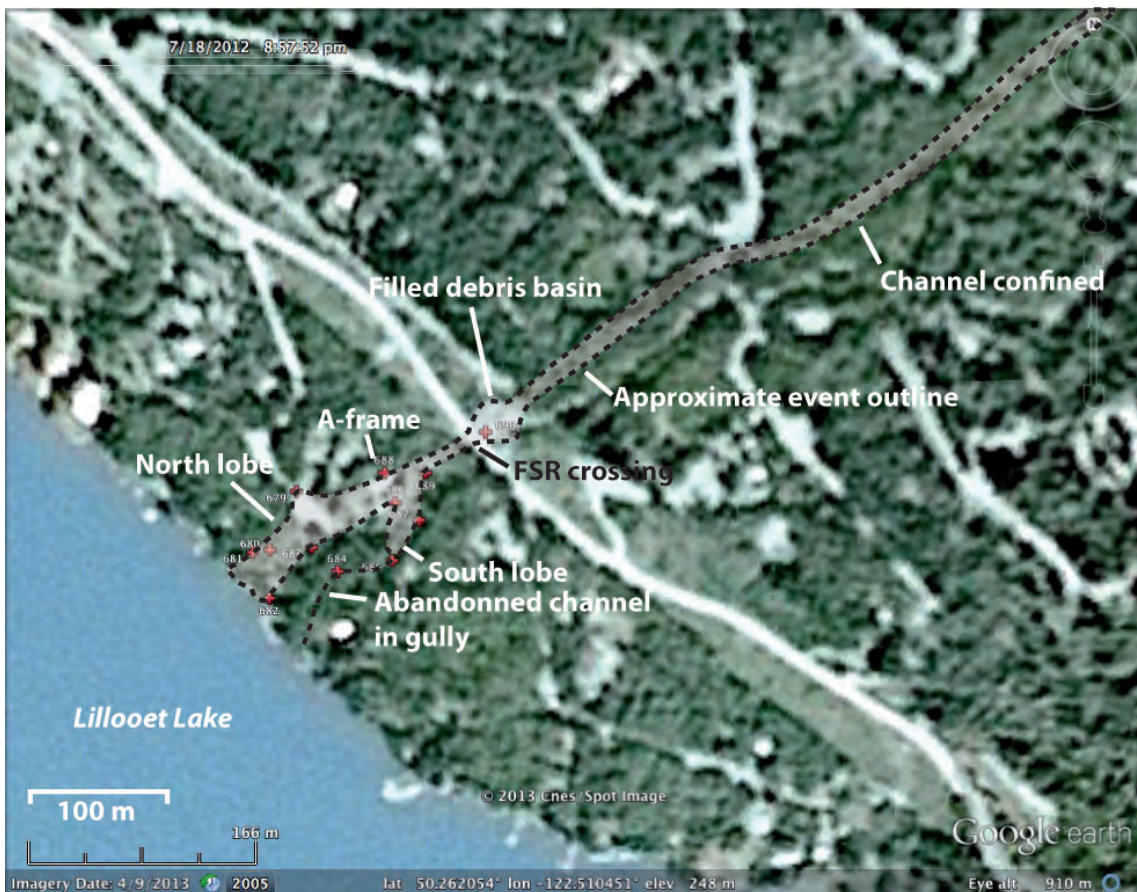
**Figure 1.** Approximate outline of the August 30 2013 debris flow, Catalina Creek.

On reaching the apex of the debris cone, the debris flow remained confined along the ~900 m length of channel downstream to the debris basin just upslope of the FSR crossing, perhaps depositing 7-15 m<sup>3</sup>/m along this length (6000-14000 m<sup>3</sup>); it filled the debris basin (1000 m<sup>3</sup>); deposited 4-5 m of debris on the FSR (300-500 m<sup>3</sup>); then carried on down the channel depositing a large lobe (750-1000 m<sup>3</sup>) on the south bank, plugging the channel at a footbridge crossing; and avulsed north, overrunning the boat launch and reaching the beach. The north lobe swept over the driveway of the A-frame house, pushed a small pickup truck into the lake, and destroyed a boat rack full of boats. In the deposition zone of the north lobe, the debris is on average 1-2 m thick along the margins and <1 m thick along the centre of the track, with a volume of perhaps 2000-6000 m<sup>3</sup>.

Based on these observations, the total debris deposition below the apex could be on the order of 10,000-25,000 m<sup>3</sup> in volume, a Class 4 debris flow (Table 1). The material was a bouldery slurry, with a 30-40% clast content of cobble to medium boulder, with maximum clast size up to 2-3 m b-axis.

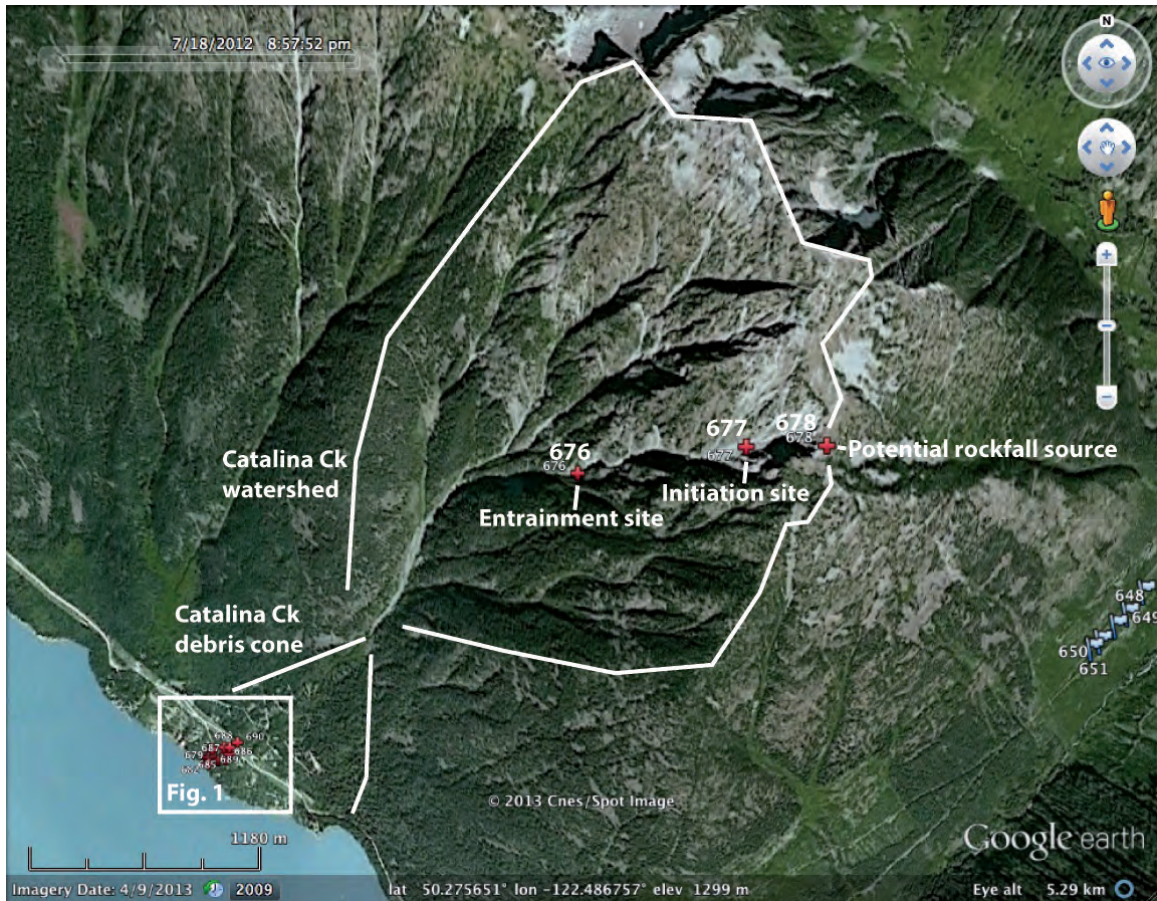
The helicopter overview flight revealed that the debris flow initiation site was located in the upper part of the watershed in an eastern bedrock gully system (Fig. 2). This is the same gully system that produced a debris flow in 2010 (Cordilleran 2010). The headscarp was in a debris blanket overlying smooth bedrock (WP 677, Photo 8). As the debris travelled downslope more debris was entrained by channel erosion (WP 676). At the crest of slope an area of tension cracking in bedrock was noted, and this is a potential rockfall source area (WP 678, Photo 9). This area was identified in 2010 (Cordilleran 2010).

**Figure 2.** Catalina Creek watershed showing the initiation site of the August 30, 2013 debris flow. WP numbers and debris source locations are cited in the text.

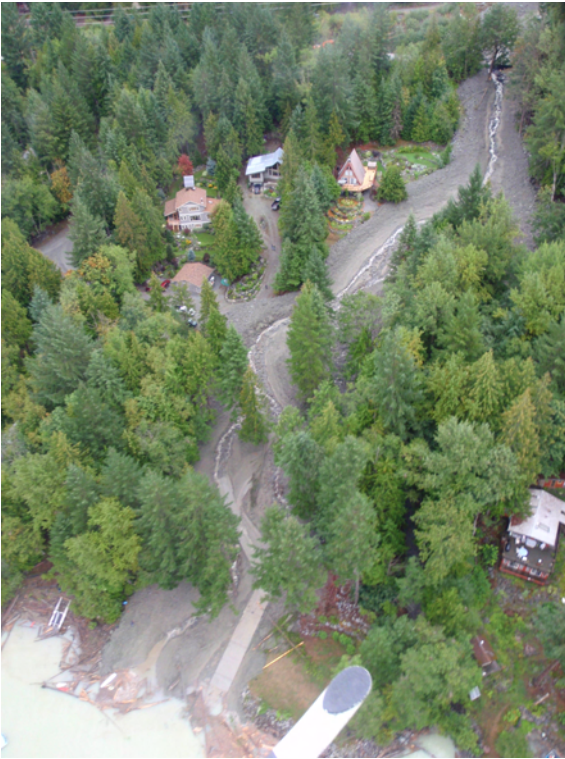
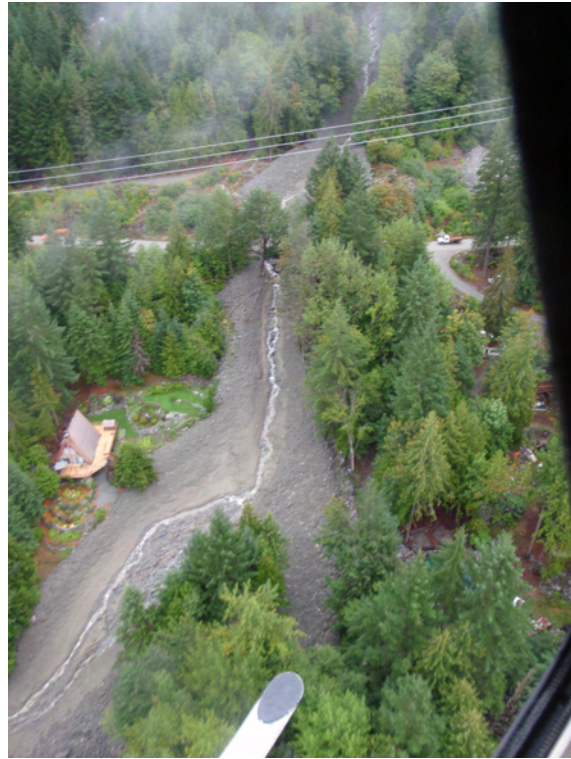
**Photos 1 & 2.** Aerial oblique NE views of the deposition zone below Lillooet Lake FSR. Note the southern lobe that triggered the northerly avulsion. The avulsing lobe missed the A-frame house by only a few metres. A pickup truck in the driveway was destroyed by the event and is likely in Lillooet Lake.

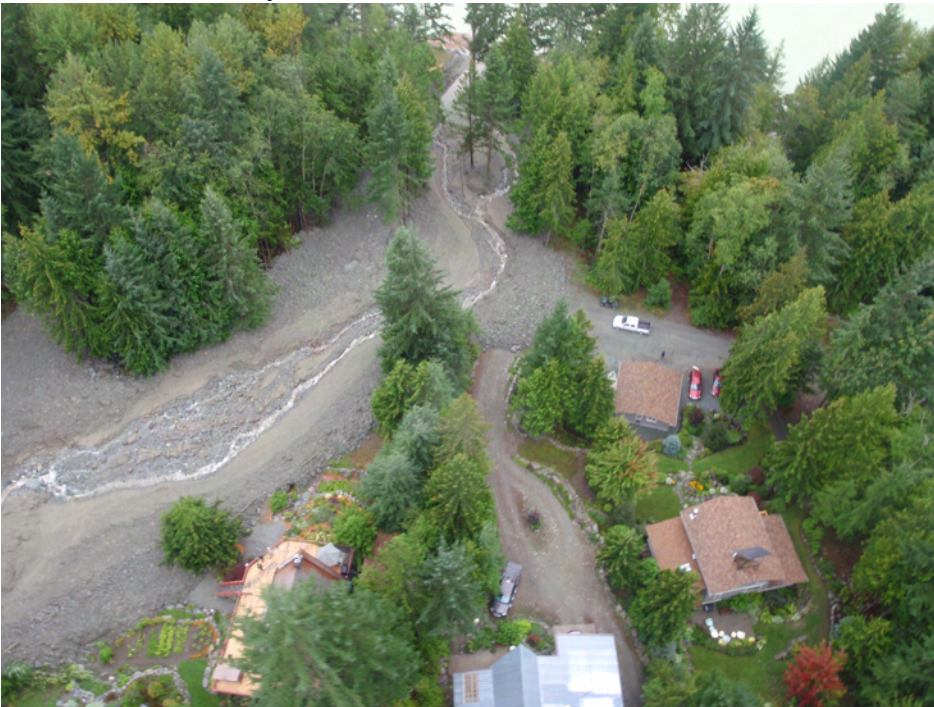
**Photo 3.** Aerial oblique SW view showing the proximity of the avulsed lobe to the A-frame house (left) and the lobe on the subdivision road near the white car.

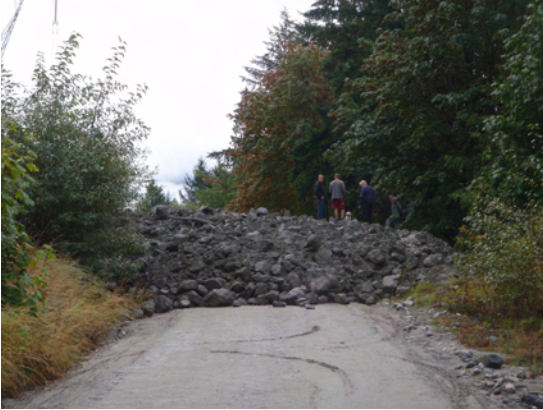
**Photo 4.** View SE from campside to woodside at the 4-5 m of debris on Lillooet Lake FSR.

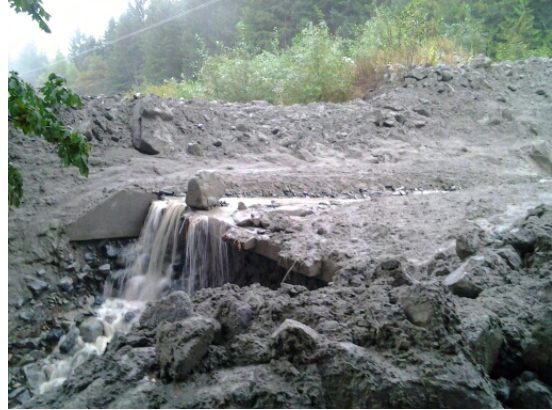
The FSR bridge was inspected (Photo 5). Only a portion of the deck and abutment wingwalls were visible on the downstream side of the bridge. The bridge opening was plugged, the deck overtopped, the guard rails destroyed and the wingwalls appeared somewhat undermined. Despite this impact, the bridge appeared not to have shifted.

**Photo 5.** View NW at the downstream edge of the FSR bridge before cleanup. Seija Halonen photo.

Once the channel upstream and downstream of the bridge opening, and the opening itself, are fully cleared of debris, a proper engineering inspection of the bridge will be required prior to allowing regular traffic, especially larger vehicles, to resume.

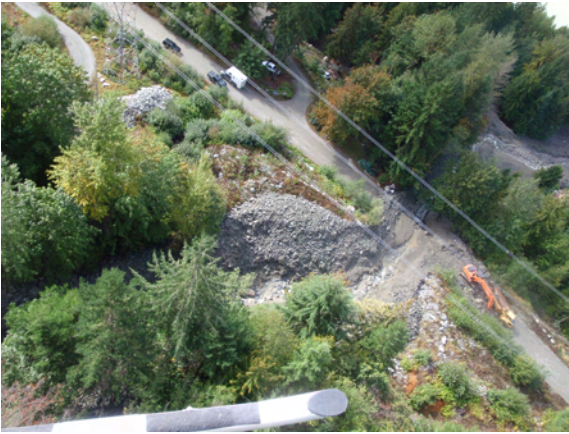
**Photo 6.** Aerial oblique SW view of filled debris basin upstream of the FSR.

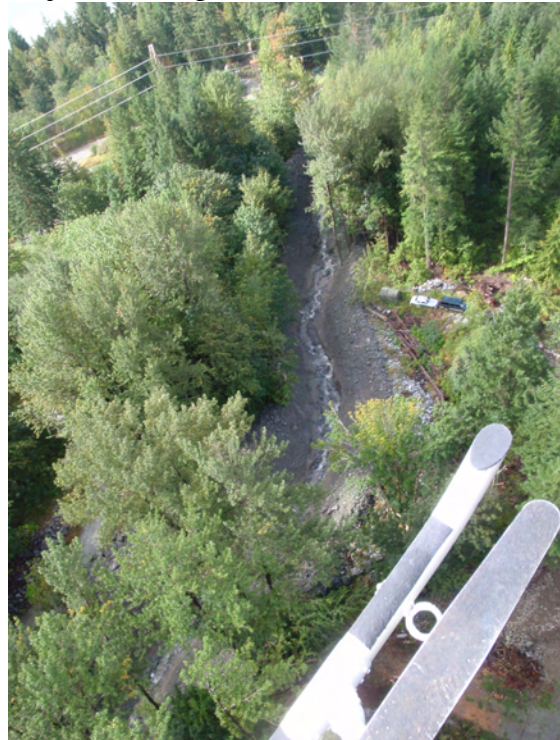
**Photo 7.** Aerial oblique SW view of channel upstream of FSR. In this area the debris flow remained confined.

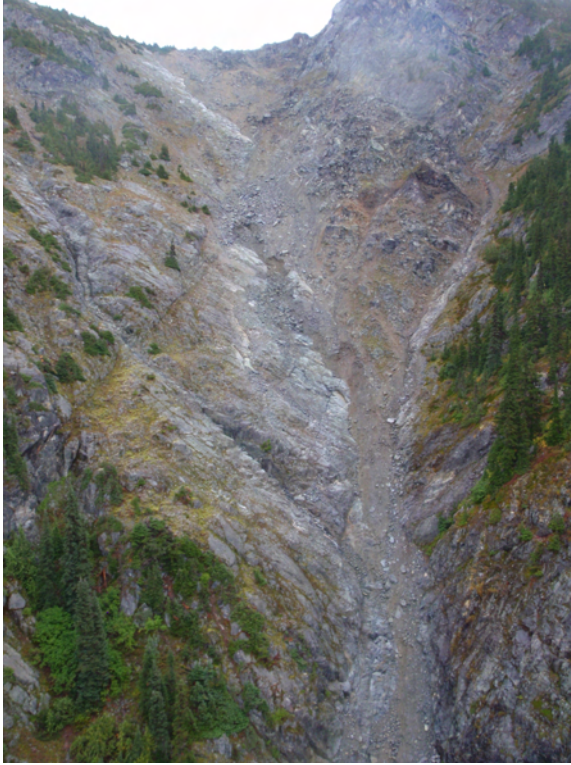
**Photo 8.** WP 677. The debris initiation point is visible as a series of spoon shaped scallops on the lower edge of the debris blanket where it overlaps bedrock.

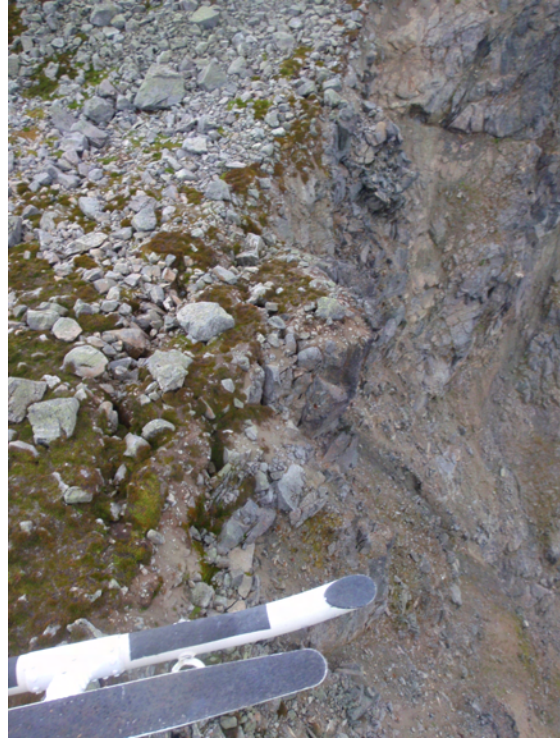
**Photo 9.** WP678. Area of tension cracking in bedrock. This site identified in 2010 represents a potential rockfall source area. Rockfall onto the debris blanket downslope could entrain significant volumes of additional debris.

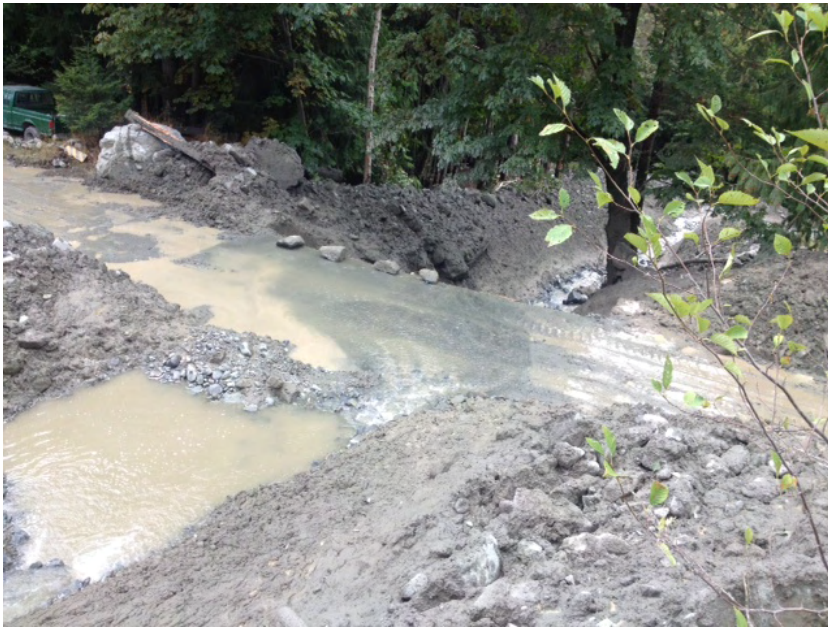
As of 11 am debris was being cleared off the road alignment, and spoil was to be endhauled to a site campside where material was stored during the previous cleanup in 2010 and 2012. Apparently as of late this afternoon, one-lane traffic had been restored (Photo 10).

**Photo 10.** The FSR as of late afternoon, August 30 2013. Seija Halonen photo.
