**GEOTECHNICAL ASSESSMENT  
Eight (8) Lot Residential Subdivision  
9669 Pemberton Portage Road, Devine, BC**

Document Type: Final Report

Date: January 11, 2021

Project No.: **K-211121-00**

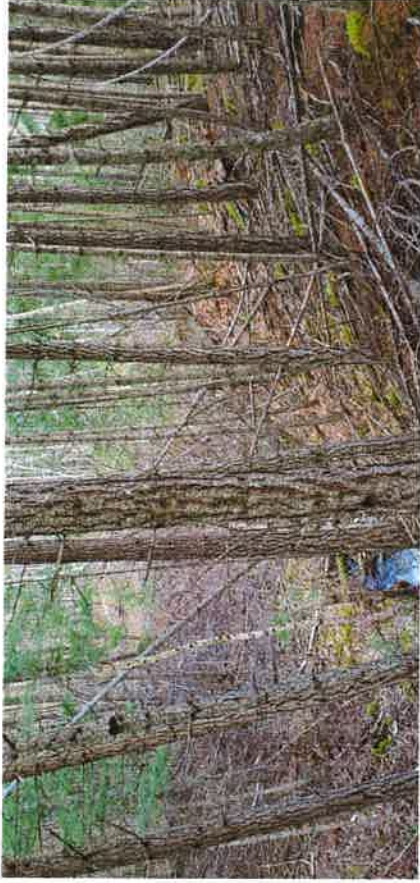
**PHOTO 1 – Slope to Blackwater Creek WP 1**

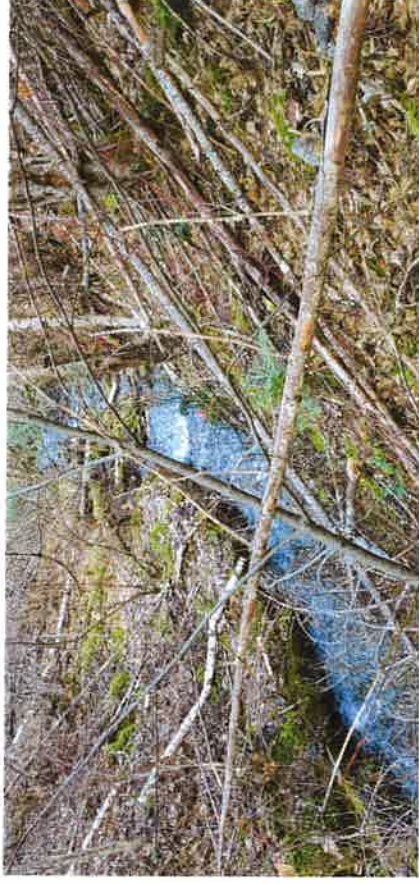
Blackwater Creek flowed from west to east along the northern property boundary flowing into Gates River east of Pemberton Portage Road. The creek was about 2m wide and incised into the surface about 0.5m with near vertical banks.

**PHOTO 2 –Blackwater Creek Bank Erosion WP 1**

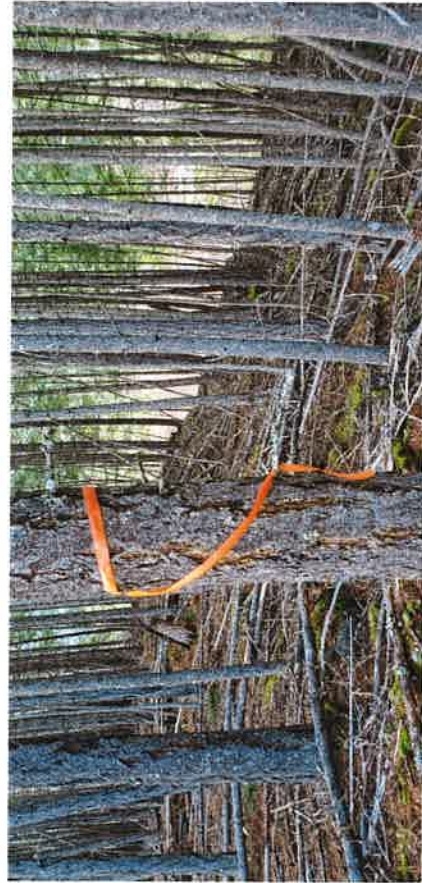
**PHOTO 3 – Slope Crest WP 3**

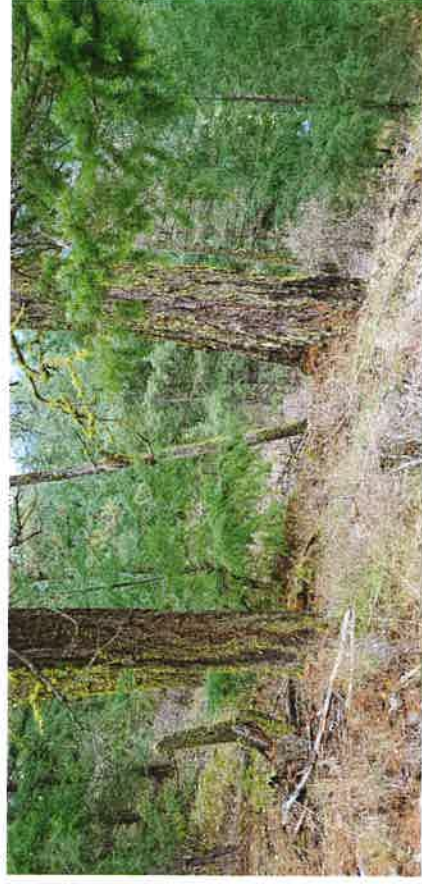
**PHOTO 4 – Slope Crest WP4**

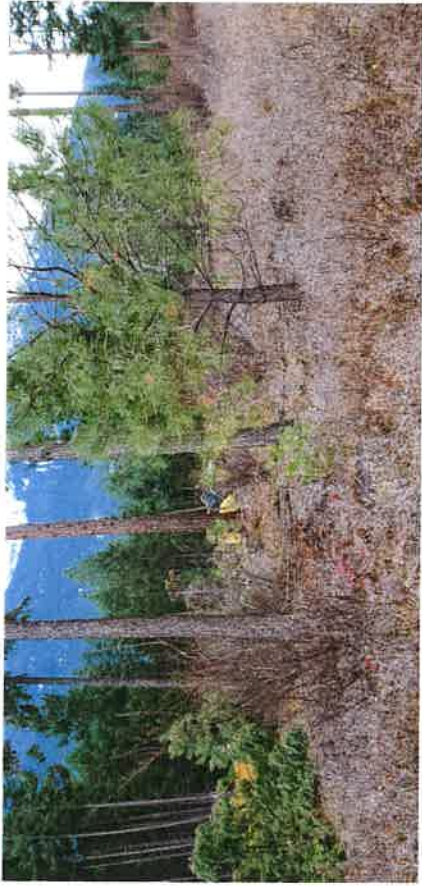
**PHOTO 5 – Generally Flat Lying Ground Surface WP5**

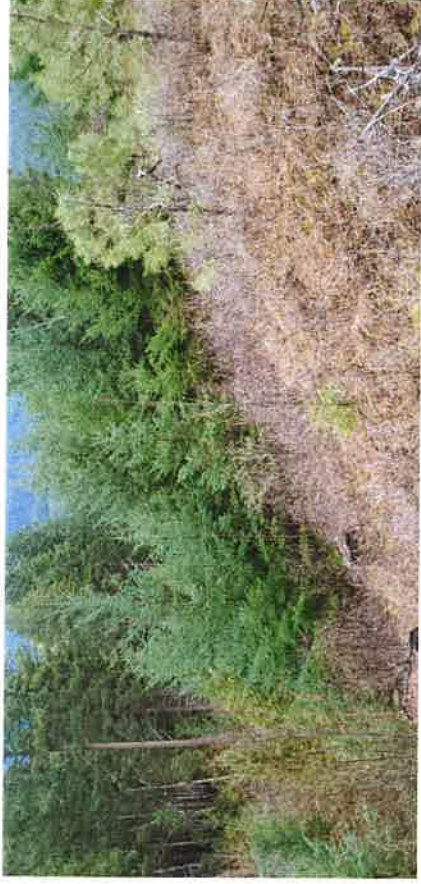
**PHOTO 6 – Slope Crest WP6**

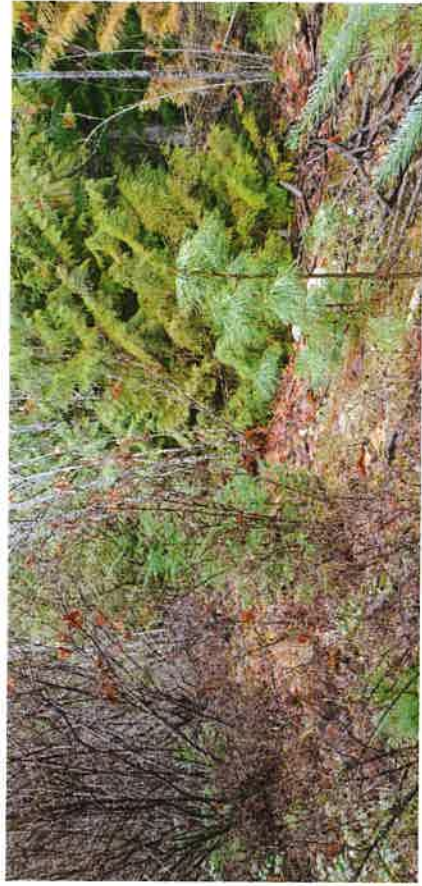
overgrown access road was noted near the northern property boundary on the south side of the Blackwater Creek gully extending about 200m into the property.

**PHOTO 7 – Old Access Road WP7**

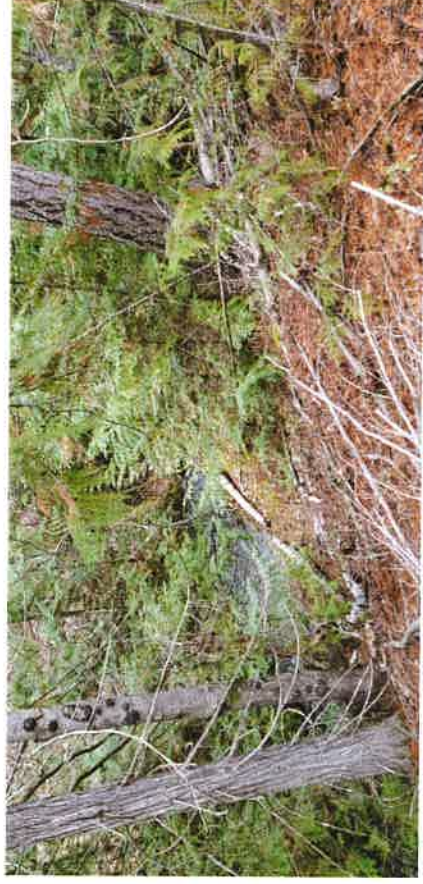
**PHOTO 8 – Slope Below Old Access Road/ Blackwater Creek WP8**

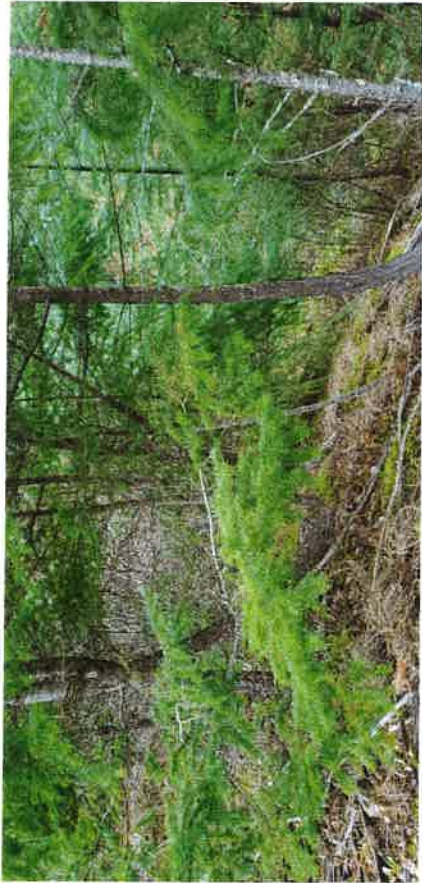
**PHOTO 9 – Slope Crest WP9**

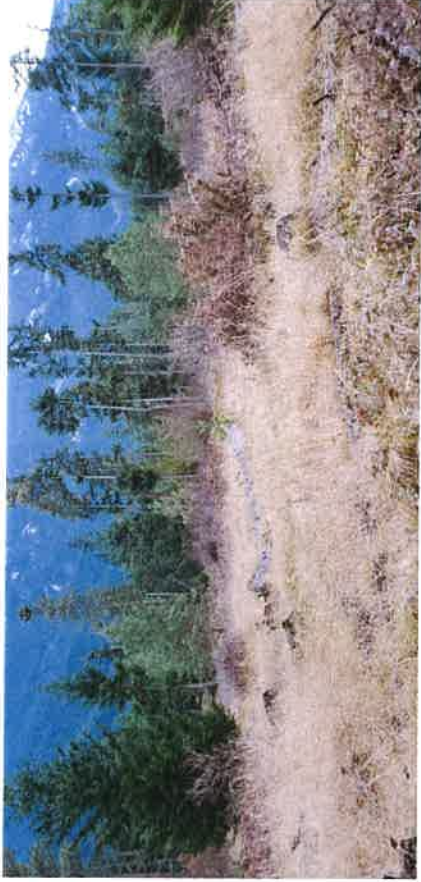
**PHOTO 10 – Generally Flat Lying Ground Surface WP10**

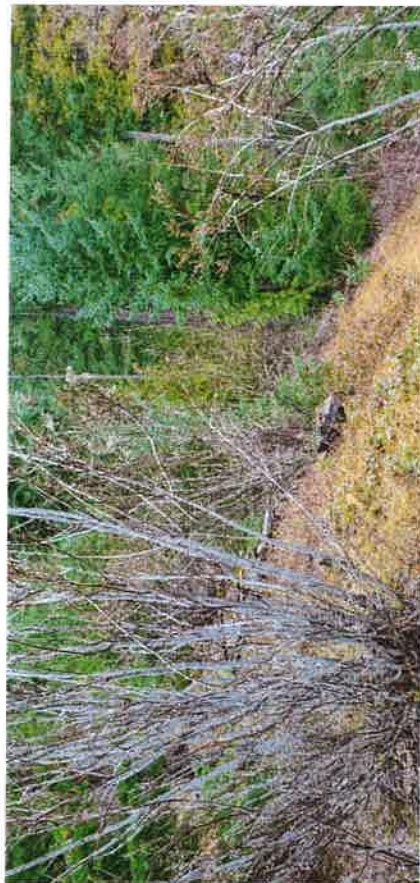
**PHOTO 11 – Slope Crest WP 11**

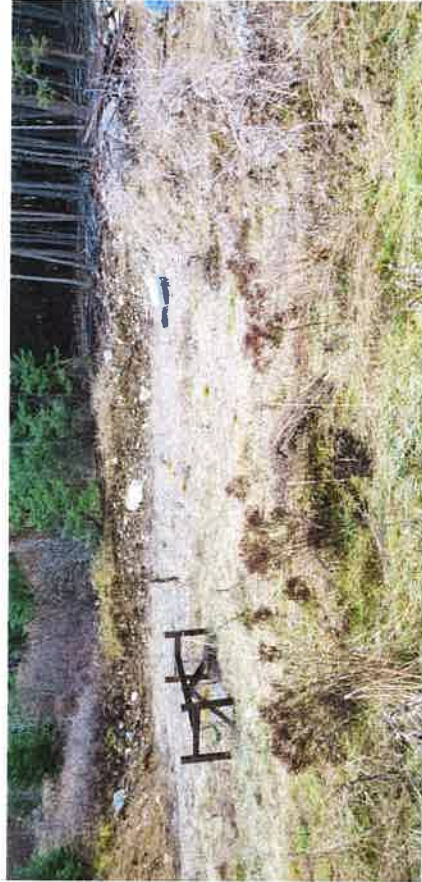
Soils observed in cut slopes within the property generally consisted of SAND with some gravel and trace to some silt, indicative of fluvial deposits.

**PHOTO 12 – Excavation NW Corner Exposing Soils WP11**

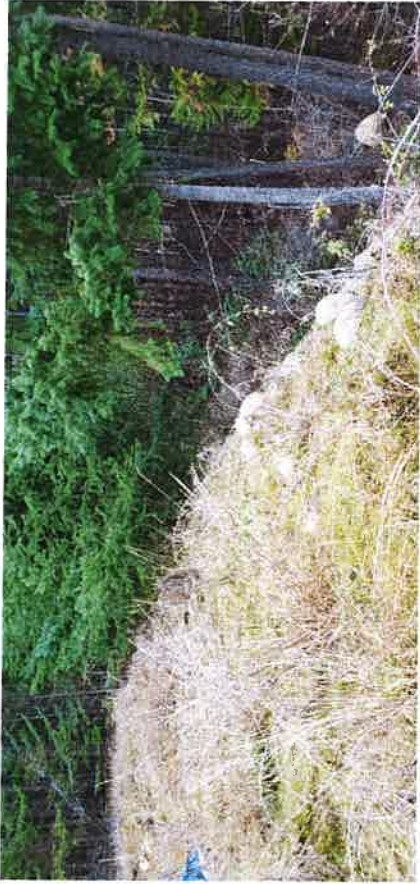
**PHOTO 13 – Slope Crest WP12**

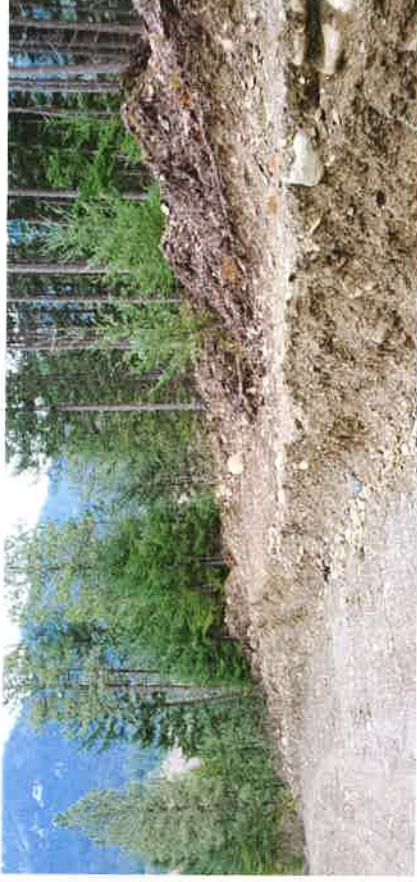
A gravel access road had been constructed from Pemberton Portage Road north of the school yard to access the property. It is understood that water wells had been drilled for each of the proposed lots. An

**PHOTO 14 – Access Road to Proposed Lots**
