***STRUCTURAL REVIEW OF SQUAMISH-LILLOOET REGIONAL DISTRICT OFFICE,
BUILDING, 1350 ASTER ST., PEMBERTON, BC***

May 28, 2015

Squamish-Lillooet Regional District & Village of Pemberton

**Fromme Engineering Ltd.
P.O. Box 2600, Squamish, BC
V8B 0B7
Tel: (604) 815-0858**

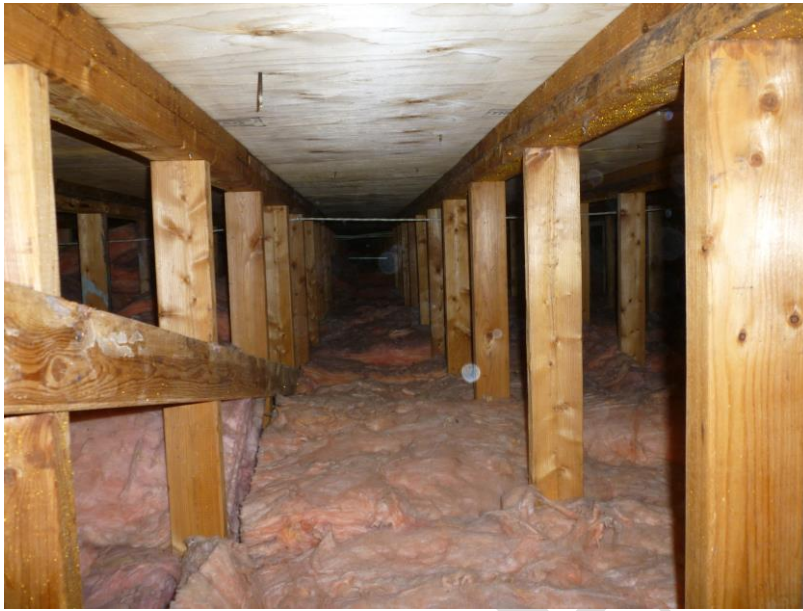
Photo A1 – Pony Walls Supporting Roof Sheathing

- Built-up roof.
- T&G Plywood (assume 1/2 inch, condition and thickness not determined).
- Continuous 2X4@16" O.C. pony walls on sleepers, supporting plywood sheathing directly.
- Existing old built-up roof (tar and gravel).
- 2X12@16" O.C. roof rafters.
- Batt. insulation.
- GWB ceiling.

- At next re-roofing replace existing damaged portions of roof sheathing to suit, plus add additional 5/8 inch tongue and groove plywood over-lay on existing.
- Upgrade connection of existing roof trusses to exterior walls and along potential additional shear wall locations at 2nd floor (See Sketches in Appendix C).
- Add shear walls and hold-down anchors in strategic locations at upper floor (See Sketches in Appendix B).
- Strengthen existing connections and reinforce existing beams at grid line B (See Sketches in Appendix C).
- Reinforce existing lintels at north and south elevations along grid lines A & C.

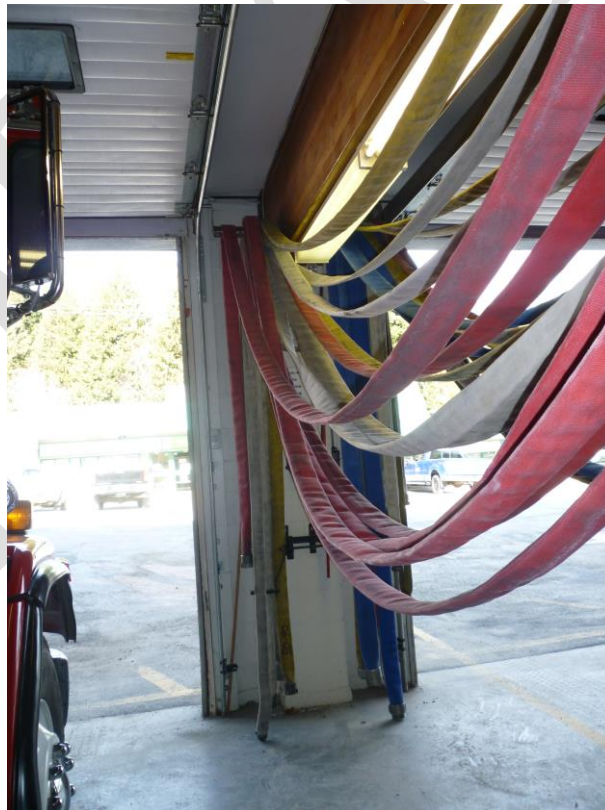
Photo A2 – Hose Drying Ground Floor

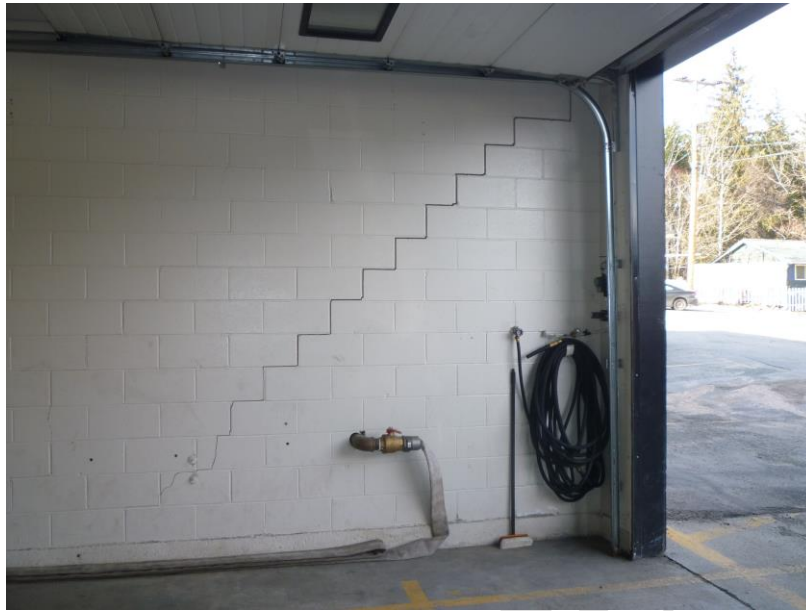
- Block walls showing settlement damage/cracking. Also non definitive connection of block walls for out of plane lateral forces.
- Indeterminate load path at grid line 3 if used for lateral load element locations.

- Signs of settlement in foundations in several locations, specifically at grid line C in location of previous flood event/water line break, and 2 & 3. The north side of the building appears to have settled.
- The majority of existing foundation structure is indeterminate, as no existing drawings appear to exist, except for the annex addition on the south side. Foundations shown in

Photo A3 – Settlement Crack in Block Wall

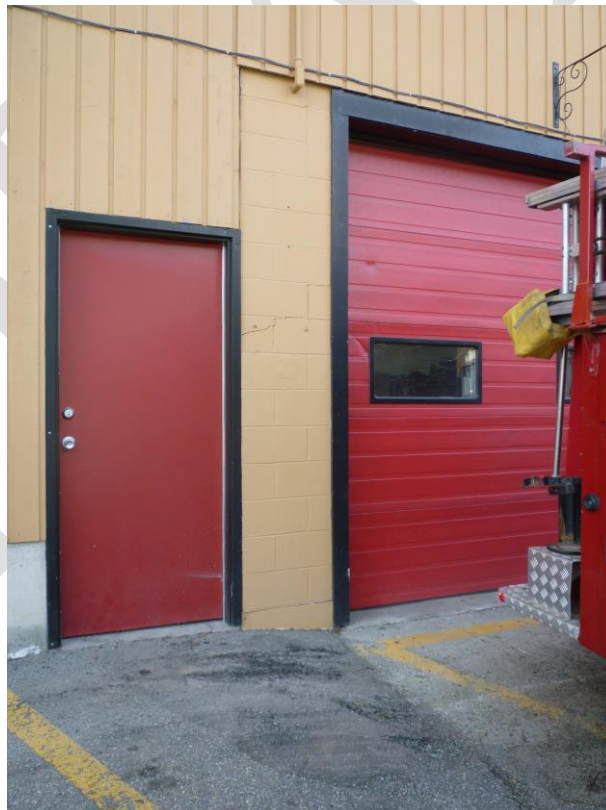
Photo A4 – Diagonal Crack in Block Wall Pier
