*Pierre A. Friele, MSc, PGeo*  
*P.O. Box 612*  
*1021 Raven Drive*  
*Squamish, BC V8B-0A5*  
*Ph. (604) 849-0250*  
*email. pfriele@gmail.com*

Sarah Morgan  
SLRD EOC Director  
P: 604-894-6371  
[www.slrd.bc.ca](http://www.slrd.bc.ca)

V1 December 10, 2021; V2 December 13, 2021

During the recent atmospheric river events (Nov 14-15; Nov 27-29; Nov 30-Dec 1; 2021), Jason Creek, at Ivey Lake, near Pemberton, BC experienced three extreme hydrogeomorphic events and washed out the Jason Creek culvert at Reid Road two times. The events were accompanied by overland flow flooding of several properties, localised bank erosion, minor damage to Portage Road, and threatened the CN Rail line.

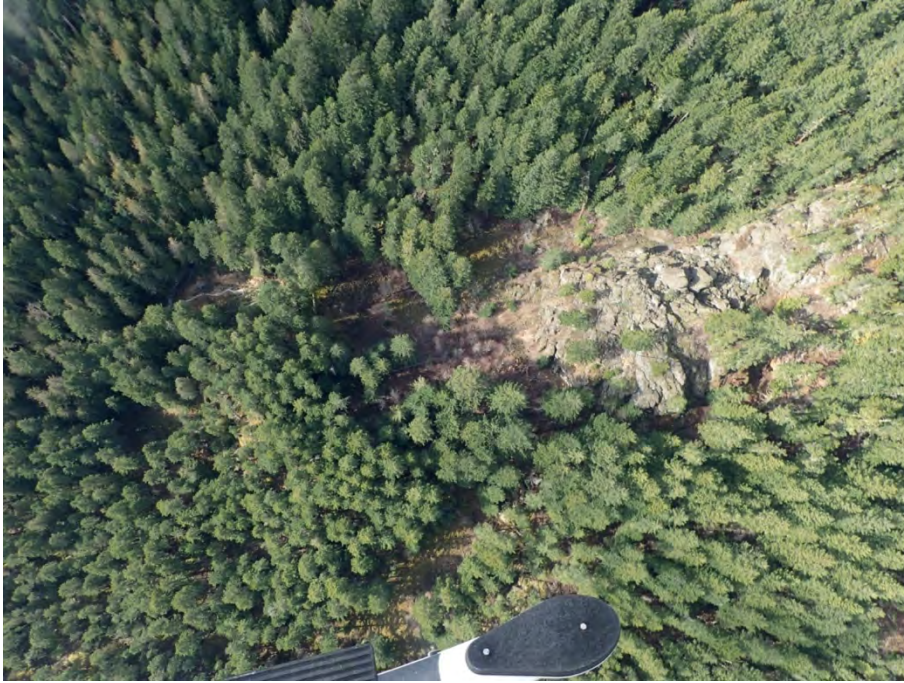
**Photo 3.** WPs 6-12. View straight down on sagging slope above the 1990 & 2021 failure sites. On center right (north) is bedrock cliff sagging and spreading to the left. On the center left (south) is a small opening with creek visible, and that is the slide area. In the center is a talus opening. The talus is normally faulted, with a 10 m drop on the south side.

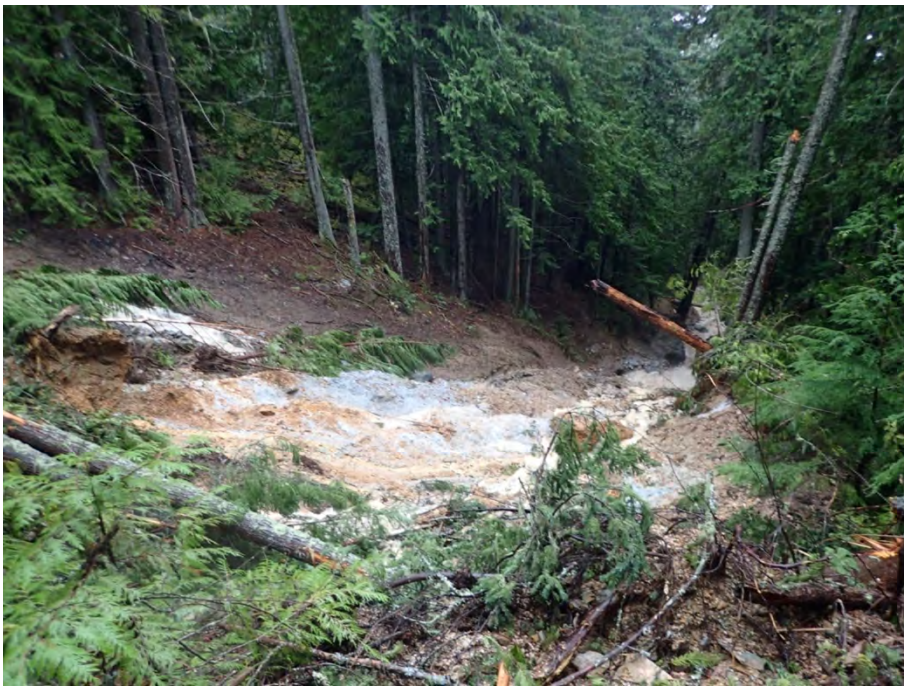
On December 1, 2021 there was a fresh landslide scar at the site of the 1990 debris flow source (Photos 4-7; Figures 1-3). Around the headscarp of the fresh scar there was unstable material bounded by gaping tension cracks (WPs 6-12); this unstable area was 50-75 m wide along its crest, by 15 m long downslope length, by 2-3 m thick, with a potential volume of 1500-3375 m<sup>3</sup>. Between Dec 1 & Dec 12, 2021 the area had changed due to the debris flow 2200 hrs on Dec 1, with windthrow, and expansion headward ~5 m distance, defined by tension cracking with 1 m dropdown (Photos 73-76). The imminent failure volume is 1000-4000 m<sup>3</sup> (30-35 m wide by 15-25 m long by 2-5 m thick). This unstable area represented the greatest residual hazard.

**Photo 4.** WPs 6-12. 1990 & 2021 failure site. Note cream to orange altered bedrock. Clayey and soft.

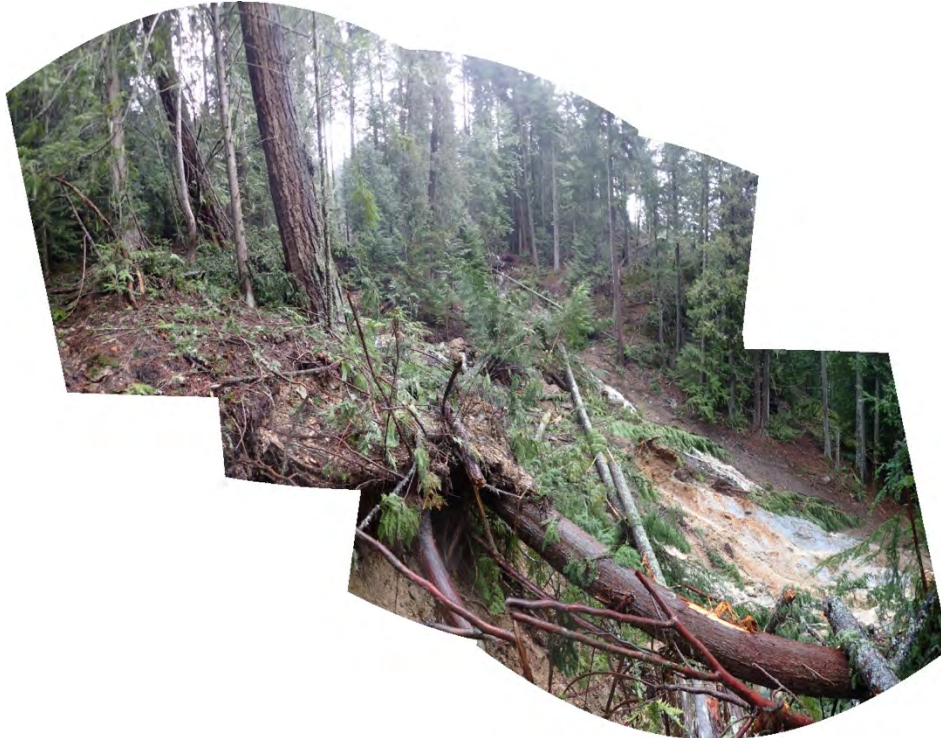
**Photo 5.** WPs 6-12. Right side failure area, view east. Note back-leaning Douglas fir marking an unstable area around the fresh headscarp (ie. hangfire).

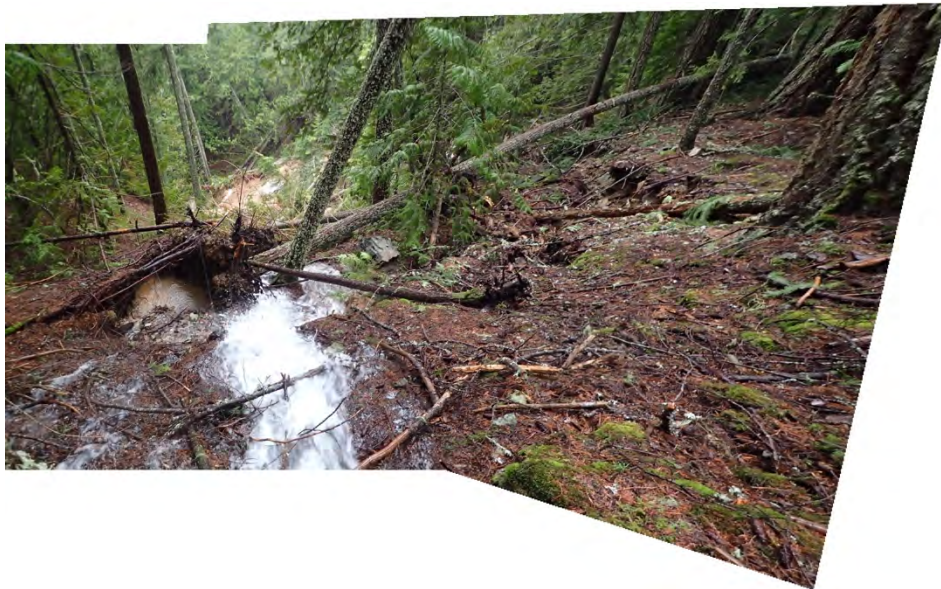
**Photo 6.** WPs 6-12. Left side failure area view south and east. Note torn ground (tension cracks) leading right (east) from creek marking an unstable area around fresh headscarp (ie. hangfire).

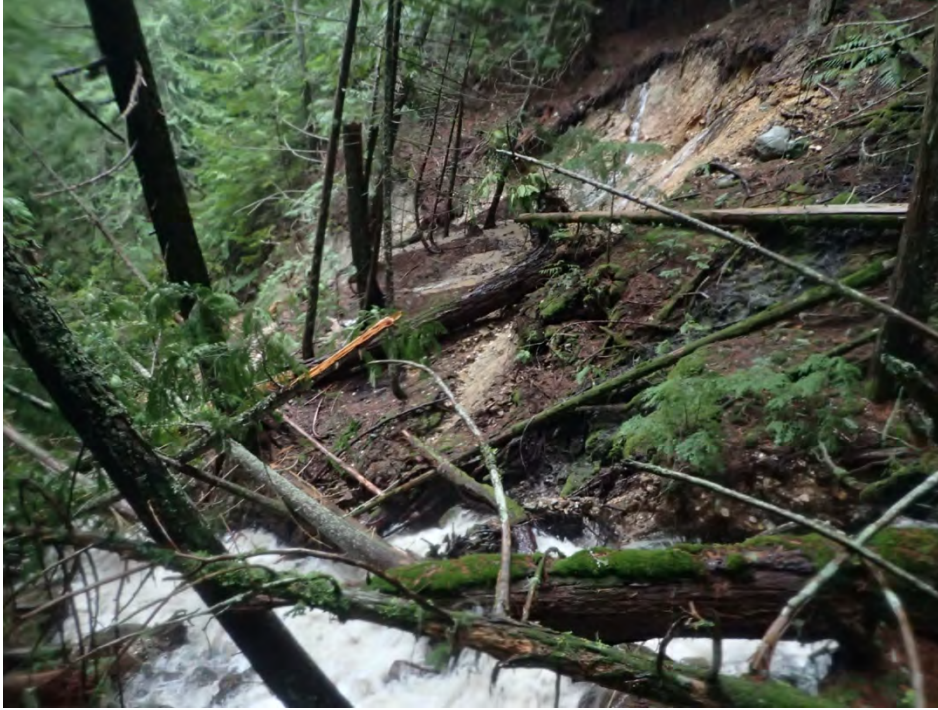
Farther upstream, on the right (west) sidewall a smaller fresh slump was noted (Photo 7; WPs 21-22), with dimensions 10 m wide by 40 m long by 2-3 m thick, or 800-1200 m<sup>3</sup> in volume. This feature had not changed on Dec 12, 2021 (Photo 78), yet remains a residual hazard.

**Photo 7.** WPs 21-22. Jason Creek, right bank slump in altered bedrock with seepage at headscarp.

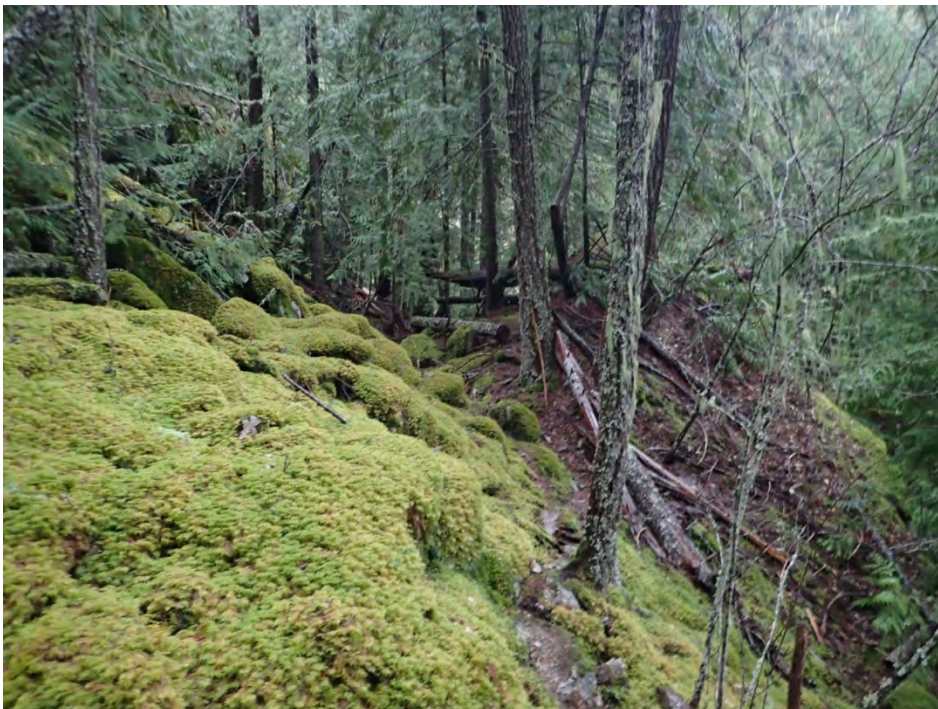
At several sites along the west sidewall there were bedrock lineaments and uphill facing (antislope) scarps (Photos 8, 9) suggestive of deep-seated bedrock instability in the sidewall (see WPs 3-5, 42; 41; 36-37, 23-25). Based on the width along the contour and sidewall length to the creek at these sites, and an assumed failure thickness of 5-10 m, then hypothetical debris flow volumes of 5000-50,000 m<sup>3</sup> are possible. On Dec 12, 2021, it was noted that the channel reach between 575-650 m elevation has a 50 m wide valley flat and is filled with colluvial blanket derived from altered bedrock (Photo 71, WP147). These deposits may reflect previous instability associated with these sidewall lineaments.

**Photo 8.** WPs 3-5. Uphill facing or “antislope scarp” on Jason Creek right bank near 1990 & 2021 failure area. These features indicate potential deep-seated instability in the bedrock.

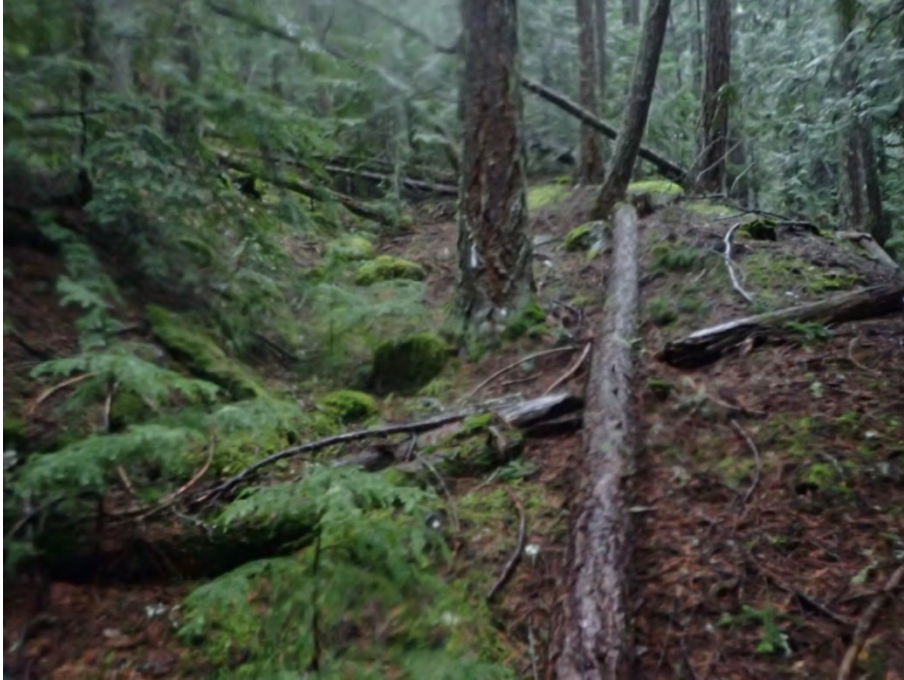
**Photo 9.** WP23. Uphill facing or “antislope scarp” on Jason Creek right bank near WPs 21-22 creek sidewall slump.

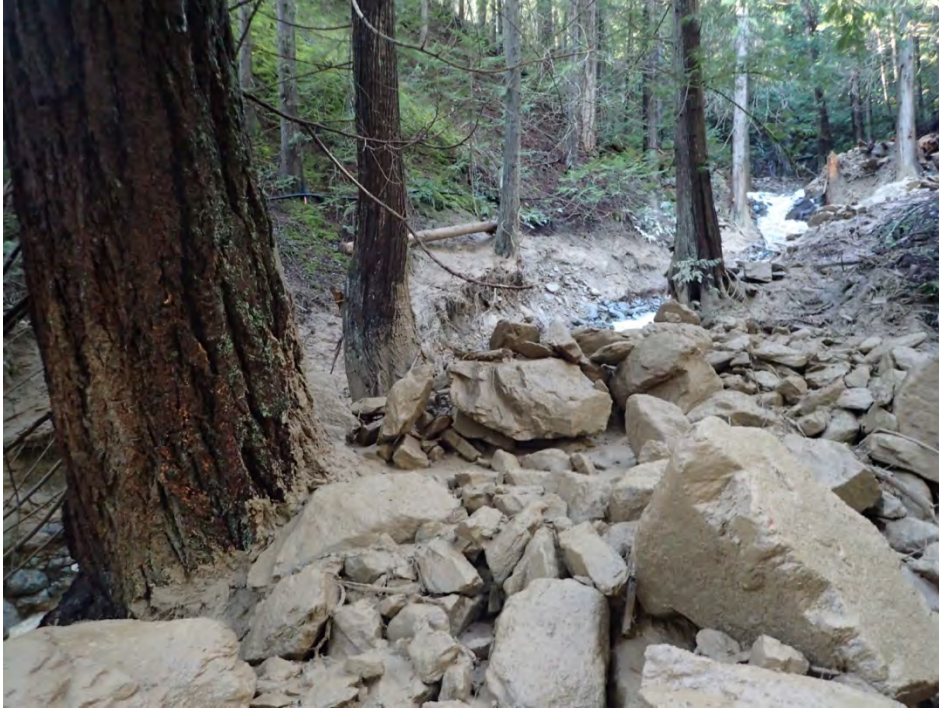
**Photo 11.** December 1, 2021 debris flow on Jason Creek. View upstream showing muddy trimlines and coarse bouldery debris. Using a “Spider” excavator, this area was cleared of debris jams between the November 15 and November 30 washout events.

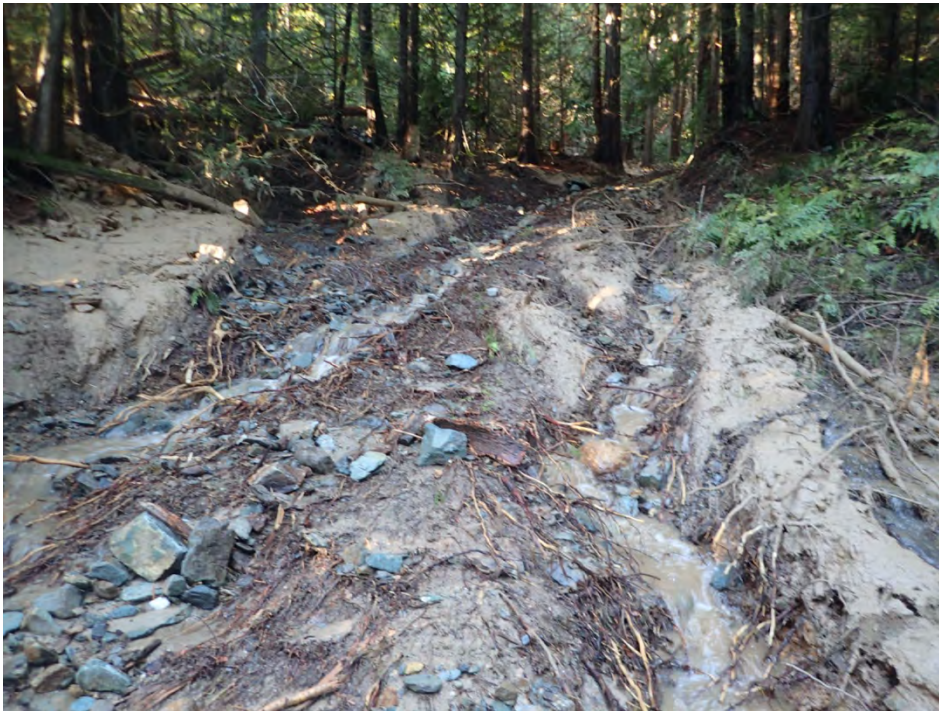
**Photo 12.** WP71. View upstream showing muddy slurry overflow onto east side of fan at apex. Main channel is to the left (west).

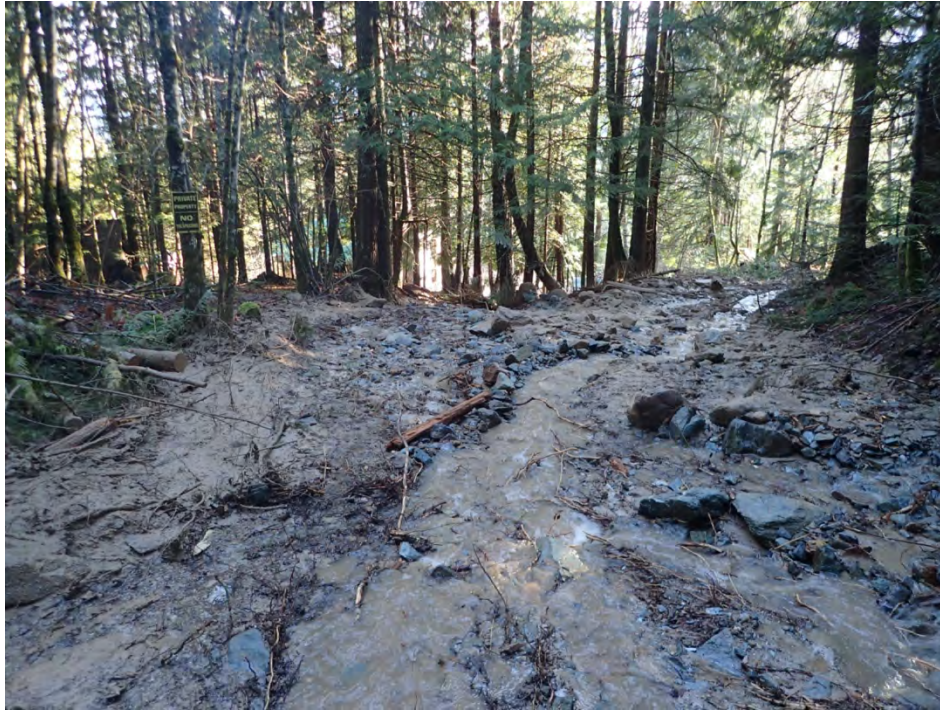
**Photo 13.** WP71. View downstream showing muddy slurry overflow onto east side of fan at apex. The bright spot in the center trees with slight blue/green colour to left is the house at 1781 Reid Road.

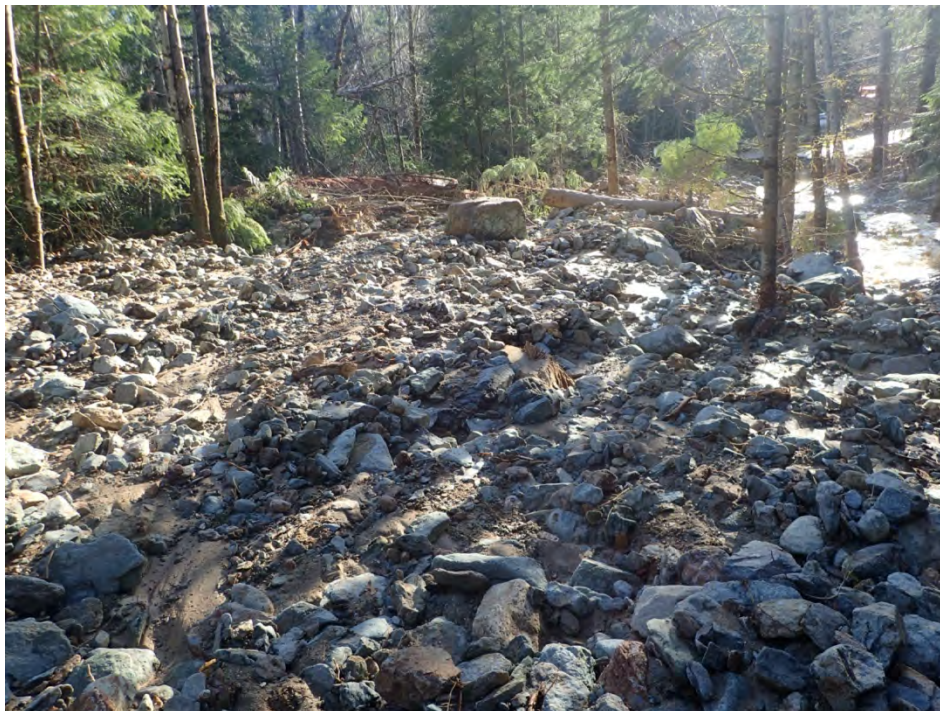
**Photo 14.** WP78. View downstream across debris deposition on left (east) bank just above Reid Road. Creek is bright area on right. Material consists of muddy cobble (0.12-0.25 m dia) to fine (0.25-0.5 m dia) boulder gravel with occasional metre-sized boulders.

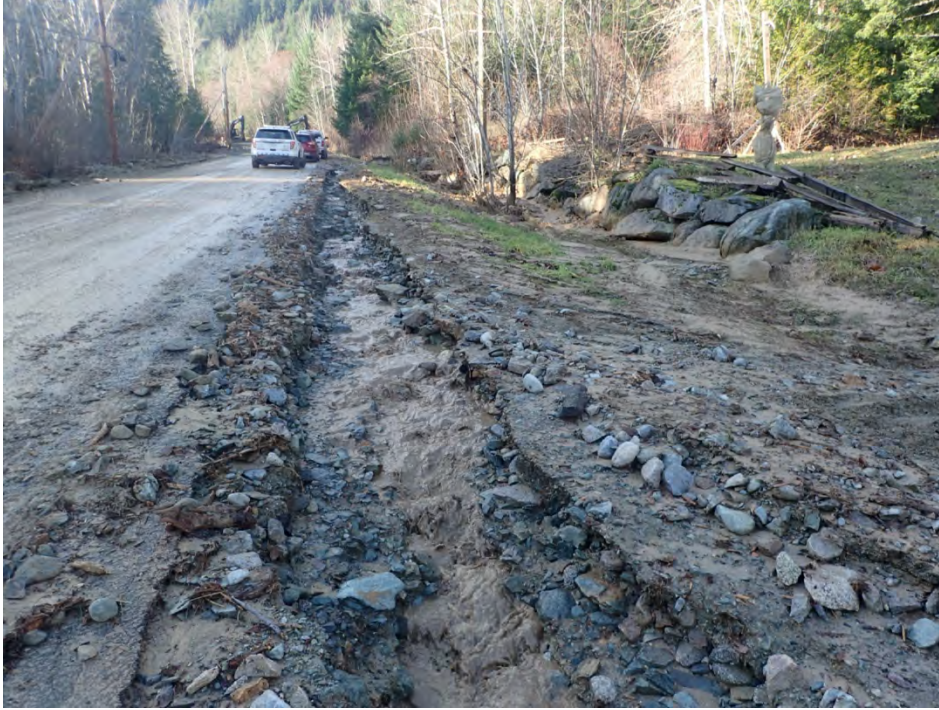
**Photo 17.** WP60. View up (east) along north side Reid Road, eroded shoulder. At this point on south side of road (WP59), water avulsed from shoulder toward house at 1802 Reid Road.

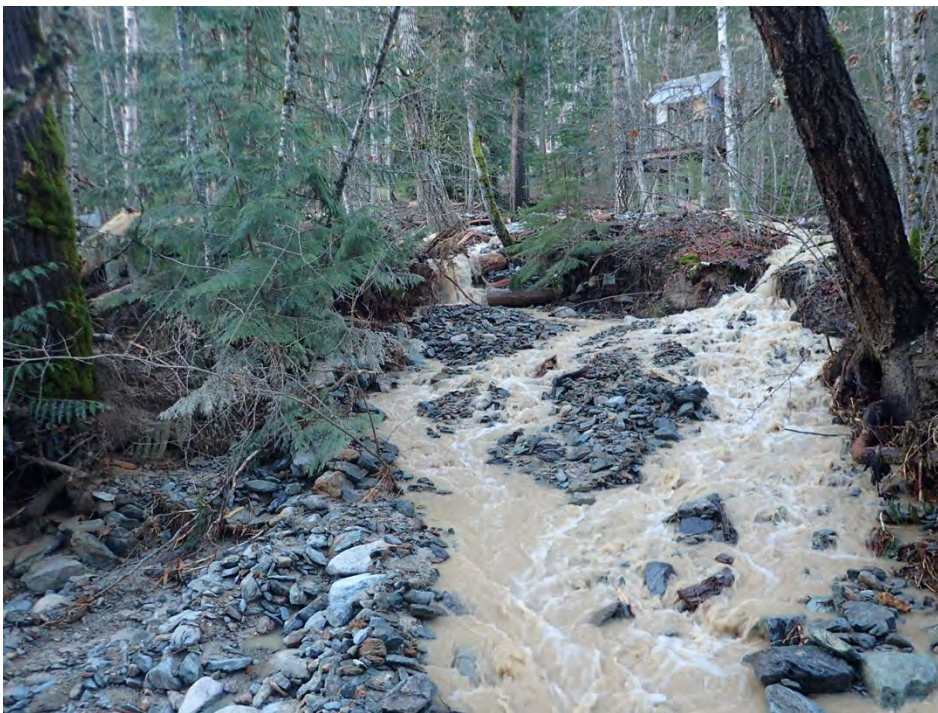
**Photo 20.** WP103. Head of nickpoint erosion. View upstream, treehouse on right.

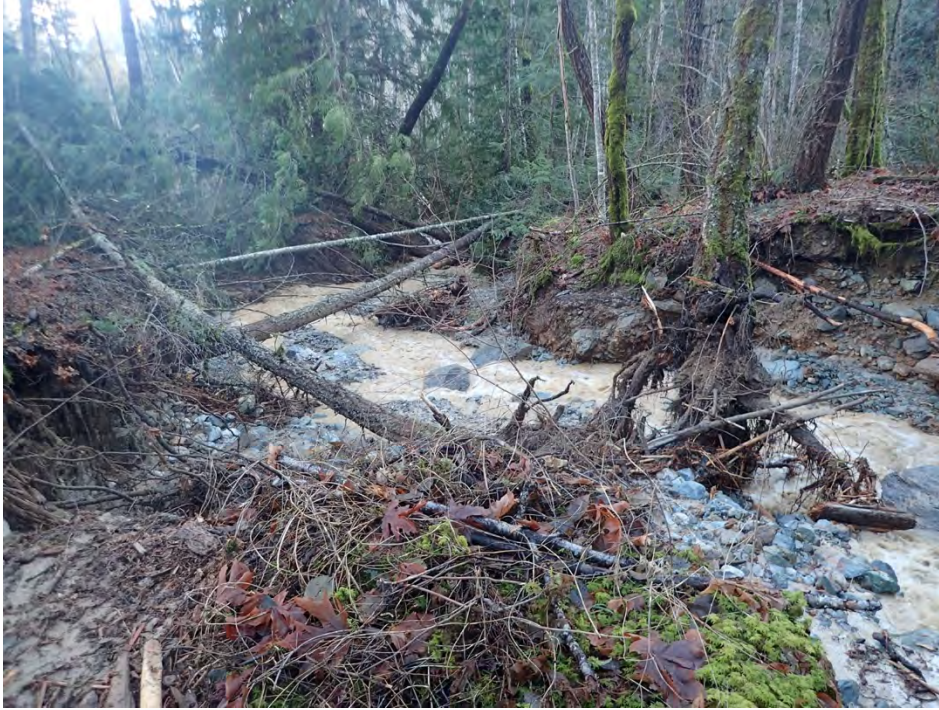
**Photo 21.** WP103. View downstream. Major channel erosion, 6 m by 2 m deep, trees down left and right.

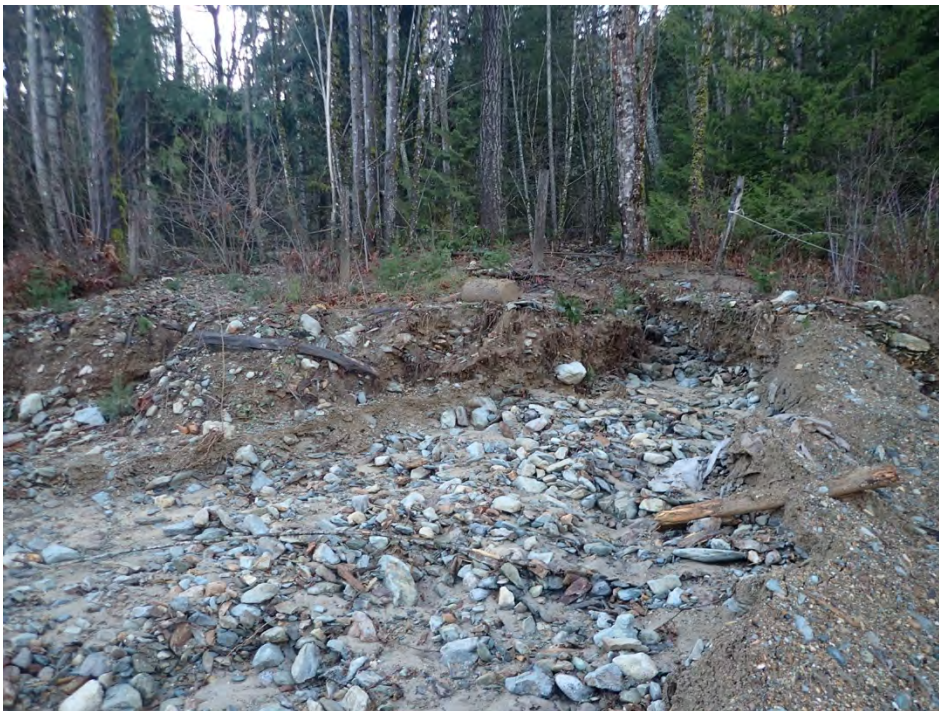
**Photo 22.** WP102. View upstream to incised overflow channel. Deposition from this overflow channel affected garlic patch (WP101) and pond (WP91) at 1788 Reid Road.

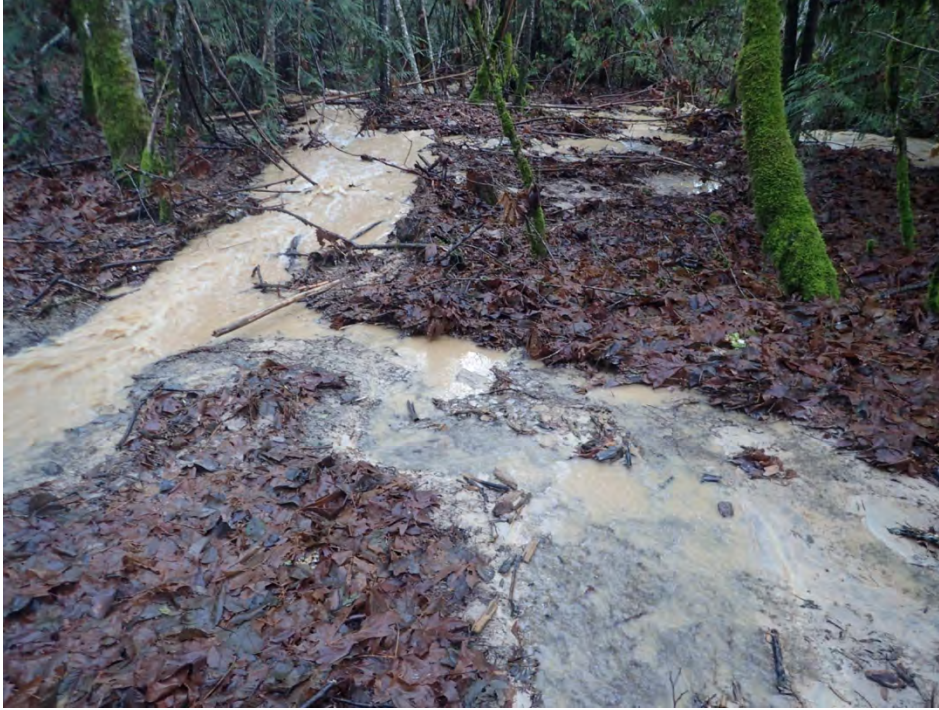
**Photo 23.** WP92. Multiple braided channels in woods.

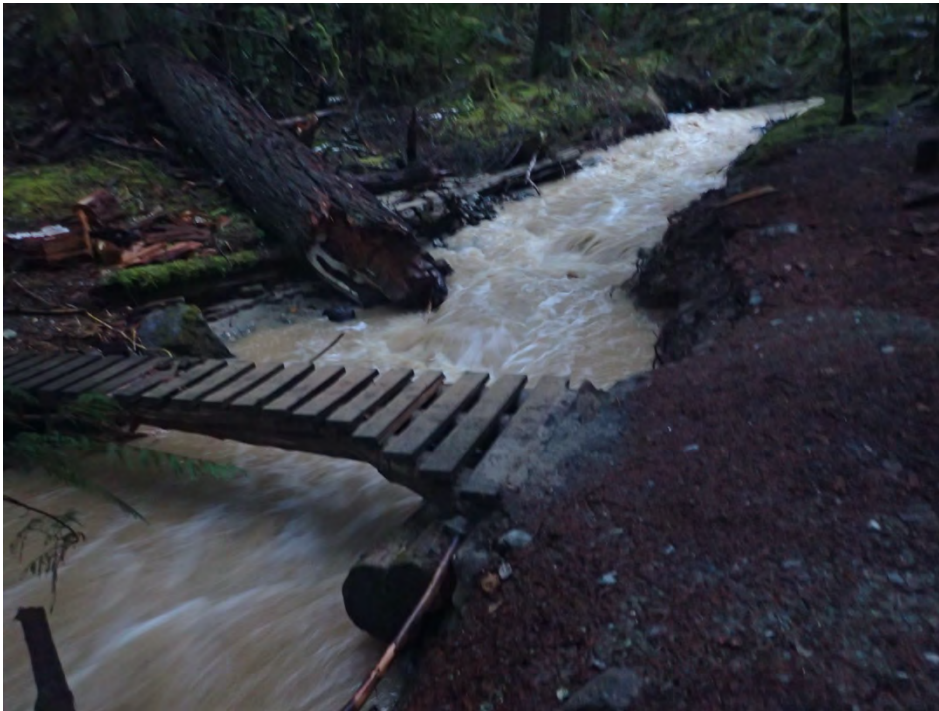
**Photo 27.** WP125. Footbridge just above lower fan apex. Minor bank erosion.

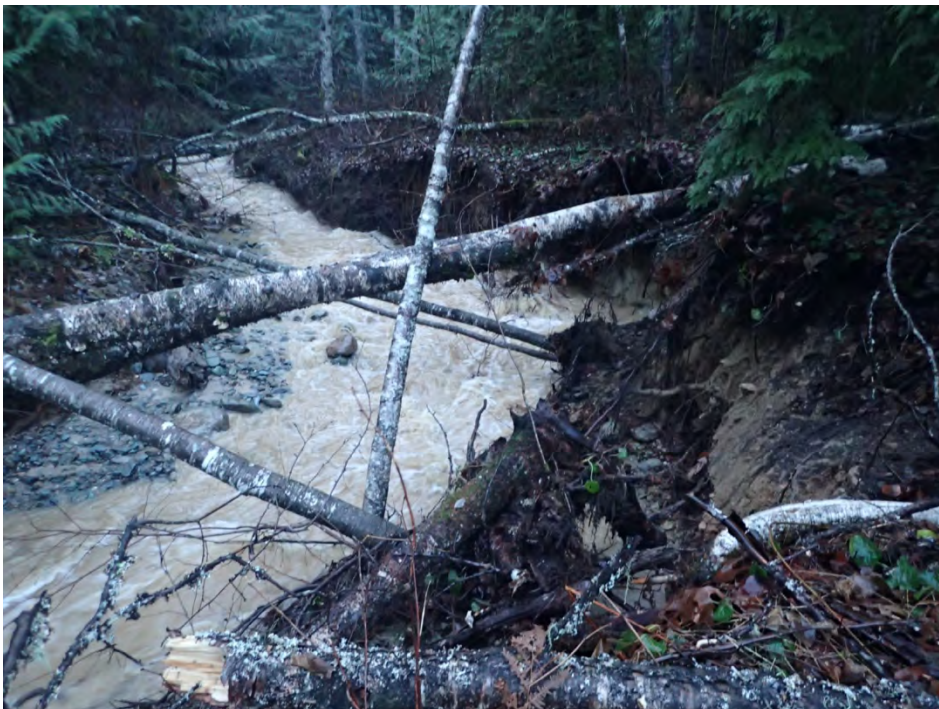
**Photo 28.** WP122. View upstream. Creek incised 1-2 m. Left bank erosion.

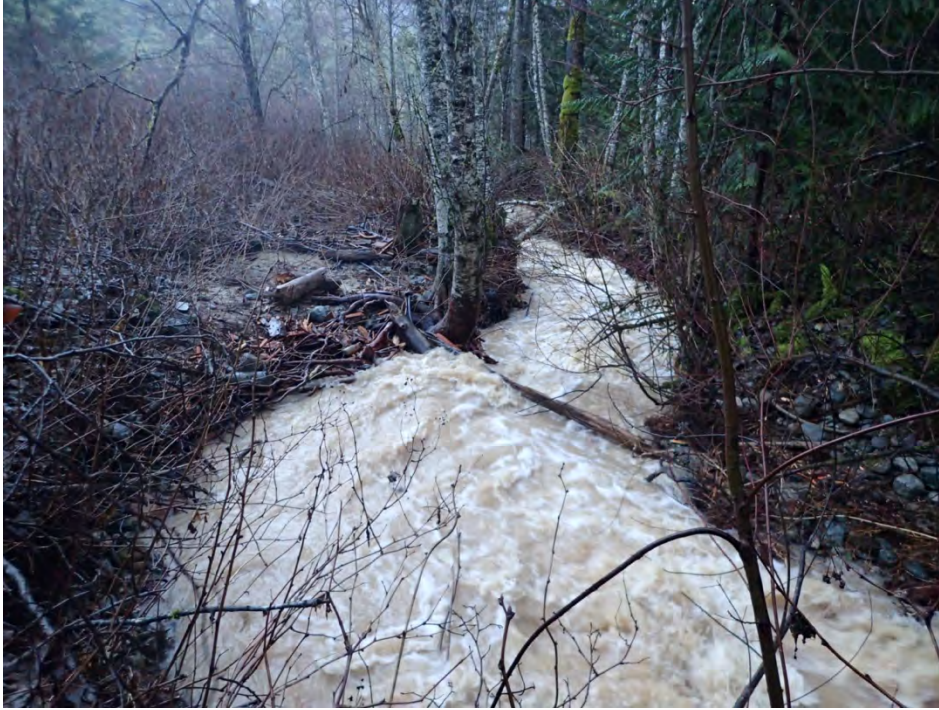
**Photo 29.** WP121. Channel confined by adhoc dike. Flood surge on left bank.

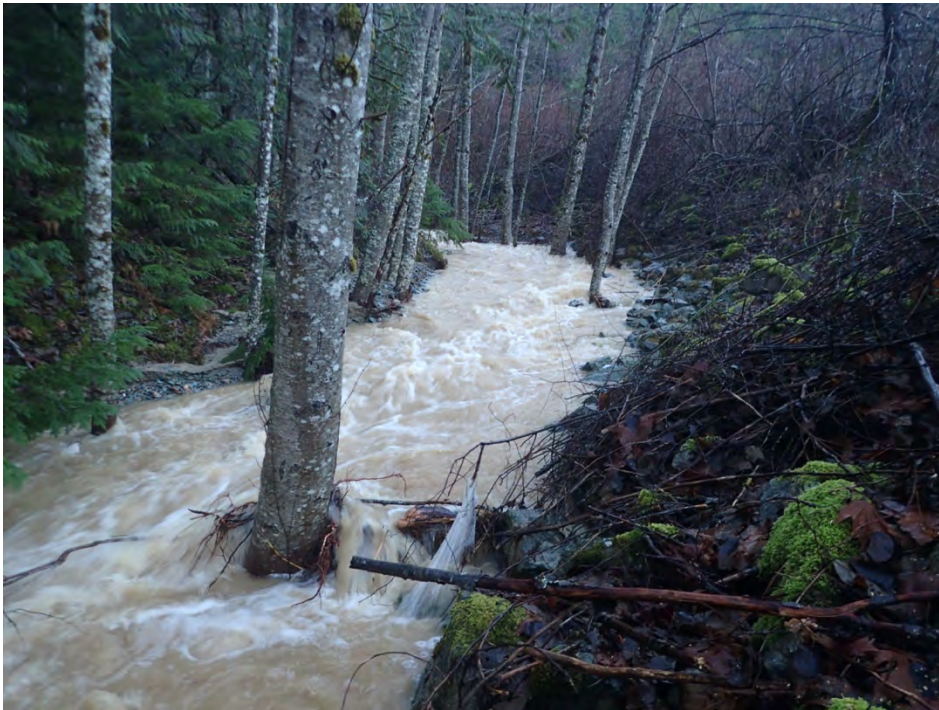
**Photo 30.** WP120. View upstream along Jason Creek, channel 3-5 m wide, incised 2 m. Note riprap bank on river left (right side photo).

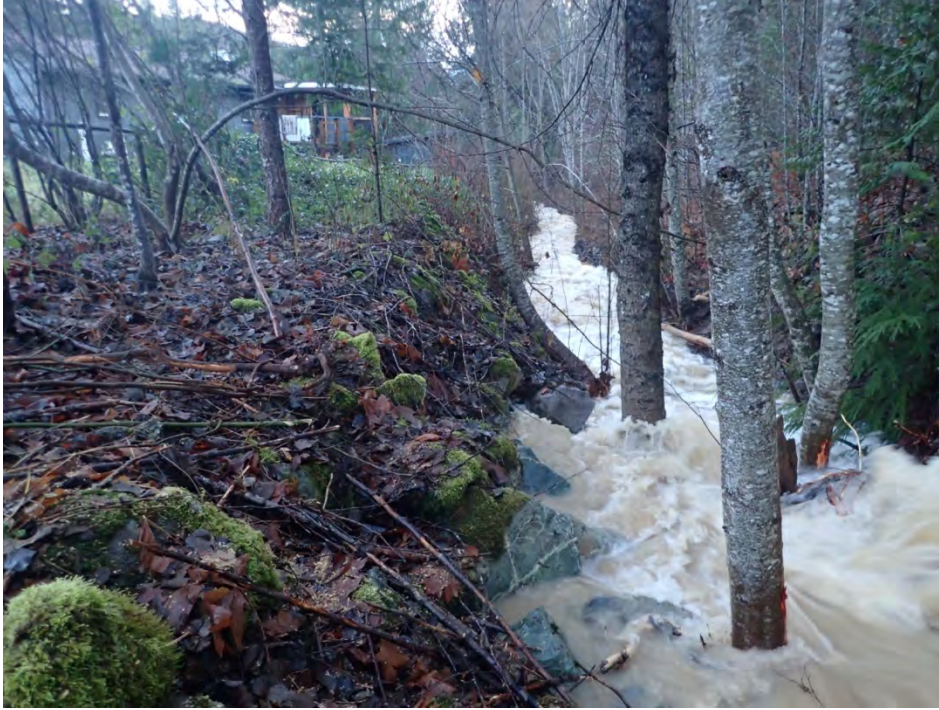
**Photo 31.** WP120. View downstream along Jason Creek, channel 2-3 m wide, incised 2 m. Note riprap bank on river left (left side photo).

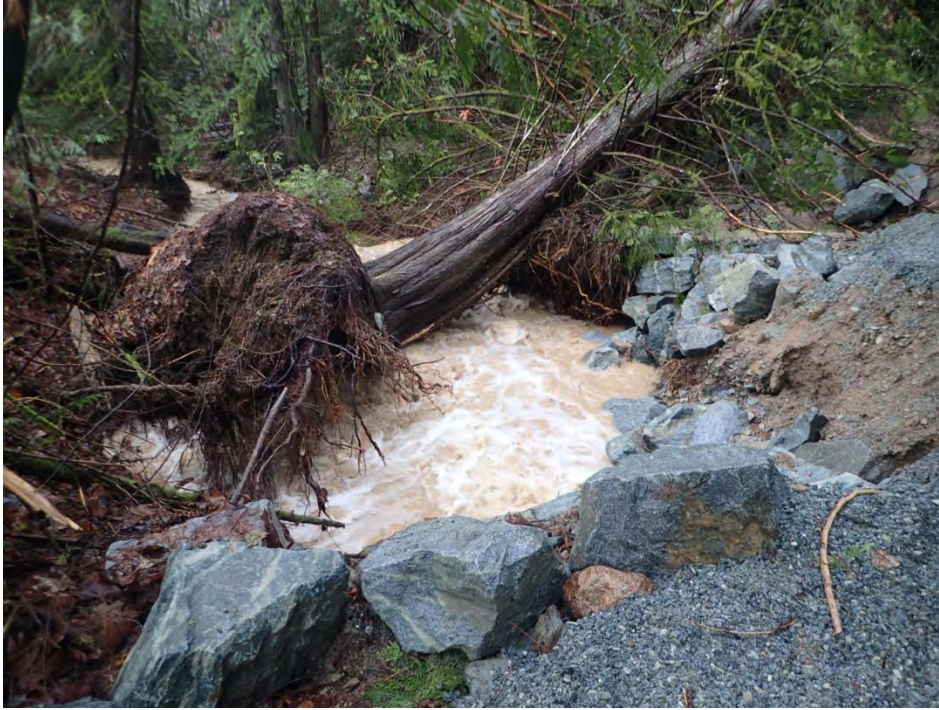
**Photo 33.** WP50. 7699 Portage Road. Creek is incised 4 m into fan surface. Internal access road crosses through incised channel; culvert plugged with wood, road overtopped causing bank erosion and undermining of trees.

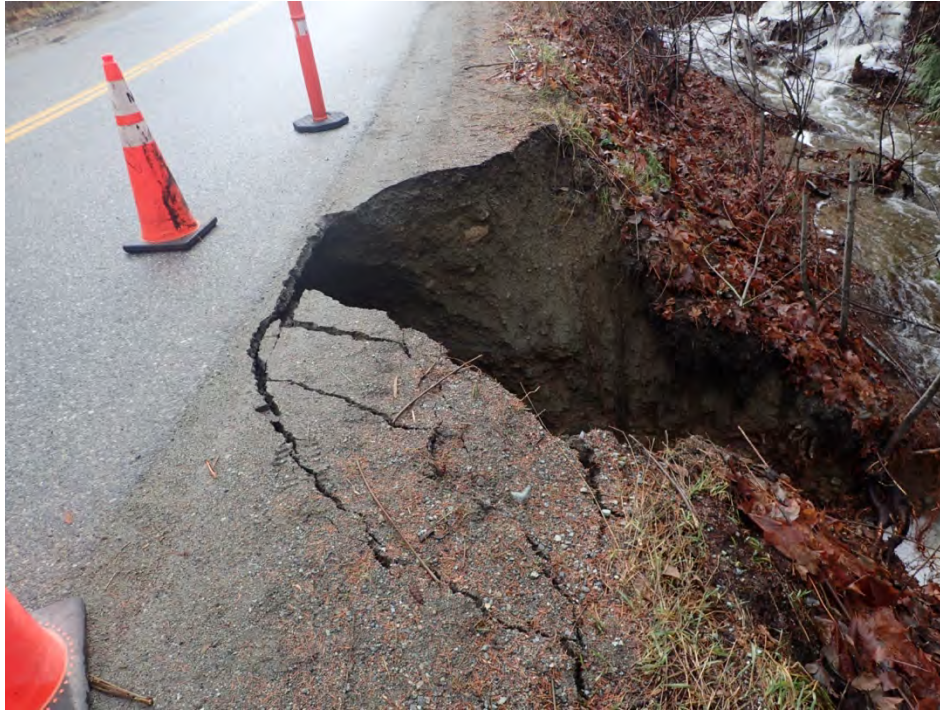
**Photo 35.** WP46. Erosion of Portage Road shoulder on upstream (north) side.

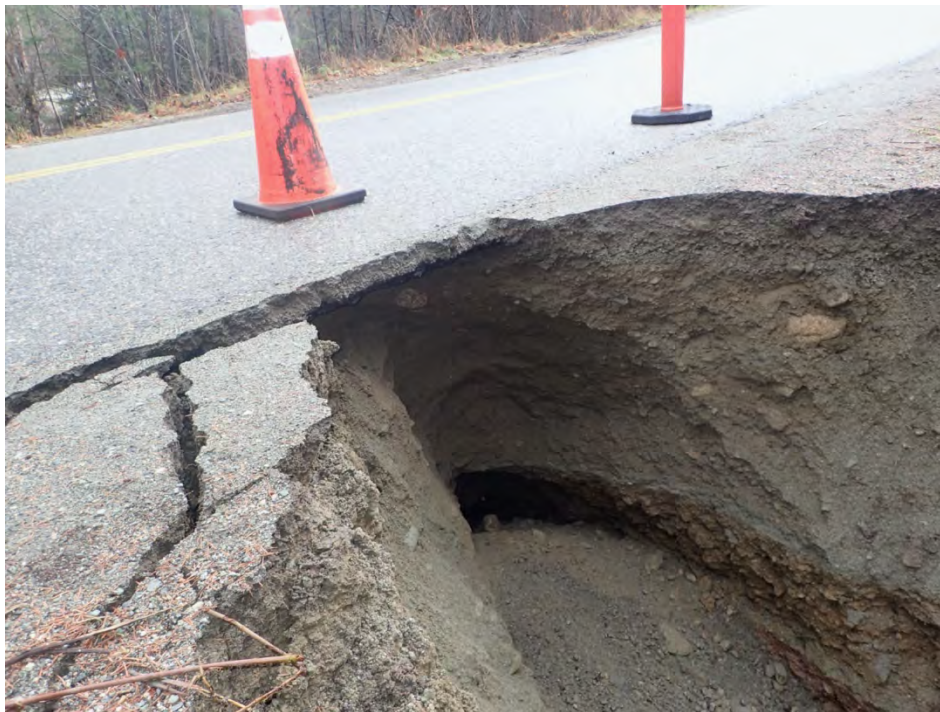
**Photo 36.** WP46. Erosion of Portage Road shoulder on upstream (north) side.

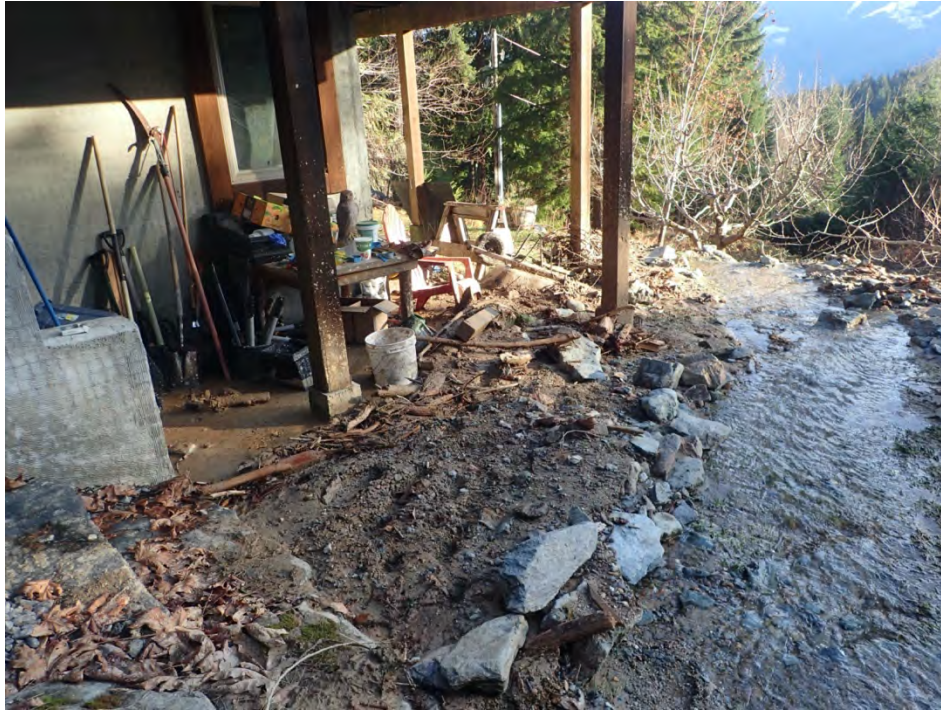
**Photo 39.** 1781 Reid Road. Porch supports at southwest corner of house clipped by debris slurry.

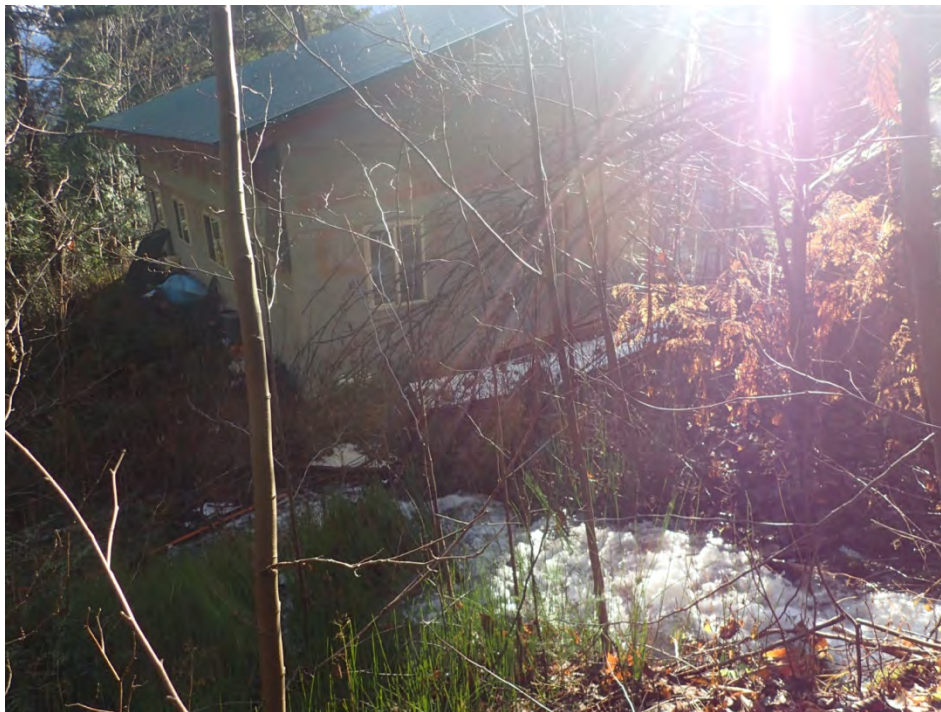
**Photo 40.** 1781 Reid Road. Shop with small creek immediately upslope. This creek is usually just a seepage.

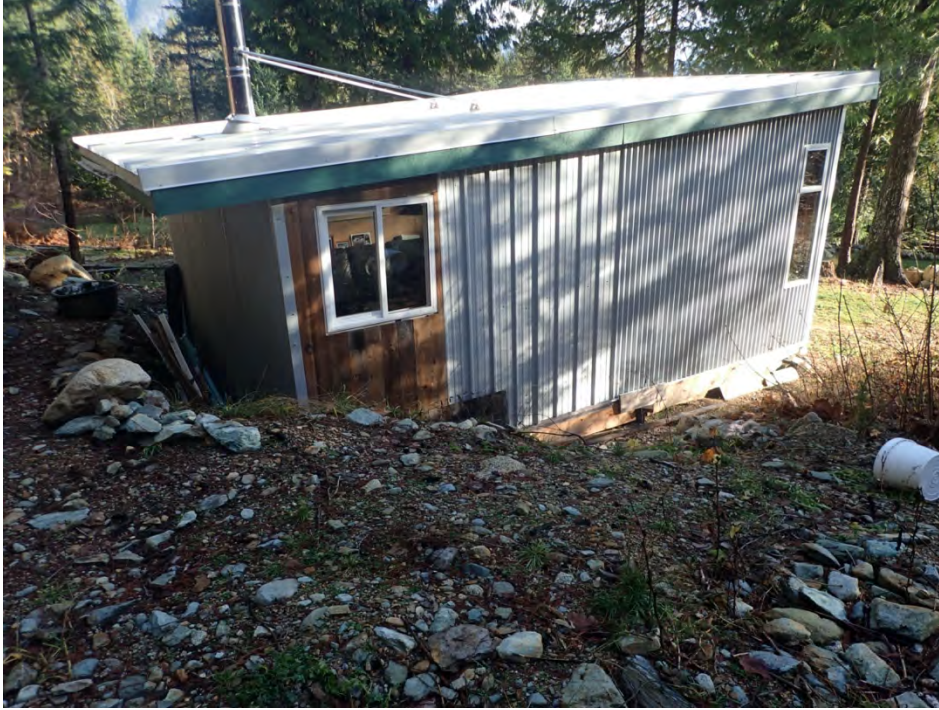
**Photo 41.** 1791 Reid Road. Slope left to right. Small residential building dug into fan and not on permanent foundation. Not resilient to flood water or debris.

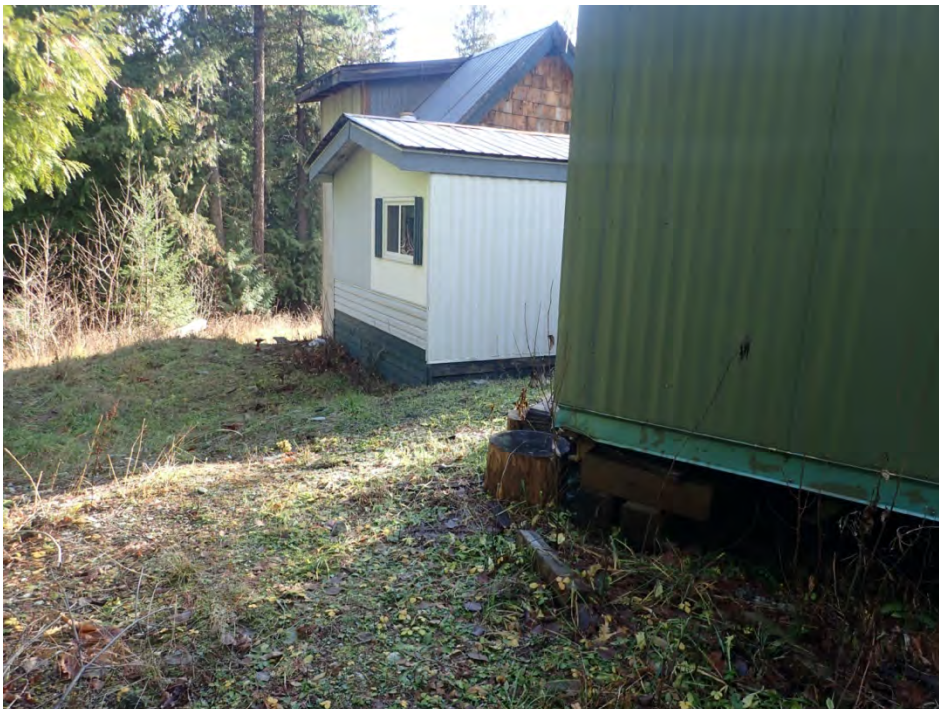
**Photo 42.** 1793 Reid Road. Collection of buildings; main floor at house at grade and accessory buildings not on permanent foundations. Not resilient to flood water or debris.

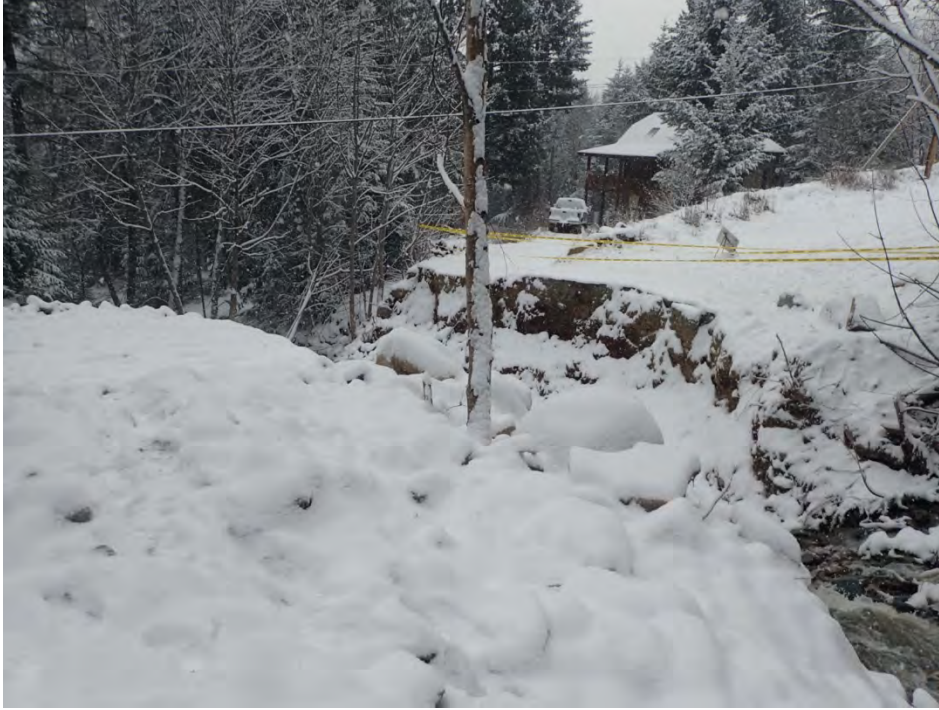
**Photo 43.** 1770 Reid Road. House on slope above fan, and somewhat shielded from hydrogeomorphic events by right bank (west) gully sidewall, since trimmed down by Reid Road. Property driveway access severed by washout.

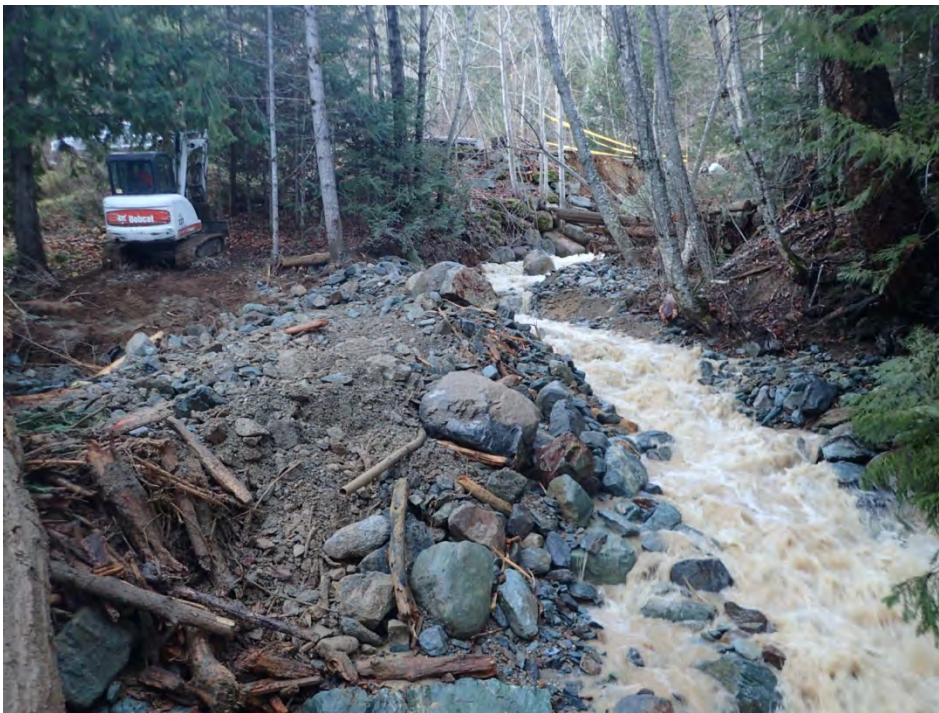
**Photo 44.** 1770 Reid Road, WP106. View upstream to road. Domestic water well is close to west side of creek and was threatened by erosion. Owner placed adhoc armour to protect well.

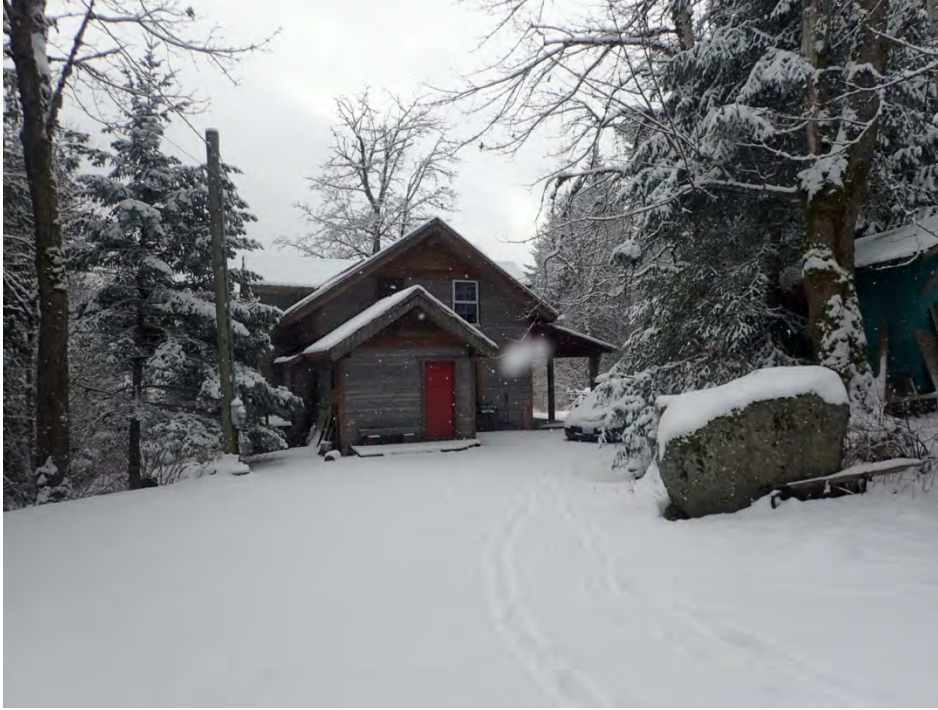
**Photo 45.** 1782 Reid Road. House. Main floor at grade; not resilient to flood water or debris. House escaped impact because slight throughput in fan by Reid Road directed overflow eastwards down road.

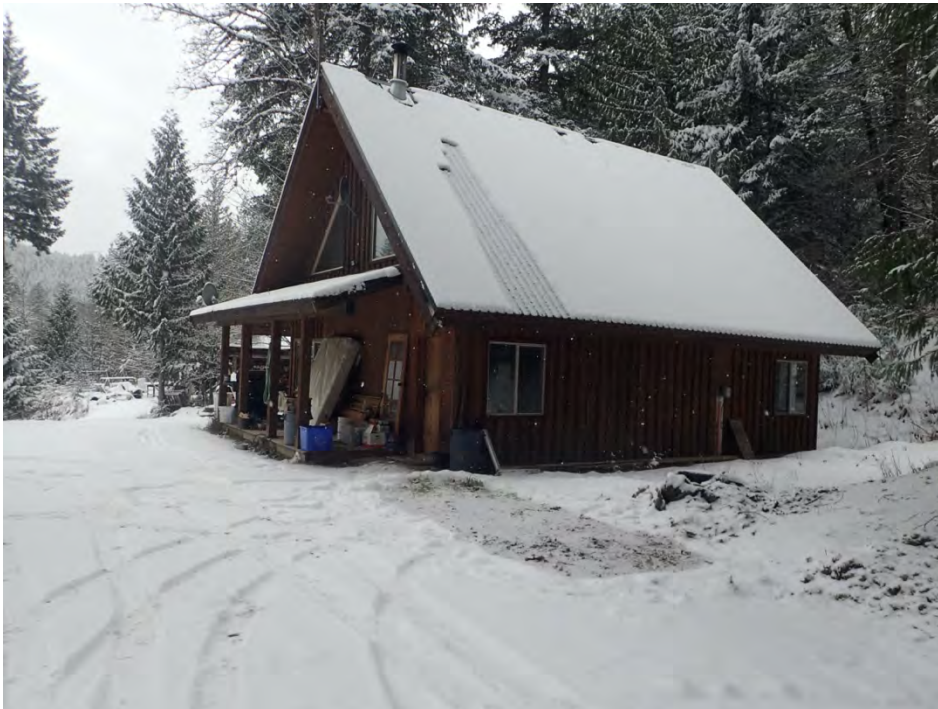
**Photo 46.** 1788 Reid Road. House. Main floor at grade; not resilient to flood water or debris. House escaped impact because slight throughput in fan by Reid Road directed overflow eastwards down road.
