*Pierre A. Friele, MSc, PGeo*  
*P.O. Box 612*  
*1021 Raven Drive*  
*Squamish, BC V8B-0A5*  
*Ph. (604) 849-0250*  
*email. pfriele@gmail.com*

Sarah Morgan  
SLRD EOC Director  
P: 604-894-6371  
[www.slrd.bc.ca](http://www.slrd.bc.ca)

V1 December 10, 2021; V2 December 13, 2021

During the recent atmospheric river events (Nov 14-15; Nov 27-29; Nov 30-Dec 1; 2021), Jason Creek, at Ivey Lake, near Pemberton, BC experienced three extreme hydrogeomorphic events and washed out the Jason Creek culvert at Reid Road two times. The events were accompanied by overland flow flooding of several properties, localised bank erosion, minor damage to Portage Road, and threatened the CN Rail line.

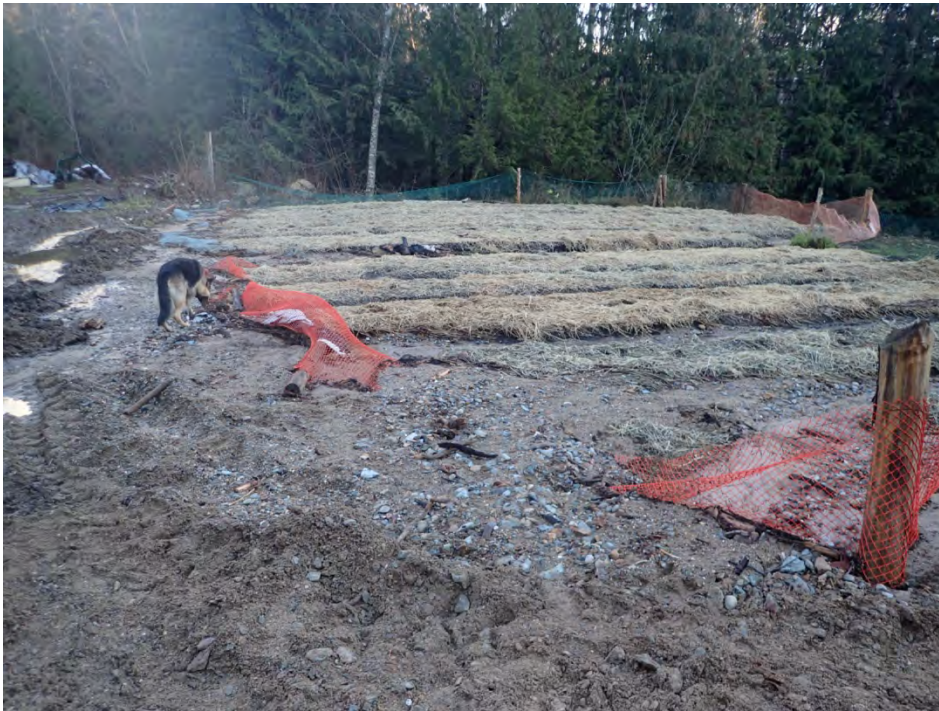
**Photo 47.** 1788 Reid Road. Garlic patch partially damaged by overland flooding.

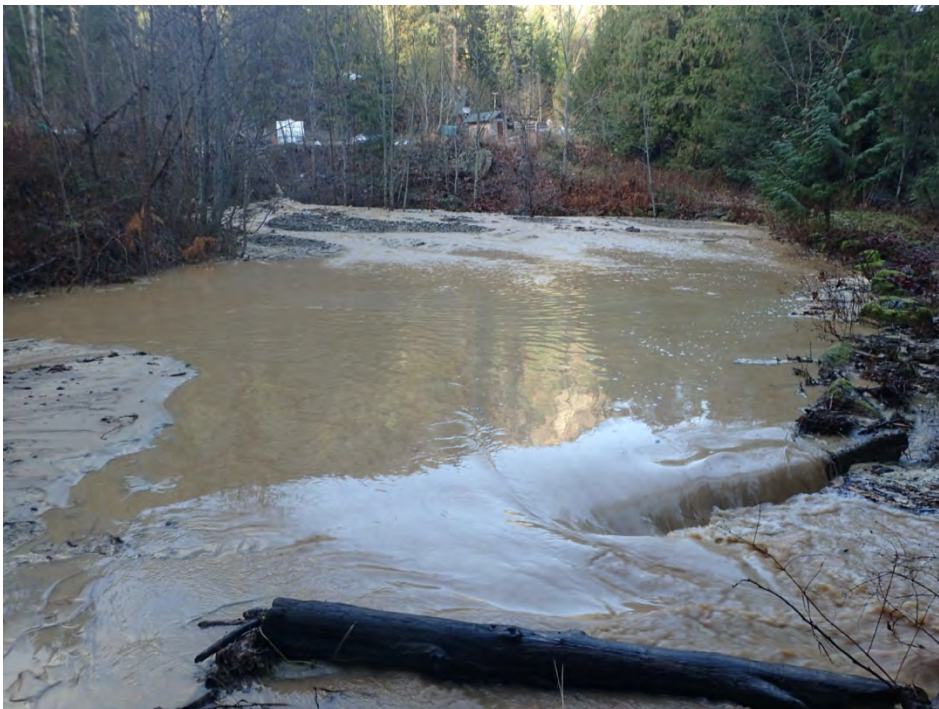
**Photo 48.** 1788 Reid Road. Dug pond filled in with sediment by overland flooding.

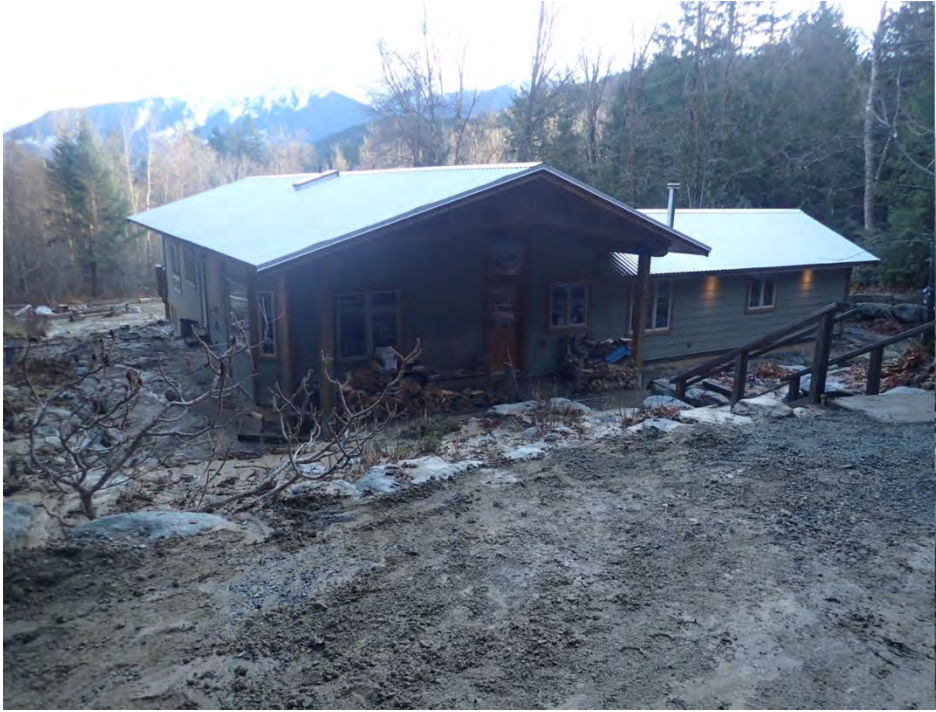
**Photo 49.** 1794 Reid Road. House dug into fan on uphill side. Main floor at grade; not resilient to flood water or debris. Overland flow affected house. Residents were evacuated between 10pm and midnight December 1, 2021.

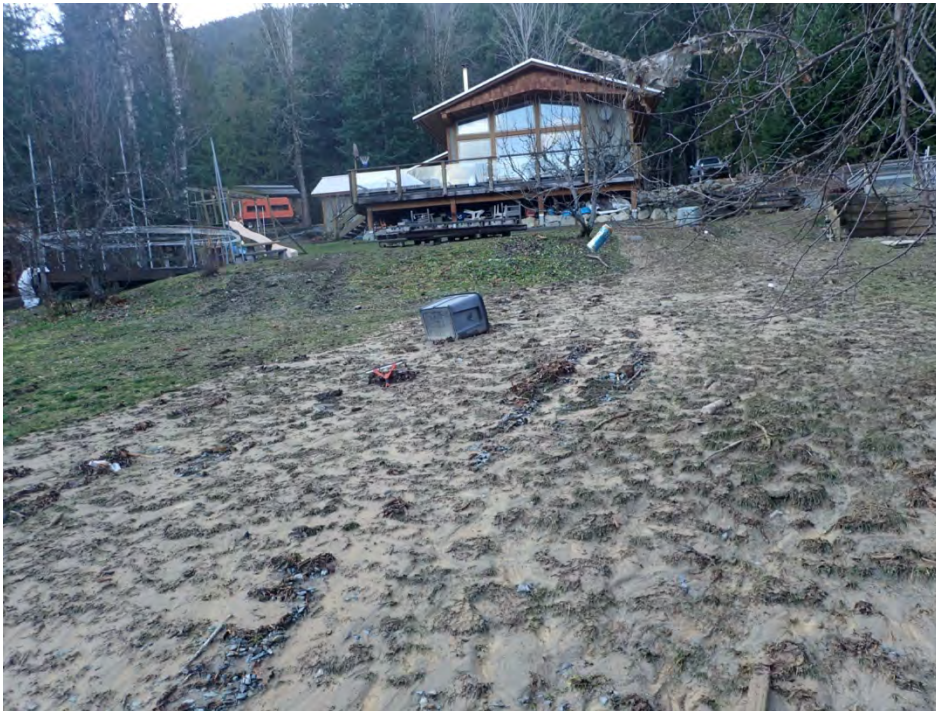
**Photo 50.** 1794 Reid Road. Overland flow ran down east side of house through yard. Residents were evacuated between 10pm and midnight December 1, 2021.

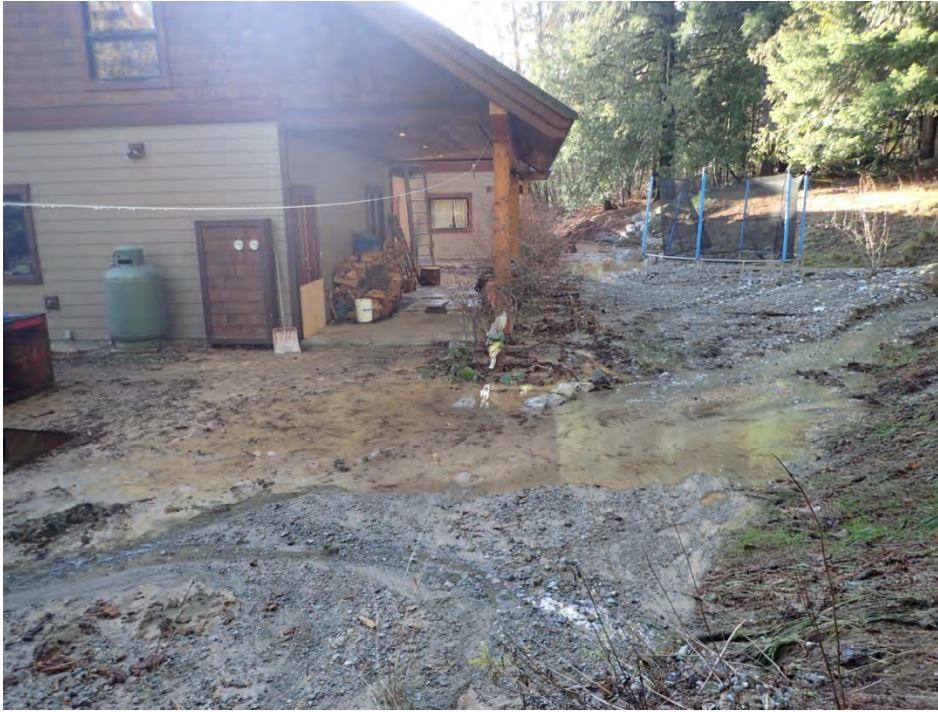
**Photo 51.** 1802 Reid Road. House with main floor at grade; not resilient to flood water or debris. Overland flow affected house.

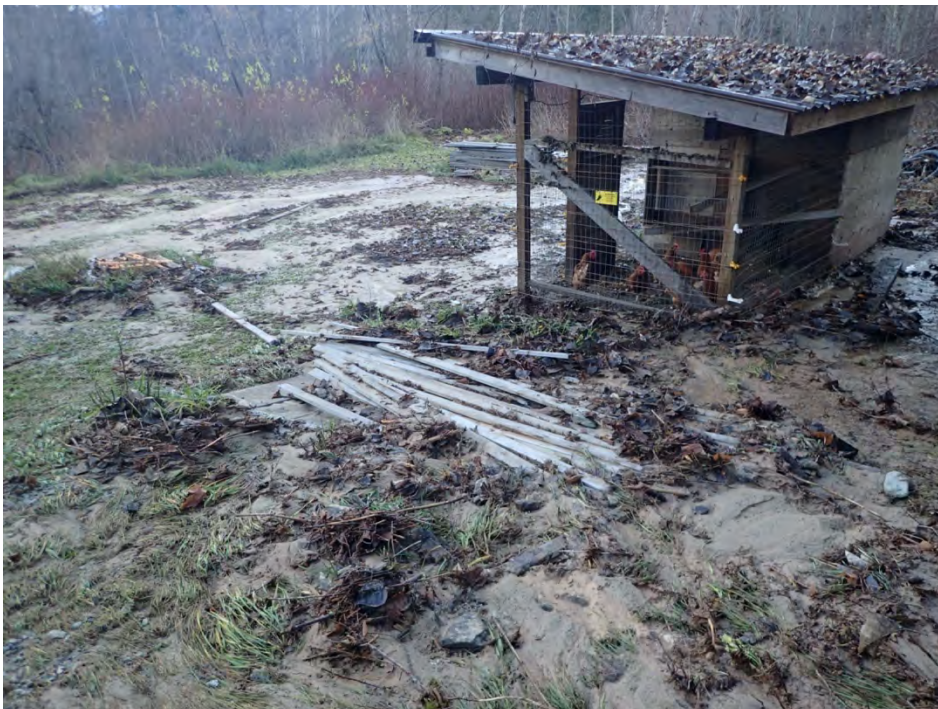
**Photo 52.** 1802 Reid Road. Chicken coop affected by overland flow.

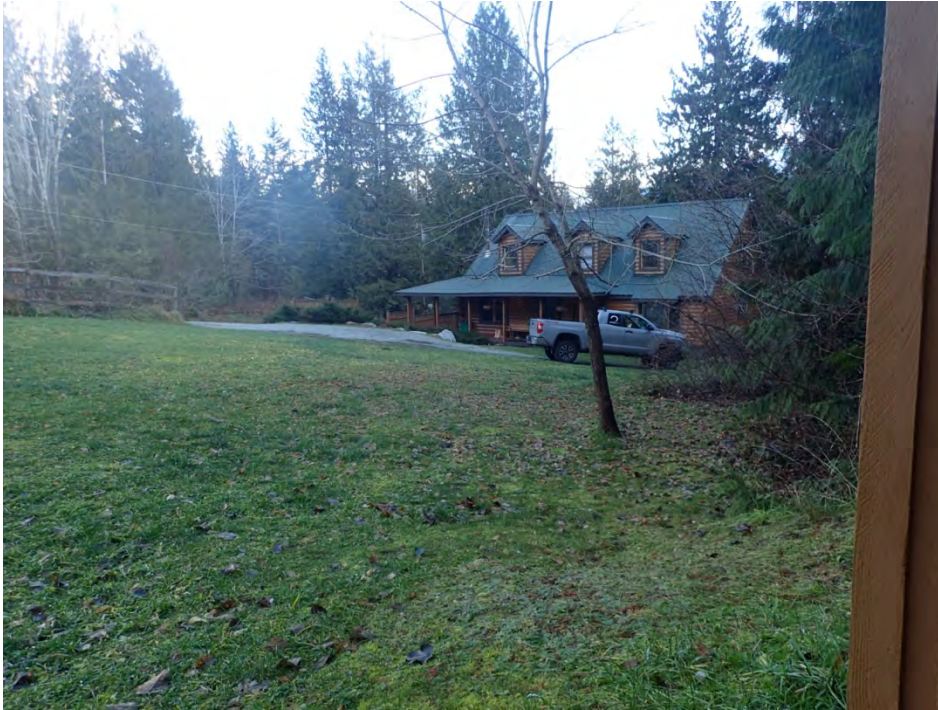
**Photo 53.** 1812 Reid Road. Although on Jason Creek fan, the house and lot were not directly affected by recent events. Main floor at grade; not resilient to flood water or debris.

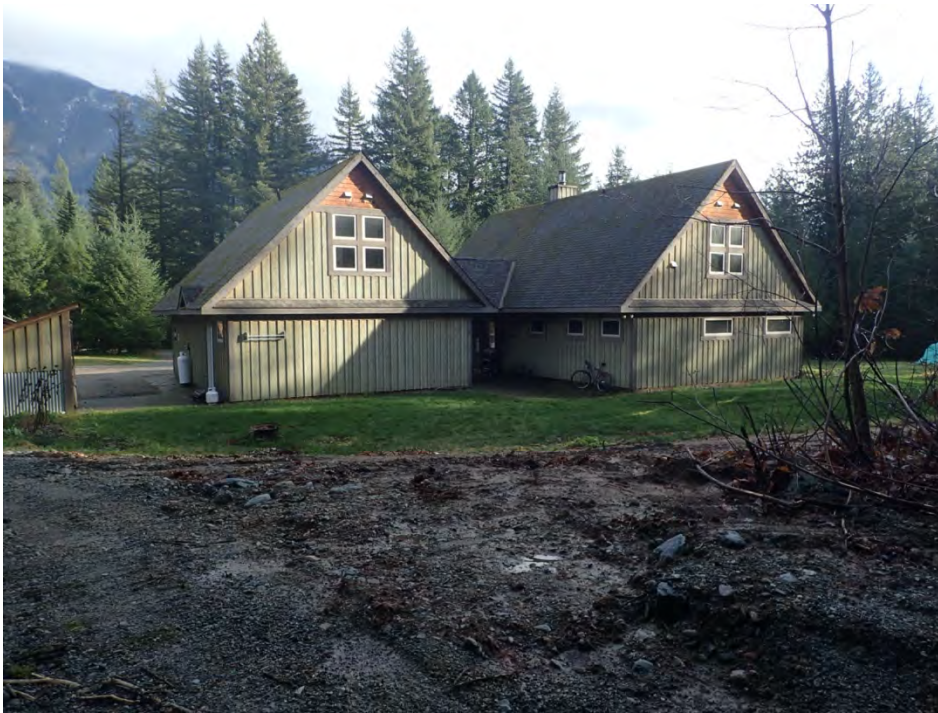
**Photo 55.** 7699 Portage Road. Main floor on grade. Not resilient to flood water.

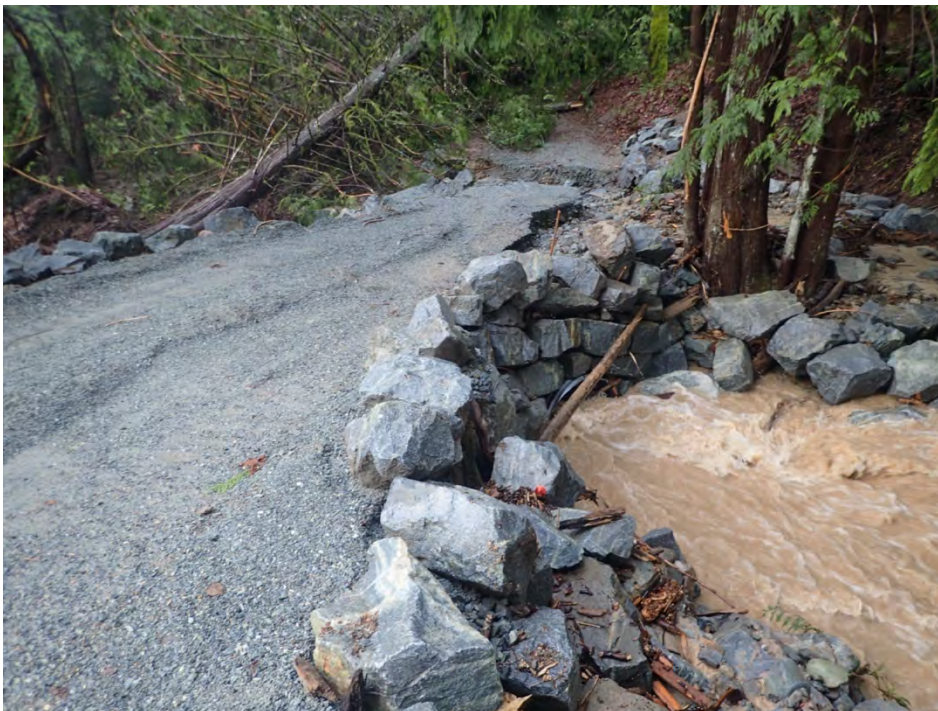
**Photo 56.** 7699 Portage Road. Culvert plugged causing overtopping and washout of internal access road to accessory building. Associated bank erosion undermined immature cedar on left bank.

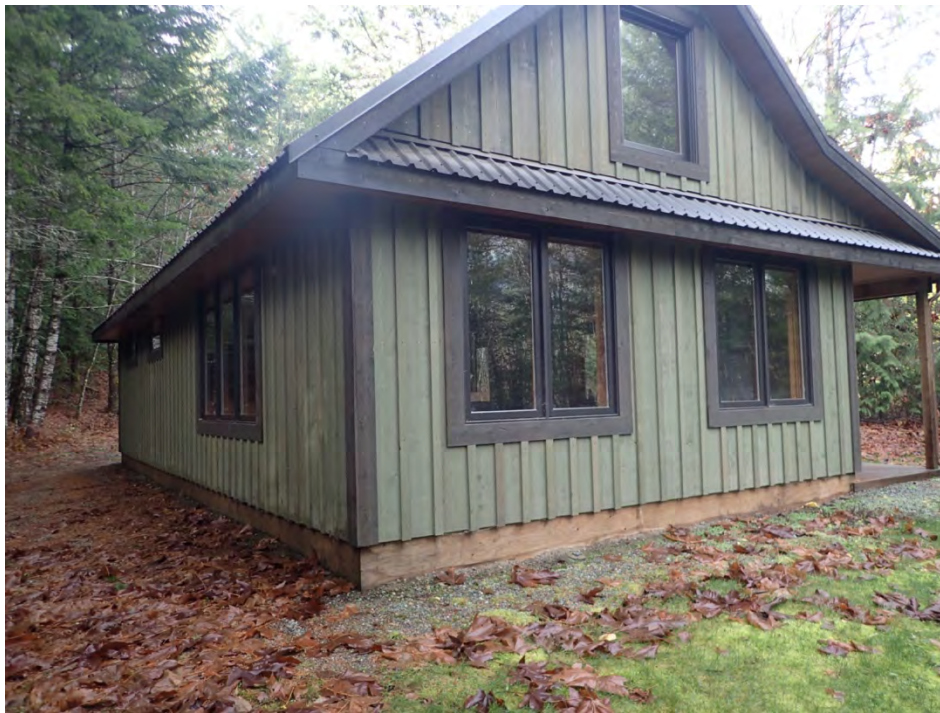
**Photo 57.** 7699 Portage Road. Accessory building. Main floor on grade. Not resilient to flood water.

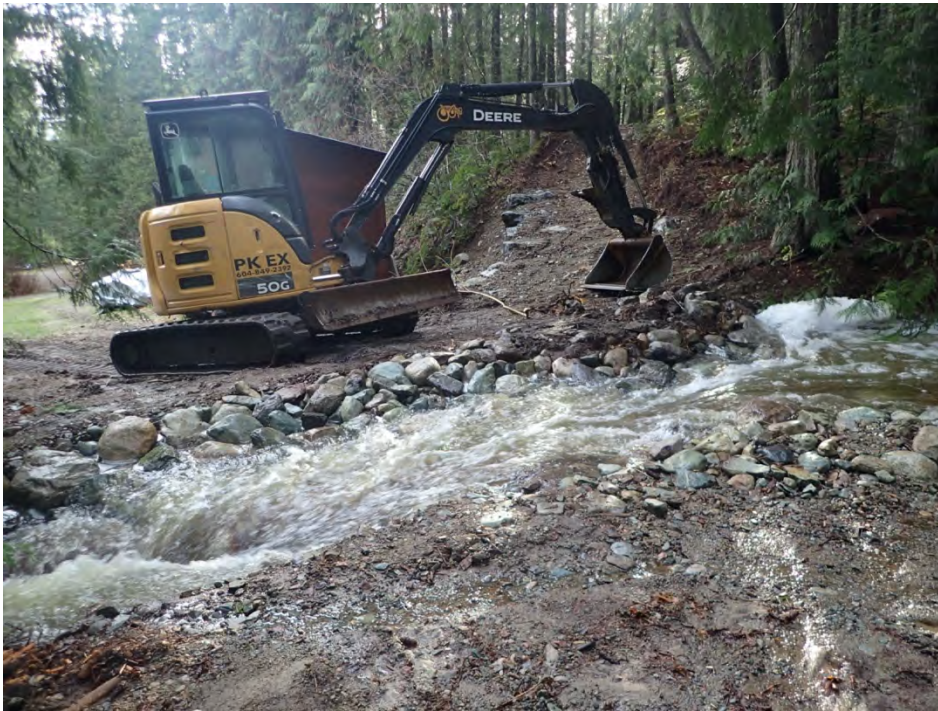
**Photo 59.** 1 Walkerville. Side creek that caused flooding in yard.

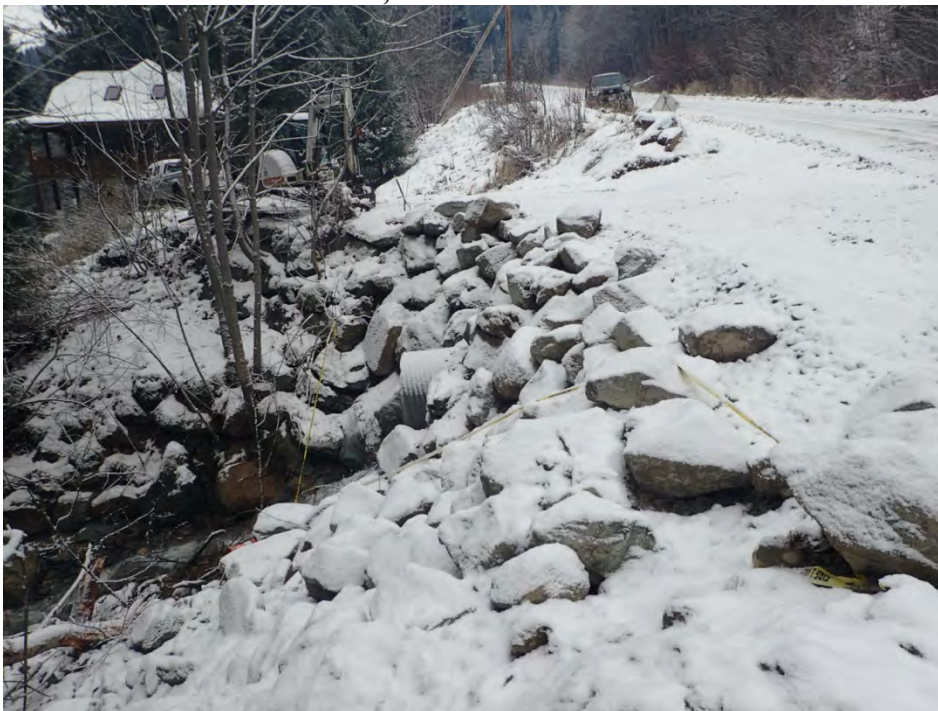
**Photo 60.** WP130. Repaired Jason Creek culvert outfall and driveway access 1770 Reid Road.

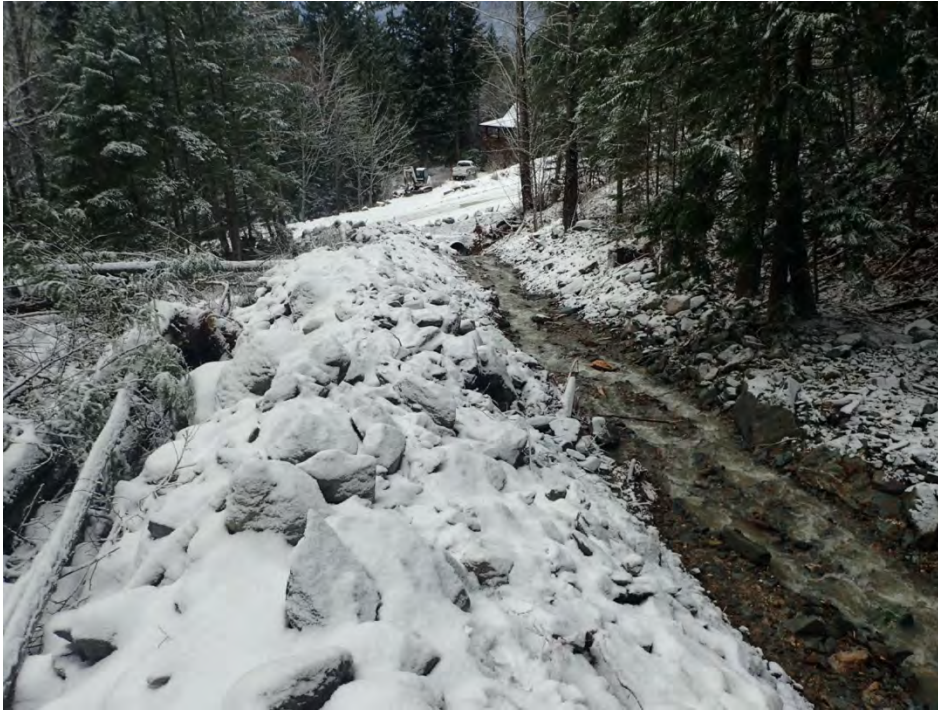
As mapped December 12, 2021, the creek cleaning created a 170-200 m debris berm on the left bank above Reid Road (WPs 130-137; Photos 61, 63, 64). The berm is not continuous, but is broken in several places, and there remains at least three avulsion points (WPs 132, 136, 137; Photo 64) where debris may avulse southeast directly affecting 1781 Reid Road.

**Photo 61.** WP131. Top end constructed boulder berm on left bank. Extends down to Reid Road. Trapezoid: 12 m crest to crest, 3 m wide creek flat, 3 m deep.

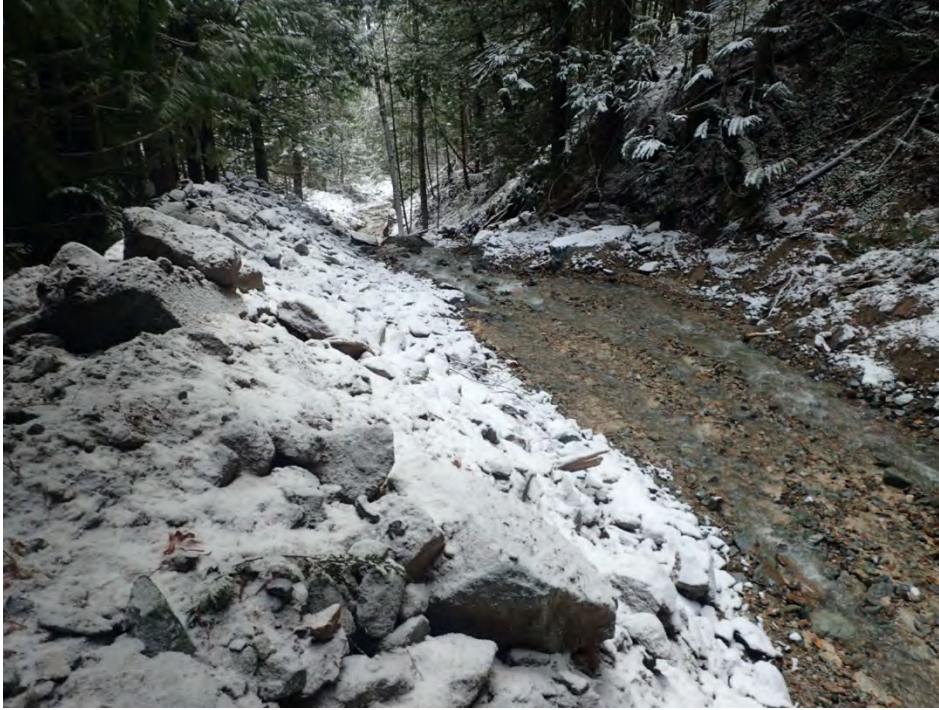
**Photo 63.** WP133-135. Left bank constructed Berm. Trapezoid, 11.5 m crest to crest, 5 m base, 2-2.5 m deep.

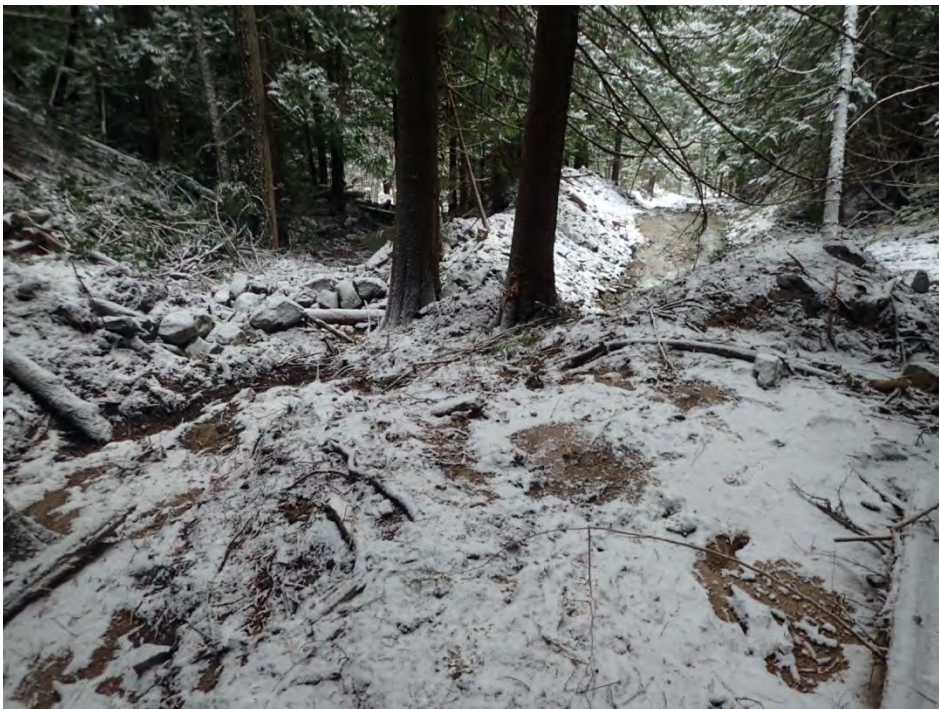
**Photo 64.** WP137. Constructed berm ends, not tied into bank. Debris flow can go around south side to 1781 Reid Road.

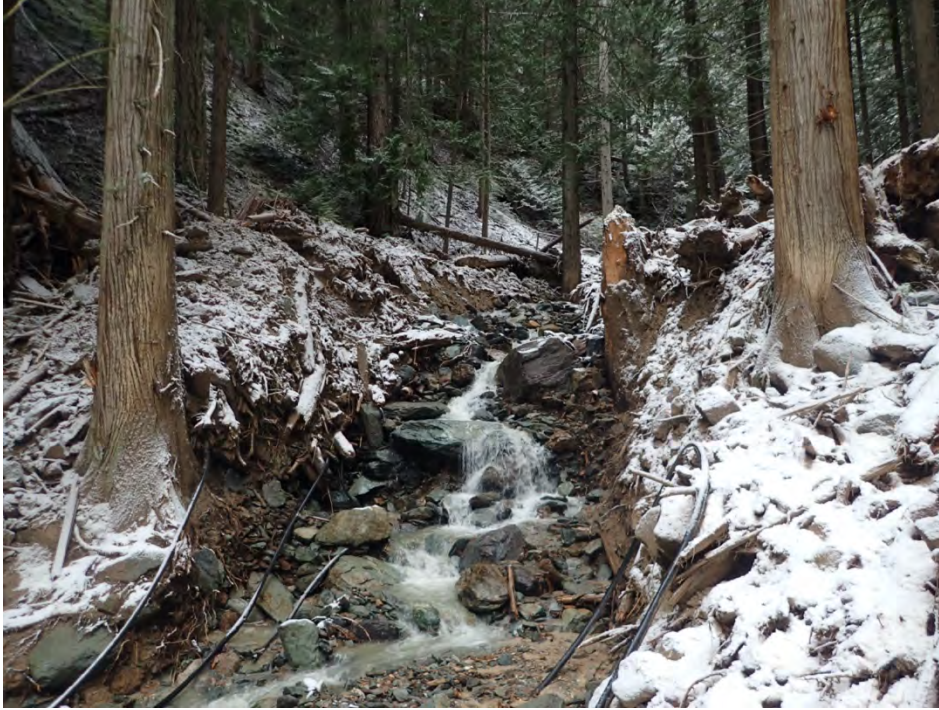
**Photo 65.** WP139. View upstream. Inset fan apex, 2 m tall erosional nick point in channel exposes colluvial fill. Note debris piled on banks by Spider Hoe.

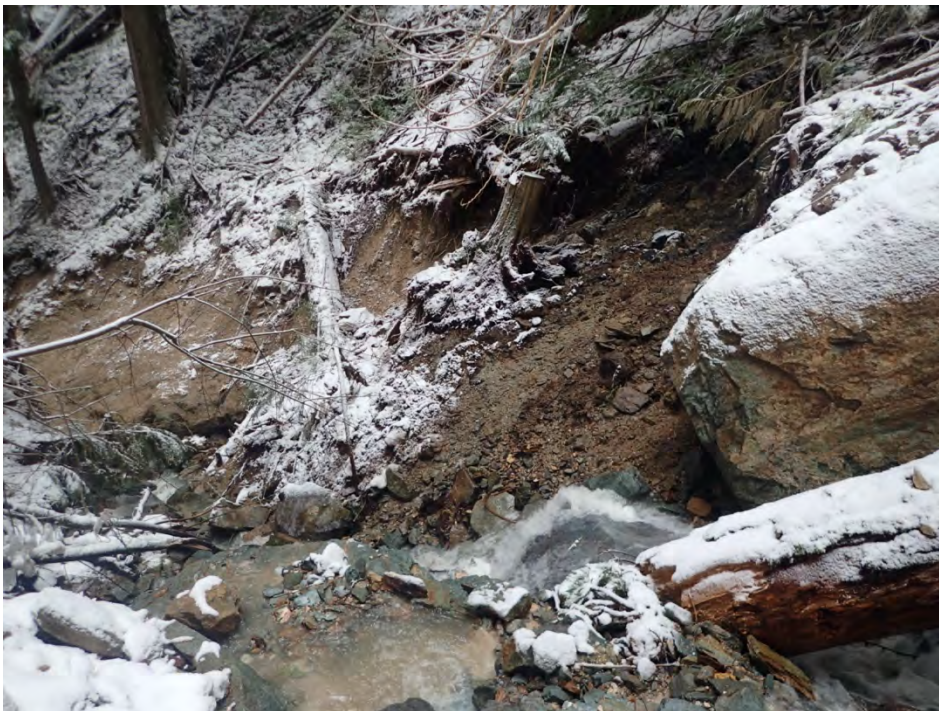
**Photo 66.** WP143. View downstream to right bank. 10 by 10 by 2-3 thick, bank slump partially blocking channel.

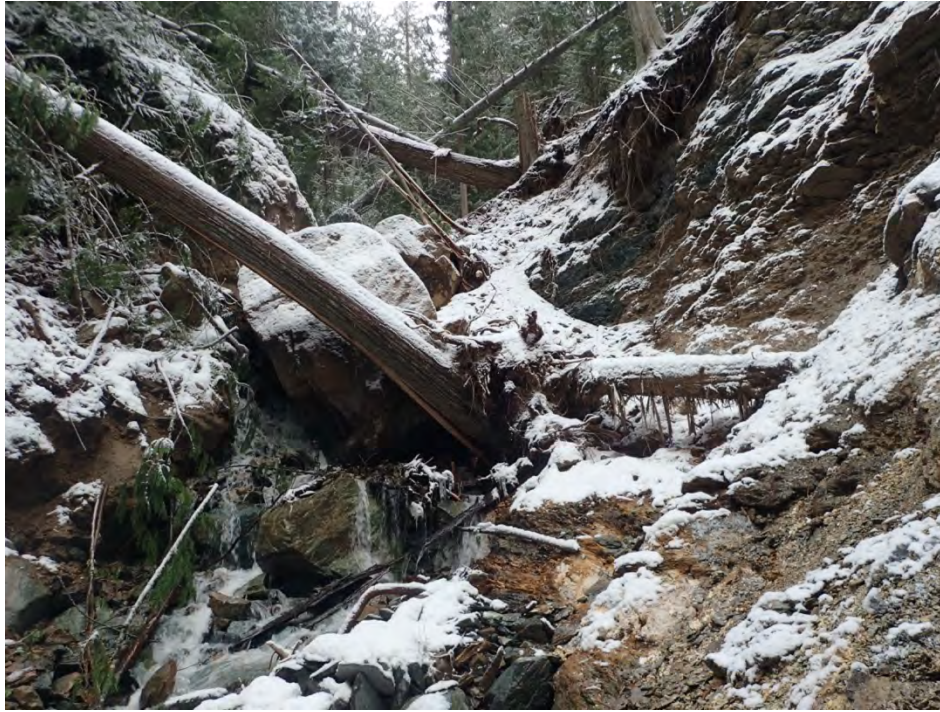
**Photo 67.** WPs 144-145. View upstream. Three large 4-6 m dia boulders block channel. Partially supported by shattered cedar stem. Upper boulders partially buried by debris sloughed from south sidewall.

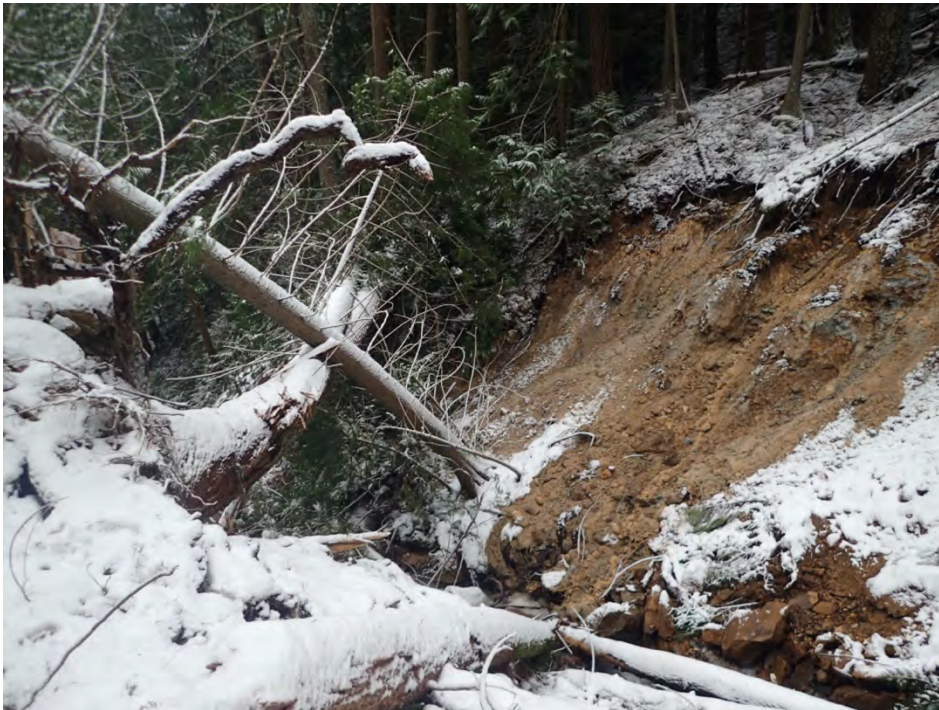
**Photo 70.** WP145. View downstream to fresh right bank 15 m wide slump. Altered bedrock, seepage.

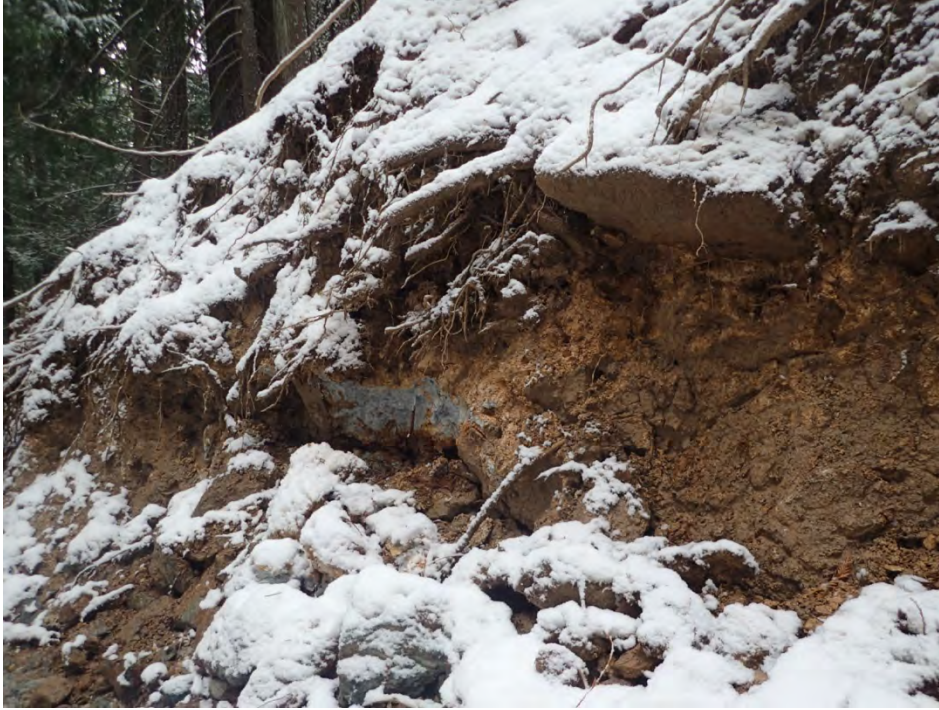
Between the fan apex at 455 m and 500 m elevation the channel has ~20-30% gradient with a valley flat ~20 m wide, with stored colluvium incised by a 12 m wide by 2-3 m deep trapezoidal channel (WPs 137-142). The Spider hoe cleared jams from this section of the channel. At 500 m elevation there is a break to a steeper (30-40% gradient), more steep-sided V-shaped channel, extending up to 575 m elevation. Through this reach (WPs 142-147) the sidewalls are undermined and unstable; there were two fresh bank slumps and several older bank slumps noted (Photo 66, 67, 70, 72). At one site (WPs 144, 145), three 4-6 m diameter boulders, the lowest partially supported by cedar tree (Photo 67), block the channel. This reach contains residual hazards that add to the total residual volume described below. From 575-655 m elevation the channel gradient breaks to 20-30% and the valley flat is up to 50 m wide (WP147). In this area the valley flat is filled 3-5 m deep with colluvium derived from degraded bedrock containing altered ripups (Photo 71).

**Photo 71.** WP147. Colluvium composed of degraded bedrock. Exposed on right bank. In this reach valley flat is the ~50 m wide and filled with sidewall slump colluvium 3-5 m thick.

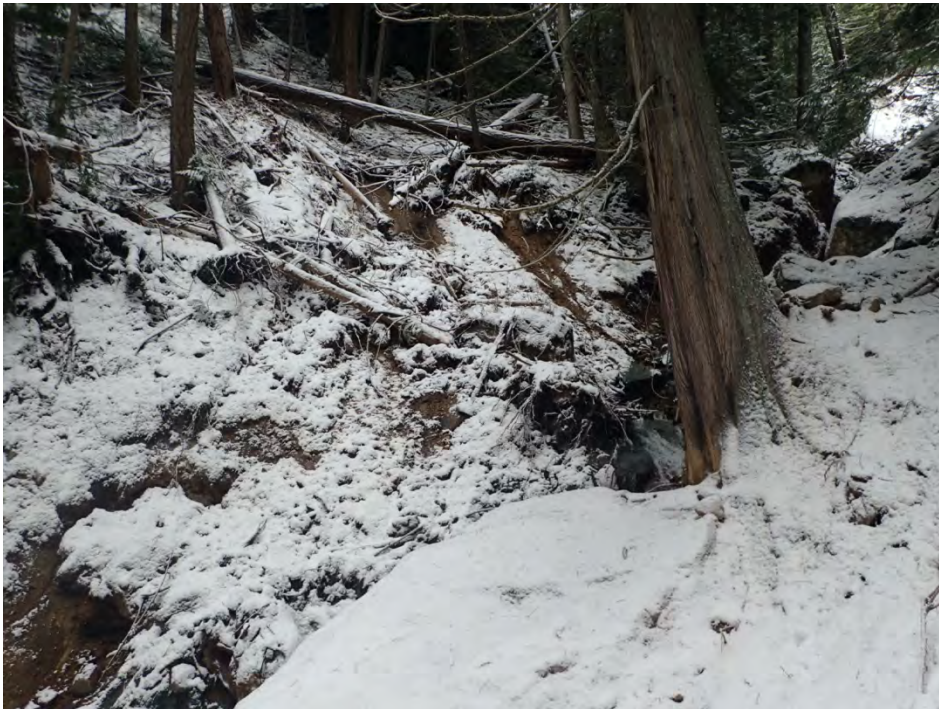
**Photo 72.** WP148. View upstream. Fresh slump/slide on right bank, 15 m wide, still 90% residual. Reach break to steep ravine upstream.

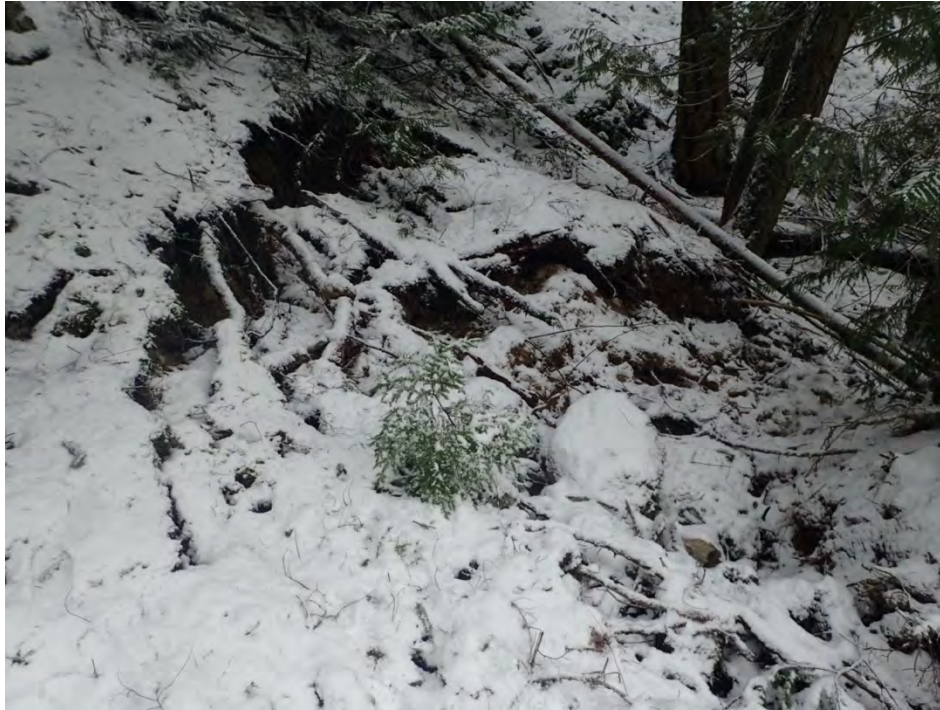
**Photo 73.** WP151. View east across crest of main active failure area. Changed since Dec 1, with new extension of tension cracking and settlement some 5 m headward.

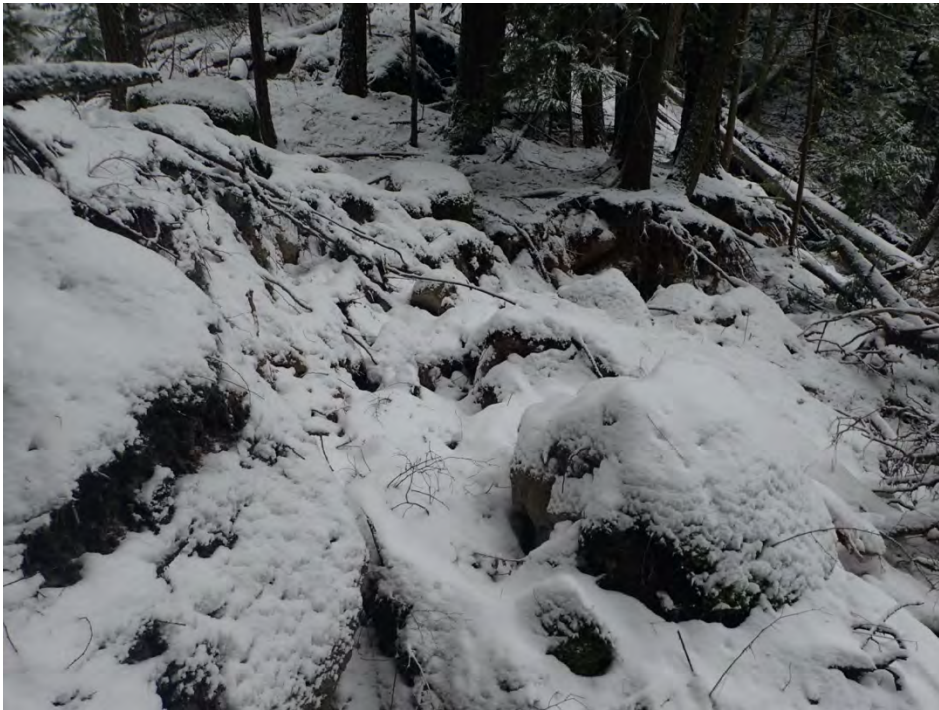
**Photo 76.** WP154. Right side of major since Dec 1 slump area, fresh tension cracking and settlement across 30-35 m wide convex slope crest, 5 m offset, 15-25 m slope length, 2-5 m thickness, or 1000-4000 m<sup>3</sup>.

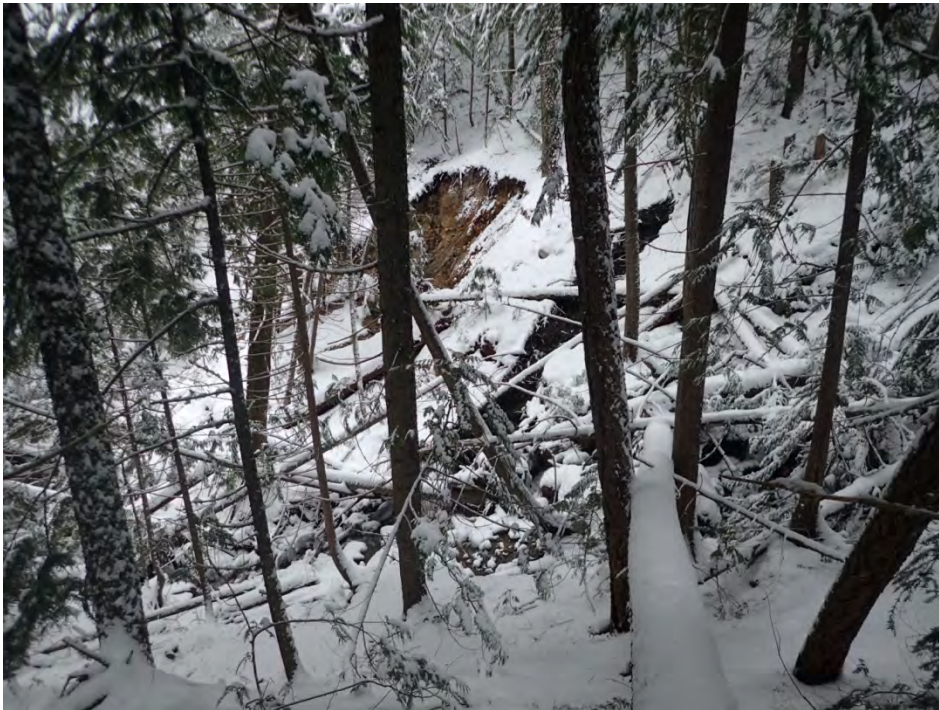
Farther upstream, on the right (west) sidewall a smaller fresh slump was noted (Photo 7; WPs 21-22), with dimensions 10 m wide by 40 m long by 2-3 m thick, or 800-1200 m<sup>3</sup> in volume. This feature had not changed on Dec 12, 2021 (Photo 78), yet remains a residual hazard.

**Photo 78.** WP158. View of slump noted Dec 1 slump. No change noted. Residual hazard.
