BC Ministry of Forests, Lands and Natural Resource Operations Thompson Okanagan Region

Bear and Pete's Creek Debris Flows on the Seton Portage Alluvial Fan

December 15, 2016

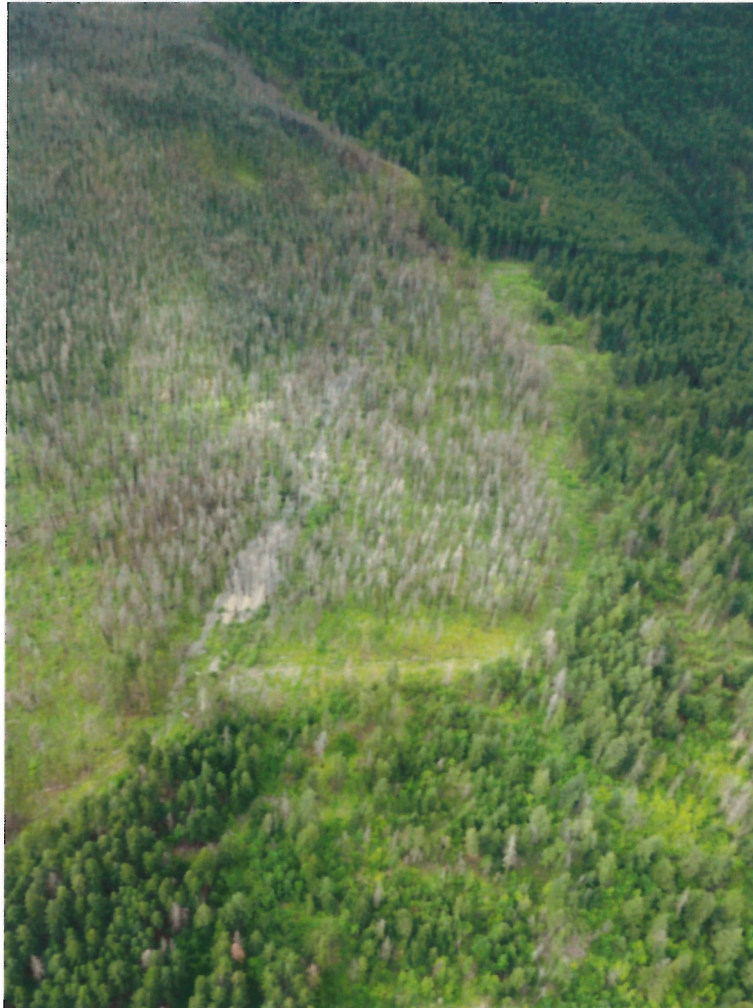
In 2013, the debris flow deposited across the fan surface but stayed above the steep face onto the residential floodplain. In the upper channel some of the debris was deposited across a wide area amongst the trees. A clear trim line in the channel at the fan apex indicates passage of a significant debris flow onto the fan surface. On the fan surface the deposit was a relatively thin and constrained deposit.

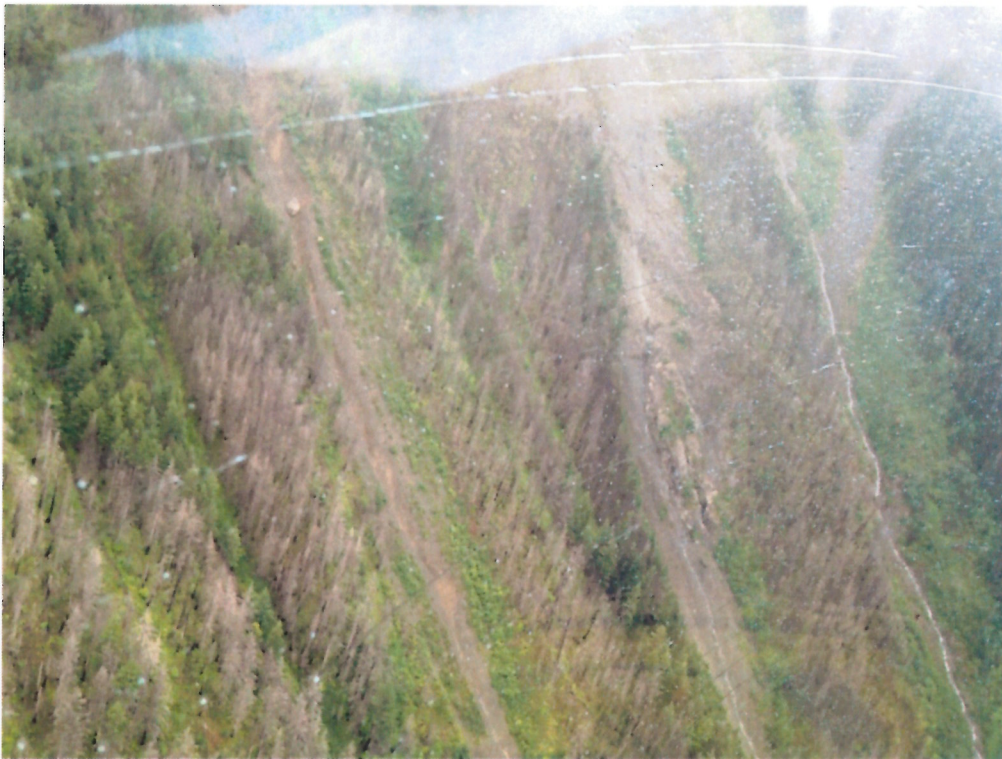
Plate 1: Upper slopes of Goat Mountain with numerous avalanche chutes feeding the main channel Bear Creek stream below.

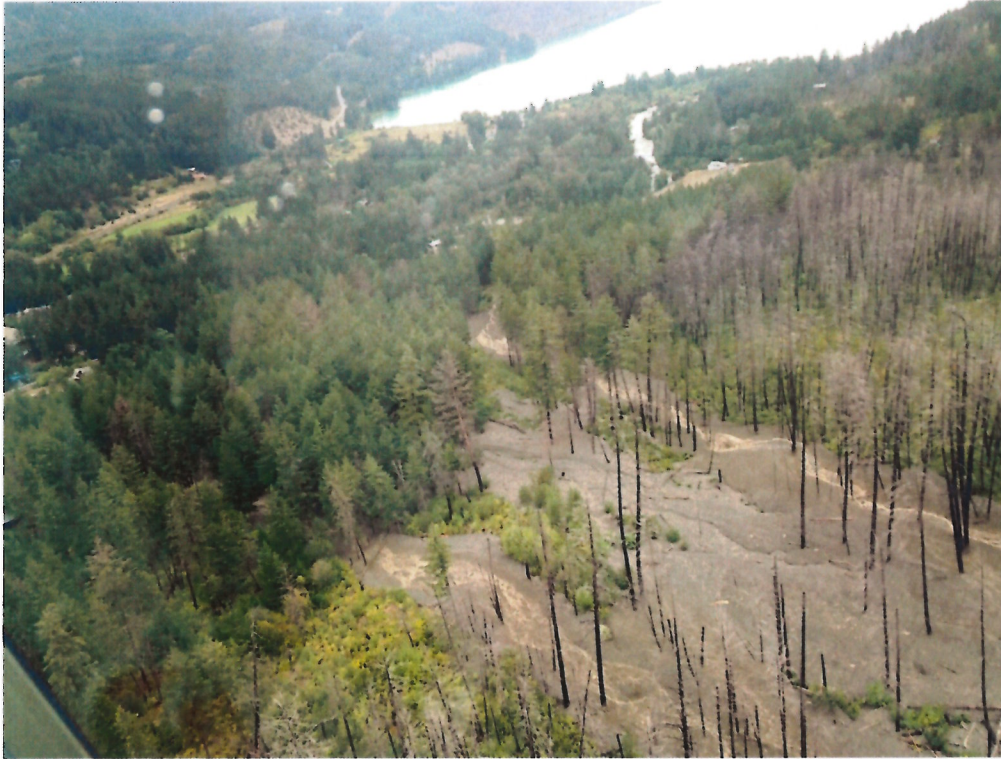
Plate 2: View of the mid-fan down to the residential areas of Seton Portage, Seton River in centre of photograph and Seton Lake in distance.

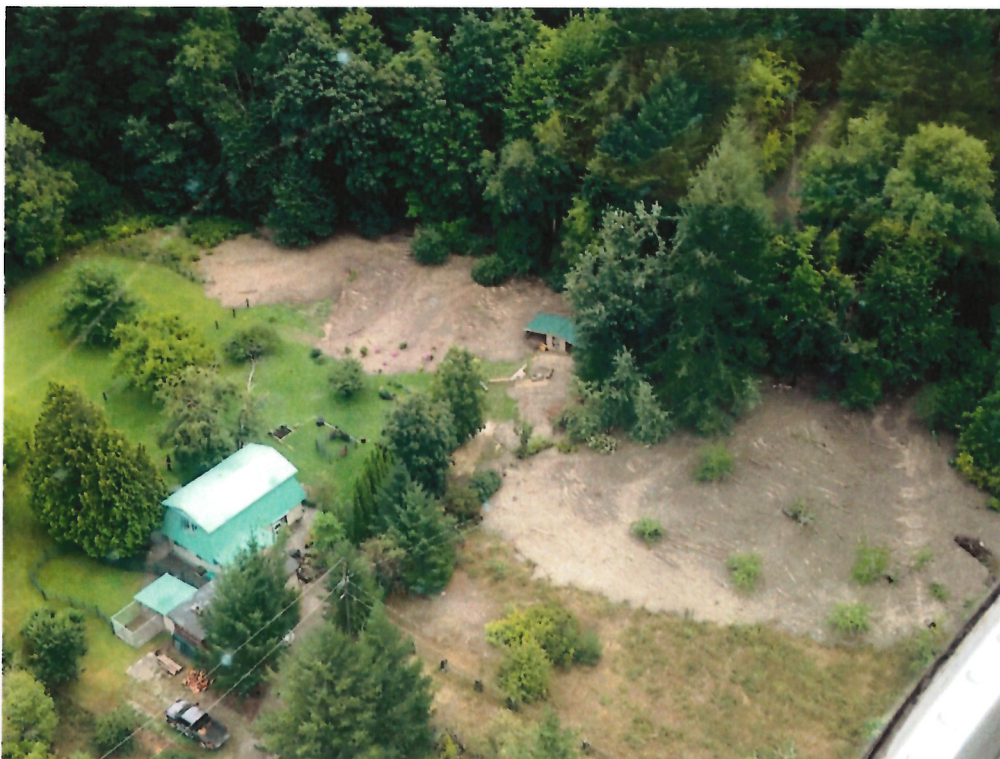
In 2016, the debris flows again crossed the fan surface and reached the floodplain, leaving larger deposits in the residential areas. The fan channel at the apex shows signs of a large event passing through. The deposits on the fan are piled on top of the 2015 surface but are wider still than the 2015 deposits. The fan surface is becoming more channelized and the channels are prograding further out onto the fan surface, increasing the distance of movement and velocity of flows across the fan surface.

Plate 3: Debris flow deposits in residential areas, July 31, 2016.

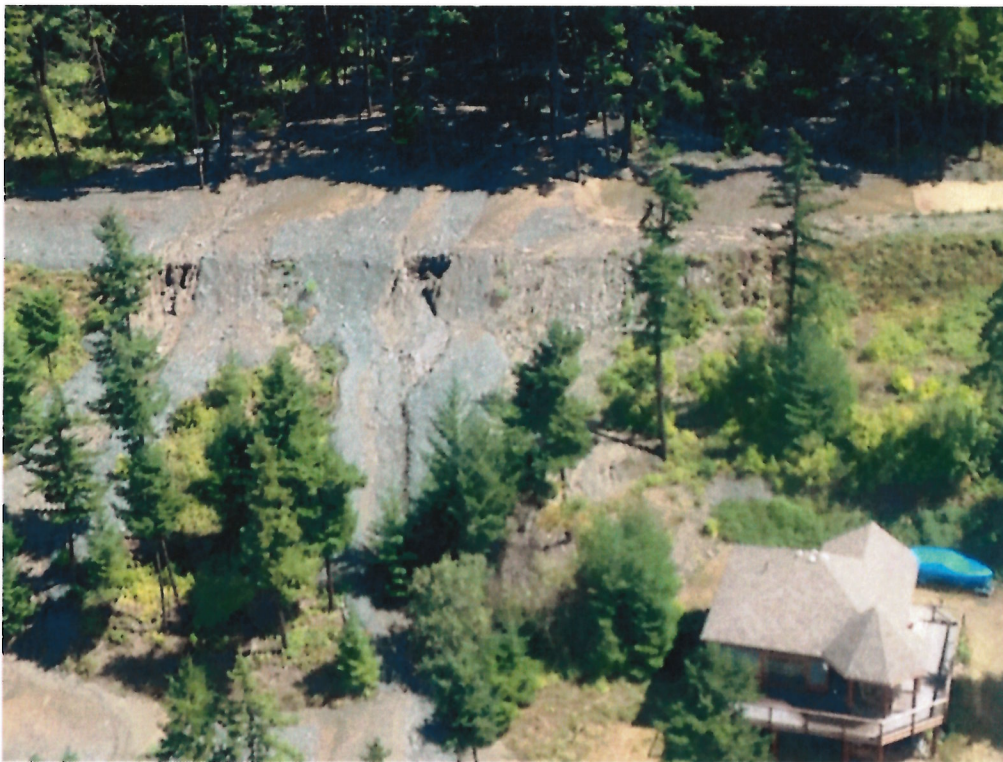
As in 2015, the 2016 event on Pete's Creek has two debris flow tracks which lead directly down to the large protection ditch and berm. In 2016, the ditch and berm constructed around the properties had been enlarged with the 2015 debris piled up on the top of the berm. In 2015, the larger flow hit the ditch close to the south end, in 2016 the larger flow came down further to the north; the flows appear to be migrating further northward and flowing more to the northwest as opposed to more westerly. In both years the overflow missed the house below and went down as far as the lakeshore road, likely following roads and trails. The ditch needs to be cleared and the berm elevated, and perhaps another study to determine if the system is really serving to protect the homeowners or if further measures, such as GeoBrugg fencing, are required, or if site occupancy is still safe.

Plate 4: Debris flow deposits overtopping the ditch and berm on Pete's Creek.

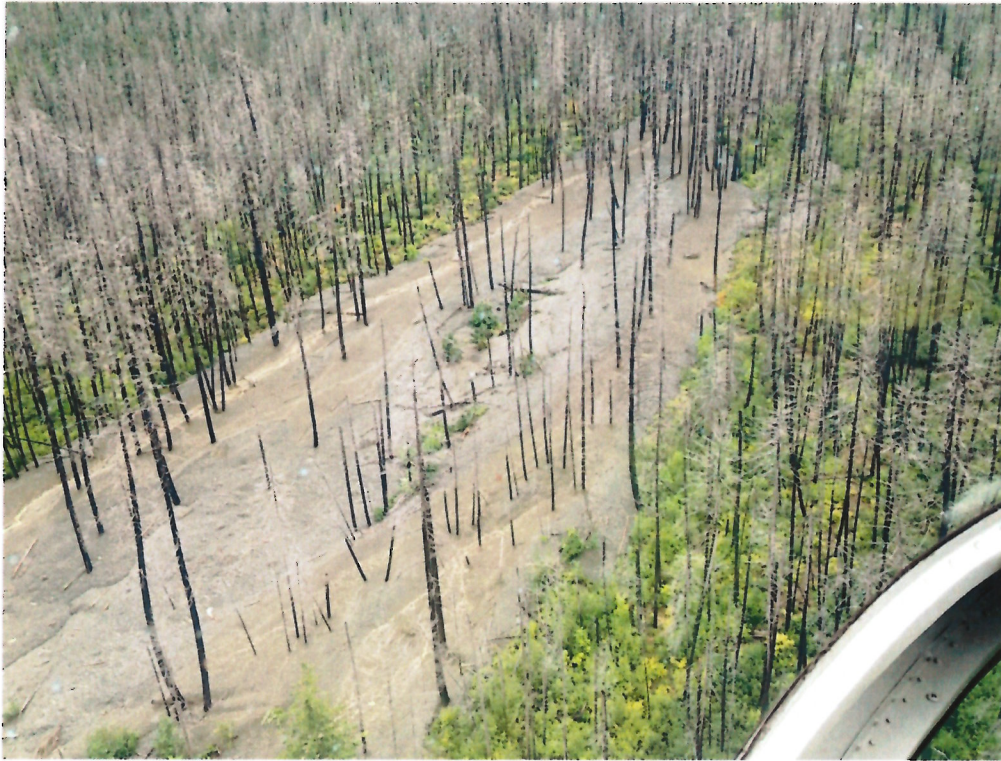
The debris flows have progressively increased in size over the period we have been observing it: they are thicker, wider and extend further down the fan surface. Comparative photos suggest a slight deepening and widening of the Bear Creek channel at the apex. Further down the fan the main channel is becoming more prominent and clearly defined by high levees for much further downstream on the alluvial fan surface than in 2009. The channel has not moved at the apex, still sweeping down and running out to the north, but the mid-lower fan may be experiencing some north-eastward movement of debris deposition. Nonetheless, a major portion of the flow passed down very similar routes in 2013, 2015 and 2016 and off the steep face and onto the upper floodplain margin.

Plate 5: Debris flow deposits on the mid-fan surface in 2016, similar location as the cover photo which was taken in 2013.
