**Post-Wildfire Natural Hazard Risk Assessment  
Casper Creek Fire K71535  
Seton Portage, BC**

**Prepared for:  
Gareth Wells, P.Geo  
Trevor Bohay, P.Geo  
Ministry of Forests  
Kamloops, BC**

**January 16, 2024  
File: 20-138**

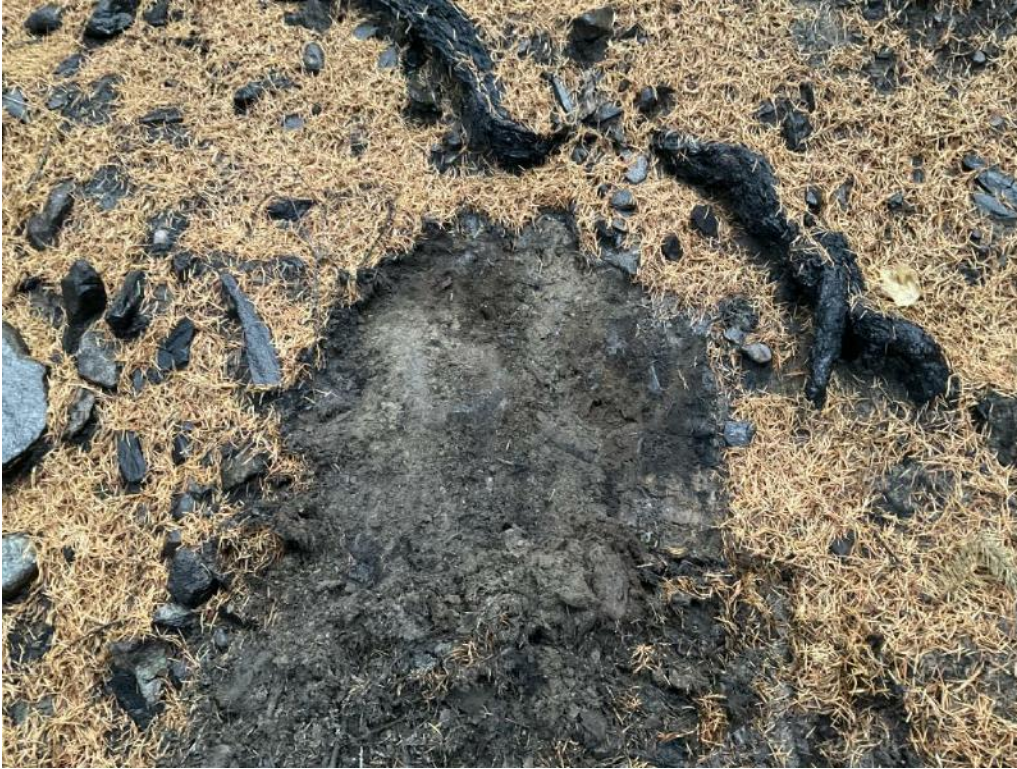
**Placemark 21** Moderate soil burn severity.

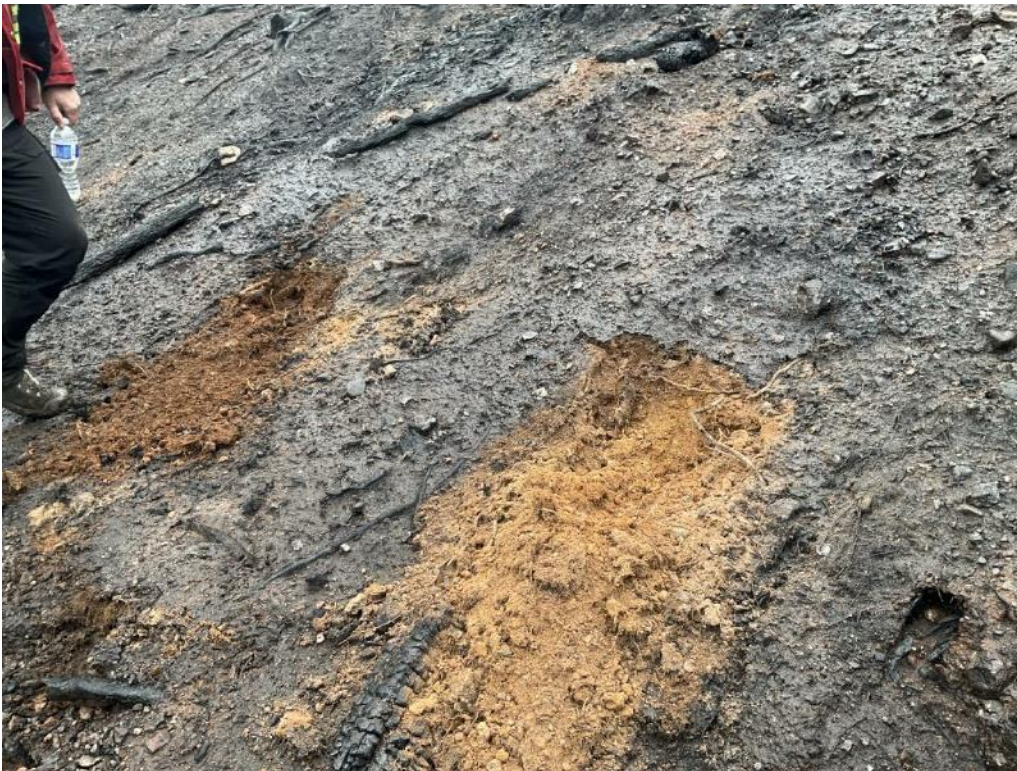
**Placemark 42** High soil burn severity.

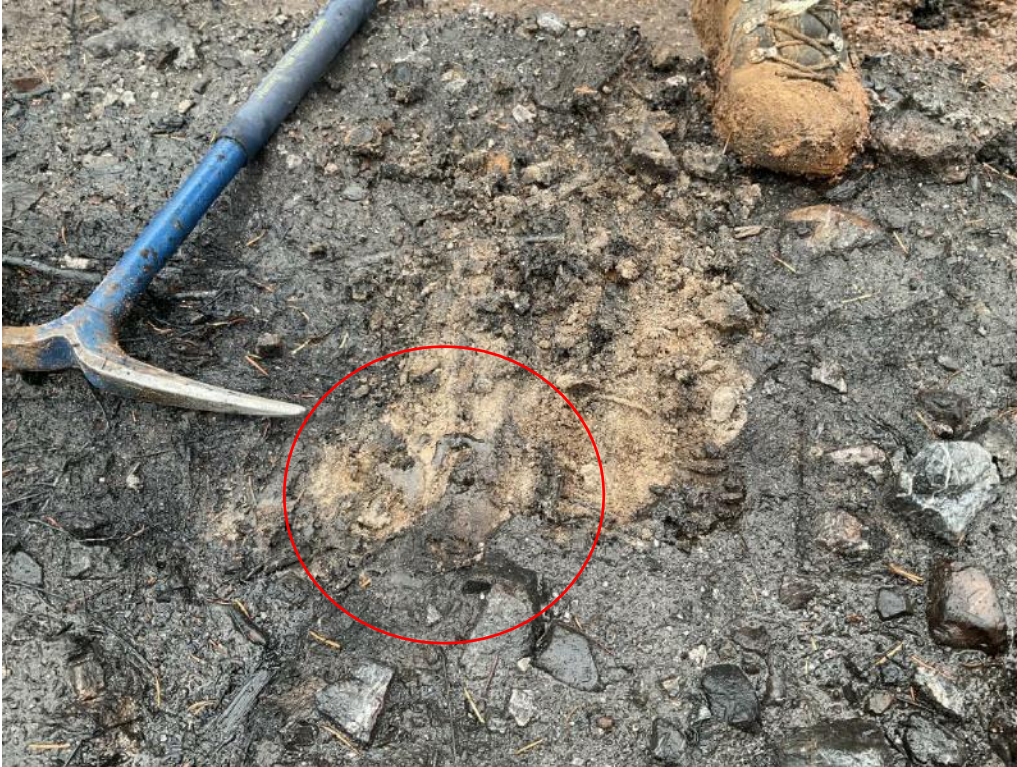
**Placemark 42** Hydrophobic soils.

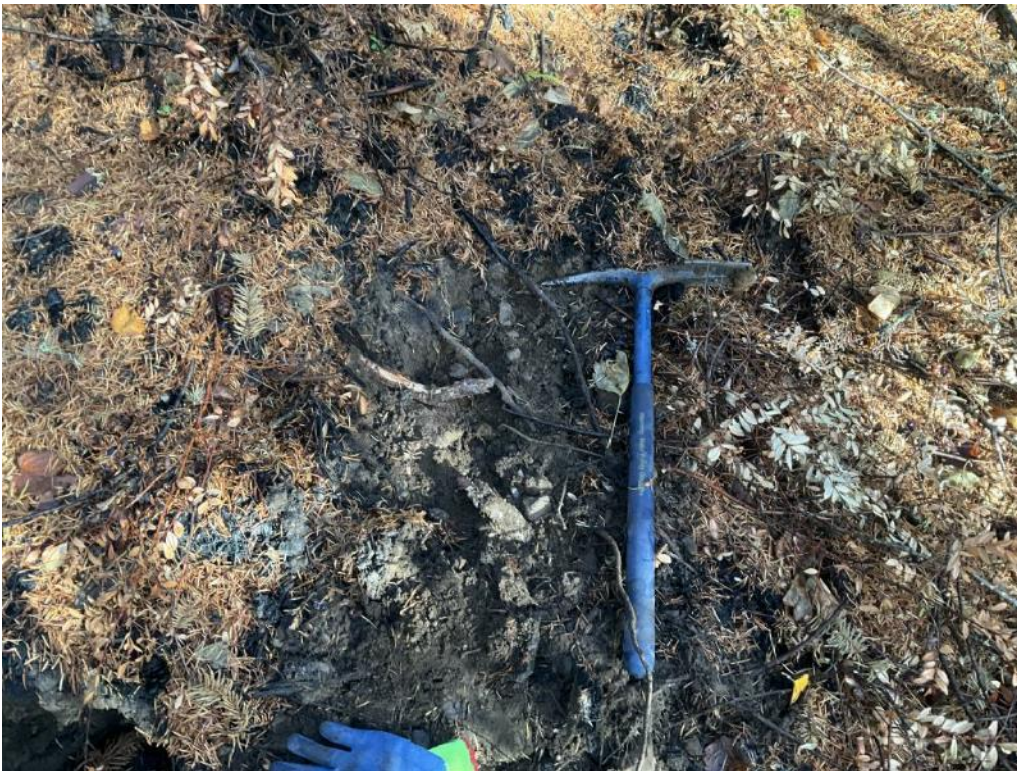
**Placemark 48** Moderate soil burn severity.

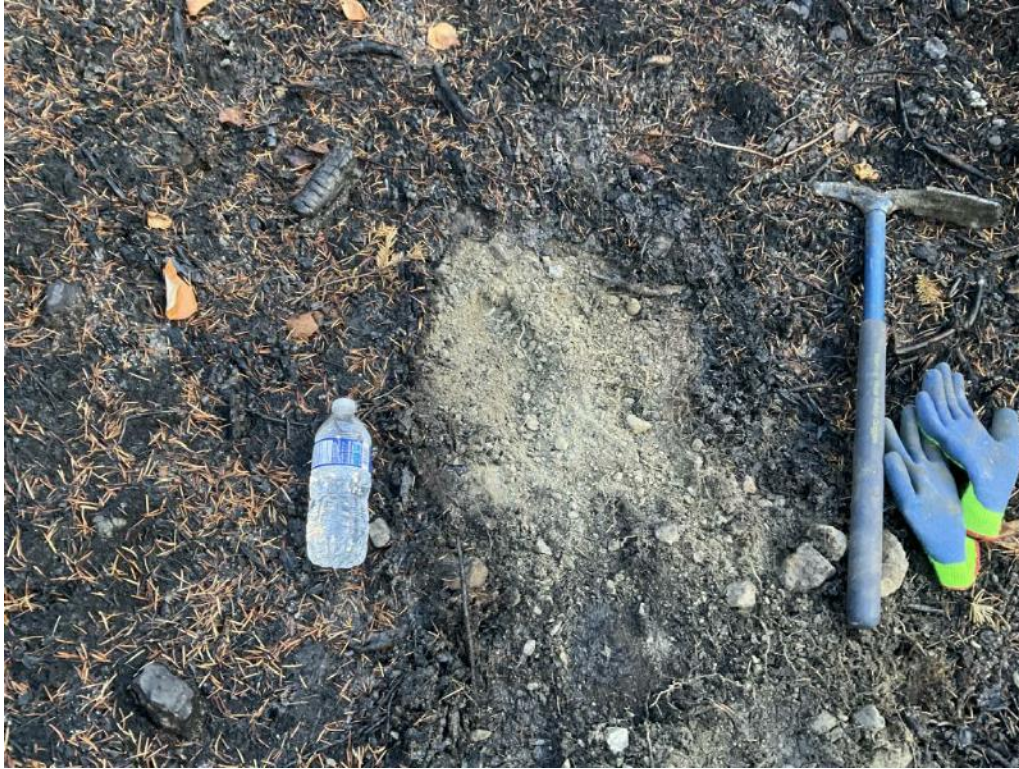
Placemark 50 High soil burn severity.

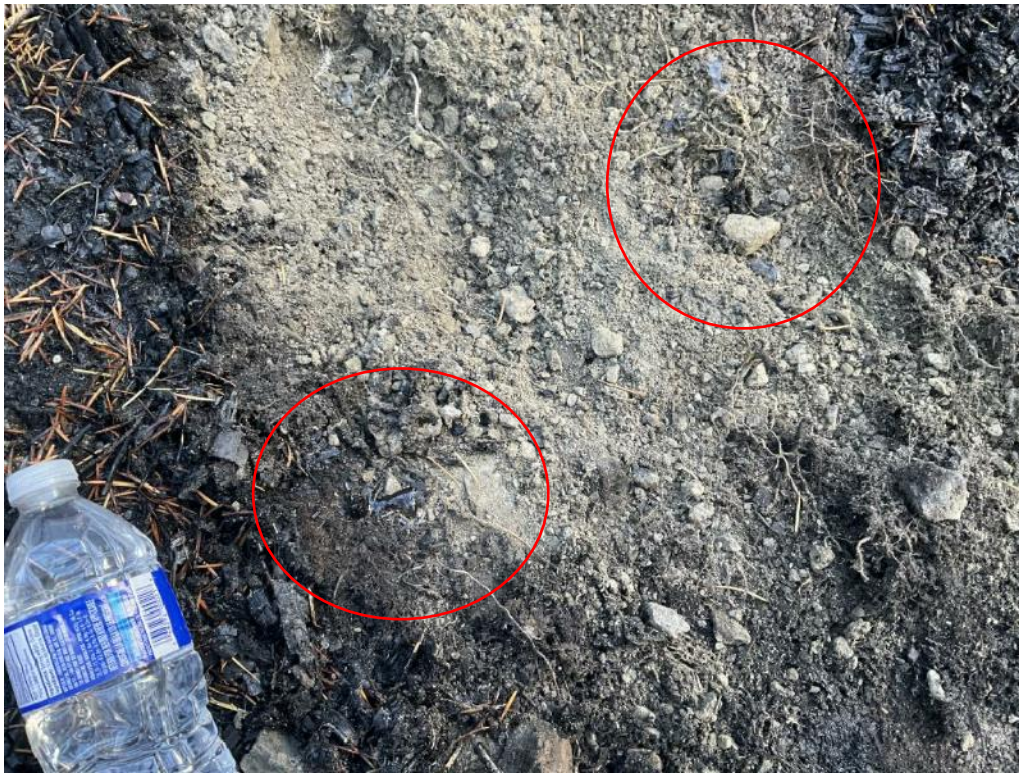
Placemark 50 Hydrophobic soils.

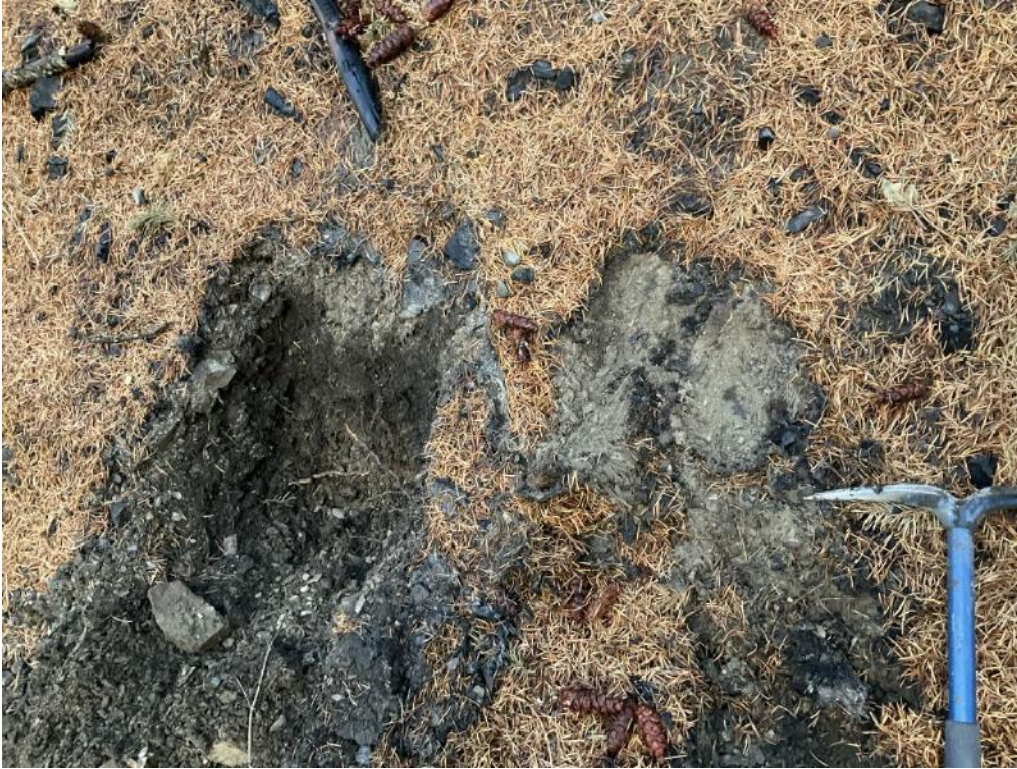
**Placemark 51** Moderate soil burn severity. Soil is hydrophobic on surface and moist at depth.

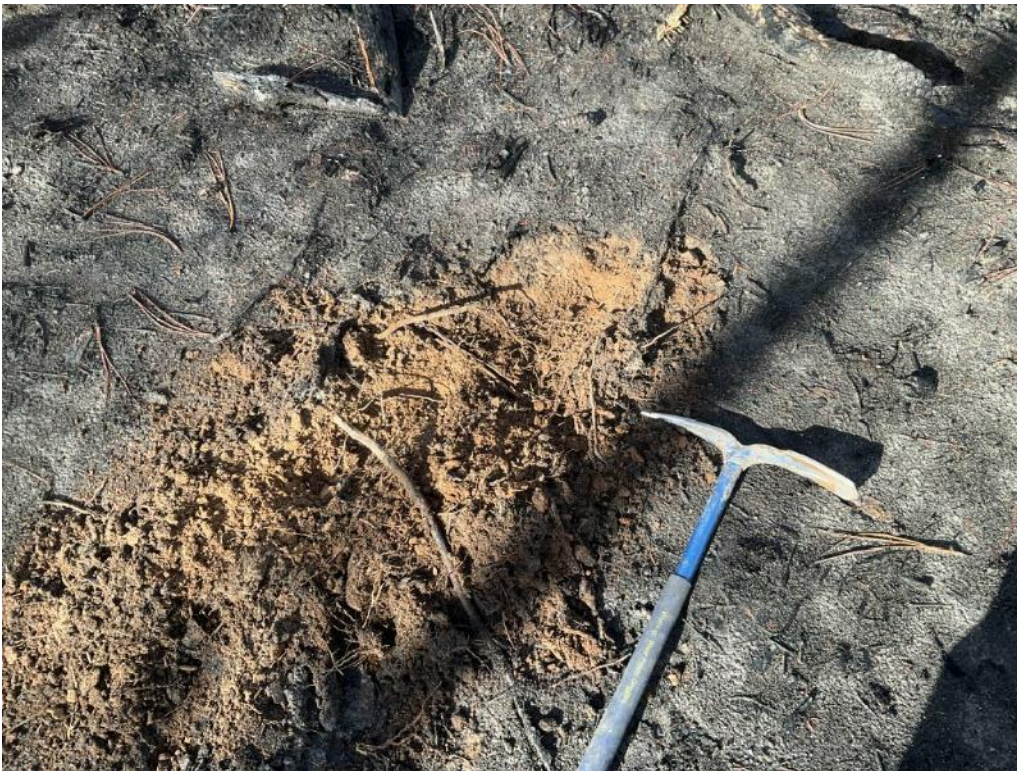
**Placemark 52** High soil burn severity.

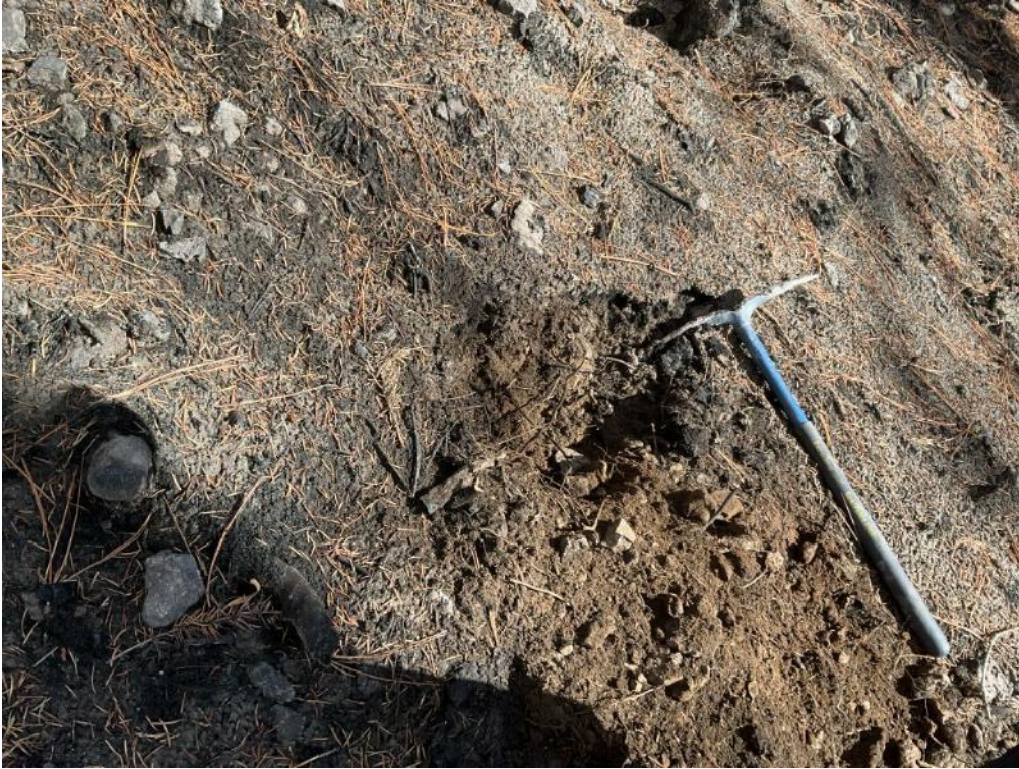
**Placemark 56** High soil burn severity.

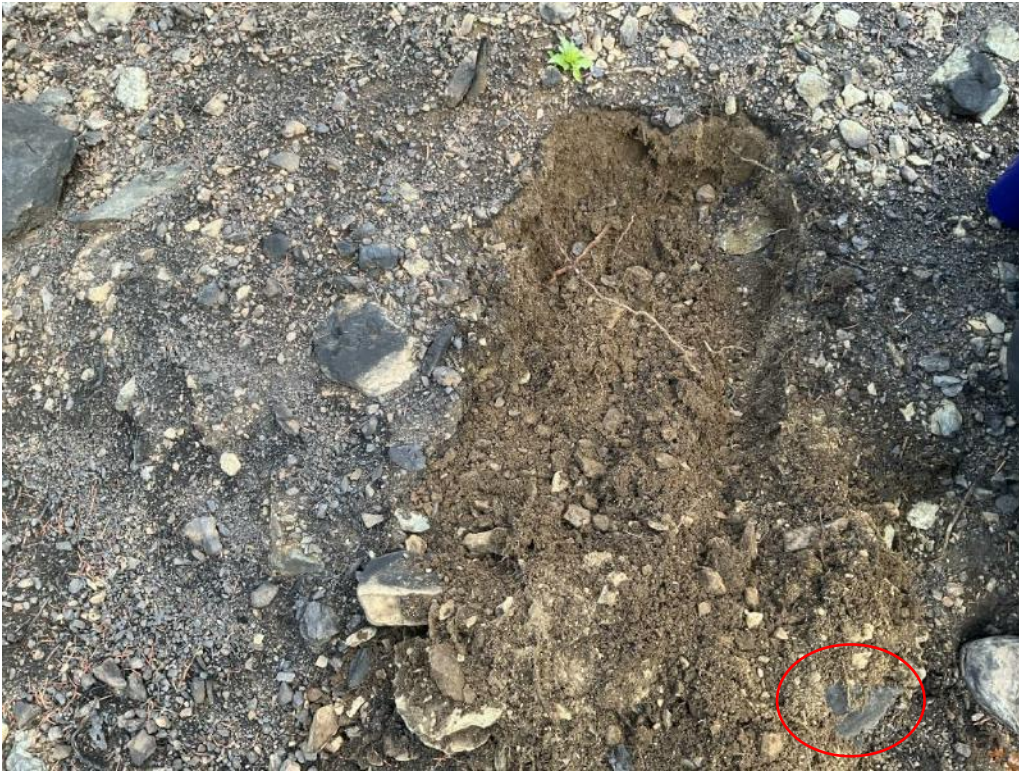
**Placemark 57** High soil burn severity, hydrophobic soil.

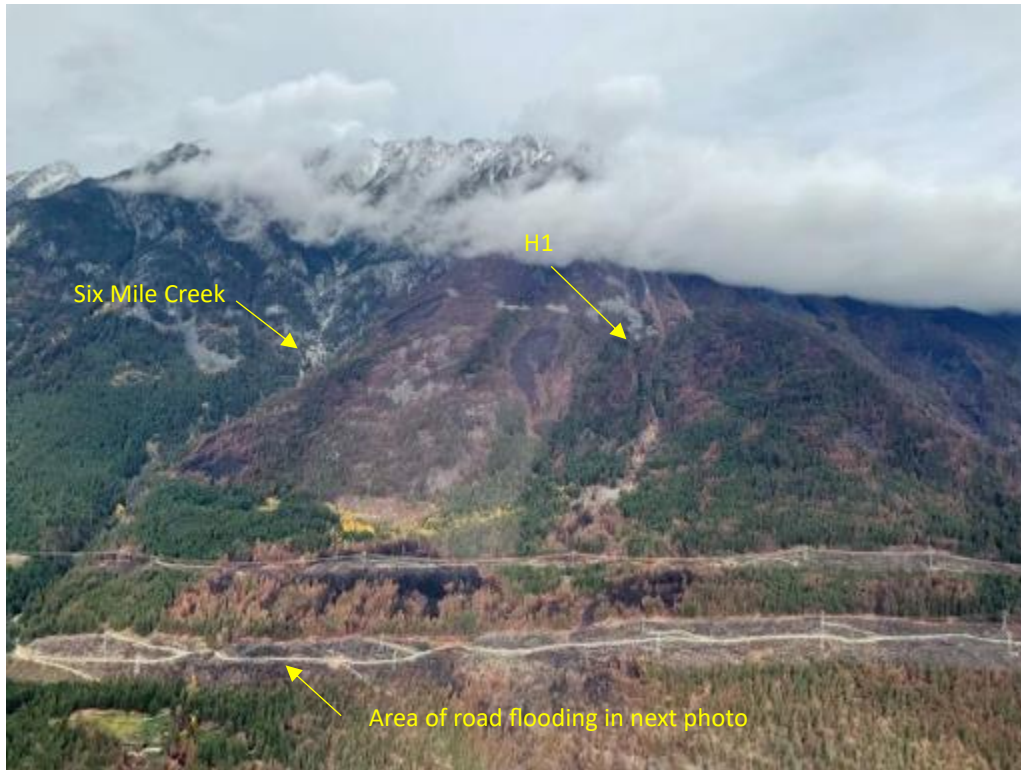
The east tributaries of Six Mile Creek are the limit of the fire boundary (Photo 1). The watershed has low to moderate vegetation burn severity and only a small area (16%) was burned. Six Mile Creek descends steep gullies before fanning out into Anderson Lake. Boulders have been deposited upstream of the culvert on Highline Road with scour below, indicating past debris flow event(s). The 2000mm CMP appears adequately sized for expected clearwater flood flows however it would likely be overwhelmed by a debris flow. As the alpine area and majority of the watershed is unburned, the debris flow hazard is not expected to significantly increase post-wildfire. The Six Mile Creek Face Unit adjacent to H1 had dry draws with no apparent surface flow. The road surface had areas of pooling water and cavities where stumps supporting the road fill have burned. An increased rockfall hazard can be expected for this section of Highline Road.

**Photo 1** Six Mile Creek watershed on the fire boundary and H1, looking north.

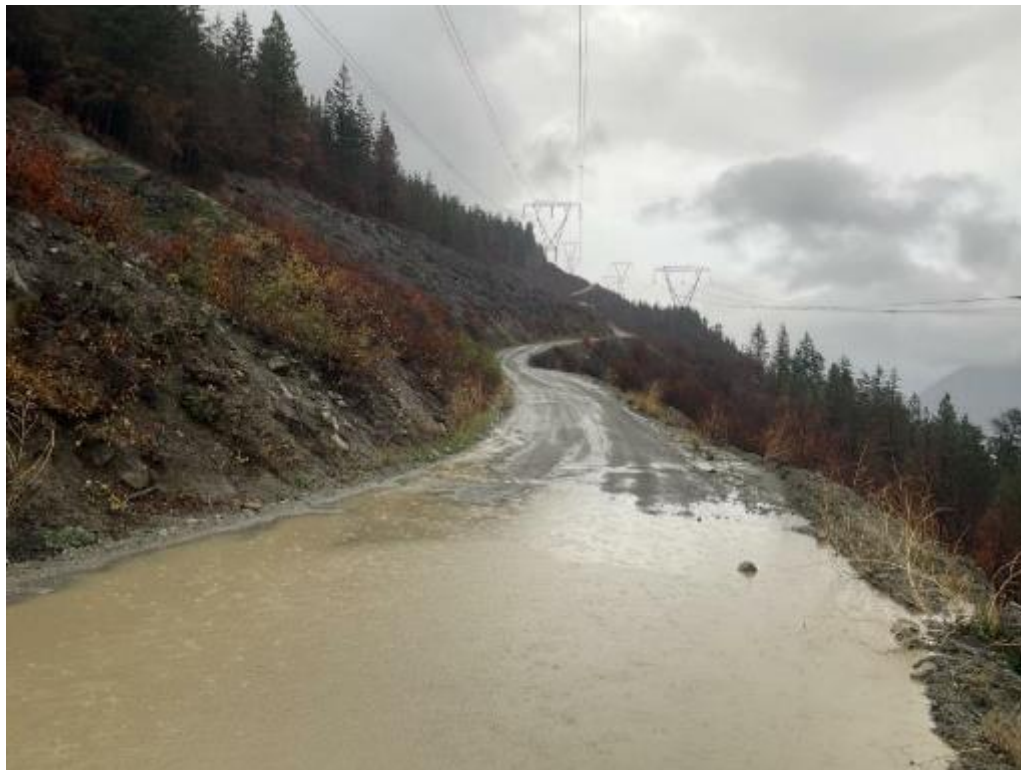
Stream H1 flows southeast into Anderson Lake and is moderately burned with patches of high burn severity. A stream channel at the location mapped as H1 on Highline Road was not observed but excessive water was pooling on the road surface in the general location (Photos 1 – 2). Within the watershed area three draws flow from the alpine with avalanche paths on the eastern draws. The streams bend west and there is a depositional area where a significant portion of the flow likely infiltrates into the ground. There is a residential property on an elevated bench on the western side of the incised stream channel.

**Photo 2** Highline Road flooding near H1 during the atmospheric river event of October 18<sup>th</sup>, 2023, looking east.

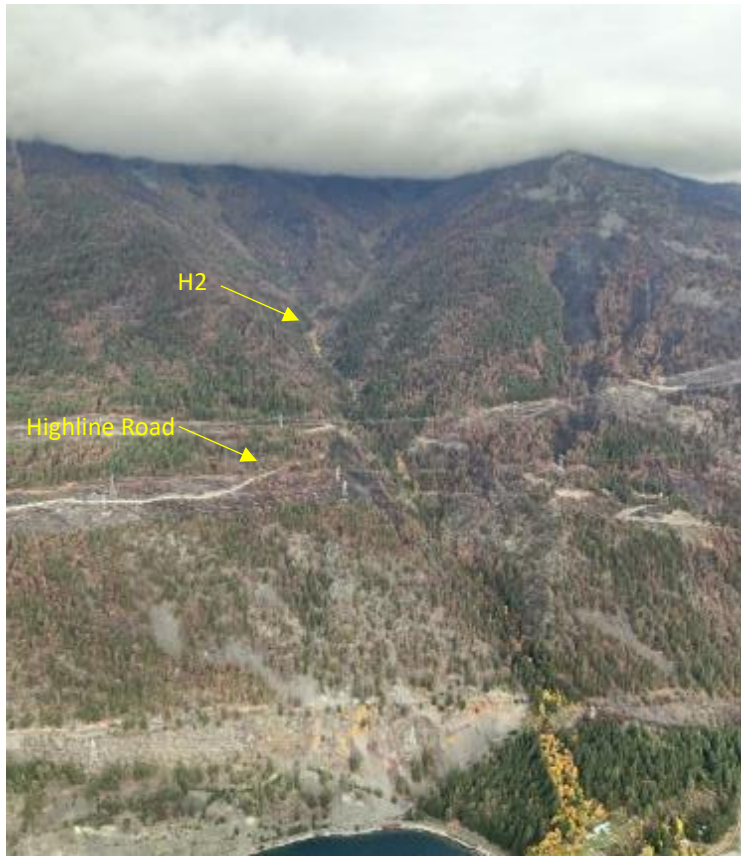
will prevent damage from debris flooding and small debris flow events. As the debris flow hazard has increased post wildfire due to the moderate and high burn severity (63%), larger events are possible. The H2 watershed requires a more detailed assessment as the residences on the fan could be at an elevated risk.

**Photo 3** H2 watershed with residence on fan, looking north.

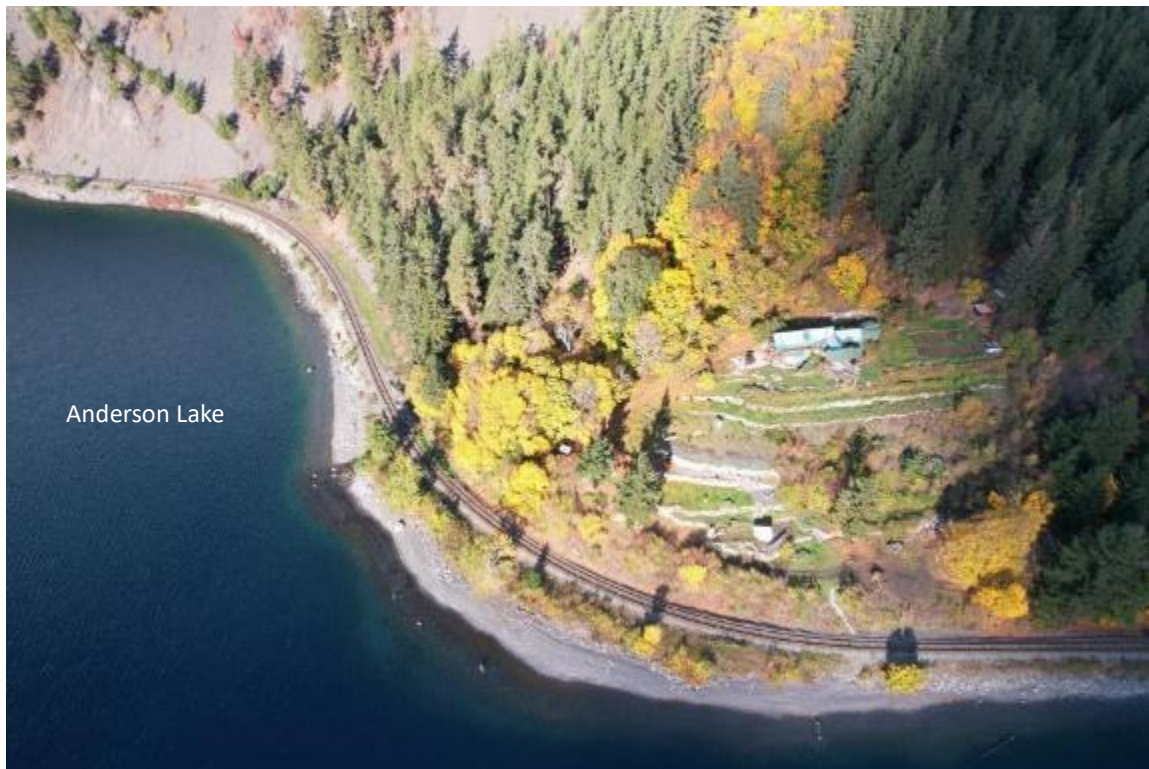
**Photo 4** Residences on H2 fan below Highline Road.

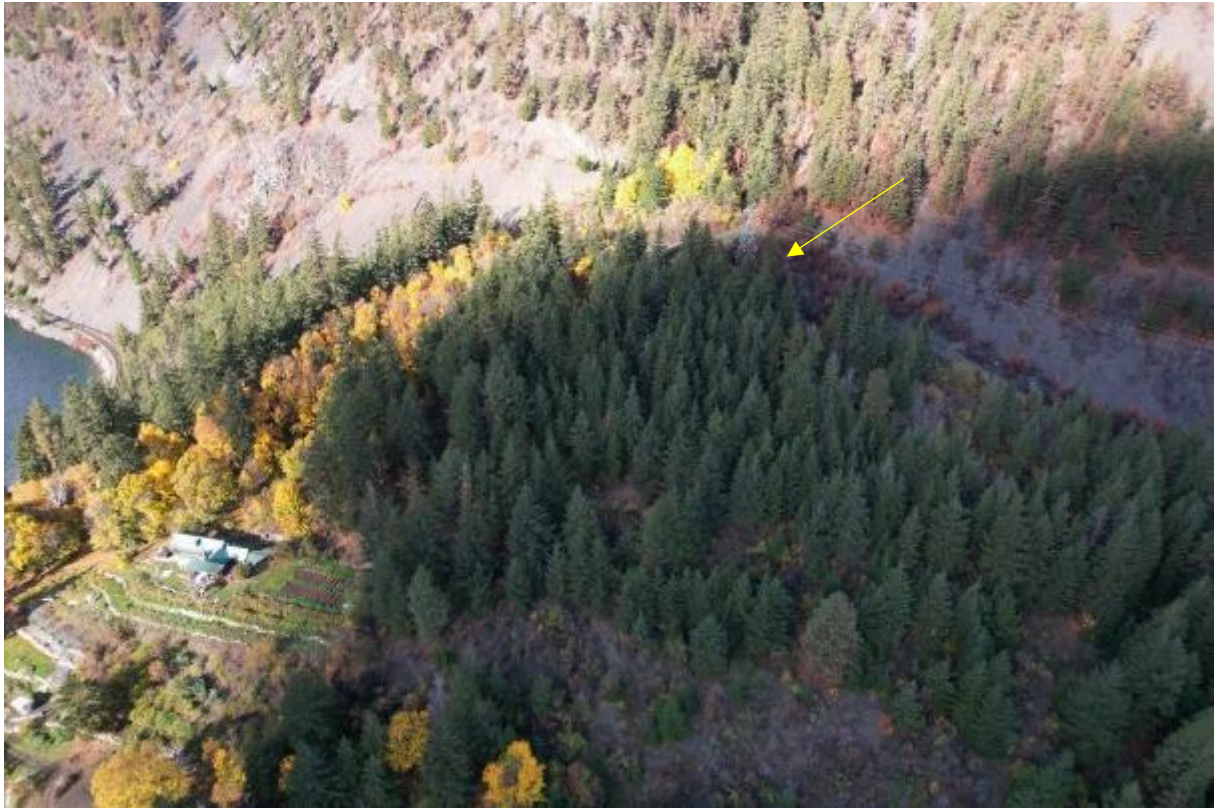
**Photo 5** H2 fan below Highline Road. Note BCH transmission line tower near fan apex. Stream is well confined in a large draw adjacent to the structure.

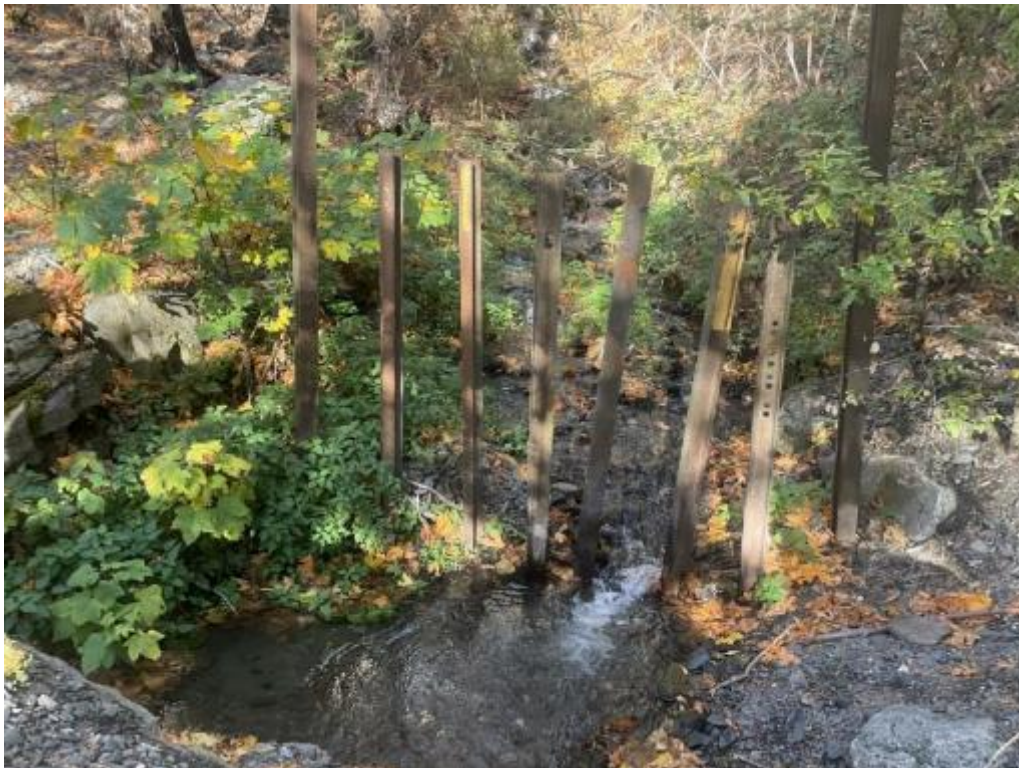
**Photo 6** Mitigation structure upstream of culvert inlet at the residential road crossing of H2 at the fan apex.

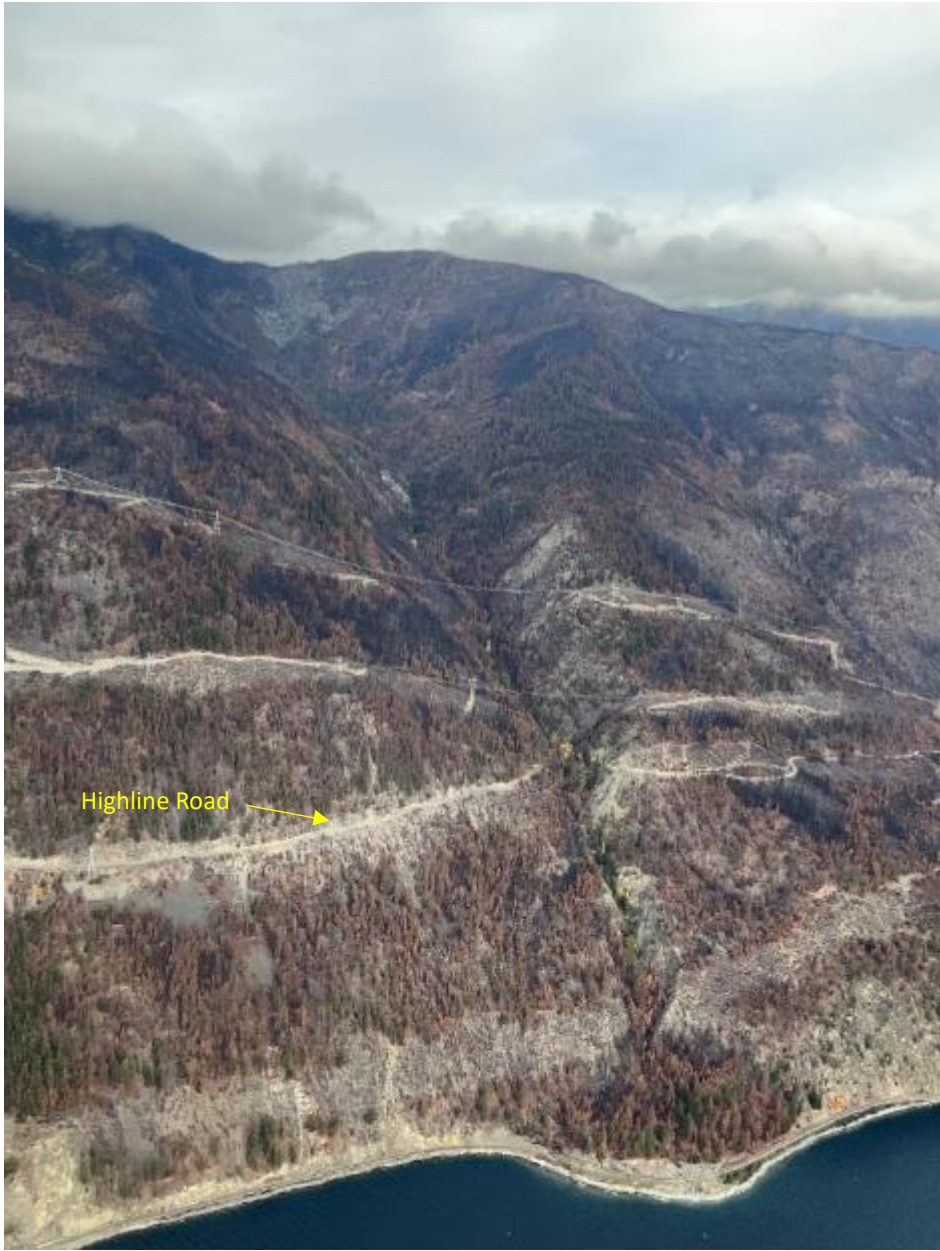
Sundquist Creek descends a steep bedrock canyon before reaching the fan adjacent Anderson Lake (Photo 8). The watershed has moderate (40%) and high (32%) burn severity with much of the upper watershed highly burned. The 2000mm CMP in place on Highline Road appears to be suitably sized for clearwater flood events but would be overwhelmed by a debris flow.

**Photo 8** Sundquist Creek, looking northeast.

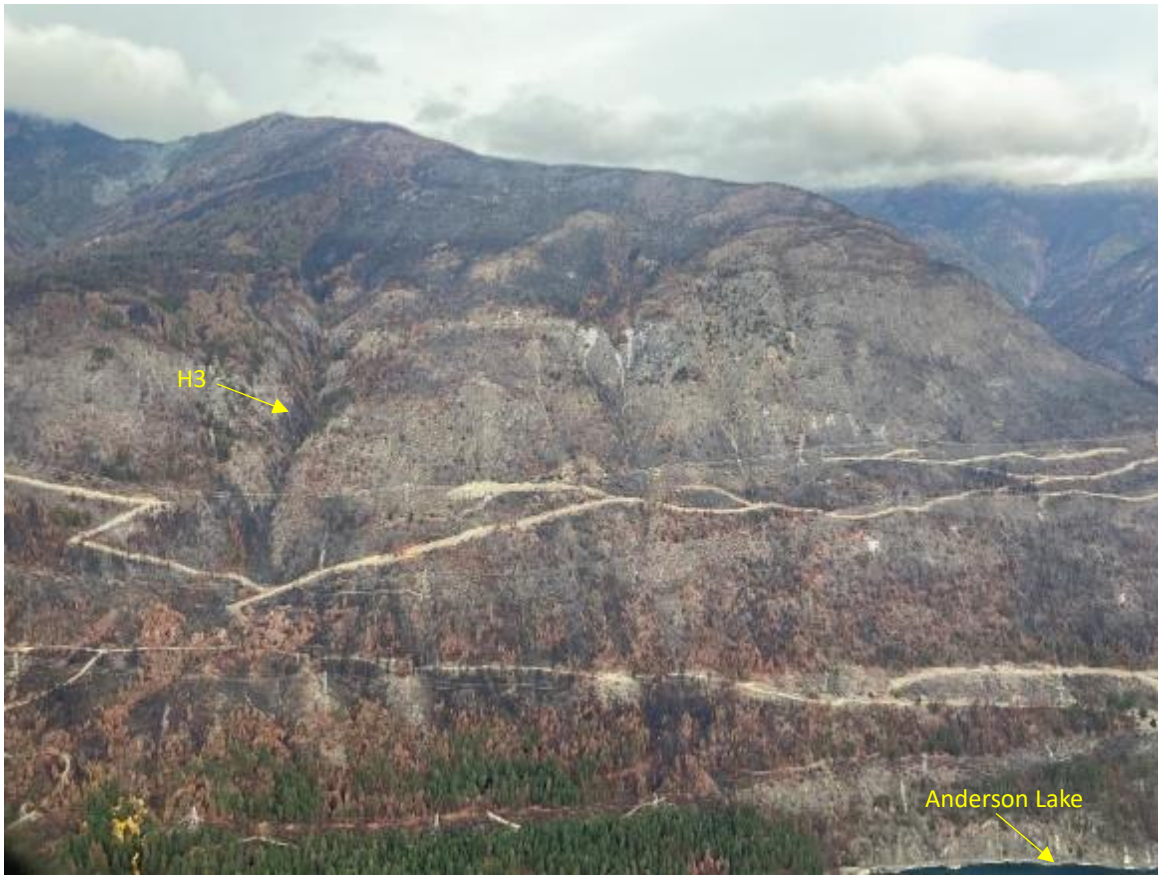
Watersheds H3 to H6 flow southeast into Anderson Lake and were burned at moderate to high severity (Photo 9). The slopes are steep, rocky faces that extend to Anderson Lake.

**Photo 9** Rocky area above Highline Road, draws do not have significant surface flow, looking north.

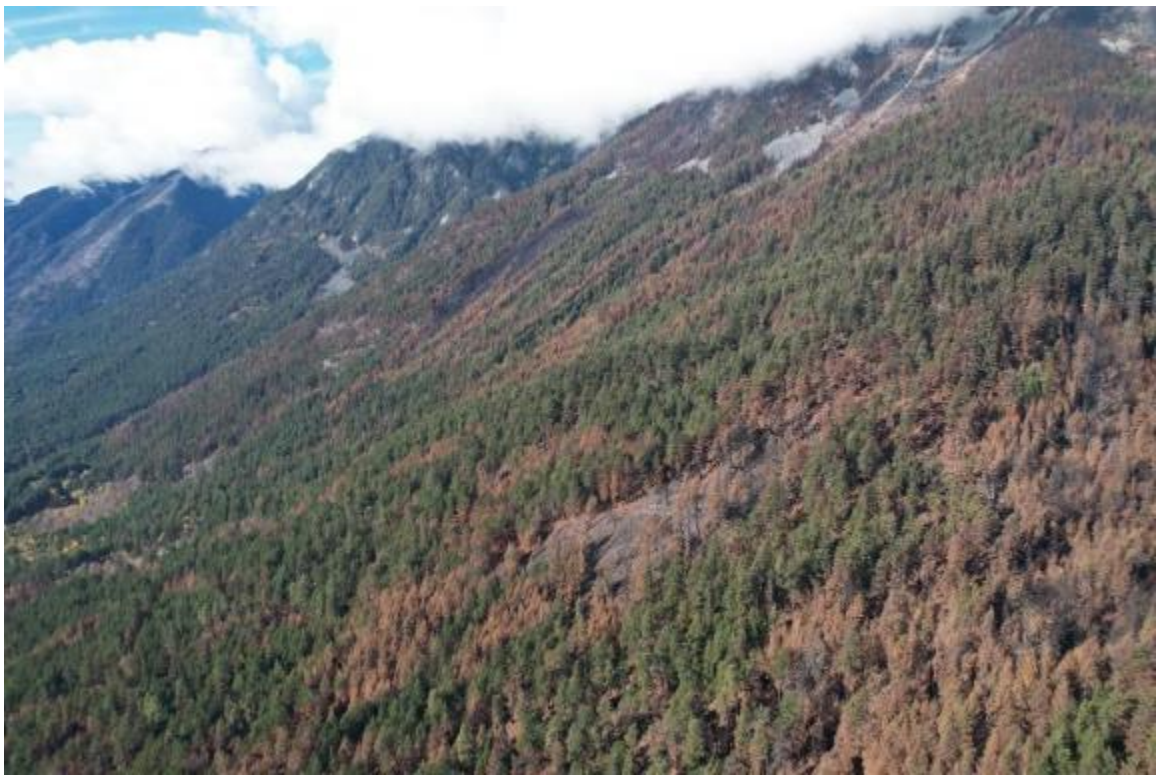
**Photo 10** Slopes above Highline Road showing mixed vegetation burn severity, looking west.

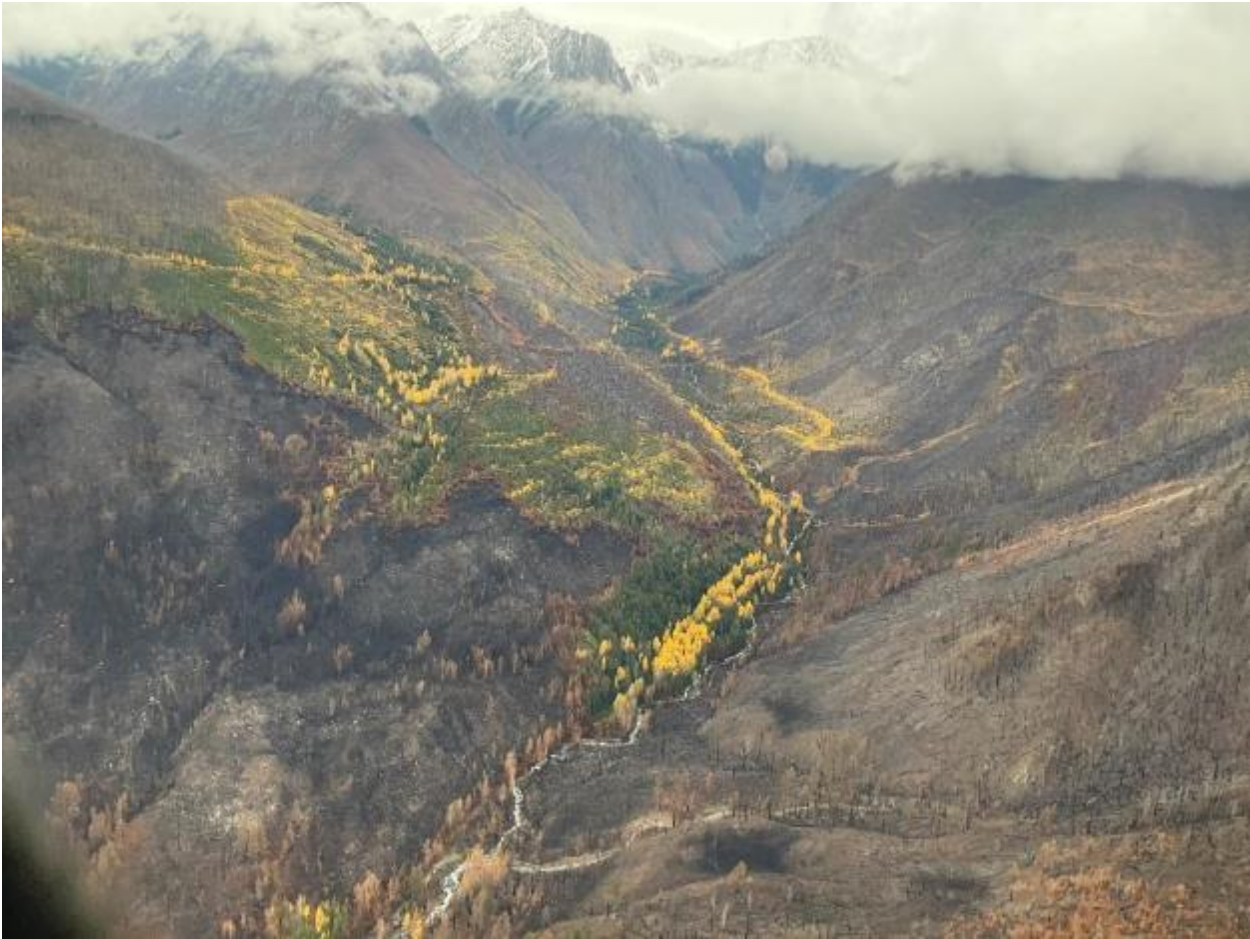
The middle portion of the Whitecap Creek watershed was burned by Fire K70198 in 2004 (Photo 14 – 15). The fire extended north and west of the Casper Creek fire and burned 2,104 ha. Fire K70198 did not appear to cause any significant landslides in the Whitecap Creek watershed. The south slopes of Whitecap Creek have high vegetation burn severity, including the areas previously burned. The north slopes of Whitecap Creek have moderate to high vegetation burn severity. The high burn severity did not extend into alpine terrain and the riparian area is mostly unburned. Near the mouth of Whitecap Creek, the burn severity is low to moderate.

**Photo 14** Upper Whitecap Creek drainage where the 2023 wildfire area overlaps the 2004 wildfire area.

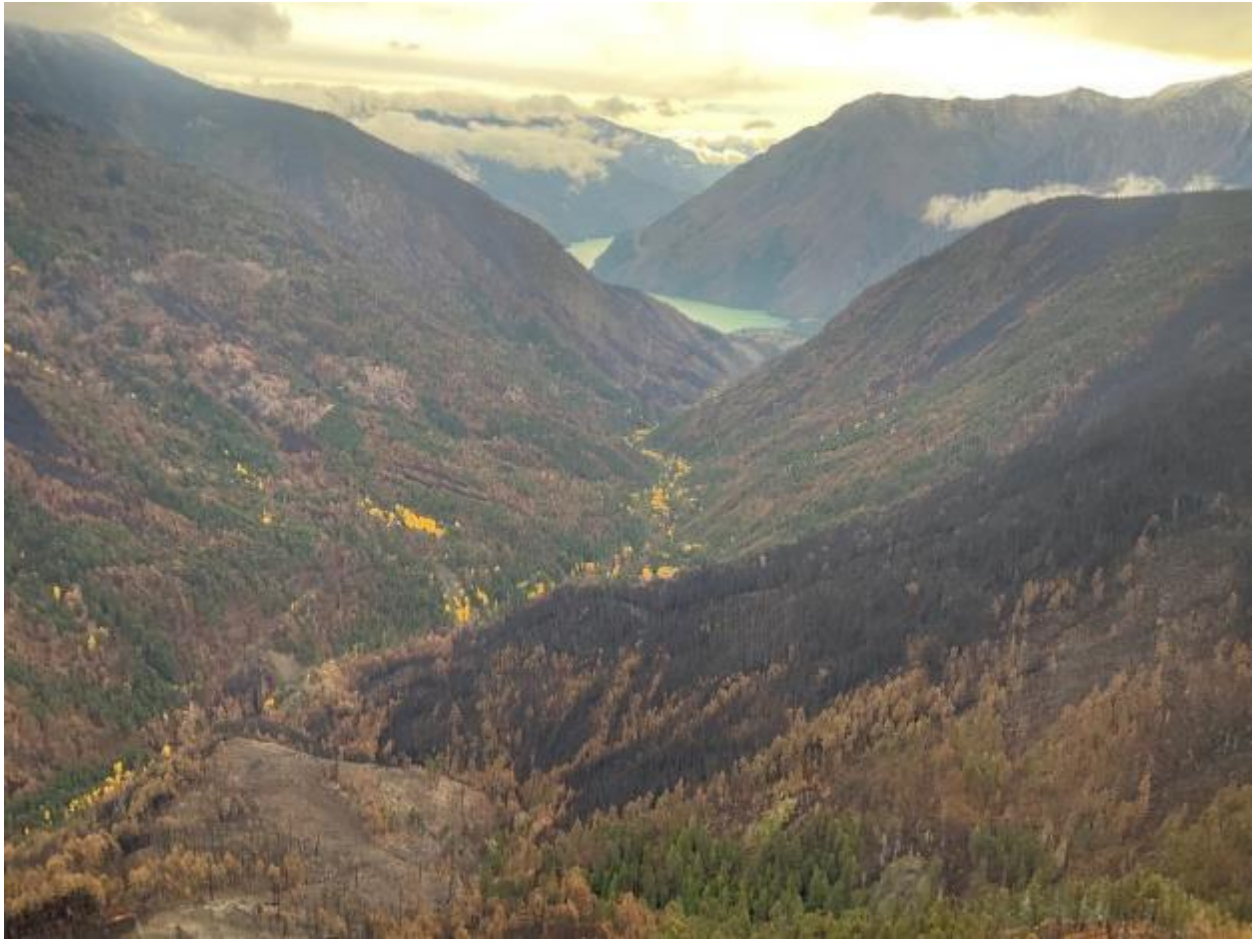
**Photo 15** Looking down through the lower Whitecap Creek drainage. Note the immediate riparian area has a relatively low burn severity.

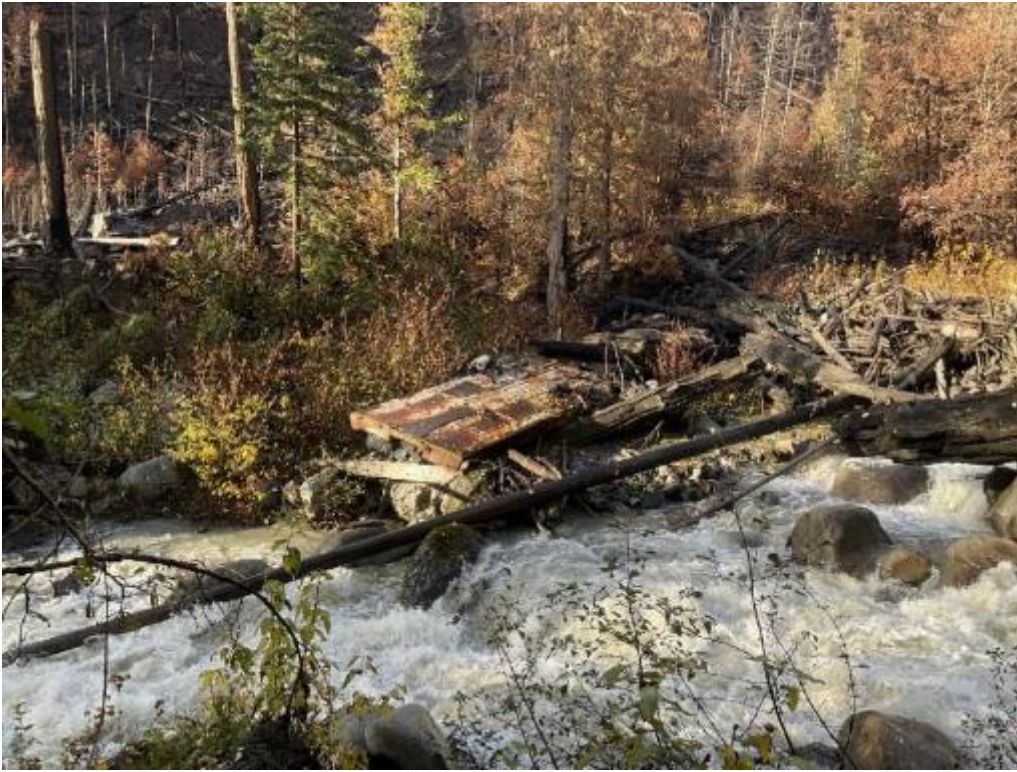
**Photo 17** Upper Whitecap Creek bridge that has been previously washed out, looking west.

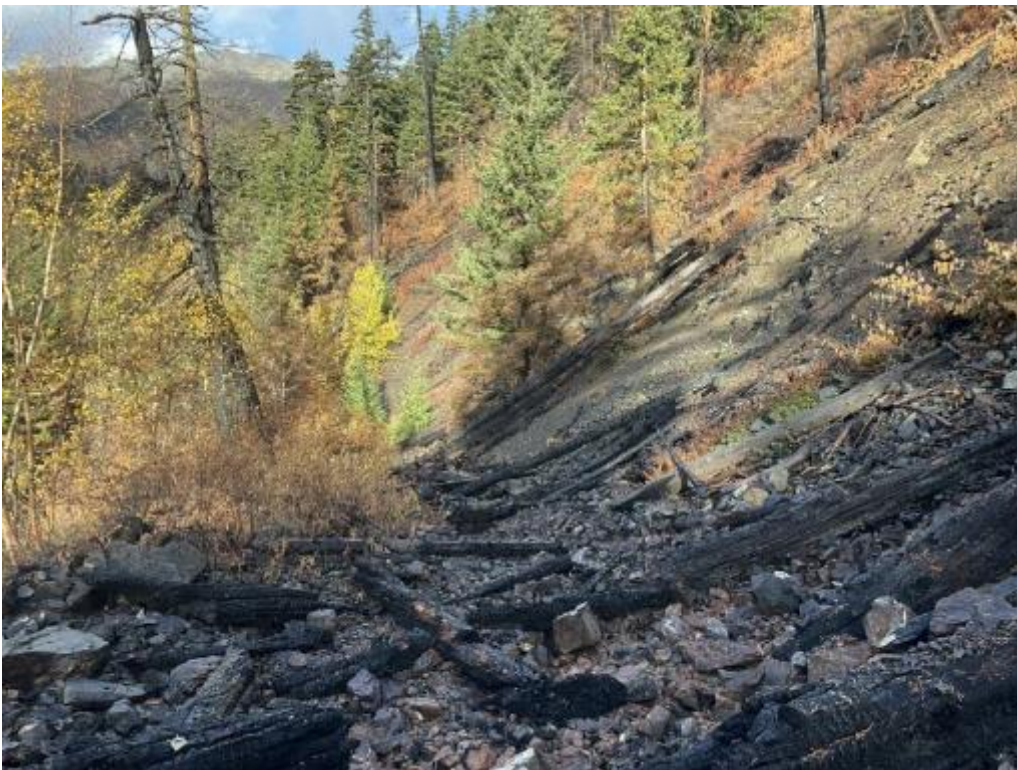
**Photo 18** Ravelled scree slope and rockfall deposits on Whitecap FSR, looking north.

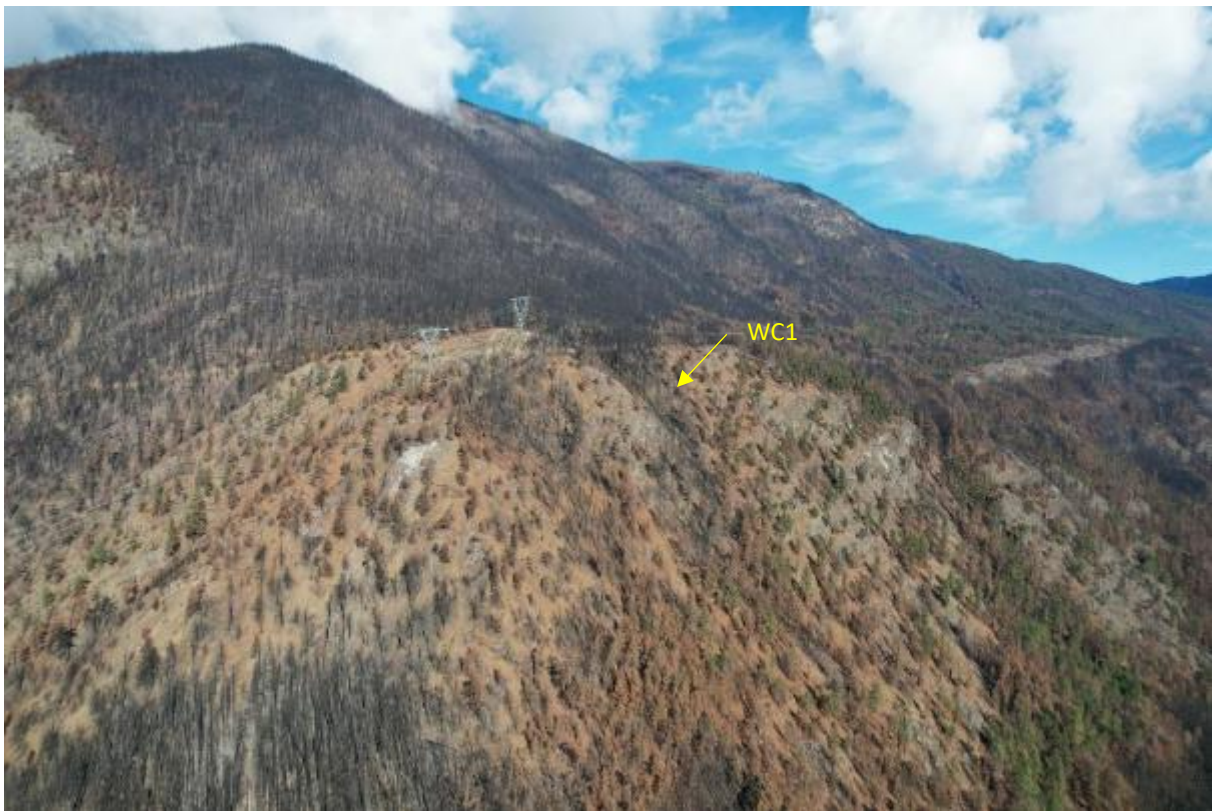
WC1 is interpreted as a relic draw and likely has insufficient surface flow to result in a debris flow. It may develop smaller slurry type events during large runoff events as it originates in a mid-slope position below 900 m asl (Photo 22). It should be noted that our field work was during a forecasted atmospheric river event, yet no runoff was noted in these draws at the time of our fieldwork. WC2 and WC3 descend steep, gullied terrain. WC2 is a large draw with a relatively low gradient reach where it is crossed by the FSR. A significant channel was not noted on WC2. WC3 hosted a past small debris flow that deposited on Whitecap FSR. The debris flow hazard of WC2 and WC3 has likely increased, but significant runout to Whitecap Creek is not expected based on past events.

**Photo 22** WC1 draw, looking northeast. Note the extensive burn area above the upper transmission line.

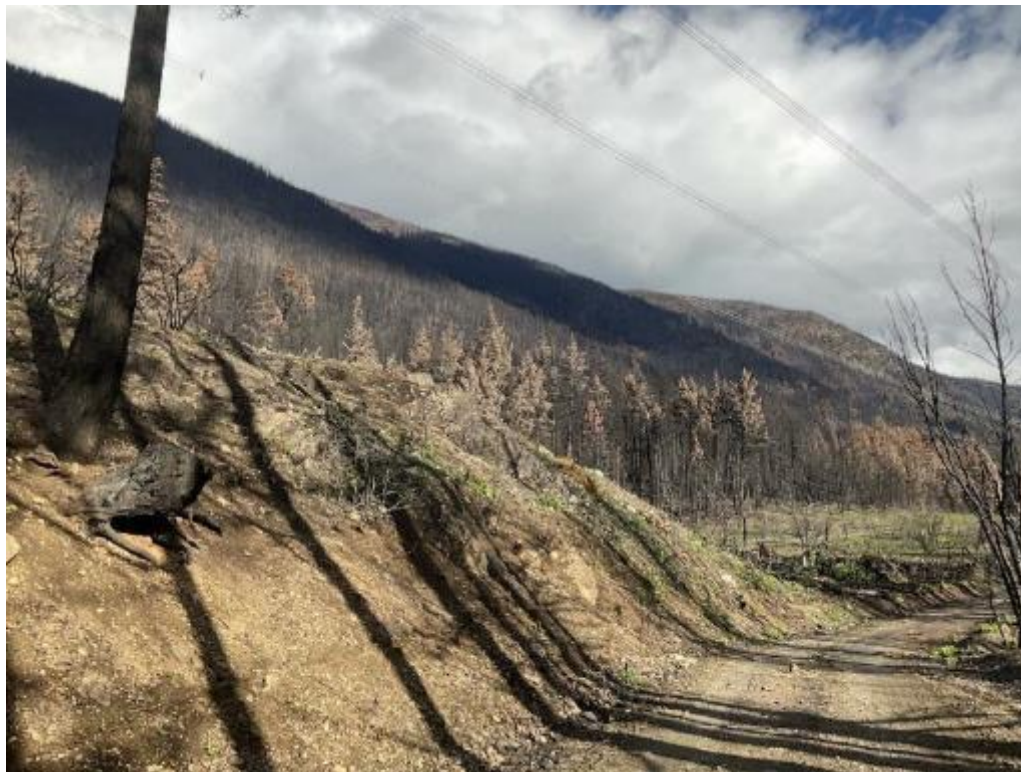
**Photo 25** High vegetation burn severity slopes in the upper SF3 watershed, looking east.
