**Post-Wildfire Natural Hazard Risk Assessment  
Casper Creek Fire K71535  
Seton Portage, BC**

**Prepared for:  
Gareth Wells, P.Geo  
Trevor Bohay, P.Geo  
Ministry of Forests  
Kamloops, BC**

**January 16, 2024  
File: 20-138**

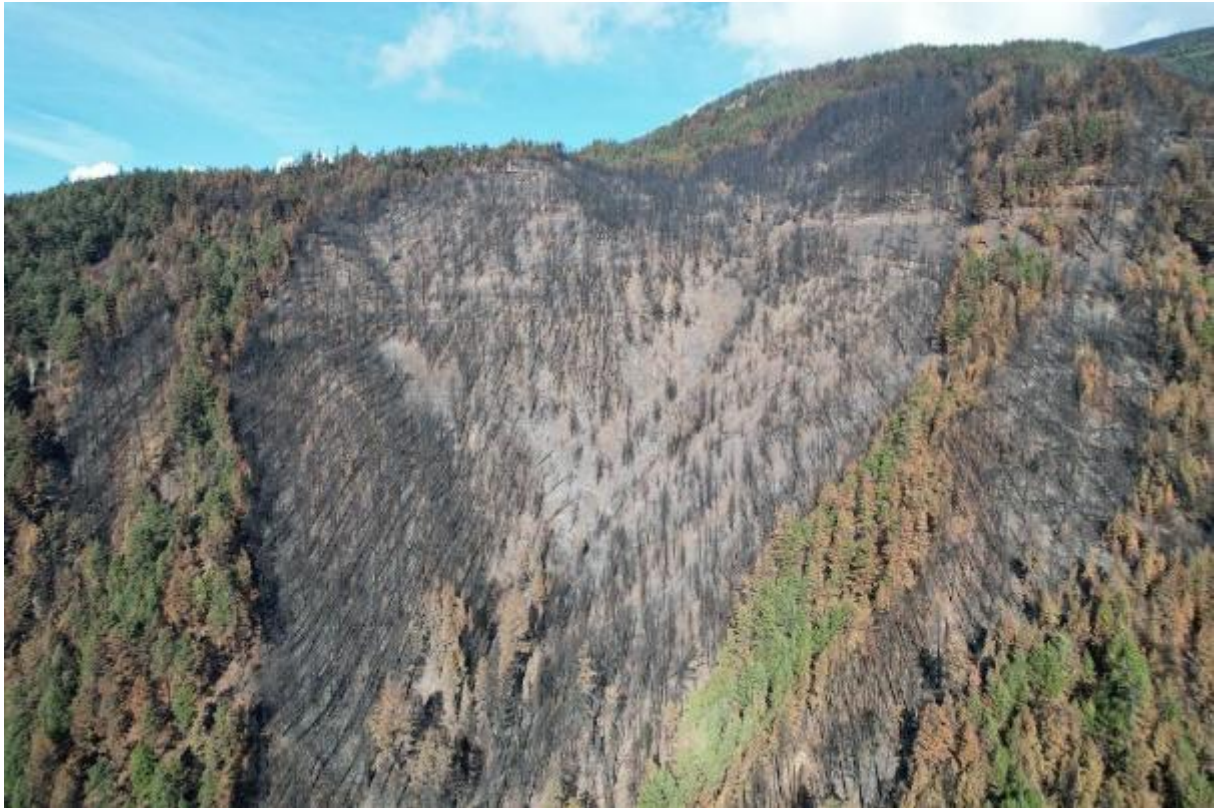
**Photo 28** Mixed burn severities on the south slopes of Mission Mountain Road, upper MM5 watershed looking north.

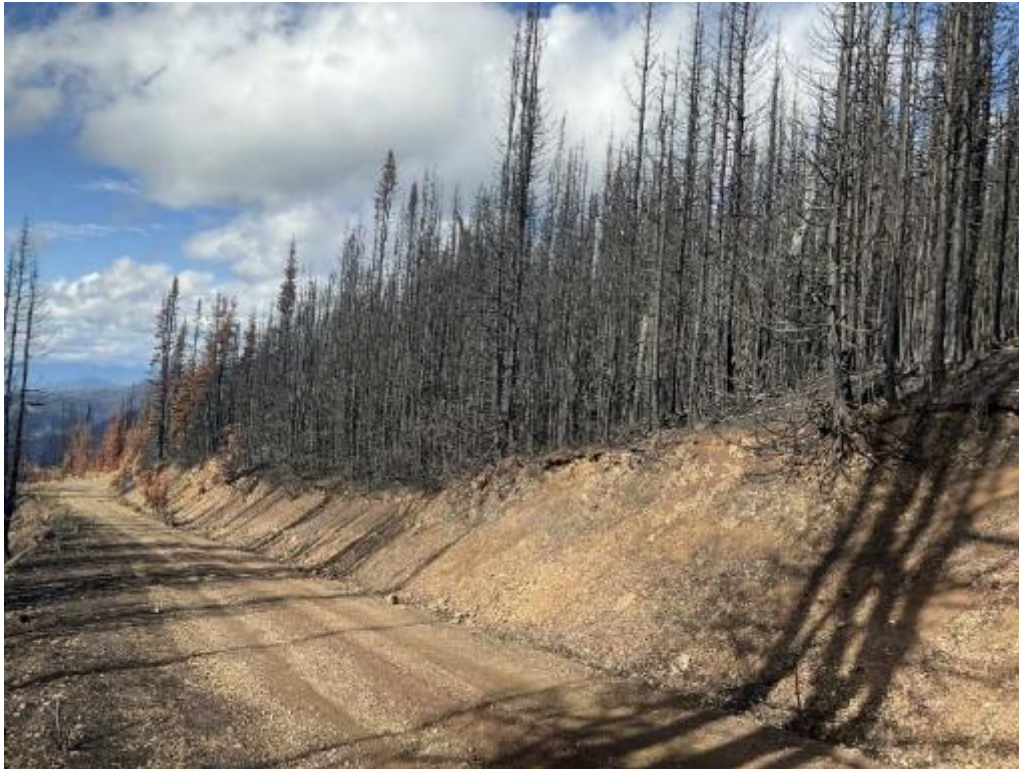
**Photo 30** High vegetation burn severity on Camoo Creek FSR, upper MD1 watershed looking east.

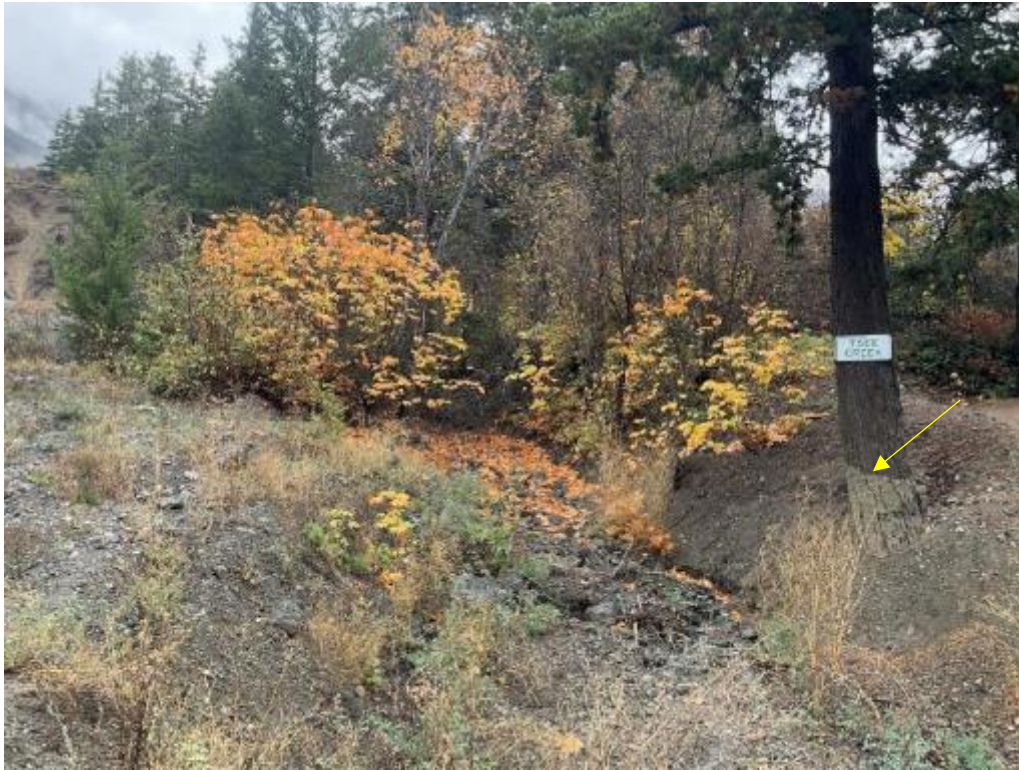
**Photo 34** Bedload material and mud splatter on lower Tsee Creek at Shalalth Cutoff Road, looking upstream.

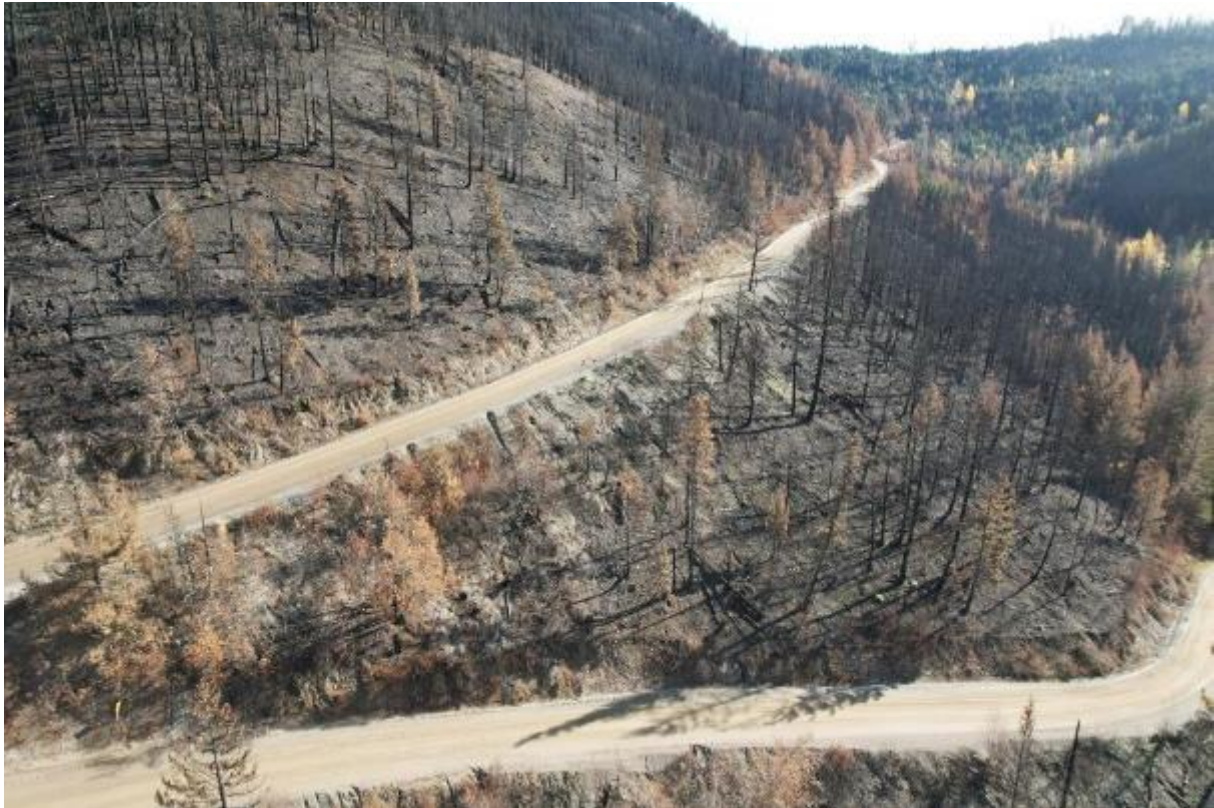
**Photo 36** Mission Mountain Road descending towards Carpenter Lake. Note eroded fill in areas of burnt out vegetation in the fill.

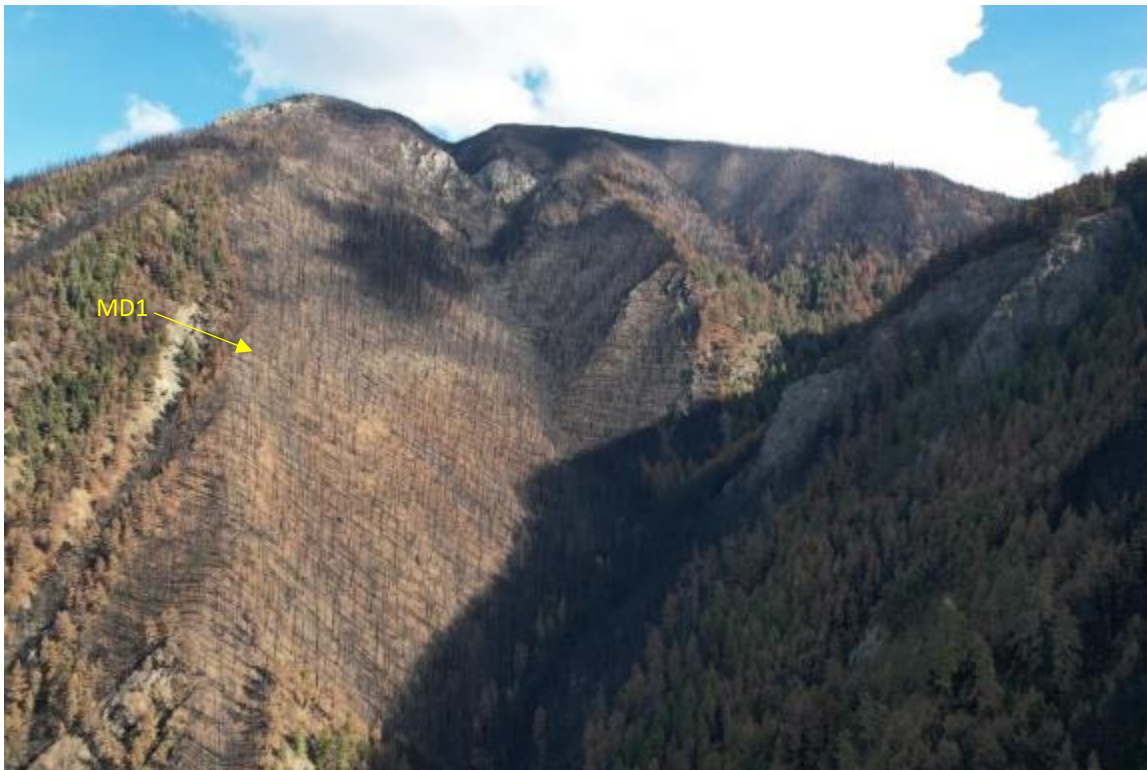
**Photo 39** MD1 watershed showing high vegetation burn severity, looking southeast.

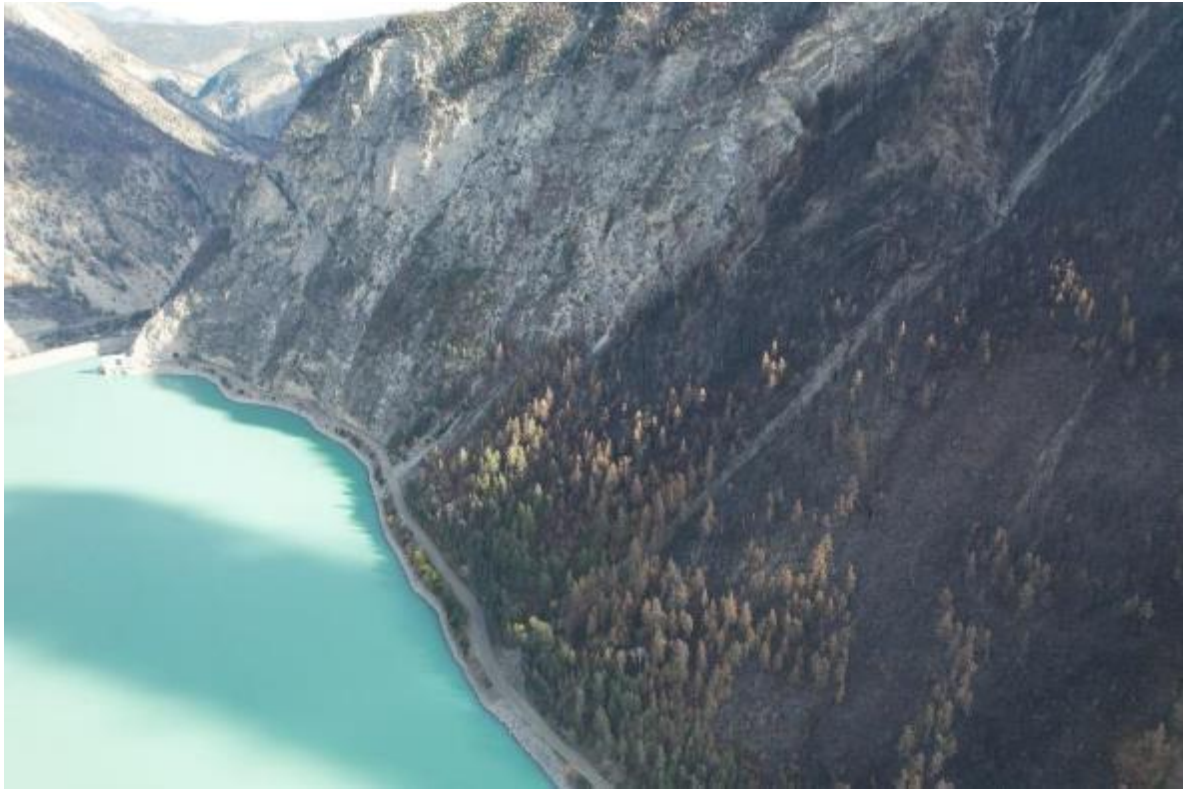
**Photo 41** Recent flow paths east of MD4.

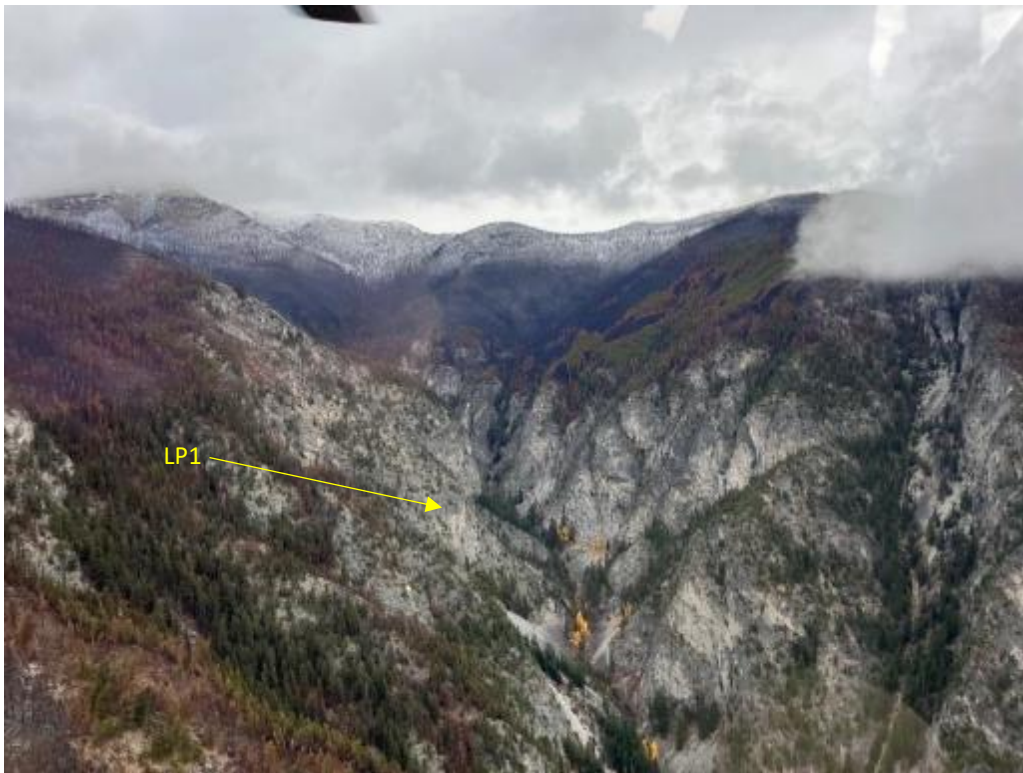
**Photo 42** LP1 watershed showing high vegetation burn severity in the upper watershed, looking north.

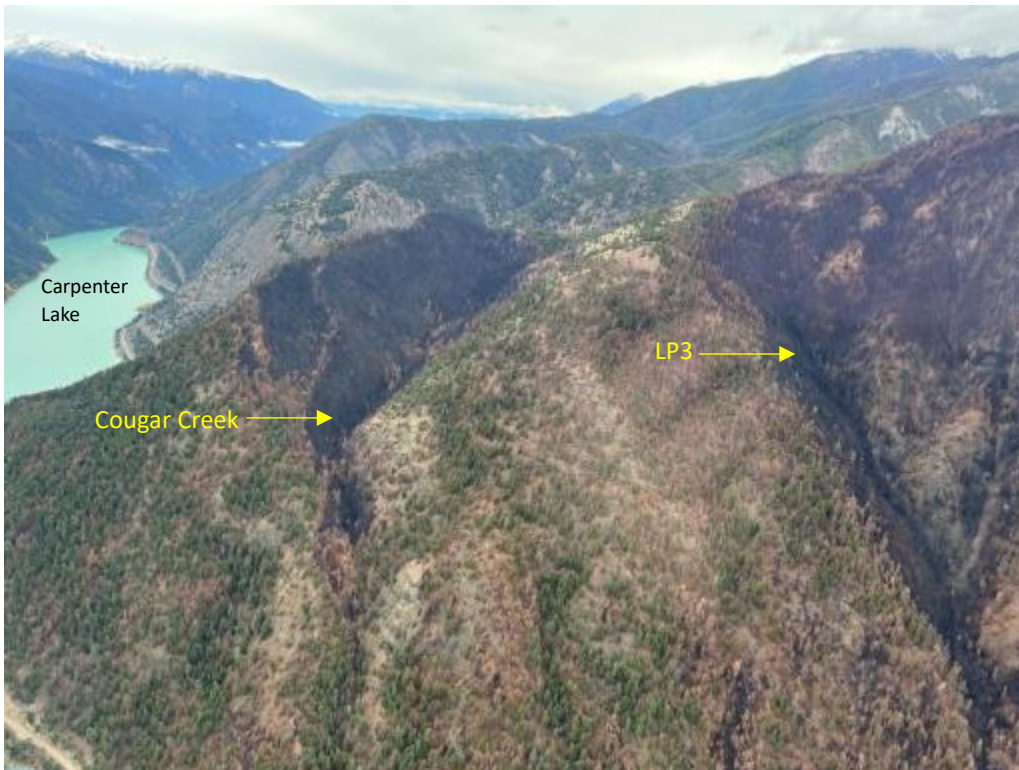
**Photo 44** Cougar Creek (left) and LP3 (right) watersheds showing unburned to high vegetation burn severity, looking west.
