Bralorne Community Sewer System Assessment Study Update

Squamish-Lillooet Regional District

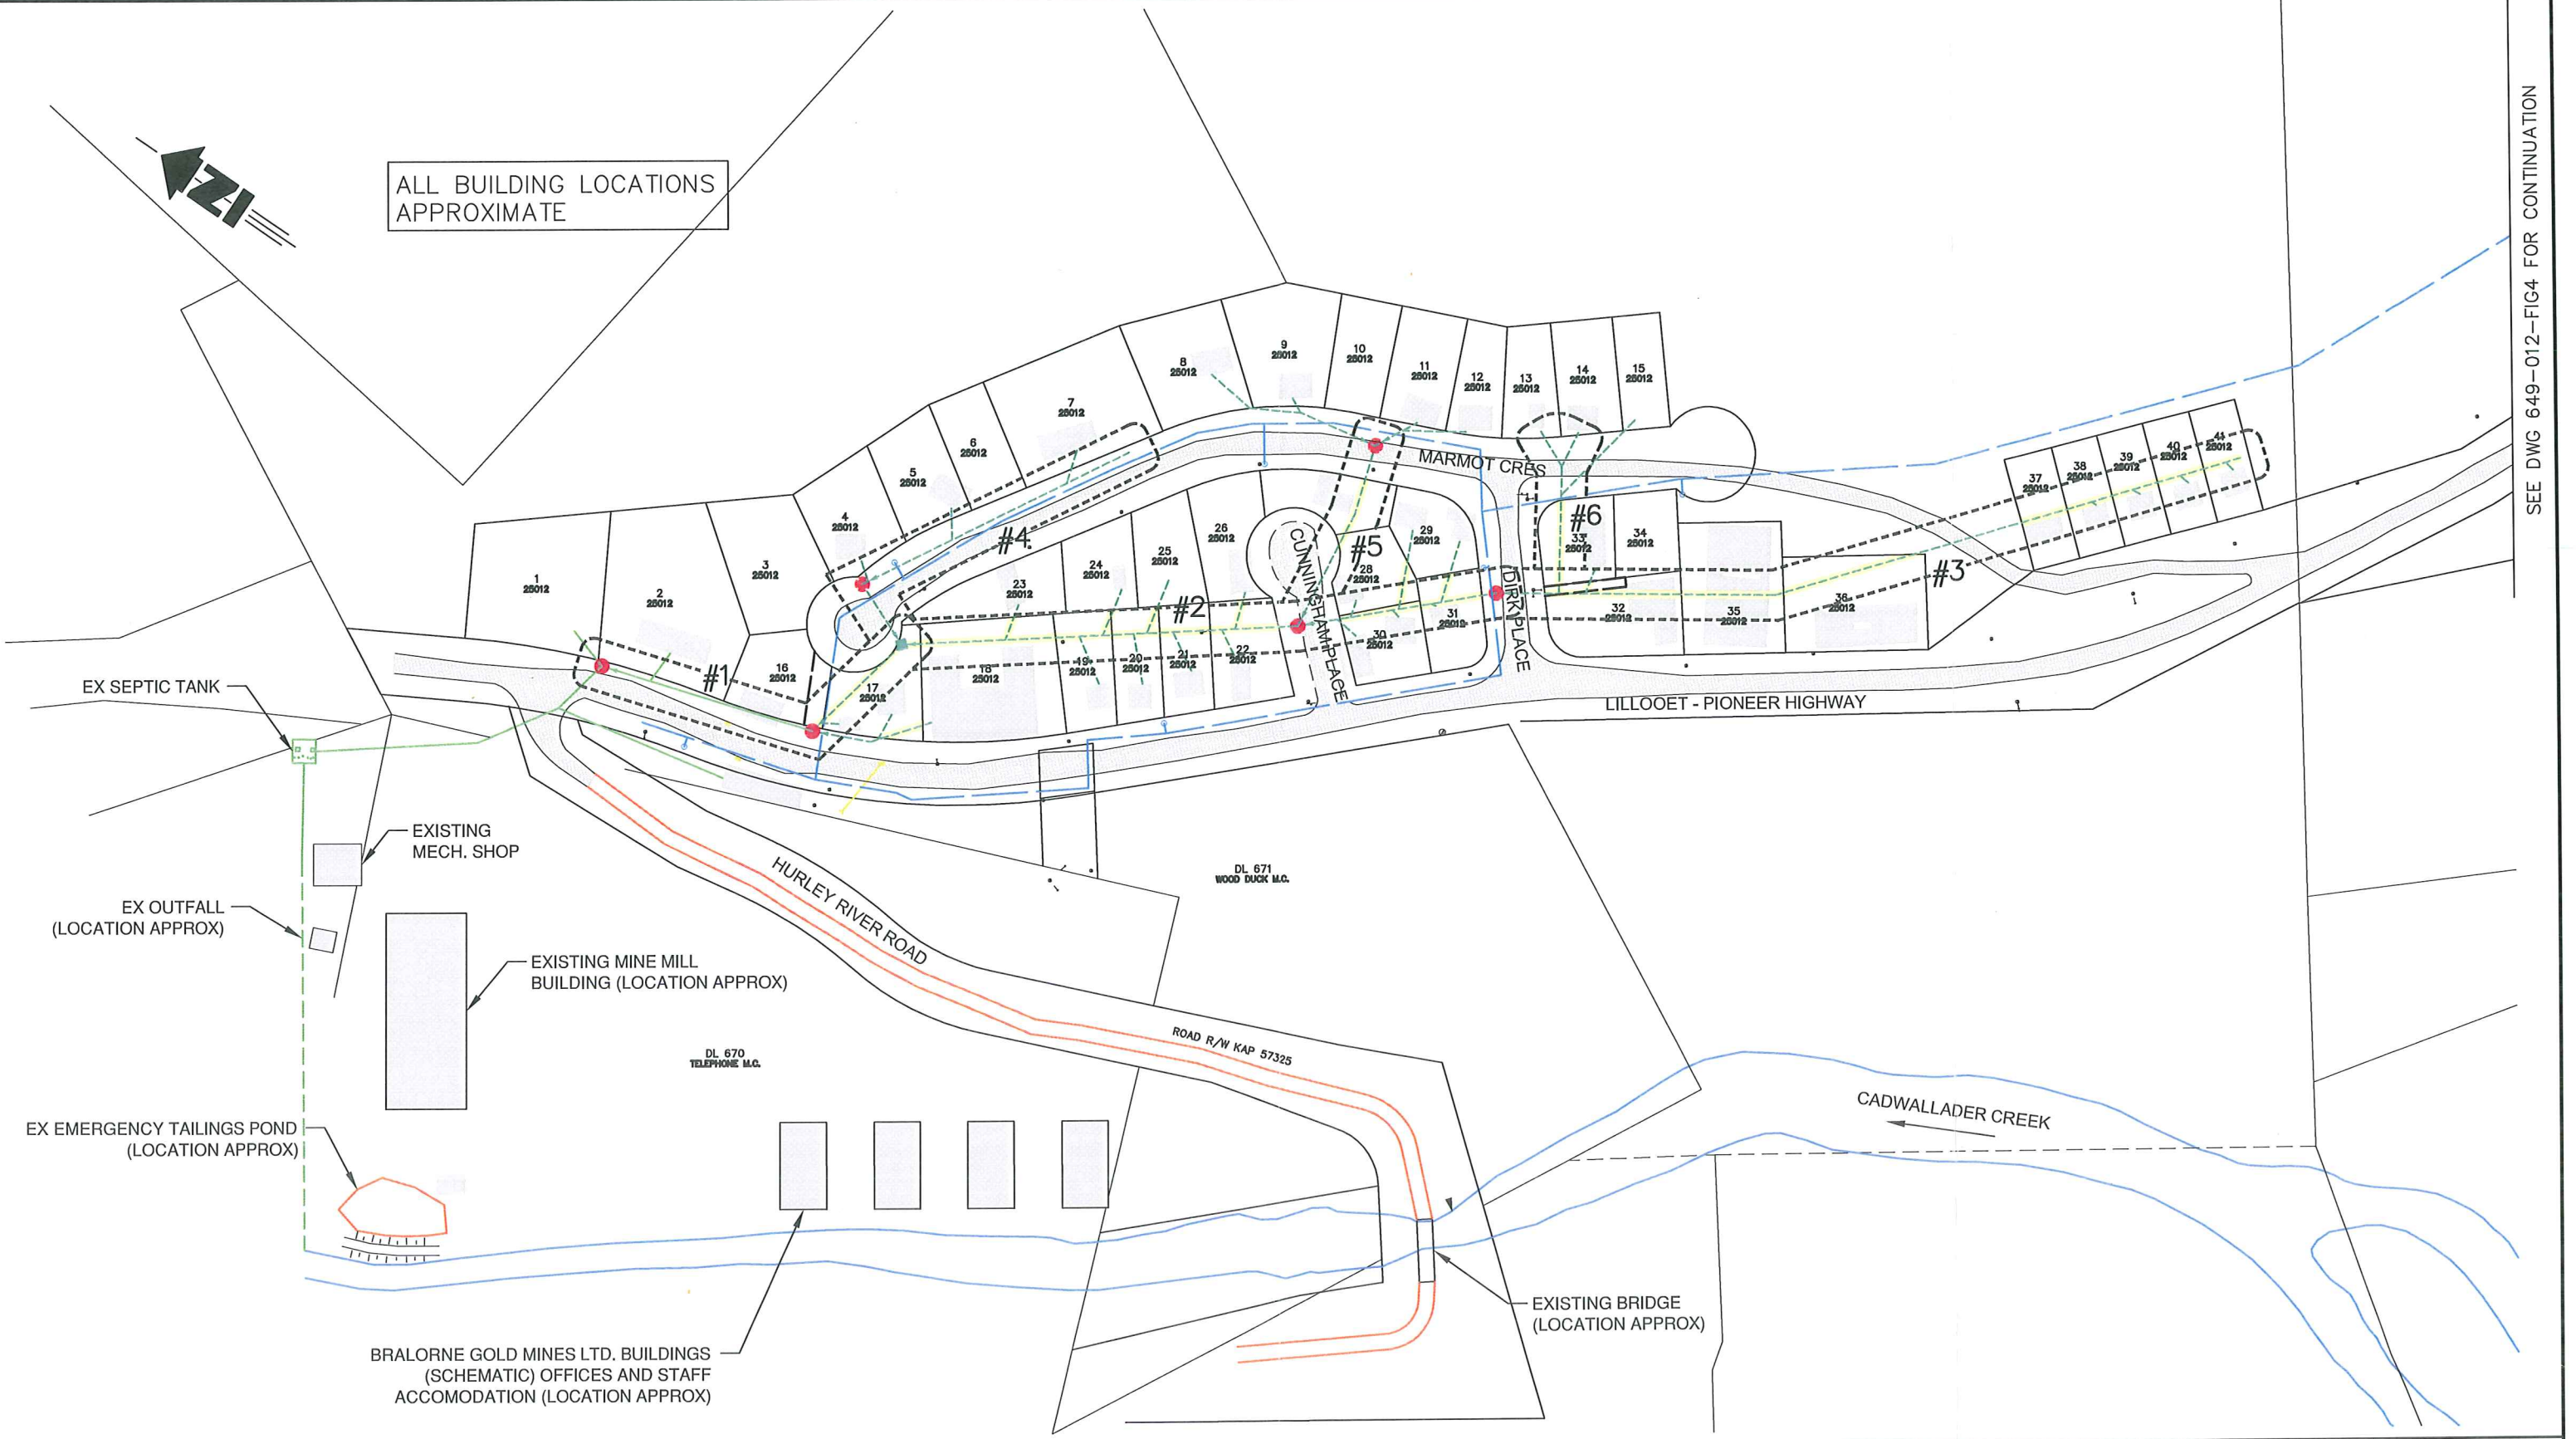
LEGEND					
⊙	POWER POLE	●	VALVE	—	WATER
⊙	LIGHT STANDARD	⊙	HYDRANT	- - -	EX SANITARY TO BE ABANDONED
○	IRON PIN	■	SANITARY MANHOLE FOUND	—	EX SANITARY TO REMAIN IN SERVICE
●	CURB STOP	●	SANITARY MANHOLE ASSUMED	—	TRESPASS AREA
		○	CLEANOUT

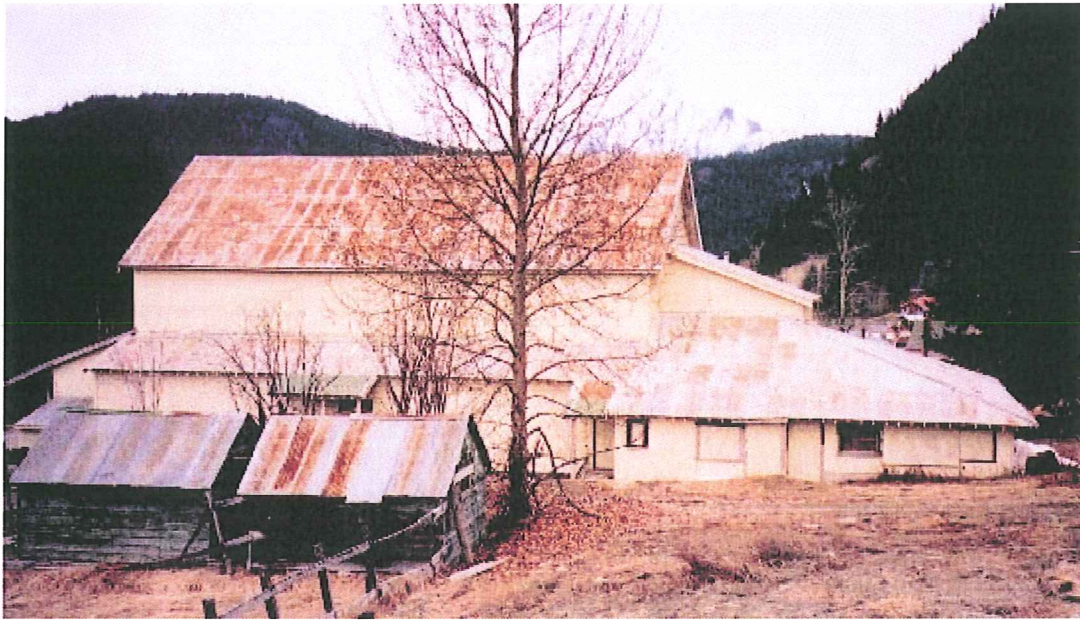
Recreation Centre Townsite #1 - 2002
(Viewing to North)

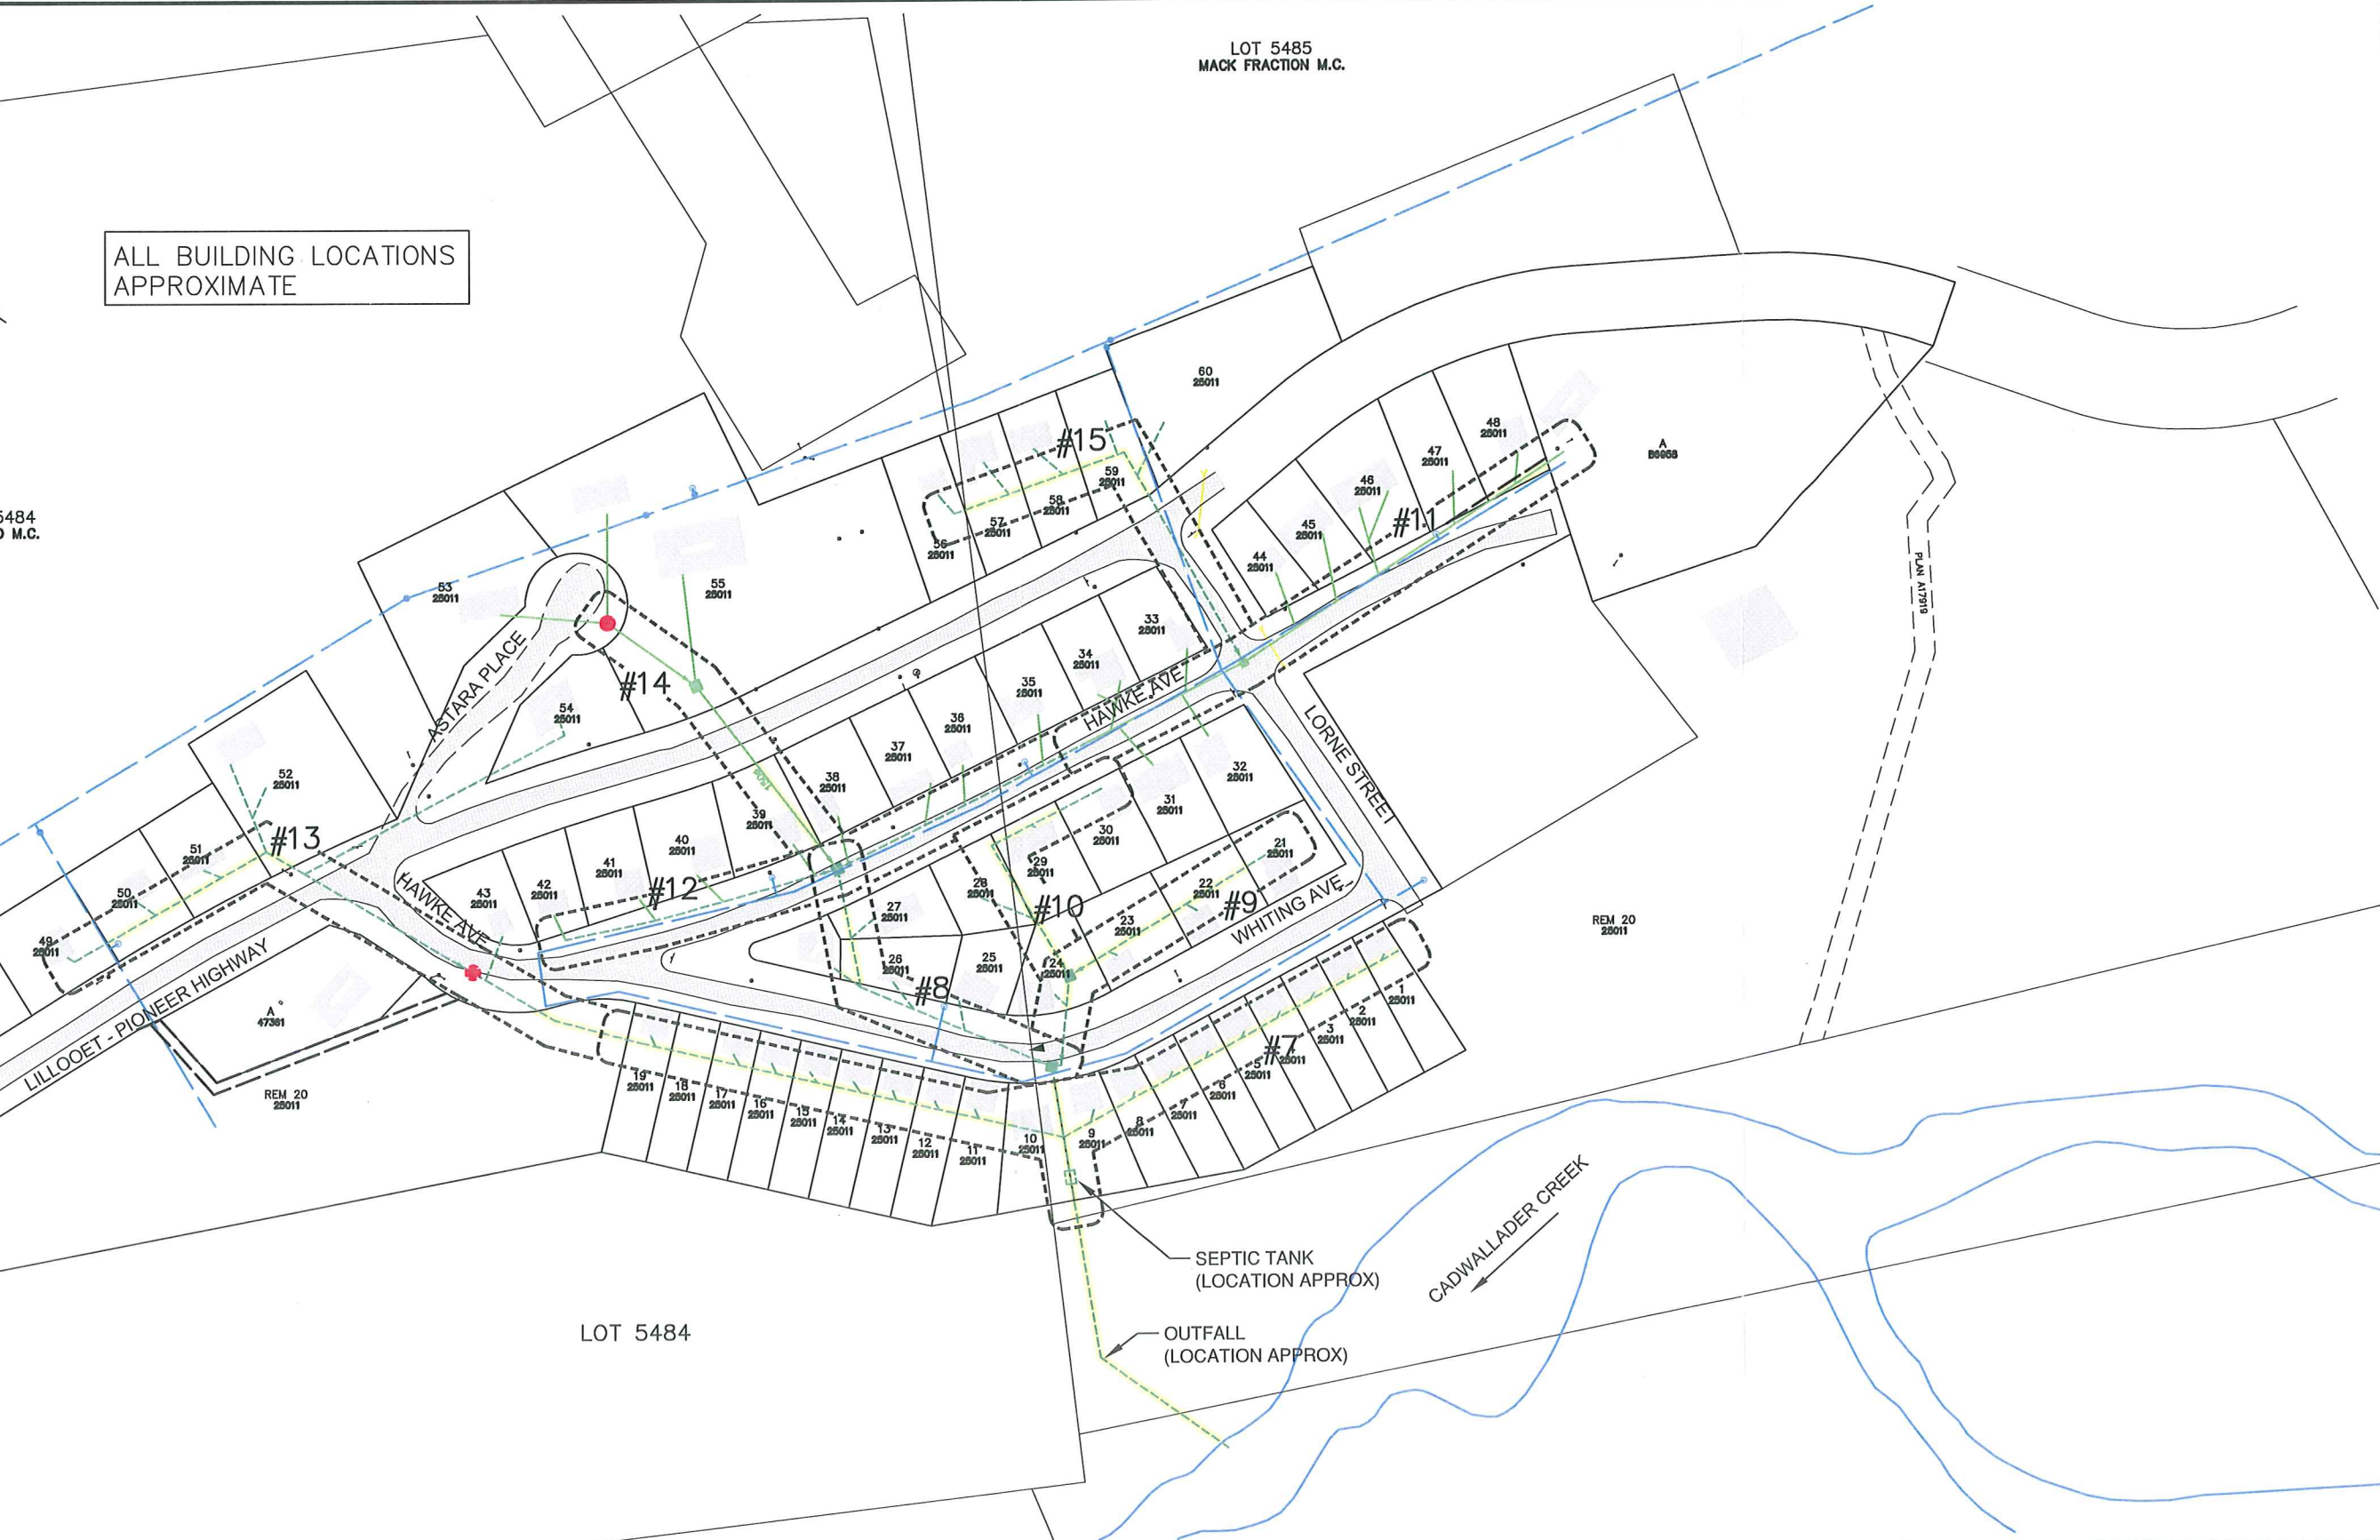
LEGEND	
⊙	POWER POLE
⊙	LIGHT STANDARD
⊙	IRON PIN
•	CURB STOP
●	VALVE
⊙	HYDRANT
■	SANITARY MANHOLE FOUND
●	SANITARY MANHOLE ASSUMED
■	PROPOSED SANITARY MANHOLE
○	CLEANOUT
---	STORM
---	WATER
---	EX SANITARY TO BE ABANDONED
---	EX SANITARY TO REMAIN IN SERVICE
---	PROPOSED SANITARY
---	FUTURE SANITARY
---	PROPOSED R/WAY
---	TRESPASS AREA

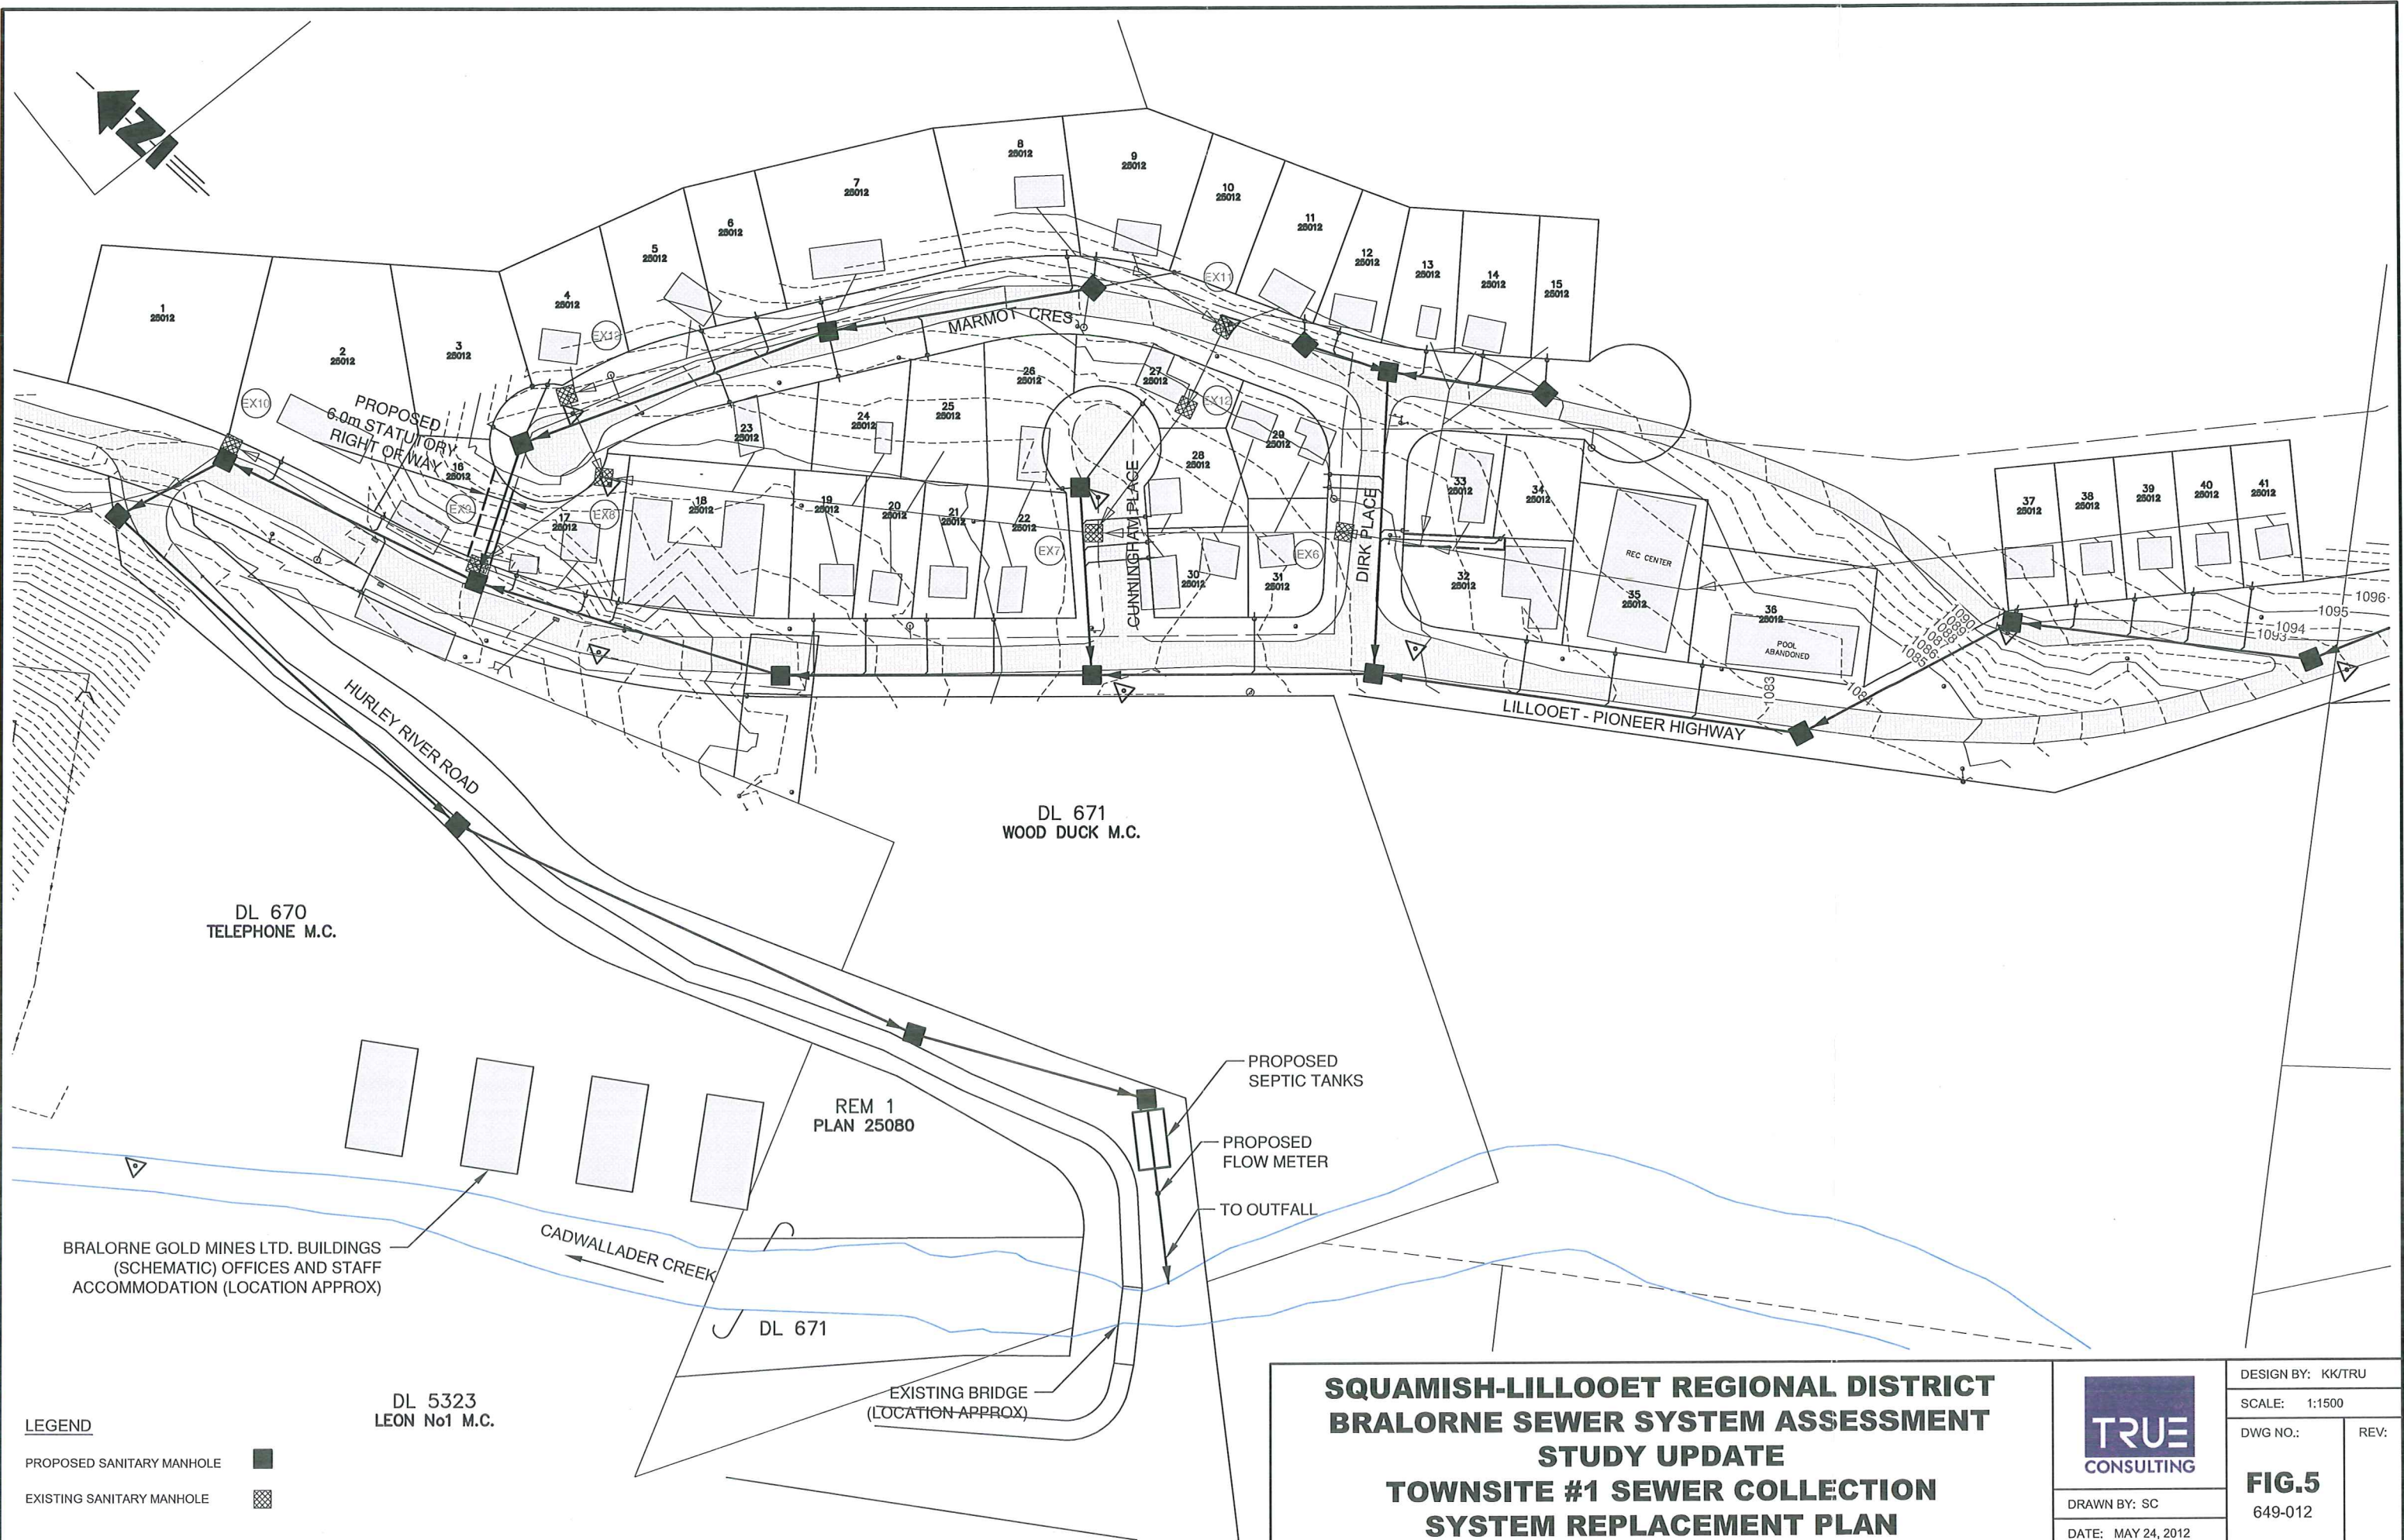
LEGEND
 PROPOSED SANITARY MANHOLE ■
 EXISTING SANITARY MANHOLE ▣

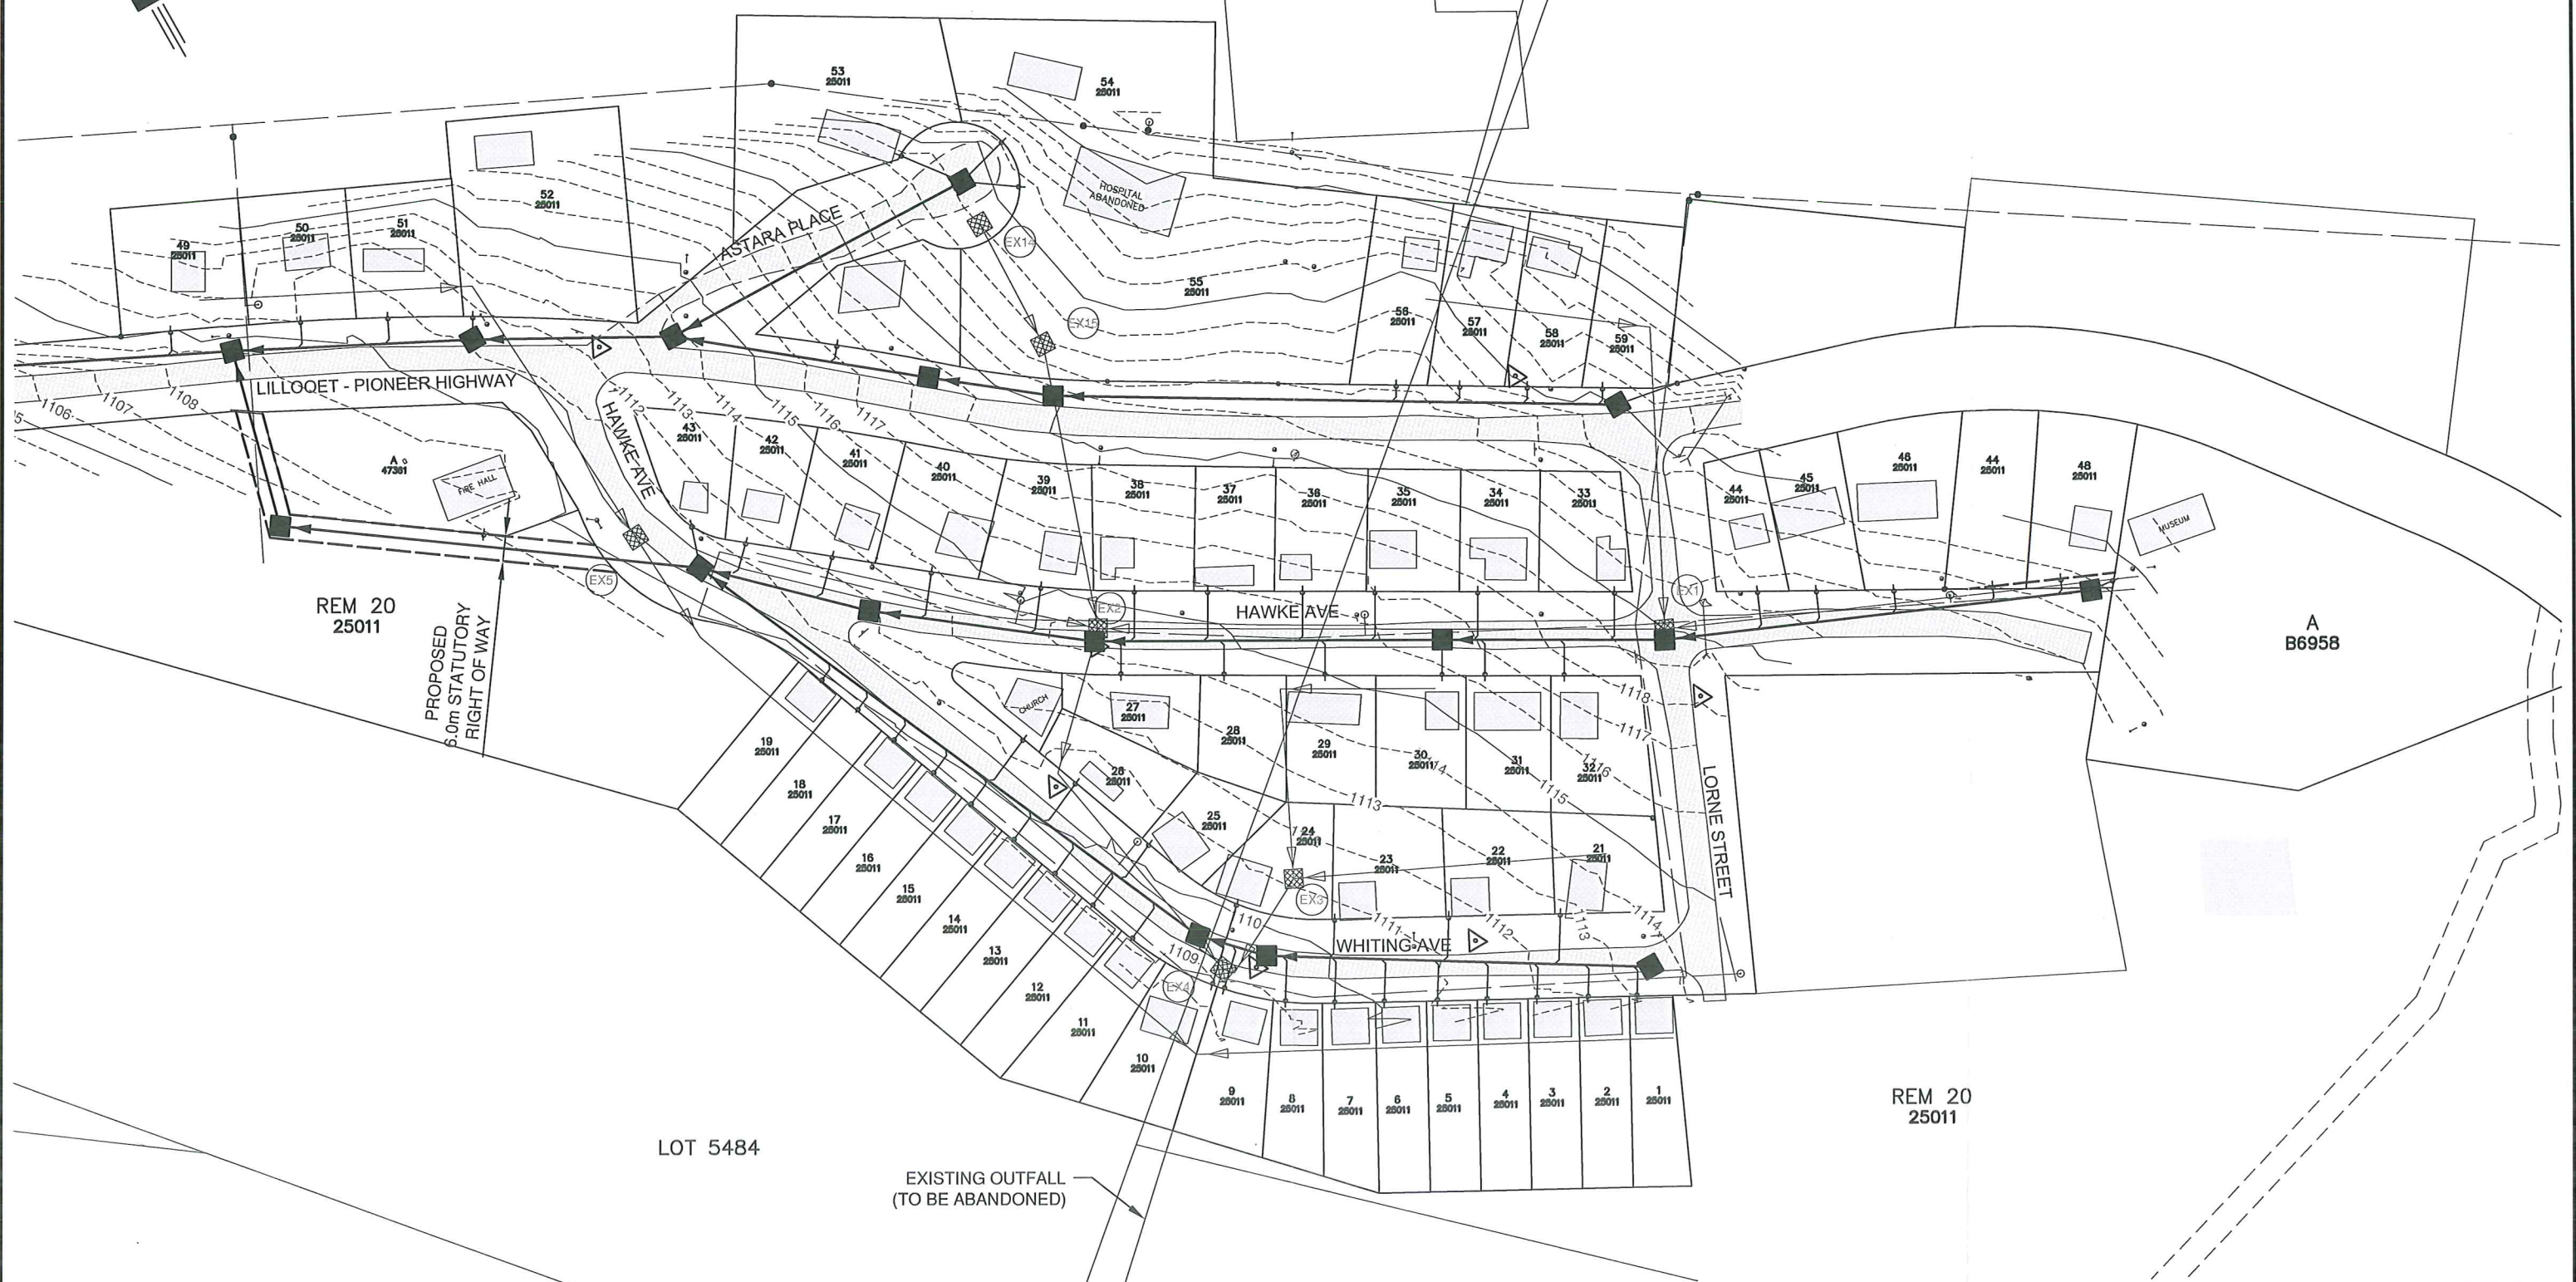
LEGEND
PROPOSED SANITARY MANHOLE ■
EXISTING SANITARY MANHOLE ▨
