February 14, 2023

File 22-93

RE: Feasibility Assessment for Proposed On-Site Wastewater Treatment System, DL 1748 Porteau Cove, Squamish, BC

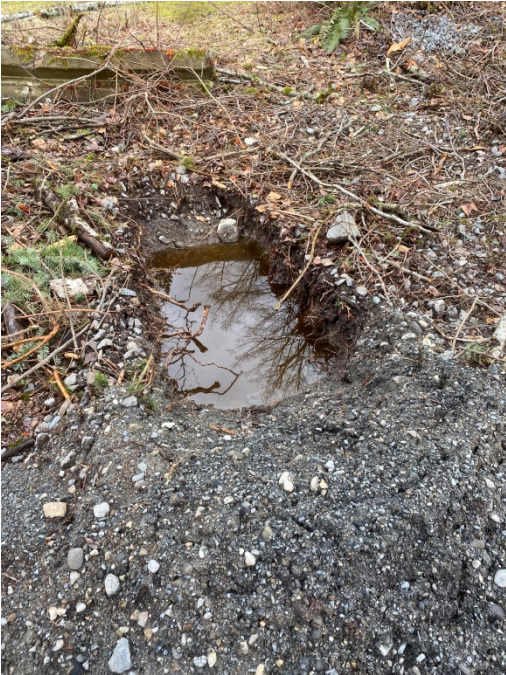
Test pit 1 located at the north end of the property (Area 1) and immediately west of the existing BC parks septic field consisted of the following:

0-300mm Silty sand, dark brown, organics, loose overlying:

300-1200mm Silt, sand, gravel, frequent cobbles, rounded, grey, dense (till like)

Heavy iron mottling was present and perched water was later encountered within approximately 200mm of the ground surface. As such, it was not possible to complete a percolation test at this location.

This area was judged to be unsuitable for receiving effluent due to the presence of a shallow restrictive layer. No further investigation was conducted in this area due to site disturbance.

Figure 1 - Photo showing Test pit 1 – Note perched water table

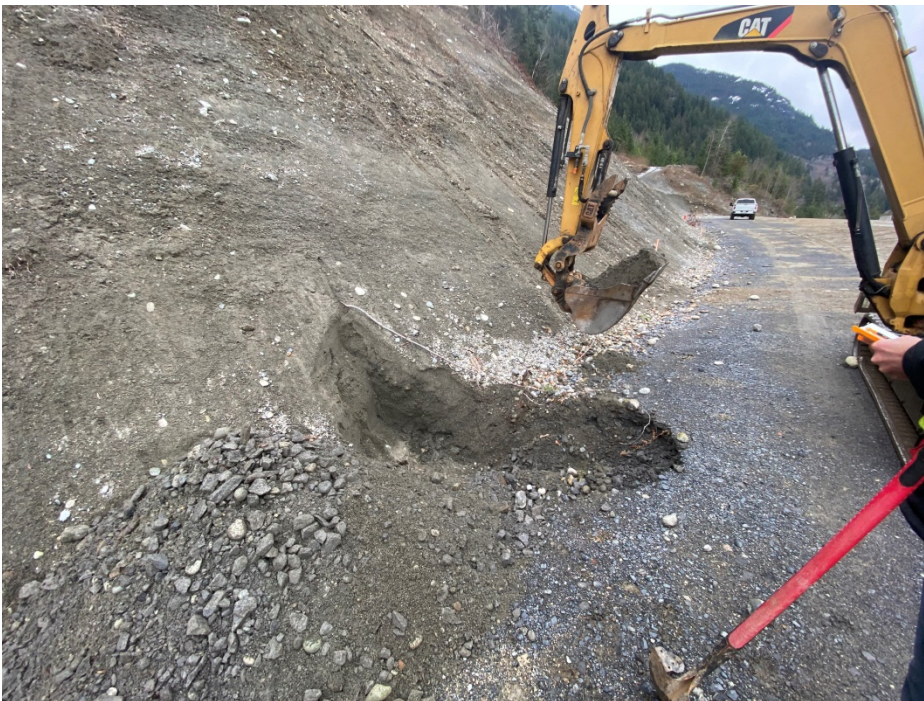
Area 2 was located south of the water course on the middle bench. Testpits 2-3 were excavated near the north end of this area on the access road just prior to reaching the top of the bench (see figure 2 below and attached site plan). Till like clayey silt and gravel was encountered at a depth of 400mm Below Ground Surface (BGS) in testpit 2 and 1200mm BGS in testpit 3.

Figure 2 - Testhole 2 looking south (north end Area 2)

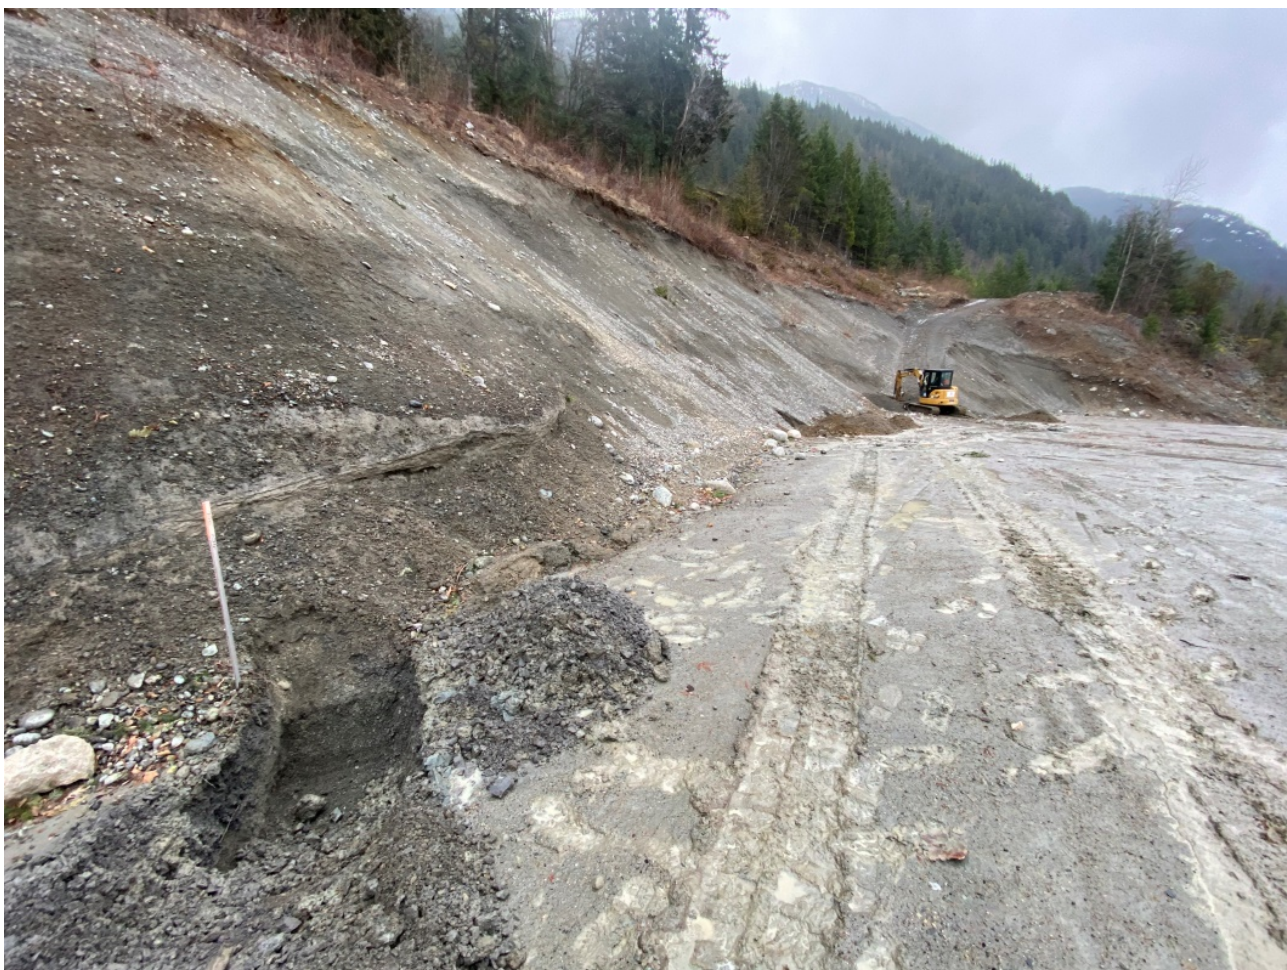
Clean loose grey sand and gravel were encountered to depths of 1.9m in each of testpits 4-7 which were excavated along the toe of the bank. Some overburden silt was observed in testpits 4-6 extending from 200 - 900mm BGS. No seepage was encountered in any of the testpits excavated in Area 2. This limited area at the toe of the slope consisting of loose native sand and gravel identified in testpits 4-7 is judged to be very favourable for receiving effluent. The native sand and gravel is judged to dive downwards at approximately the same angle as the slope (65%) to the west of the toe. It has been reported by Murrin Construction that the native sand and gravel west of the toe slope was previously mined and replaced by heterogeneous imported fill. As such, the area to the west of the toe slope was not investigated.

Figure 3 - Testpit 4 Looking South (Area 2). Native sand and gravel is visible along the slope

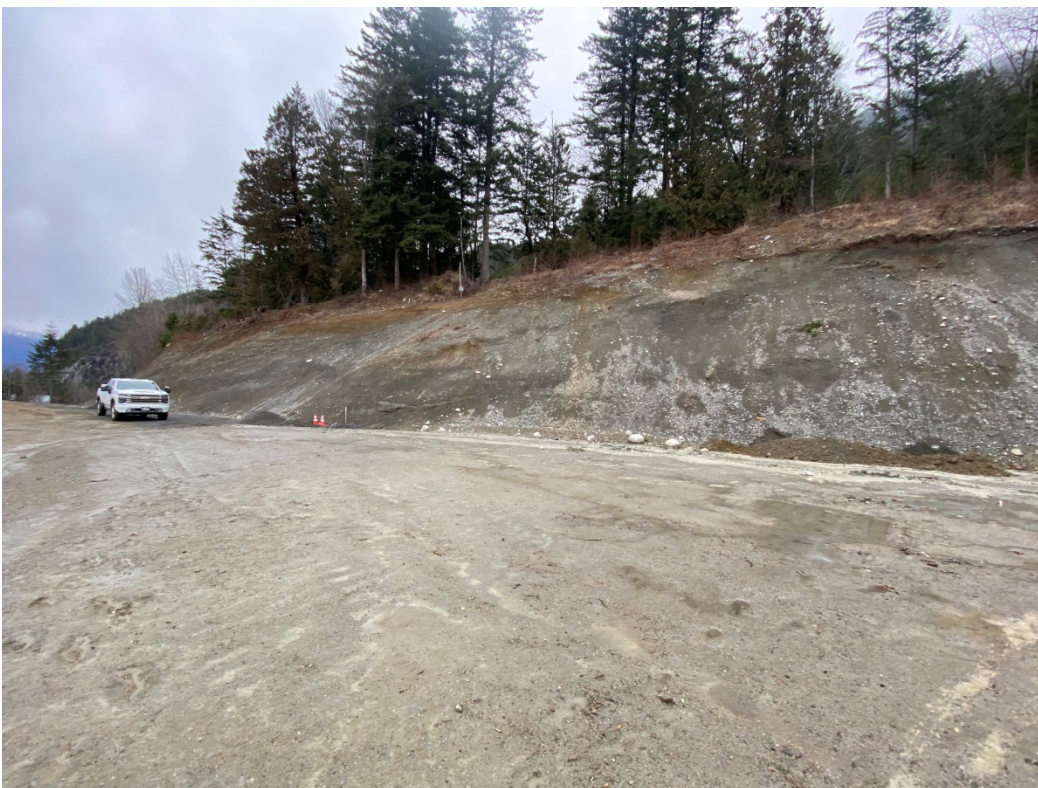
Figure 4 – Photo looking east towards toe of slope where TPs 4-7 were excavated (Area 2). The forested area above the top of bank represents Area 3

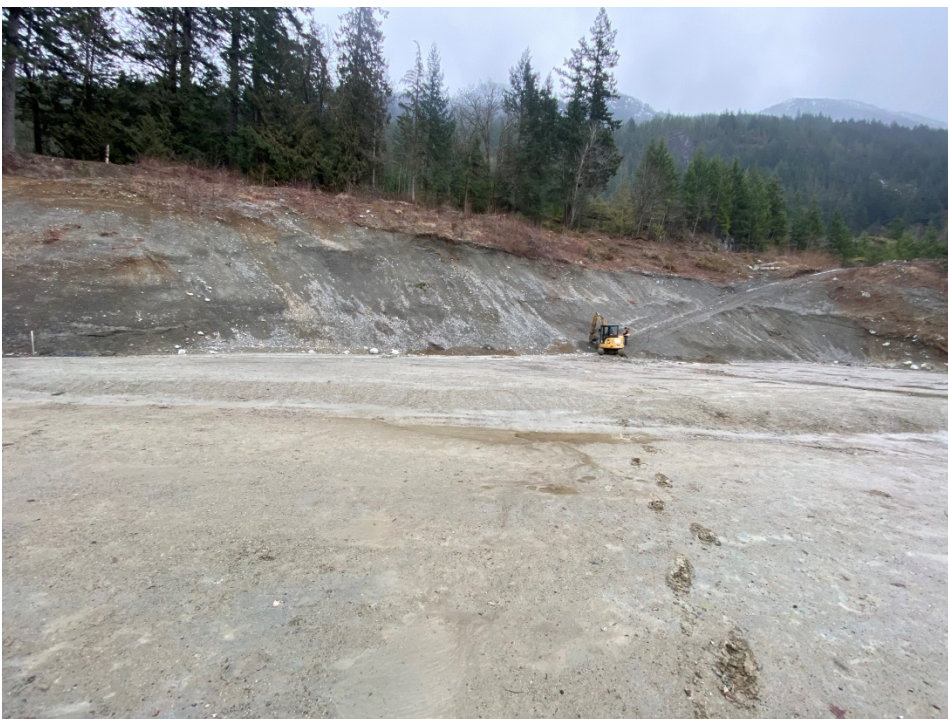
Figure 5 – View east towards TPs 6 & 7 (Area 2). The forested area visible at the top of the slope represents Area 3

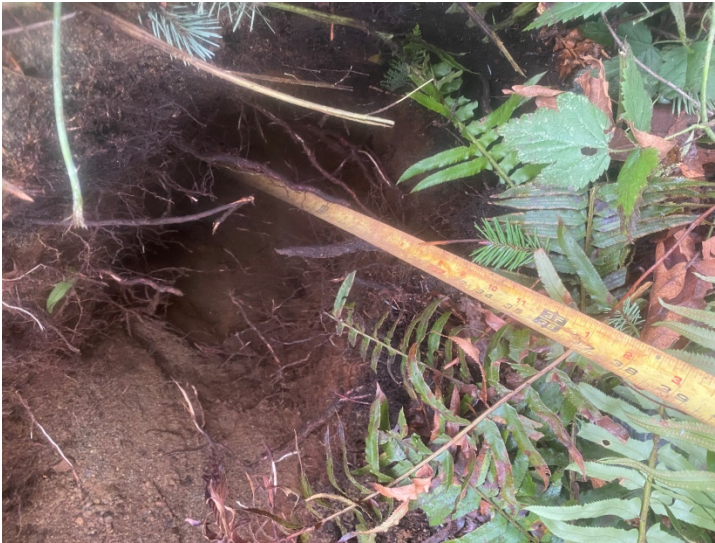
Area 3 is located on the forested upper bench east and immediately upslope of Area 2. Testpits 8-10 were excavated along this bench and consisted of the following:

0-750mm silty sand, granular, loose, reddish brown, abundant roots overlying;

750-2000m Sand, grey to light brown, trace to some gravel, loose to medium dense, occasional cobbles.

This area is also considered to be very favourable for receiving effluent.

Figure 6 – Hand excavated Testhole on upper bench (Area 3)
