## **SQUAMISH-LILLOOET REGIONAL DISTRICT**

### **SETON PORTAGE AREA INTEGRATED HYDROGEOMORPHIC RISK ASSESSMENT**

**FINAL**

PROJECT NO.:	1358005	DISTRIBUTION:	
DATE:	April 6, 2018	SLRD:	digital copy
		BGC:	digital copy

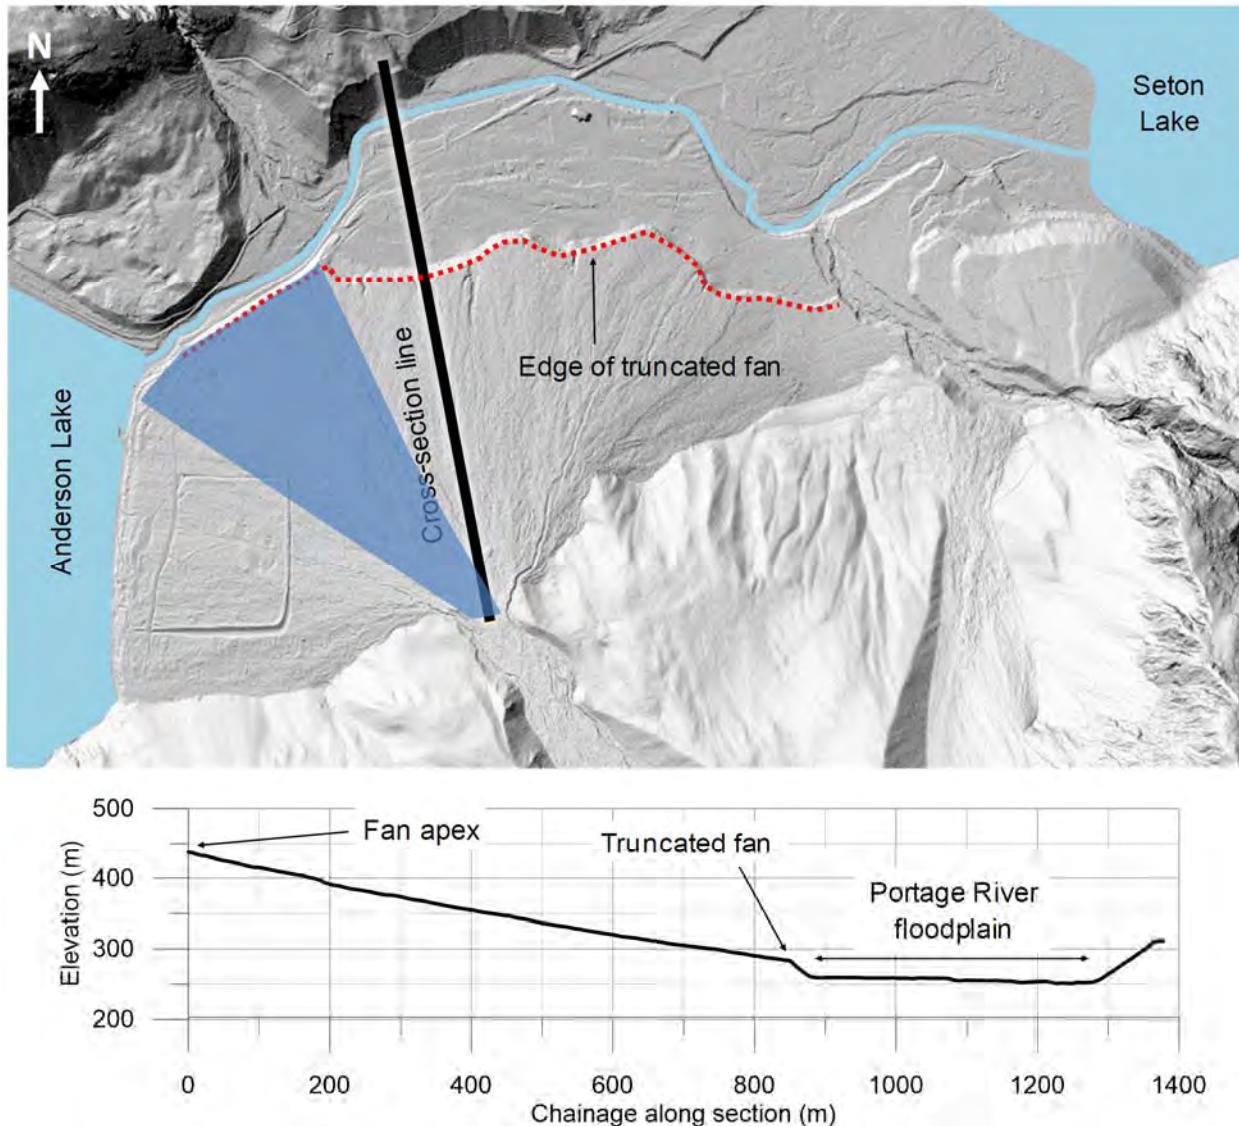
**Figure 2-2.** LiDAR hillshade image and cross-section of the Bear Creek fan showing the fan truncation and the triangular-shaped poorly channelled section upslope of the railway cut.

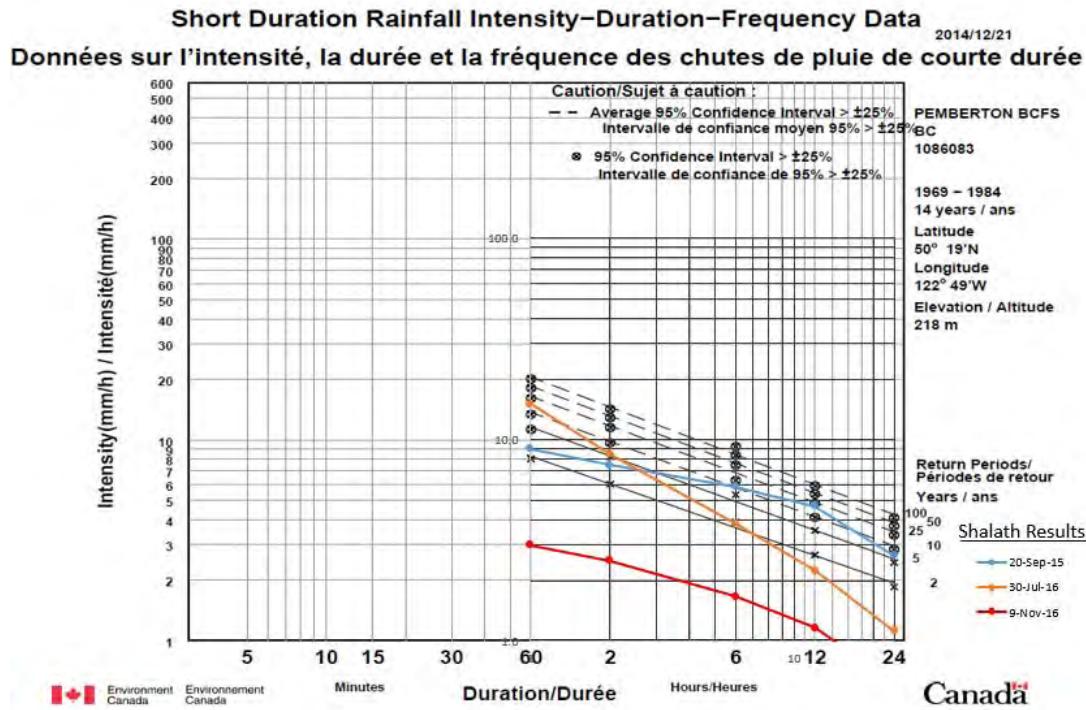
**Figure 2-3.** IDF magnitudes for the September 20, 2015 (blue), July 30, 2016 (orange), and November 8-9, 2016 (red) events, compared to the estimated IDF values at the Pemberton Climate Station.

The rainfall data from the three storm events are plotted on rainfall intensity-duration-frequency (IDF) records at the Pemberton climate station (55 km southwest; Figure 2-3) and Lillooet climate station (28 km east; Figure 2-4). These two stations vary slightly, with the Lillooet climate station having lower IDF values than the Pemberton station due to the rain shadow effect of the Coast Mountains. IDF curves have not been developed for the BC Hydro Tsal'ah climate station.

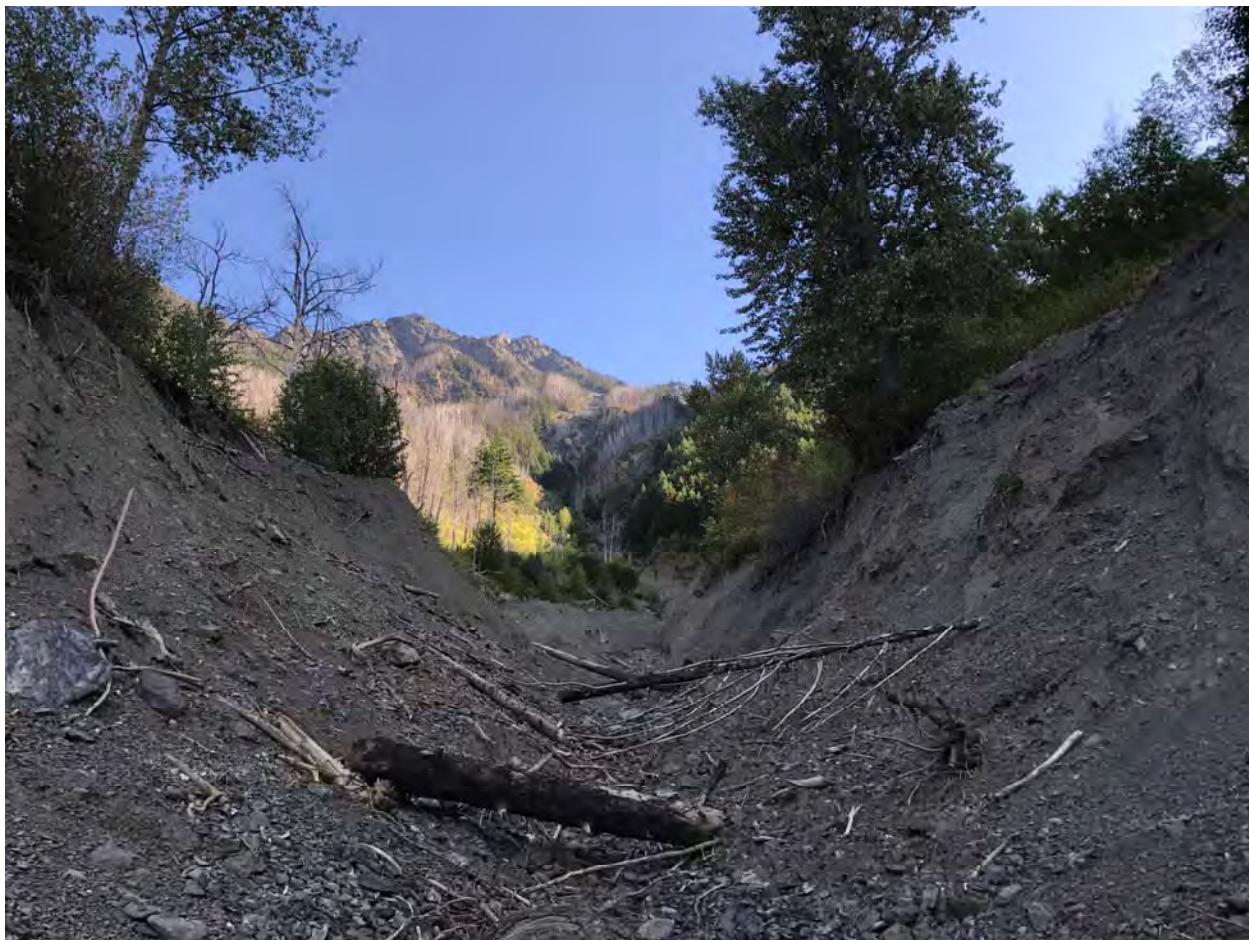
**Figure 2-7.** Bear Creek channel near fan apex. The channel is incised about 10 m and has a channel gradient of 48%. Bear Mountain in the background. Photo: BGC September 12, 2017.

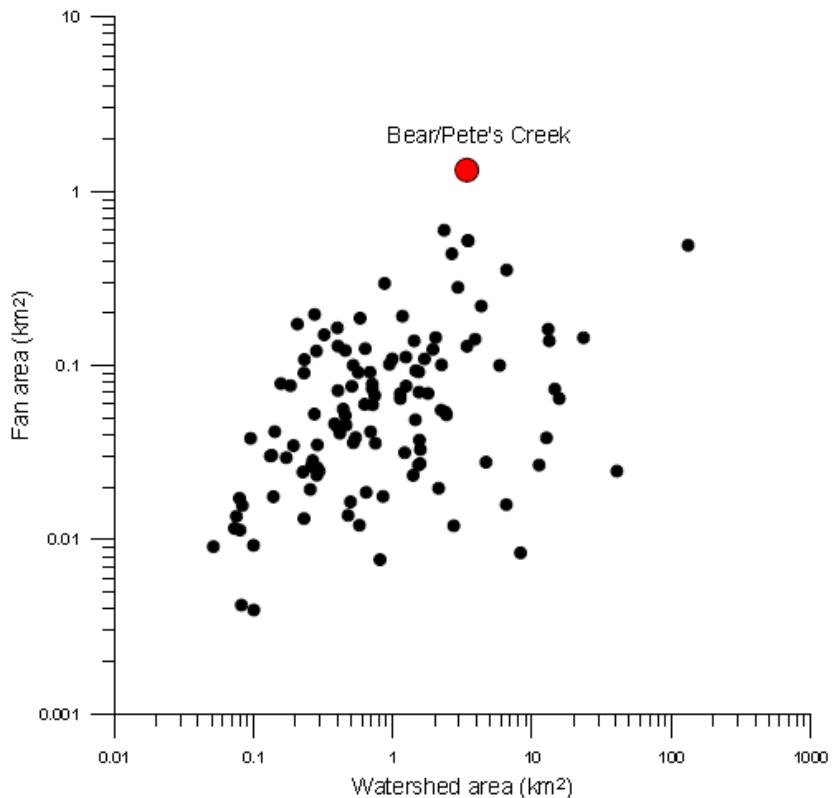
**Figure 2-8. Watershed area versus fan area for 116 creeks in BC (data from Lau 2017). Bear and Pete's Creek data are plotted as a large red dot.**

Bear Creek fan area is unusually large compared to its watershed as shown in Figure 2-8. This may be attributed to the long runout distance of fine-grained debris flows, but may also be related to a high frequency of debris flows associated with low rock mass strength and subsequent higher rates of weathering in the upper watershed. Finally, it is possible that large rock slope failures in the past have translated into very large ( $> 300,000 \text{ m}^3$ ) debris flows. Some of those are discussed in Section 3.3.3.

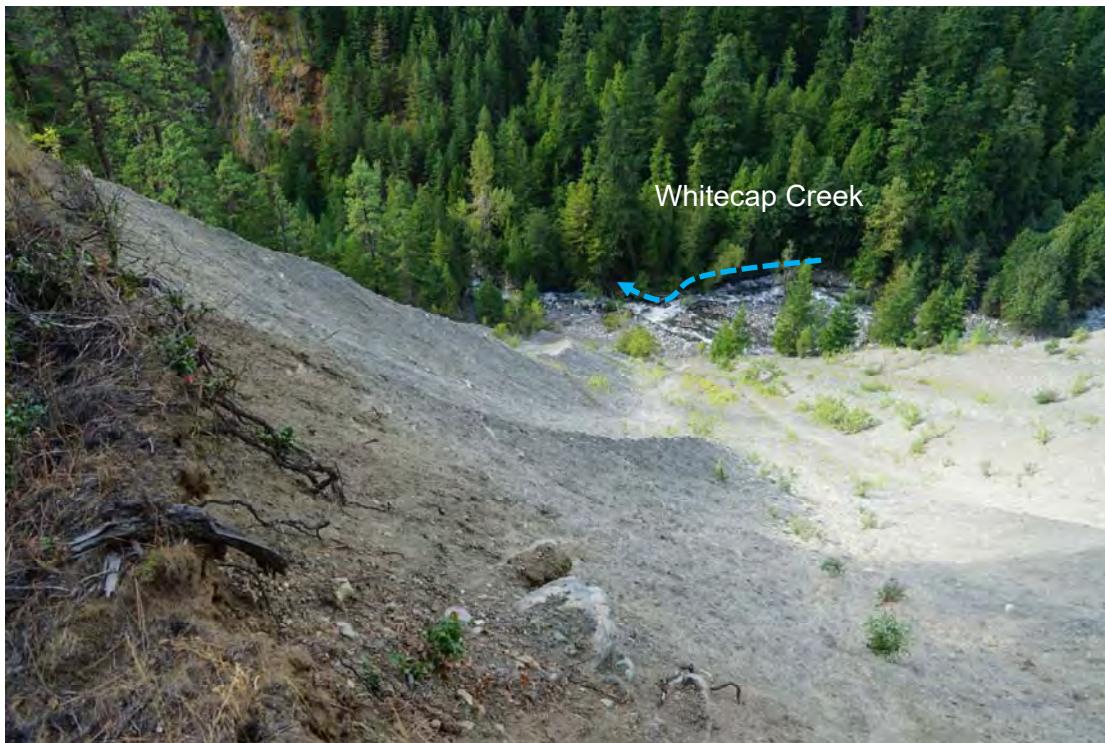
**Figure 2-9. Extensive till slope at angles of 35 to 39° approximately 700 m upstream from the fan apex of Whitecap Creek looking west. The slope is approximately 150 to 180 m long. Photo: BGC, November 9, 2017.**

Whitecap Creek is a hanging valley with a steep bedrock canyon connecting the low gradient (10%) mid channel from the fan. This hanging valley landform is typical for many creeks in the area (Spider Creek, Lost Valley Creek) and is attributable to a late Pleistocene glacier prevailing for some time in the valley bottom, not allowing creeks to incise into the freshly carved steep bedrock flanking the former glacier. Directly upstream of the steep bedrock canyon, a large ( $50,000 \text{ m}^2$ ) till slope is being undercut by Whitecap Creek and is continuously providing sediment that is then readily available for transport downstream (Figure 2-9).

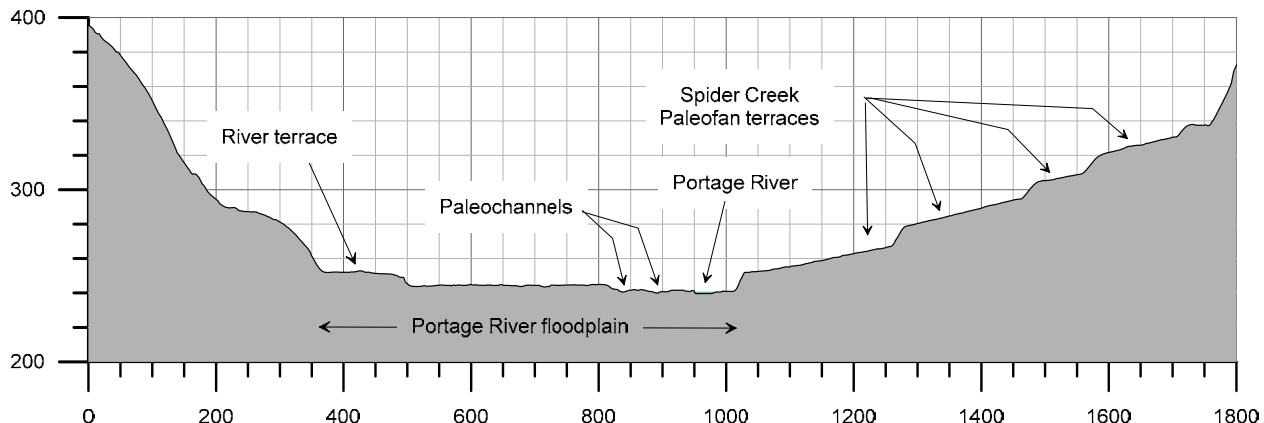
**Figure 2-14. Valley cross-section across Portage River valley near the confluence with Spider Creek (shown schematically)**

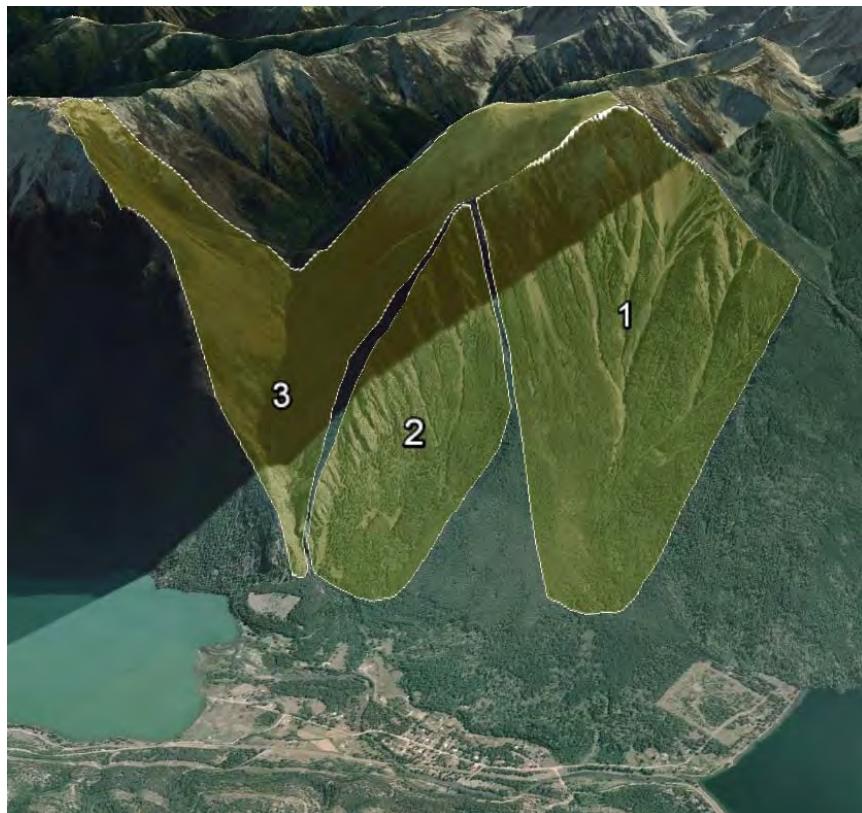
**Figure 2-15. Potential snow avalanche zones (initiation, transport, and runout) on the south side of Seton Portage (Google Earth 2015 imagery, looking southeast).**

This hydrogeomorphic assessment included a cursory review of snow avalanches where they could potentially reach currently populated areas. This work was completed by BGC's avalanche specialist Dr. Michael Conlan who reviewed satellite, LiDAR, and oblique photograph imagery. Analyzing terrain alone, there are three prominent areas subject to snow avalanches located on the south side of Seton Portage (Figure 2-15). The starting zones reach up to 2250 masl.

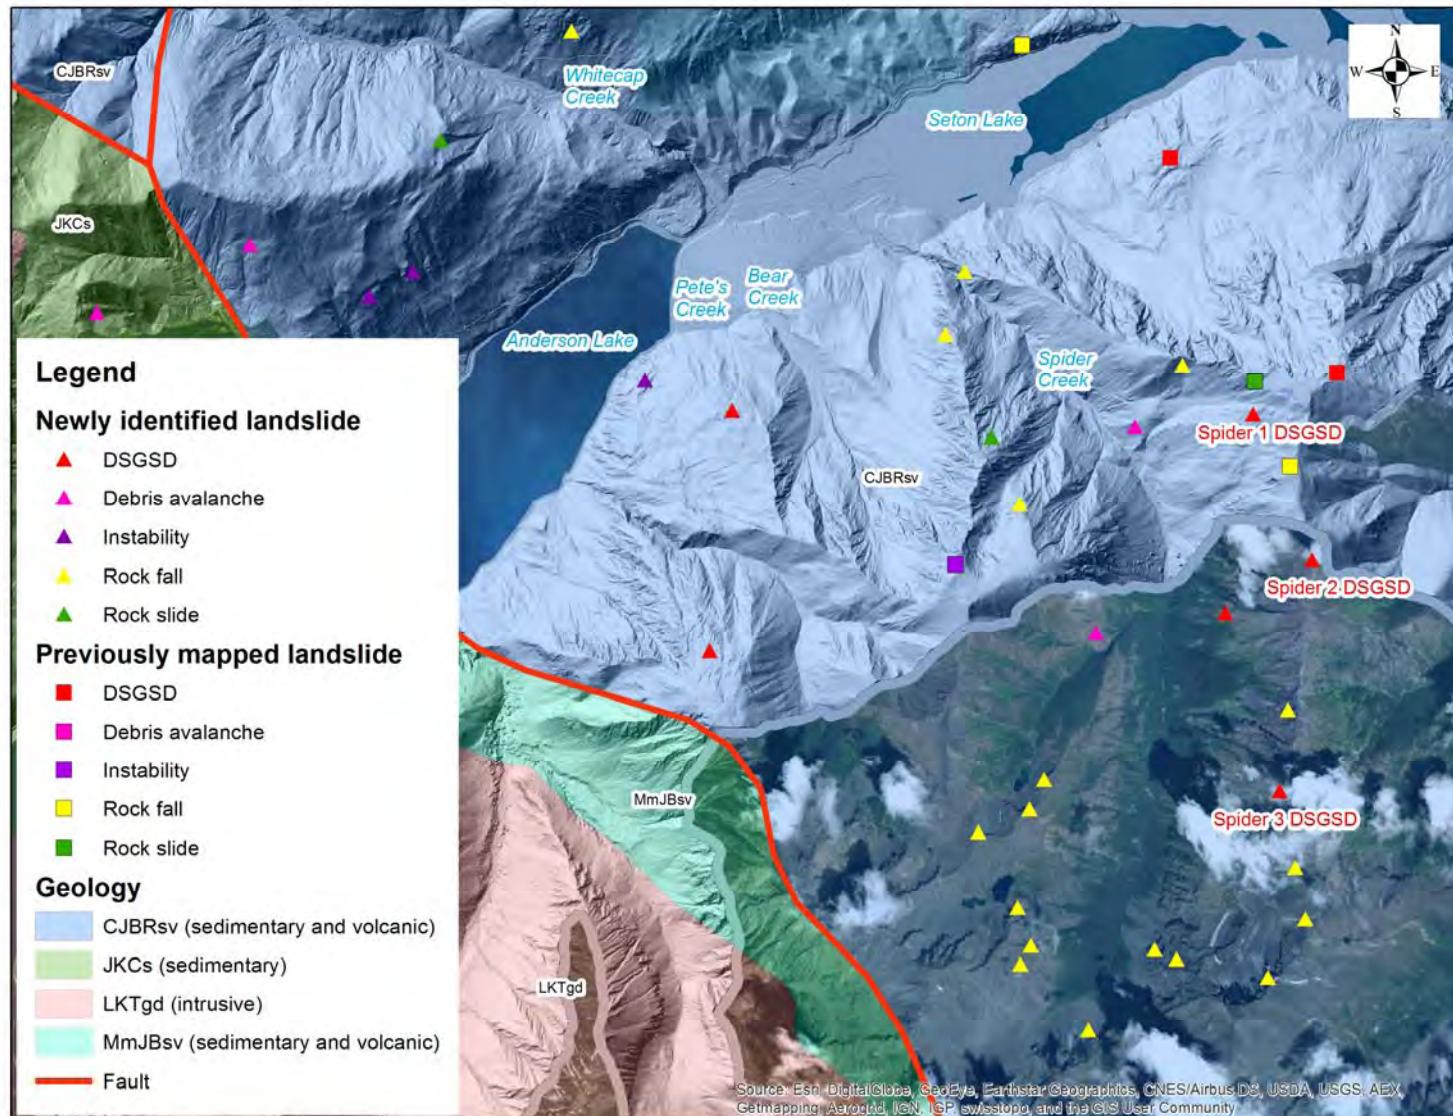
**Figure 2-16. Geology and rock slope failure inventory (discussed in Section 2.4.2) in the eastern part of the study area.**

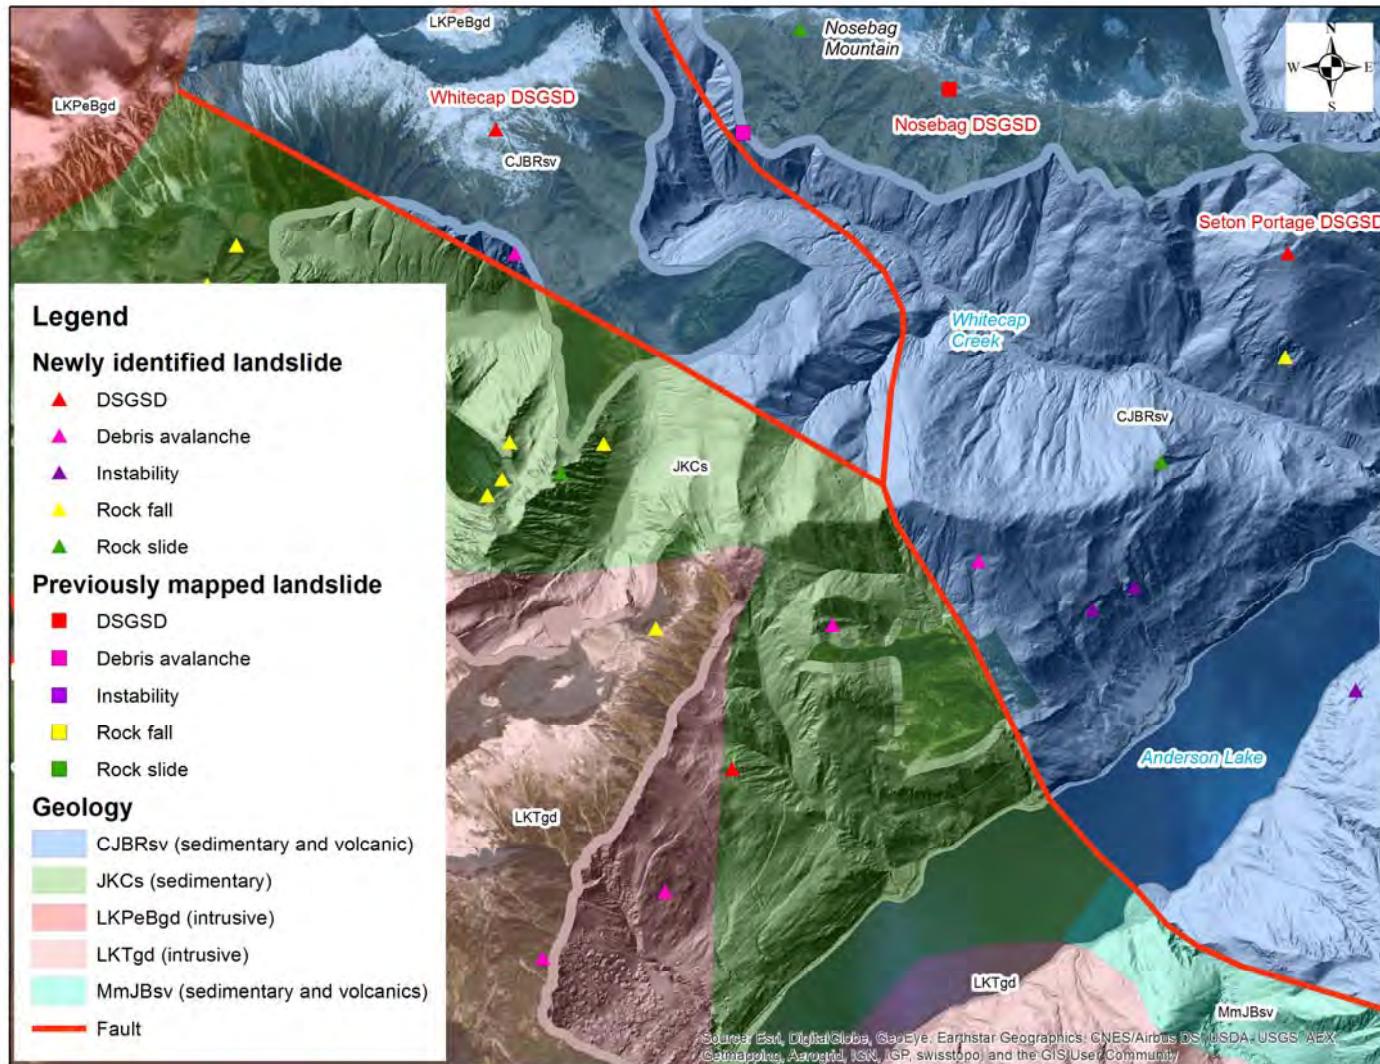
**Figure 2-17. Geology and rock slope failure inventory in the western part of the study area for previously and newly mapped landslides (Baldeon Vera 2014)**

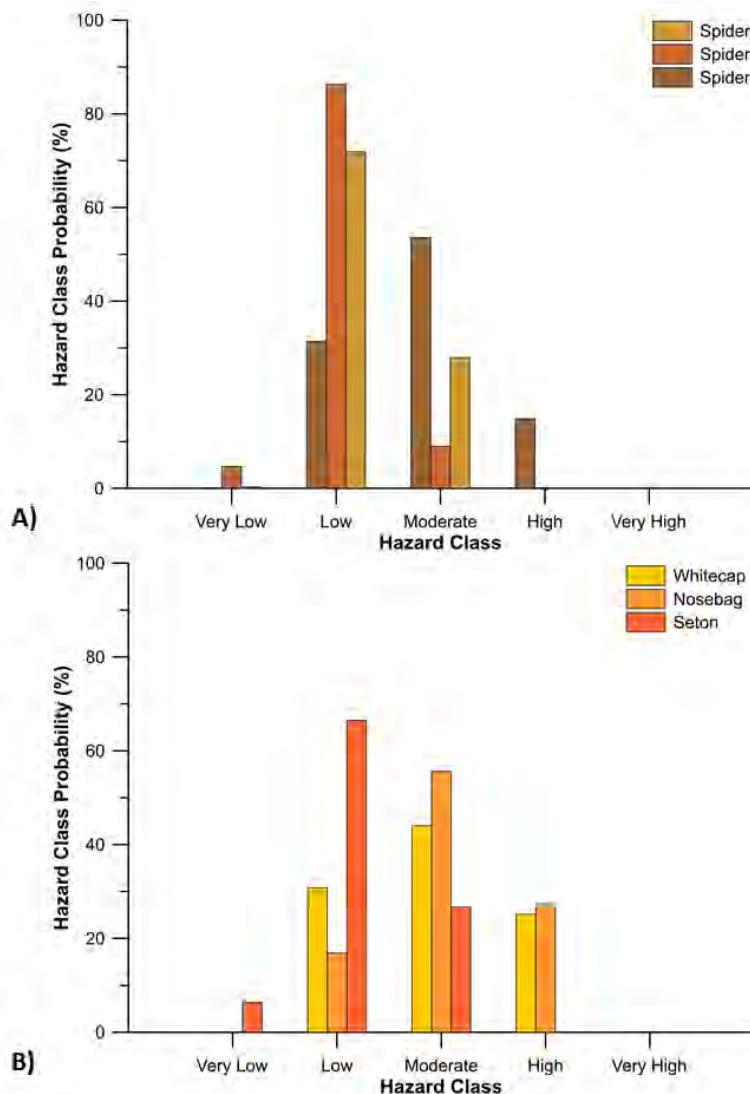
**Figure 2-18.** Summary of the hazard classification based on the Hermanns et al (2012) methodology for the A) eastern zone and B) western zone. The sum of the hazard class for a given DSGSD feature adds up to 100%. For the example Nosebag DSGSD has a 17% probability of being a low hazard feature, 56% of being a moderate hazard feature and 27% of being a high hazard feature.

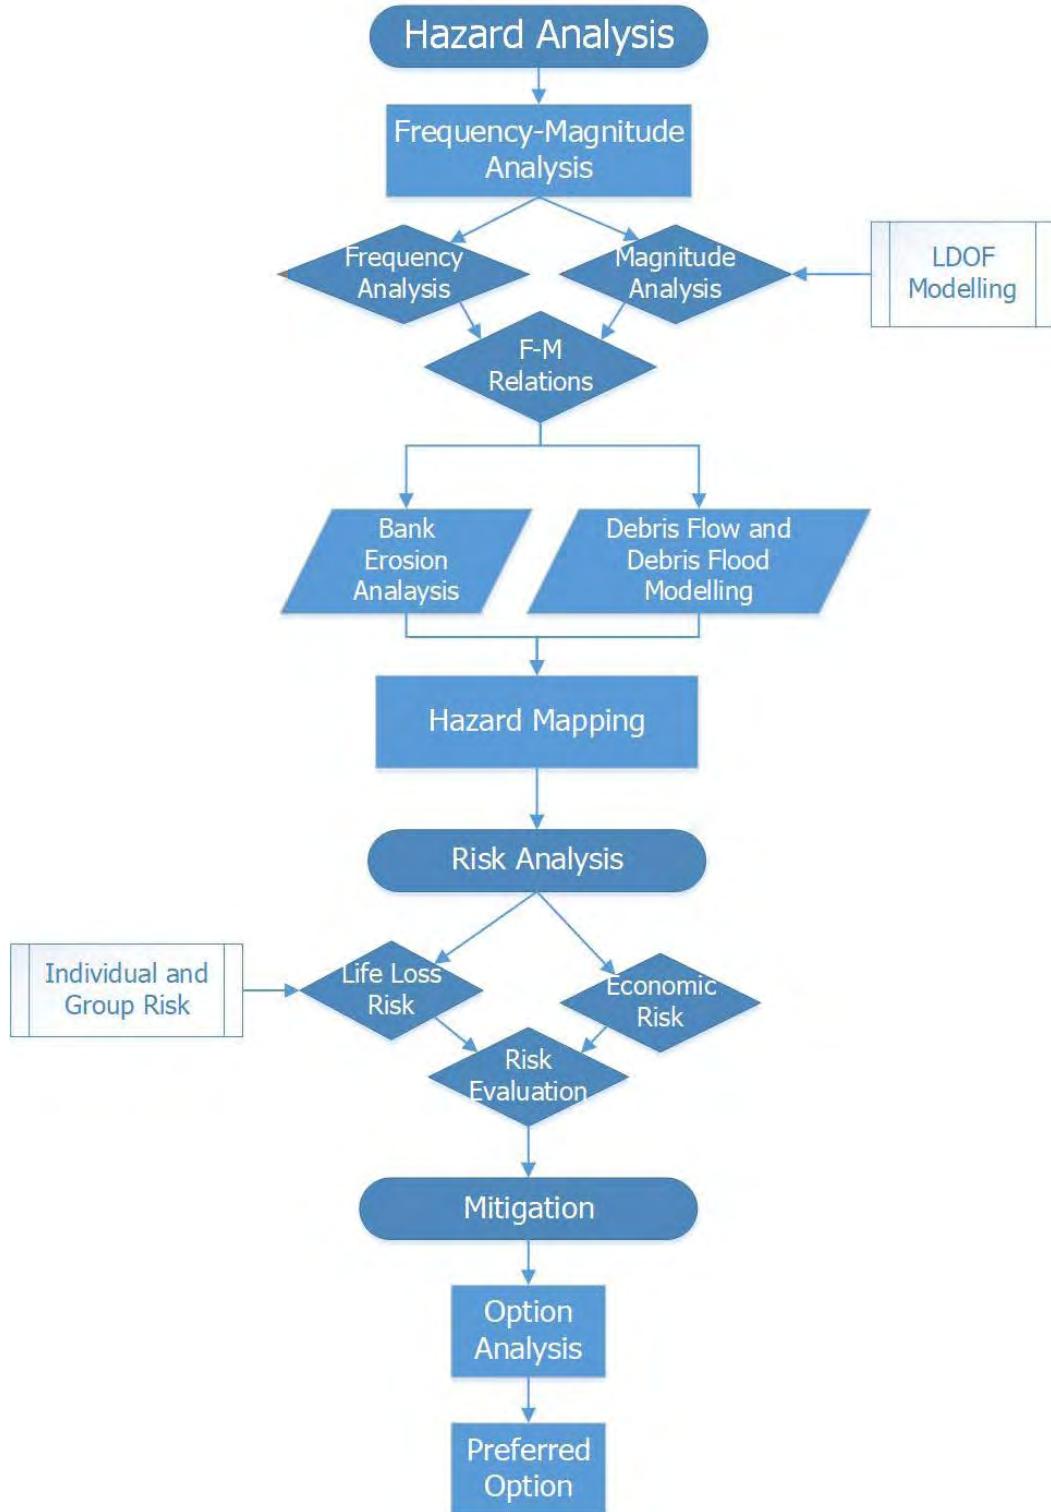
**Figure 3-1. Flow chart of the work steps required to arrives at a suitable mitigation option to reduce geohazard risk.**

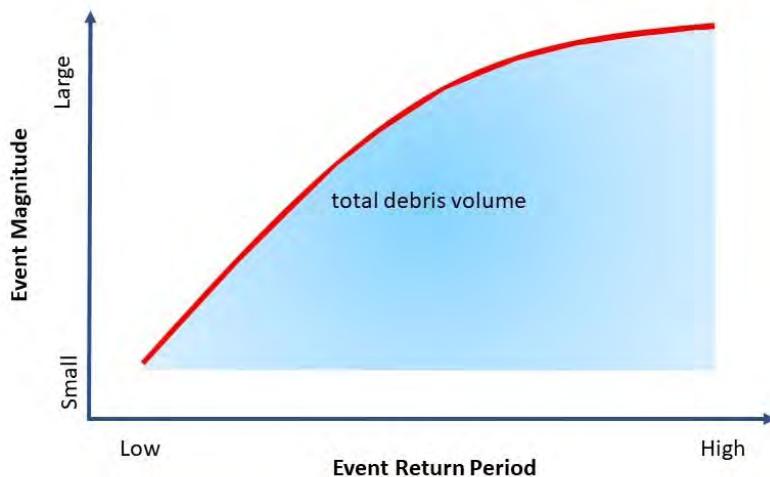
**Figure 3-2.** Conceptual frequency-magnitude curve. The area underneath the graph (shaded in blue provides the entire volume of the hydrogeomorphic event during the time period of interest)

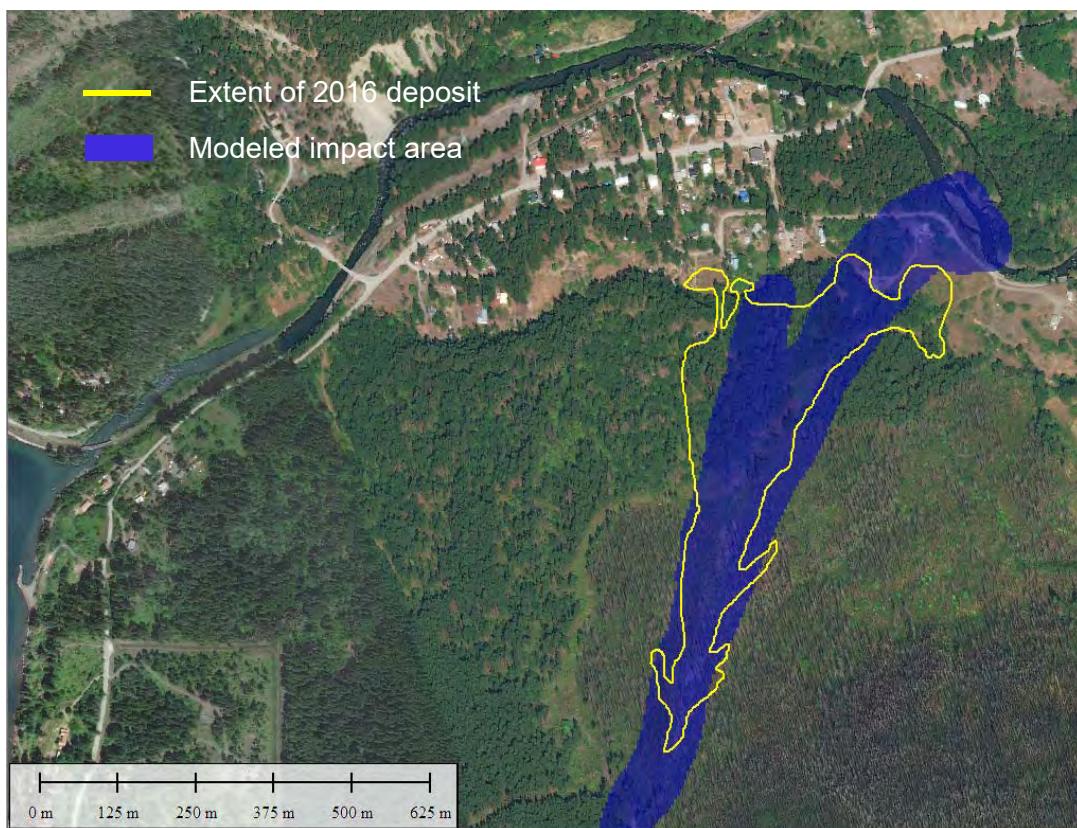
**Figure 3-4. Observed 2016 deposit and modelled impact area.**

The model geometry was generated from the 2017 LiDAR data. Debris entrainment was allowed to occur within the transport zone above the fan apex. The model rheology and flow resistance parameters were calibrated by matching the observed event volume, runout distance, and impacted area resulting from the 2016 Bear Creek event. The observed deposit compared to the modelled impacted area on the Bear Creek fan is shown in Figure 3-4. Structural damage observations were also used to check the velocity at the edge of the Bear Creek fan.

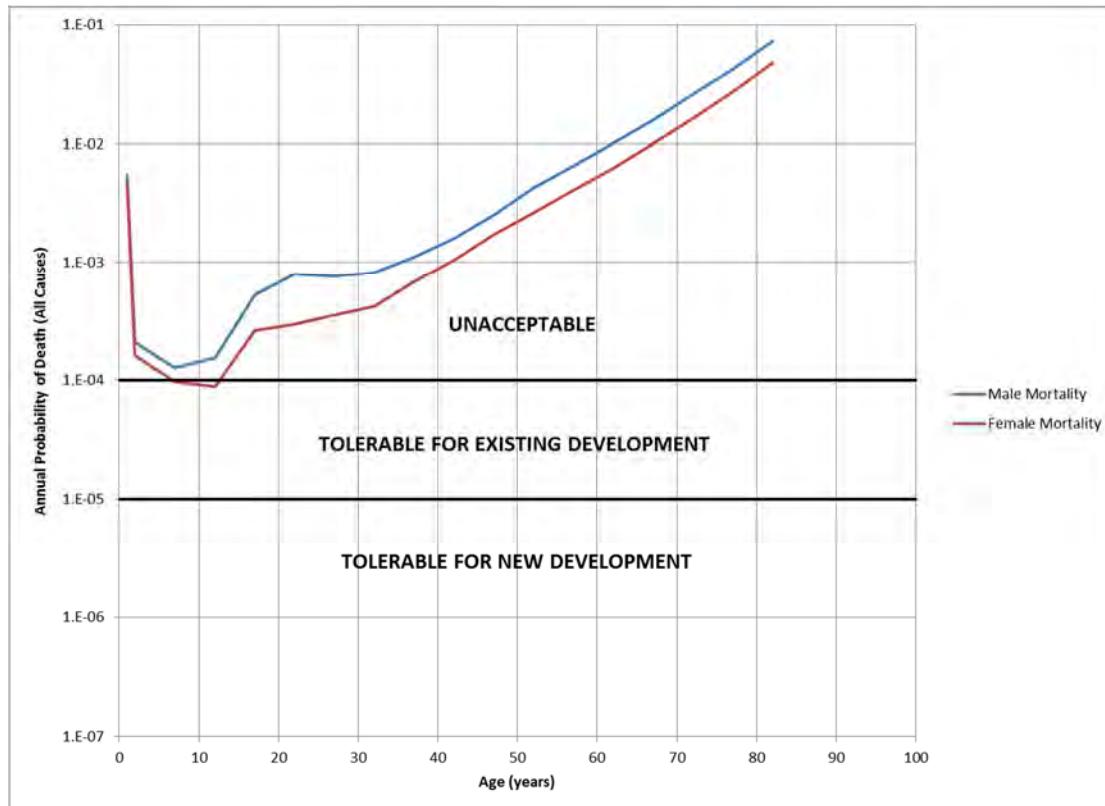
**Figure 3-6. DNV individual risk tolerance criteria for landslides compared with Canadian mortality rates (all causes) in 2008.**

For context, the DNV risk tolerance threshold of  $10^{-4}$  (1/10,000) for existing development is comparable to the lowest background risk of death that Canadians face, on average, throughout their lives. This tolerance threshold is also similar to the average Canadian's annual risk of death due to motor vehicle accidents, 1/12,500, for the year 2008 (Statistics Canada 2009).

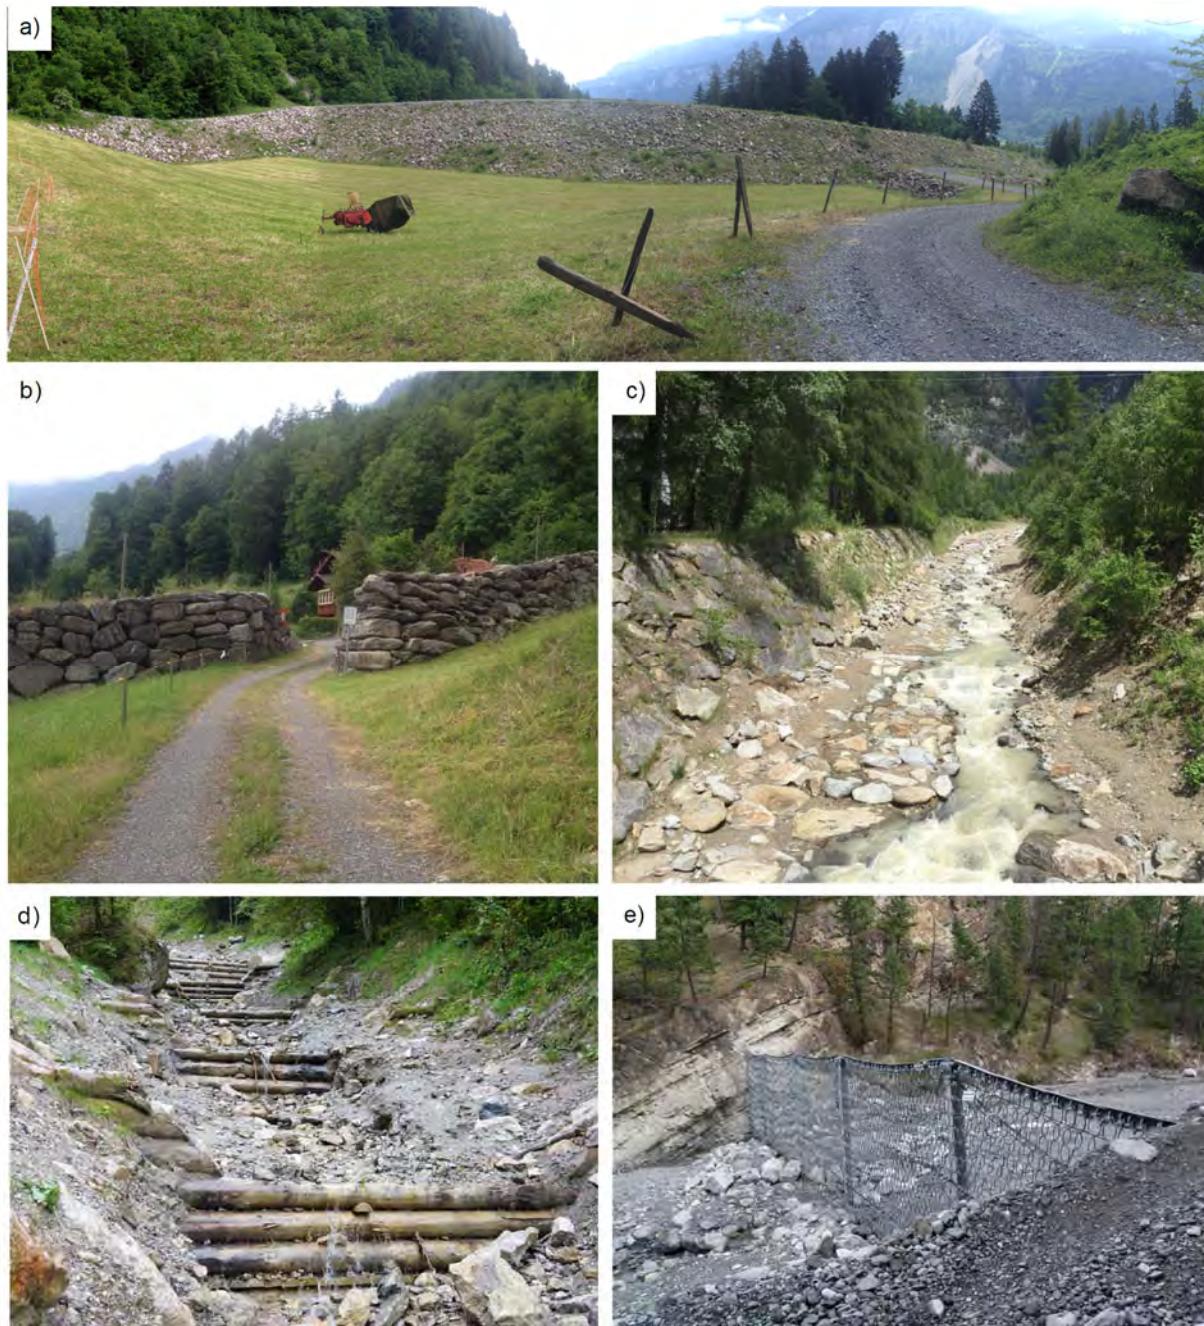
**Figure 3-8. Examples of debris-flow mitigation structures: (a) an earth-fill retention berm on Glyssibach, Brienz, Switzerland; (b) a stone diversion berm, Trachtbach, Brienz, Switzerland; (c) a conveyance channel with earthfill berms, Rennebach, Austria; (d) log crib check dams, Gesäuse, Austria; and (e) a flexible debris net for debris flood mitigation, Cougar Creek, Canmore, Alberta. Photograph (d) by M. Jakob, other photographs by E. Moase.**

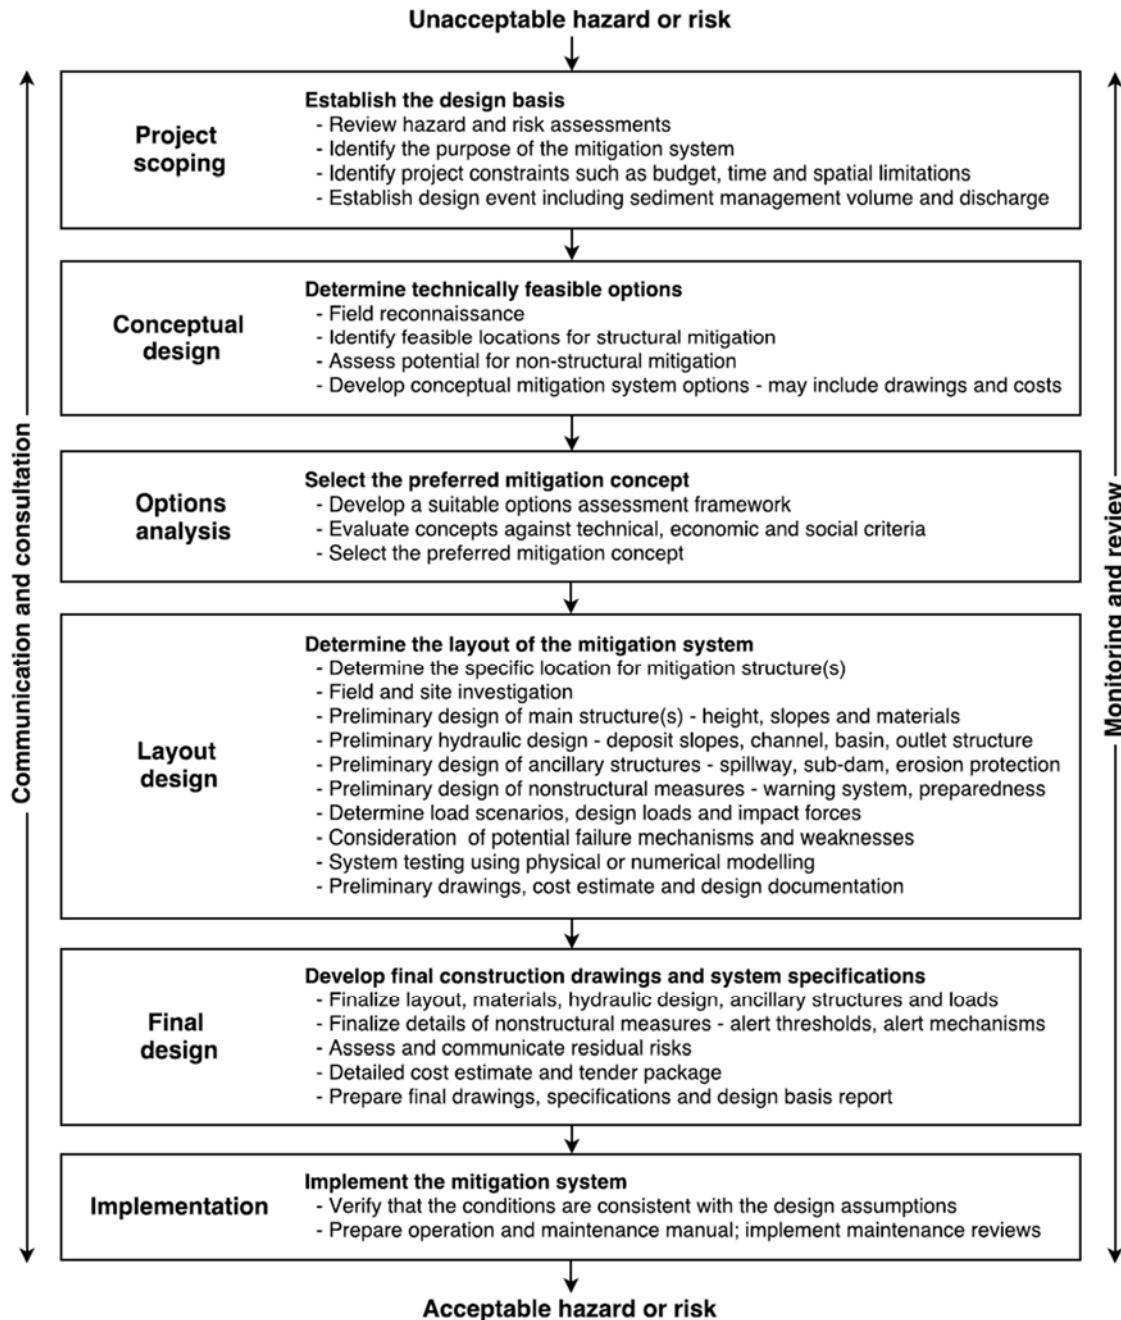
**Figure 3-9.** Recommended mitigation design approach (from Moase et al. 2017). This study included all of the first three phases and aspects of the Layout design phase.

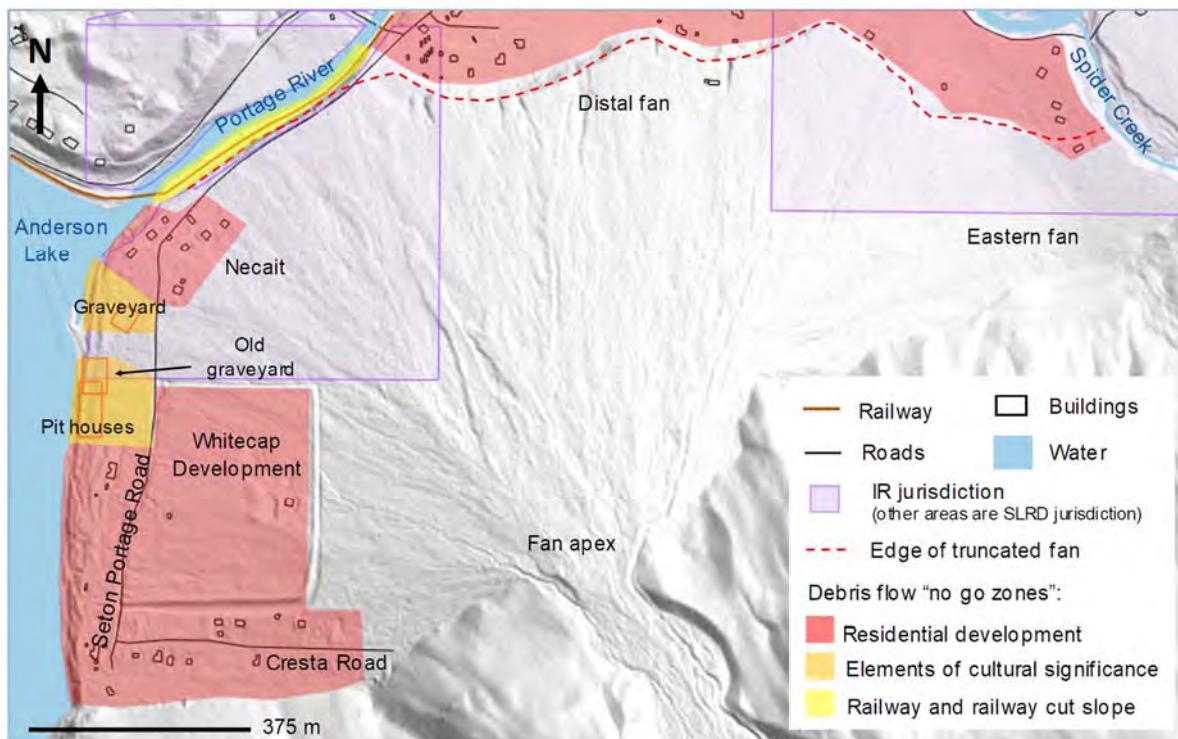
**Figure 4-3.** Overview map of the Bear and Pete's creeks fan showing elements at risk. The proposed mitigation options aim to prevent debris flows from entering the “no go zones” shaded in red, orange and purple.

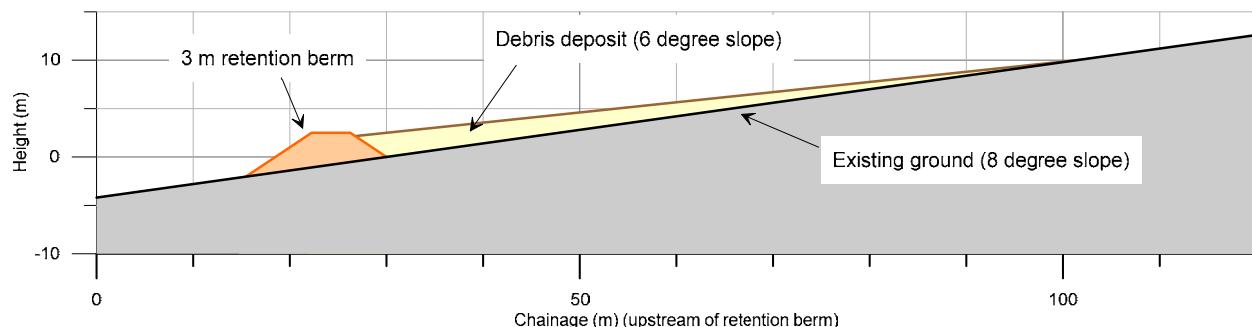
**Figure 4-7. Cross-section of the Option 3 distal berm and excavation.**

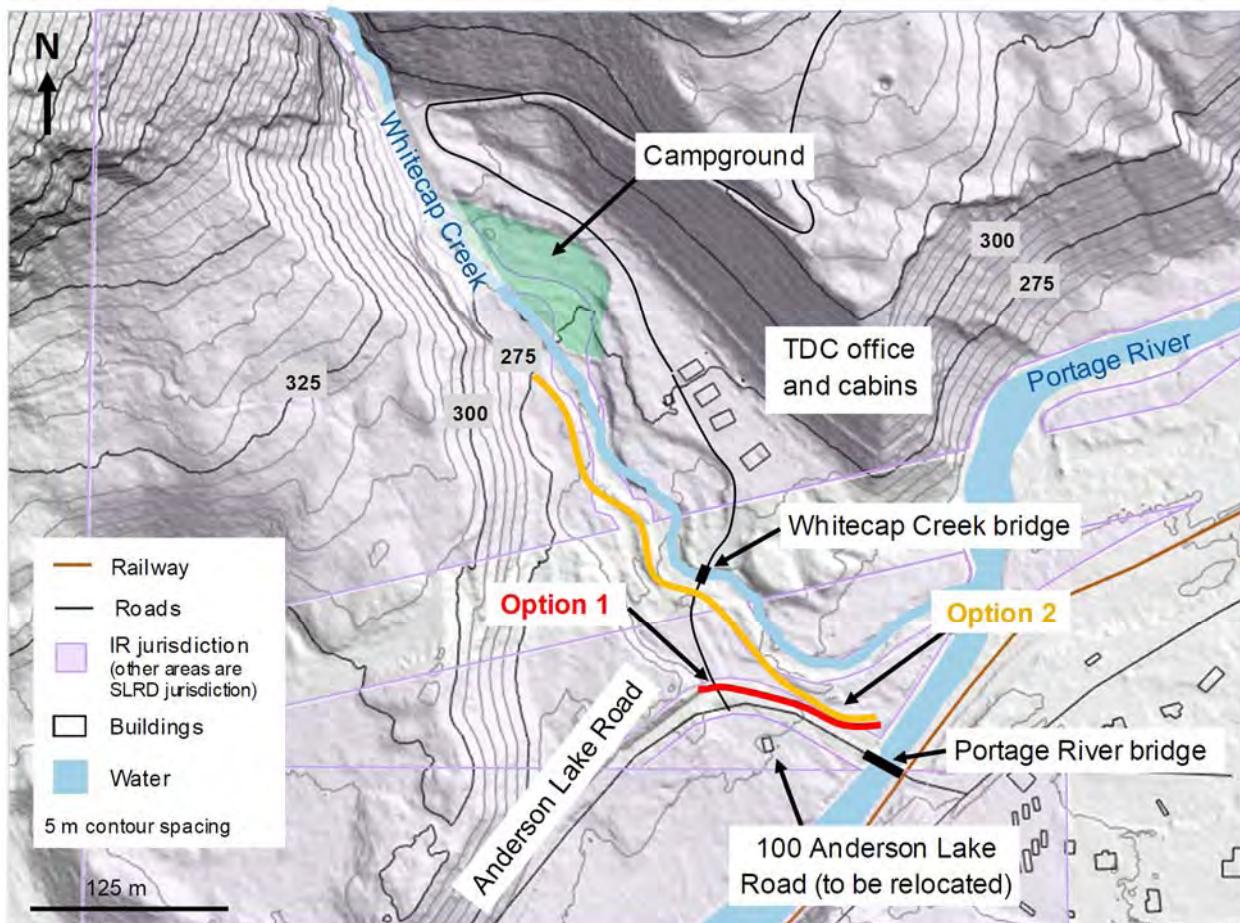
**Figure 5-1.** Whitecap Creek mitigation options including a short berm along the road (red) or a longer berm that prevents against avulsions (orange).

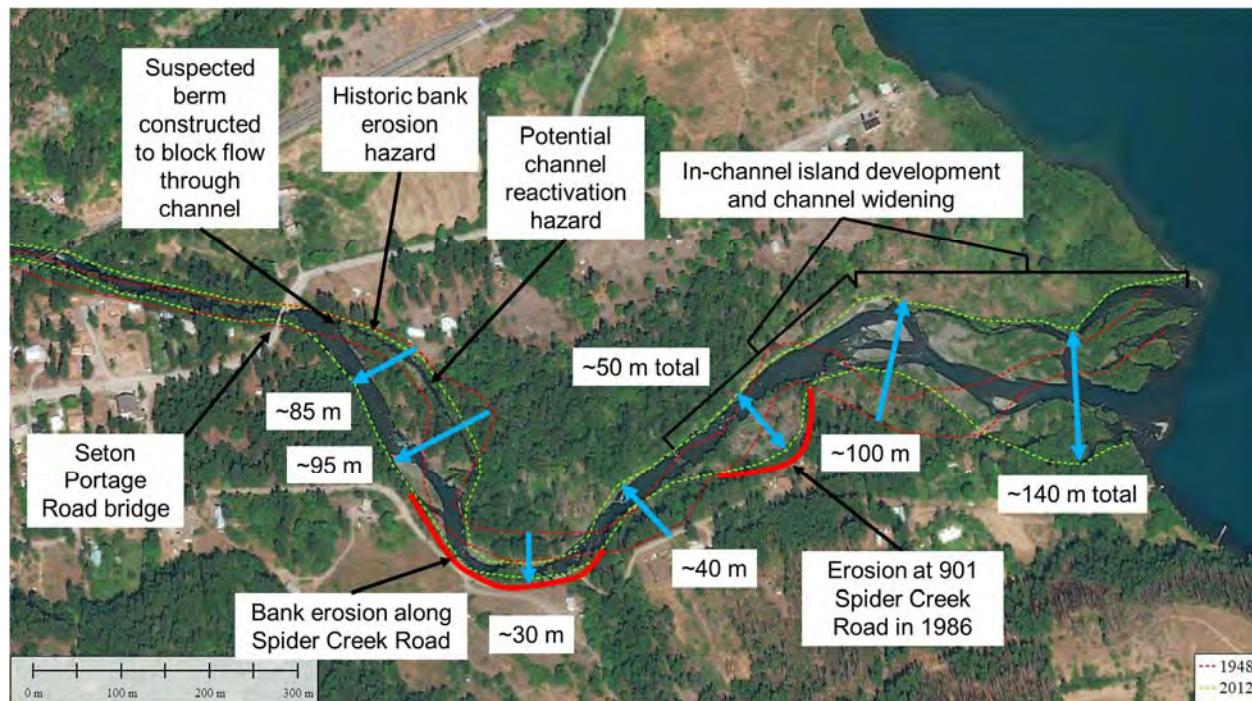
**Figure 7-1.** Portage River hazards near the mouth at Seton Lake. Blue lines represent total bank movement between the 1948 air photo (red dashed line) and the 2012 satellite image (green dashed line). The solid red lines represent areas of bank erosion hazard adjacent to Spider Creek Road and the 901 Spider Creek Road house. The background is a 2012 satellite image.

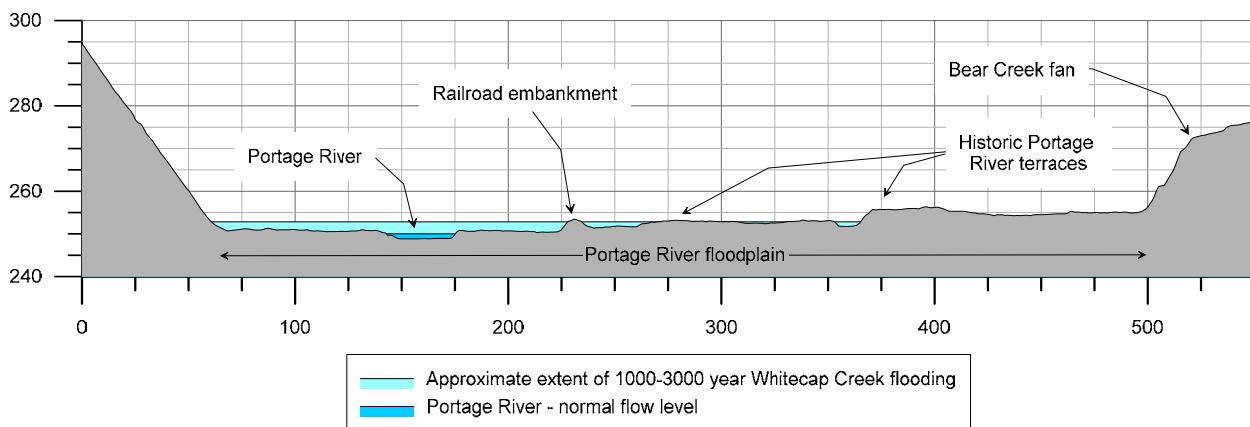
**Figure 7-2. Cross-section through the Portage River floodplain about 350 m downstream of the Whitecap Creek confluence (2x vertical exaggeration).**
