## **SQUAMISH-LILLOOET REGIONAL DISTRICT**

### **SETON PORTAGE AREA INTEGRATED HYDROGEOMORPHIC RISK ASSESSMENT**

**FINAL**

PROJECT NO.:	1358005	DISTRIBUTION:	
DATE:	April 6, 2018	SLRD:	digital copy
		BGC:	digital copy

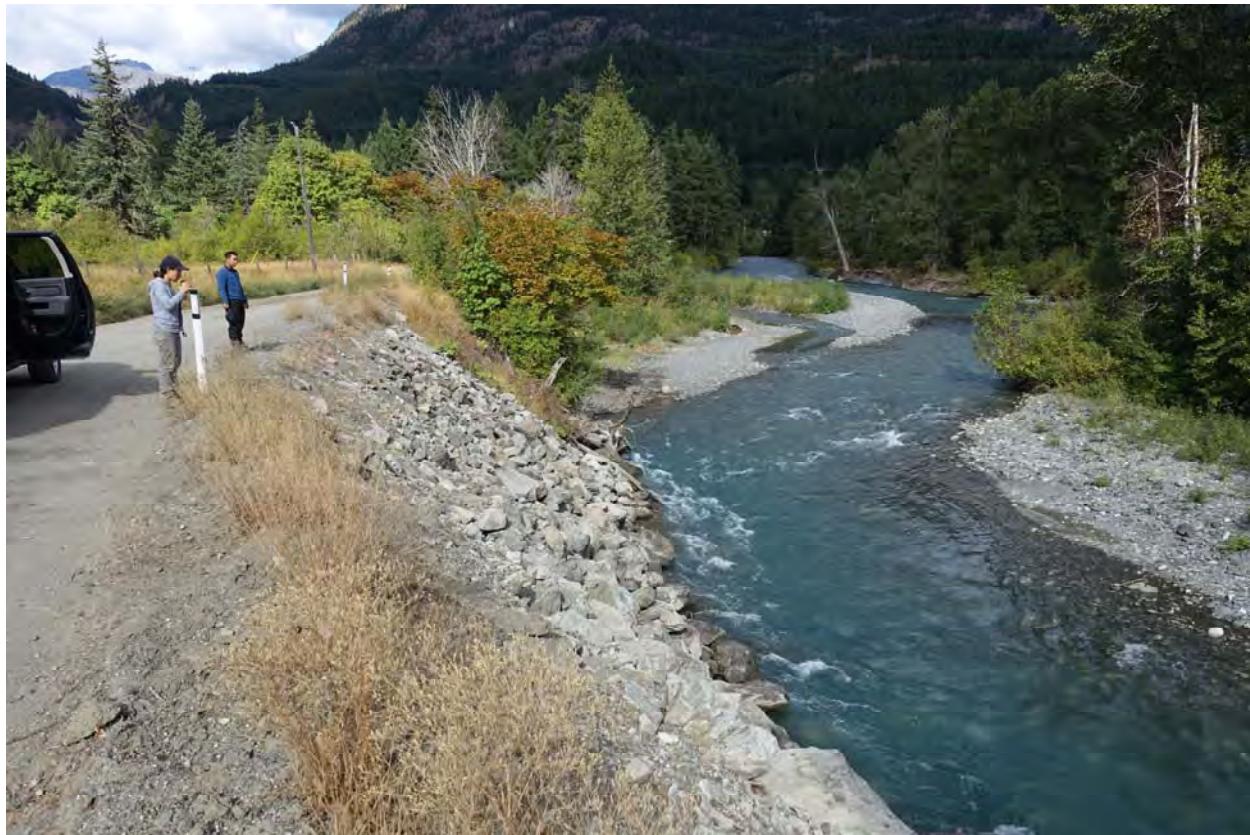
**Figure 7-3. Bank erosion at Spider Creek Road. Photo by BGC dated September 13, 2017.**

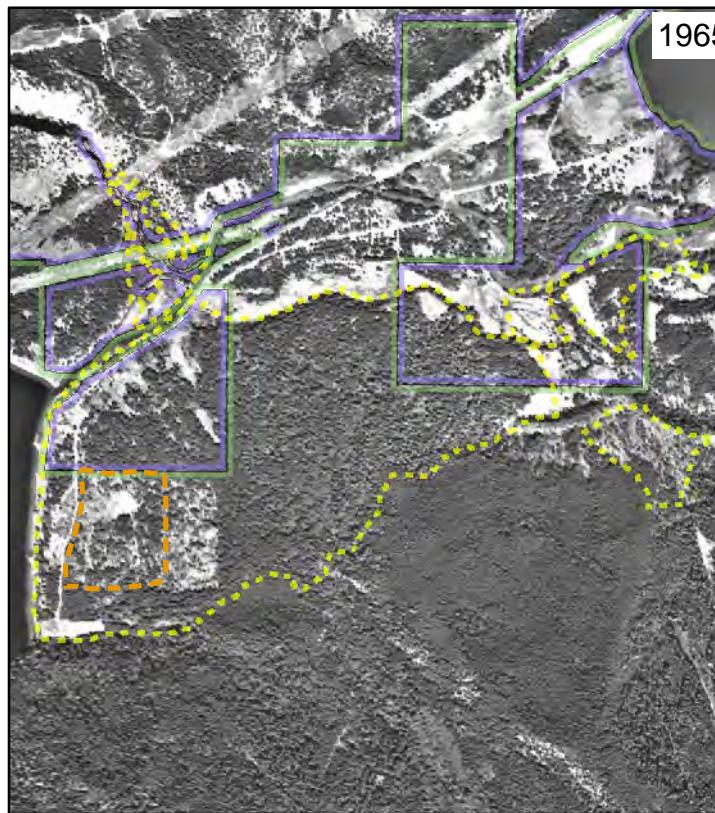
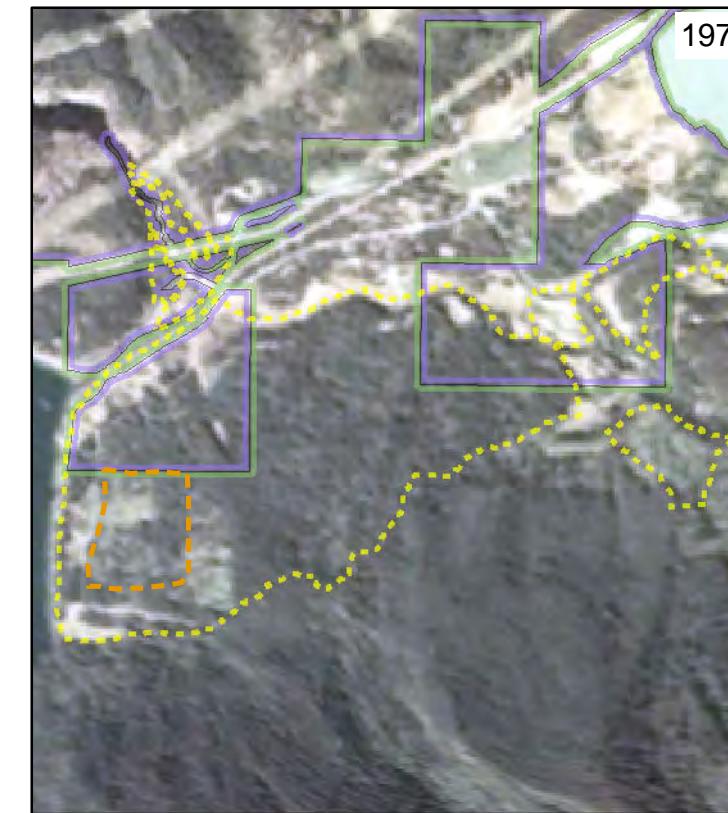
PROJECT: SETON PORTAGE AREA INTEGRATED  
HYDROGEOMORPHIC RISK ASSESSMENT  
TITLE: PORTAGE RIVER PROFILE  
PROJECT No.: 1358005 DWG No.: 06

The longitudinal profile of Portage River is shown on Drawing 06. The profile mirrors the geomorphic development of the river. From Anderson Lake to the Anderson Lake Road bridge, the river has a gradient of 0.1%. This comparatively low gradient can be attributed to the episodic sediment discharge of Whitecap Creek debris floods, which creates a back-water effect upstream. Downstream of the confluence, Portage River steepens to 1.3% on average to the railway bridge. From the railway bridge to the braided section, the gradient drops to 0.7%; the gradient at Seton Lake is 0.4%.

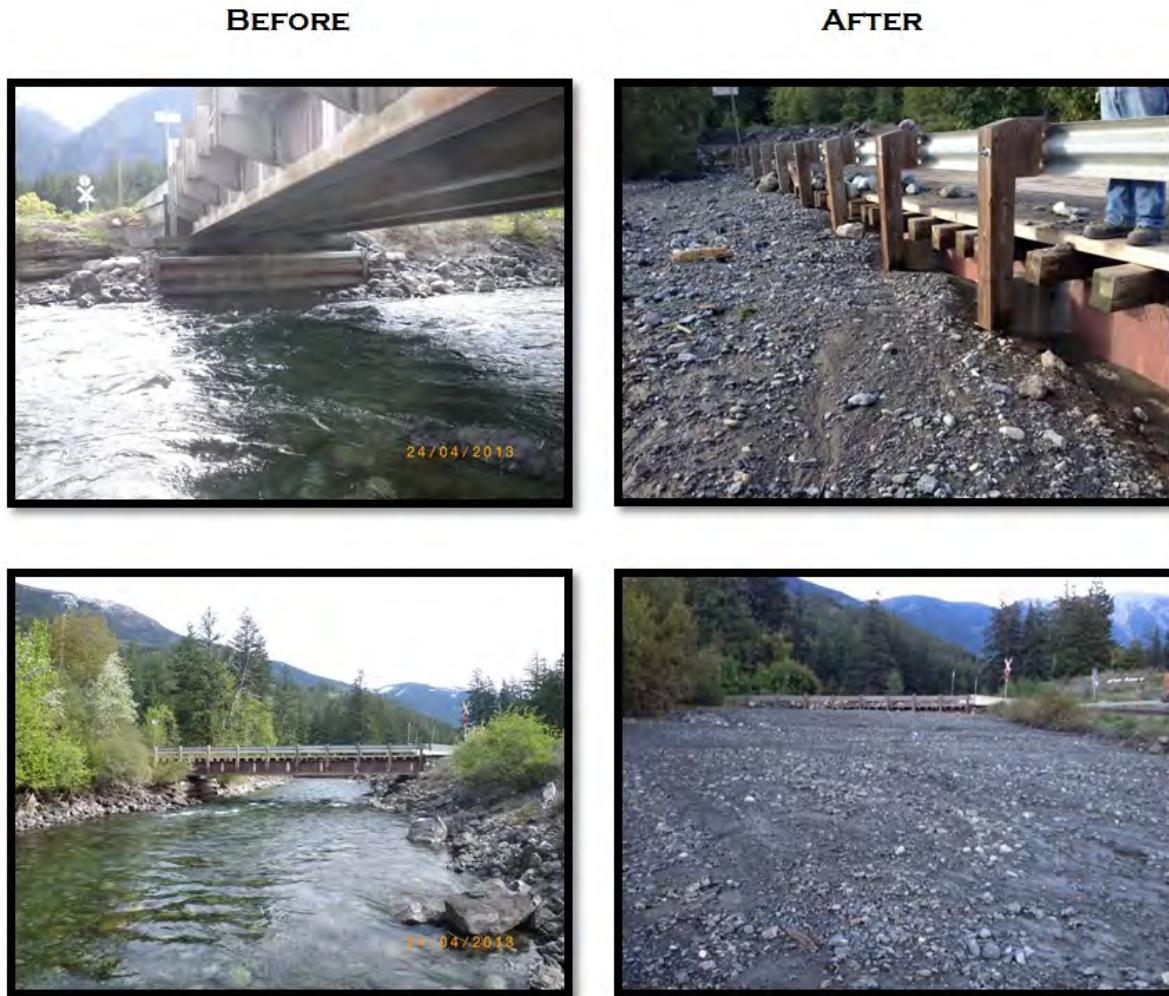
**Figure A-1. Before (left) and after (right) photos of the Seton River bridge at the base of Whitecap Creek following the 2016 event (photos provided by MOTI).**

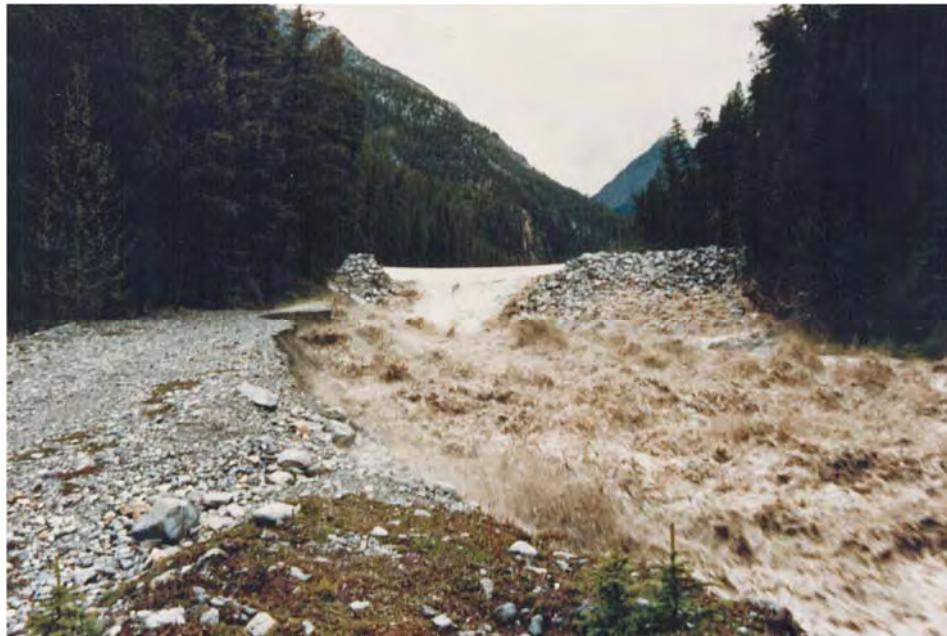
**Photograph B-1.** Example of the failure of a human-made dam on Cougar Creek shortly after the breach initiated. May 25, 1990 (Alberta Environment 1991).

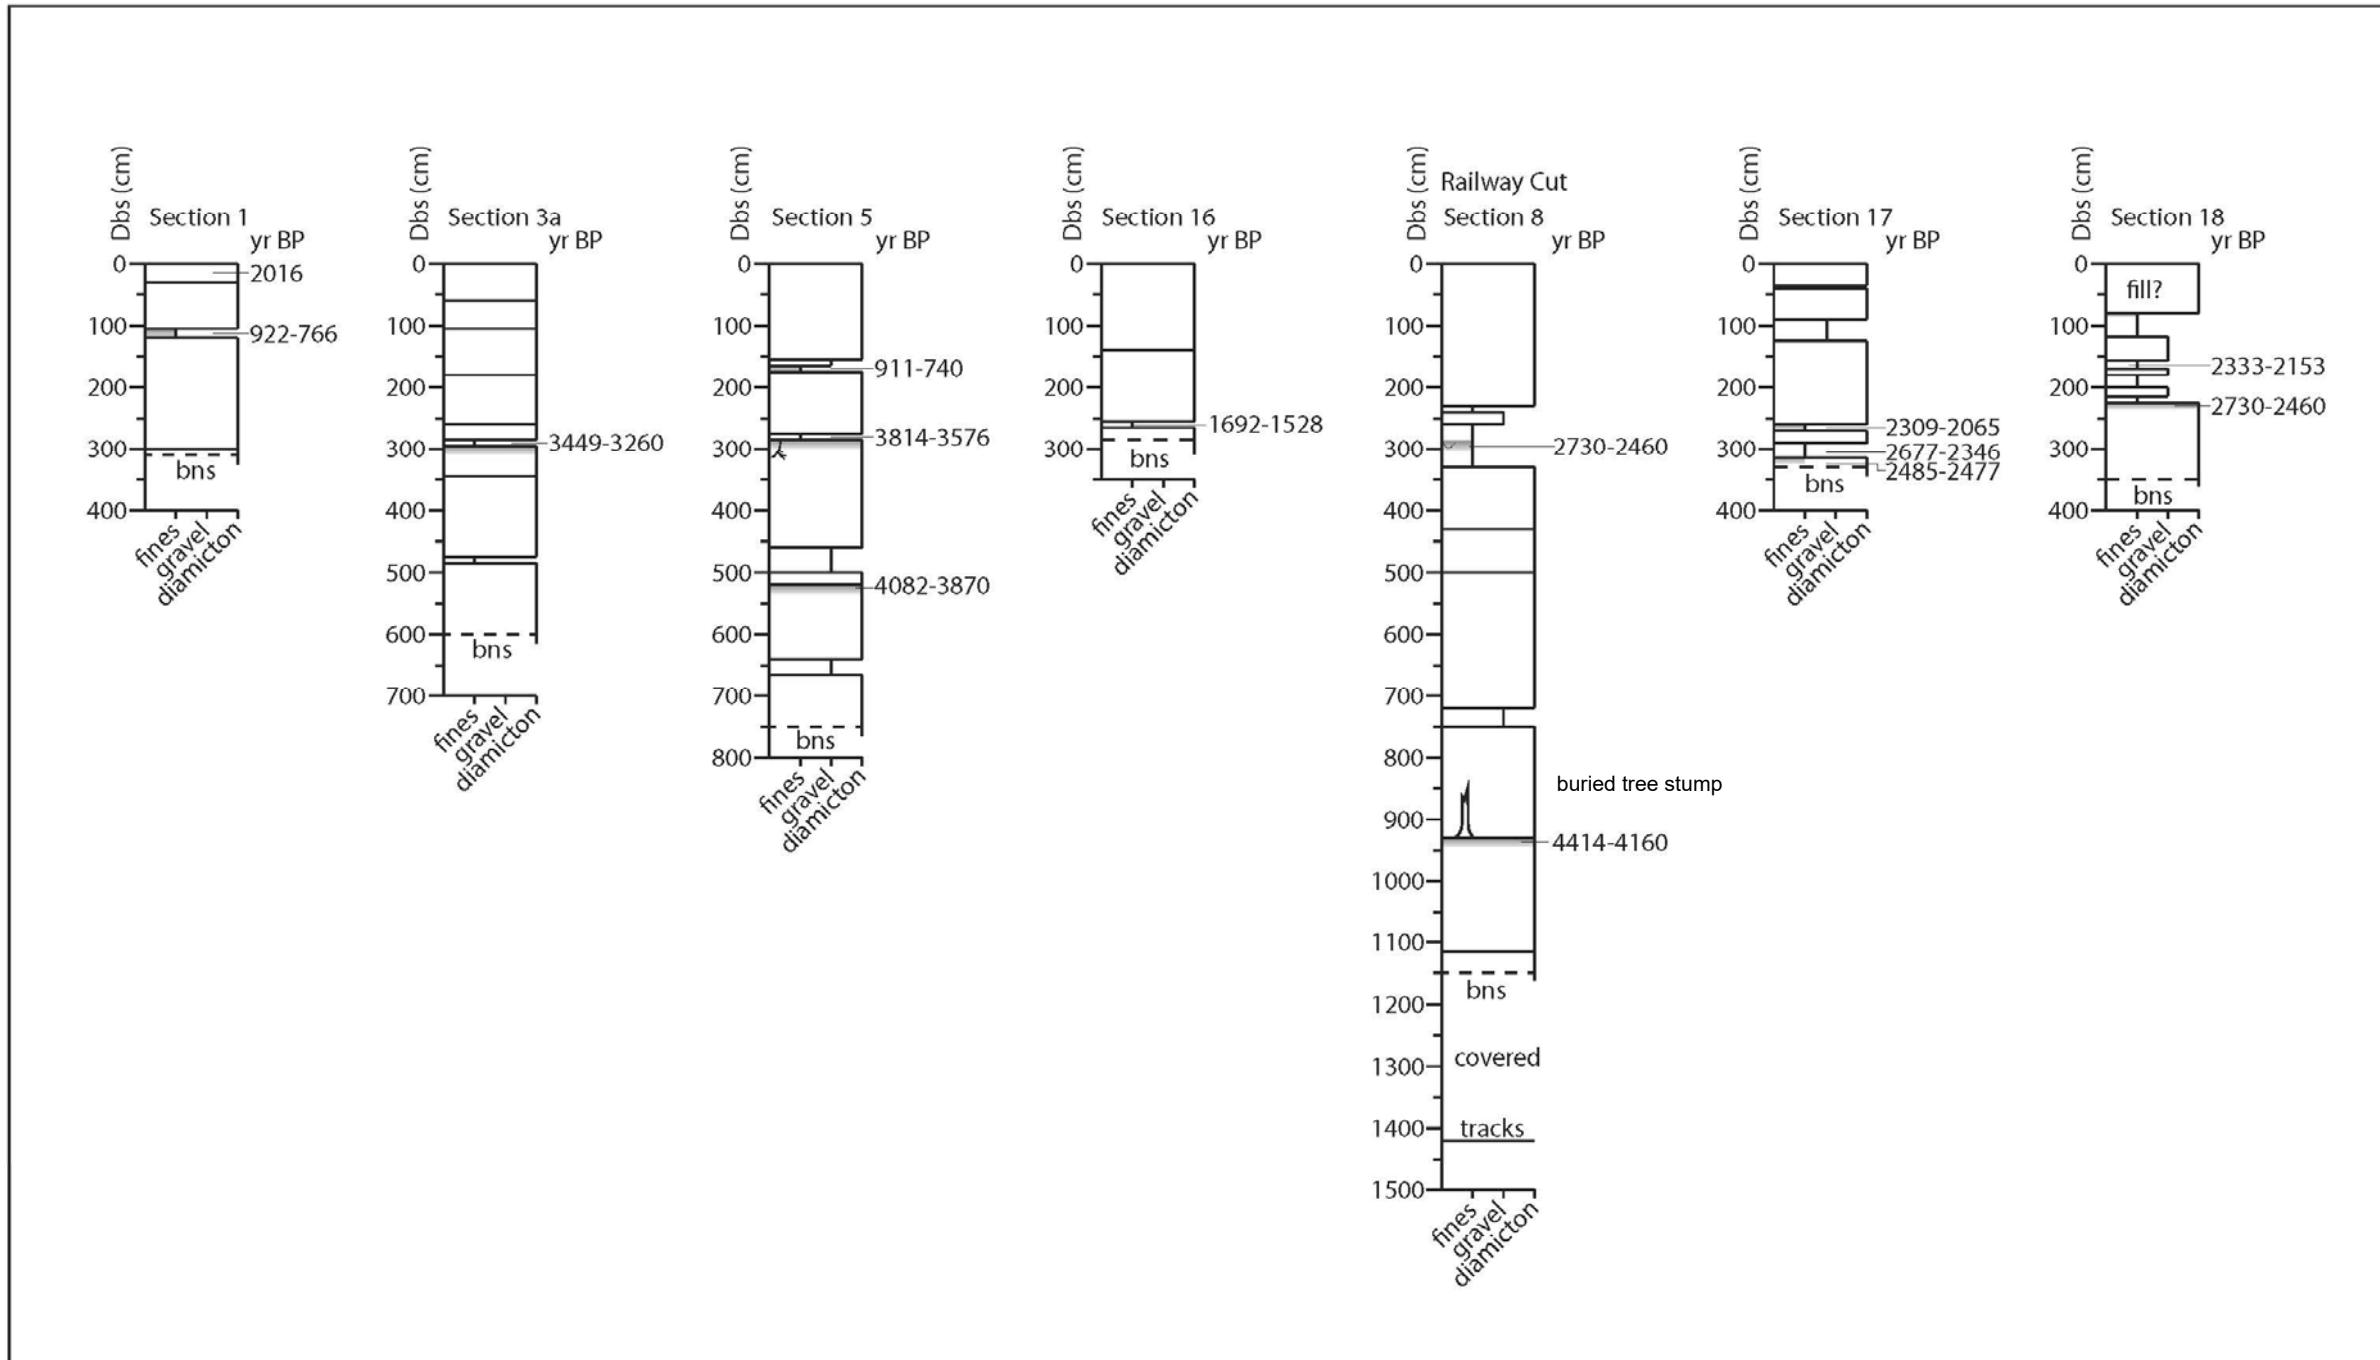
**Figure D-1.** Fence diagram for northeast to northwest distal portion of Bear/Pete's Creek fan showing  $^{14}\text{C}$  dates from test trenching at Test Pits 1, 3a, 5, 8 (railway cut), 17 and 18. Debris flow thicknesses up to 2 m were encountered. “Bns” stands for “base not seen”. Each white box represents a facies (fines, gravel, diamicton), diamicton refers to debris flow units. Dashed lines indicate ‘base not seen’.

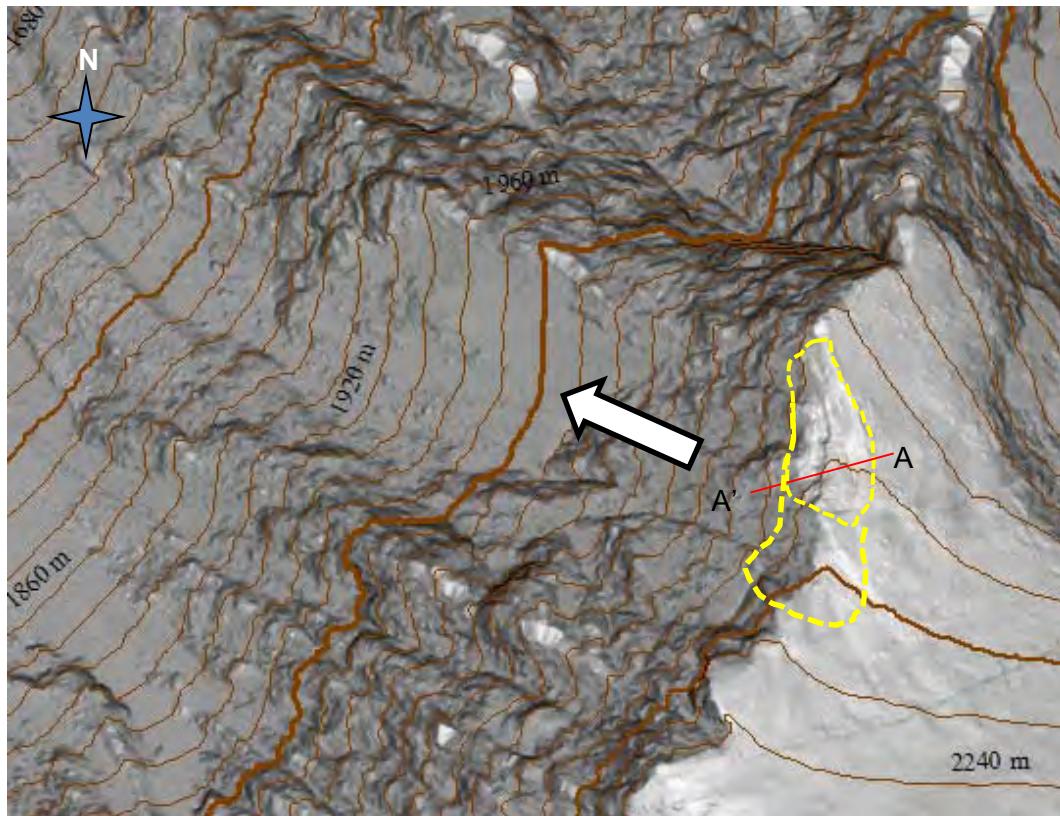
**Figure D-2. Potential rock slide sources for debris-flow initiation in the upper Bear Creek watershed at approximately 2190 m elevation, delineated in yellow. Location of cross-section is shown in red.**

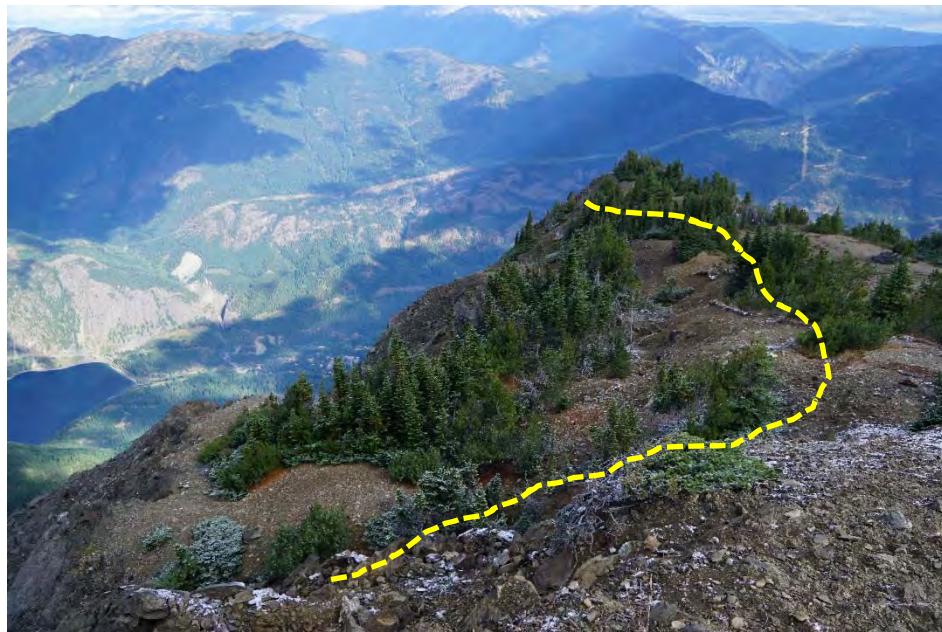
**Figure D-3.** Looking north and downslope at the top of the potential point source, delineated in yellow. Photo: BGC September 13, 2017.

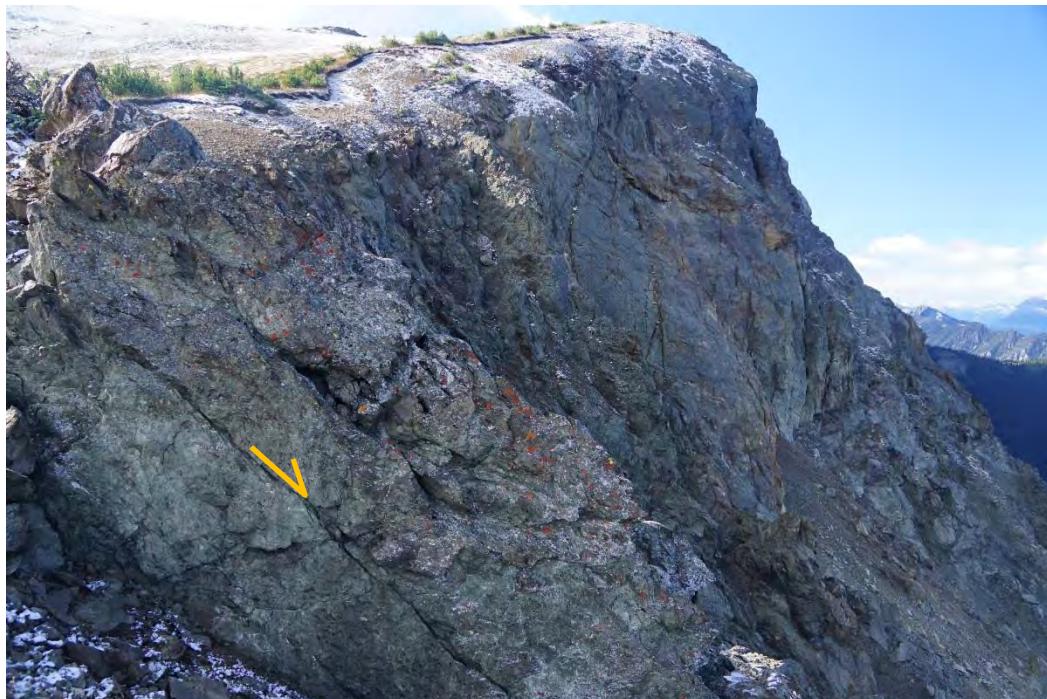
**Figure D-4.** The rock mass in the vicinity of the point source has a steeply dipping joint set ( $\sim 45^\circ$ ). Photo: BGC September 13, 2017.

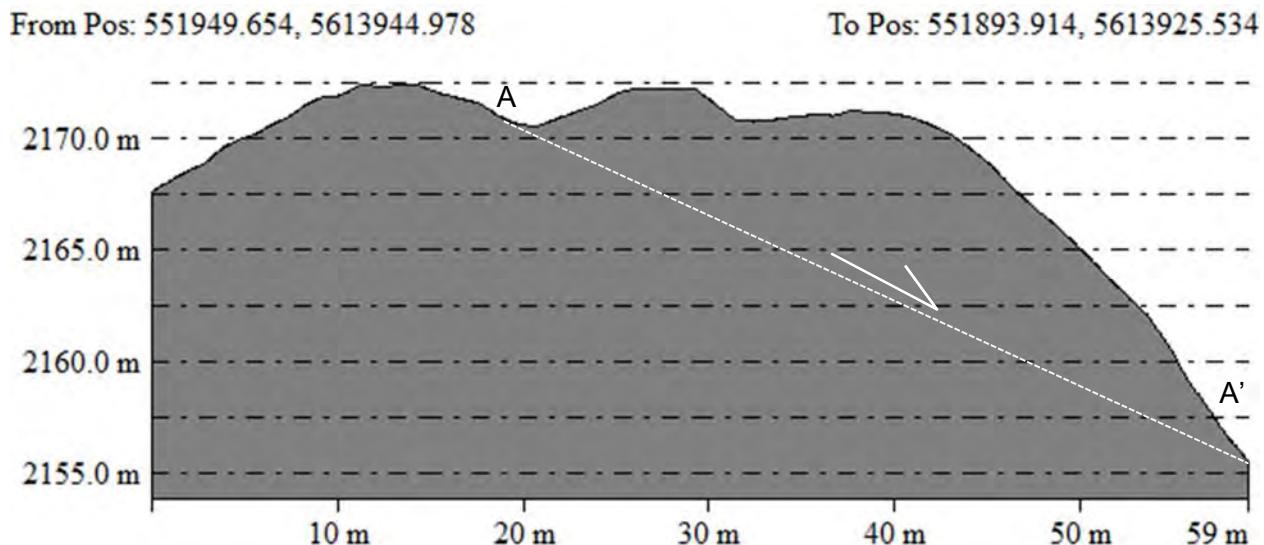
**Figure D-5. Profile through the upper rock slope shown in Figure D-2.**

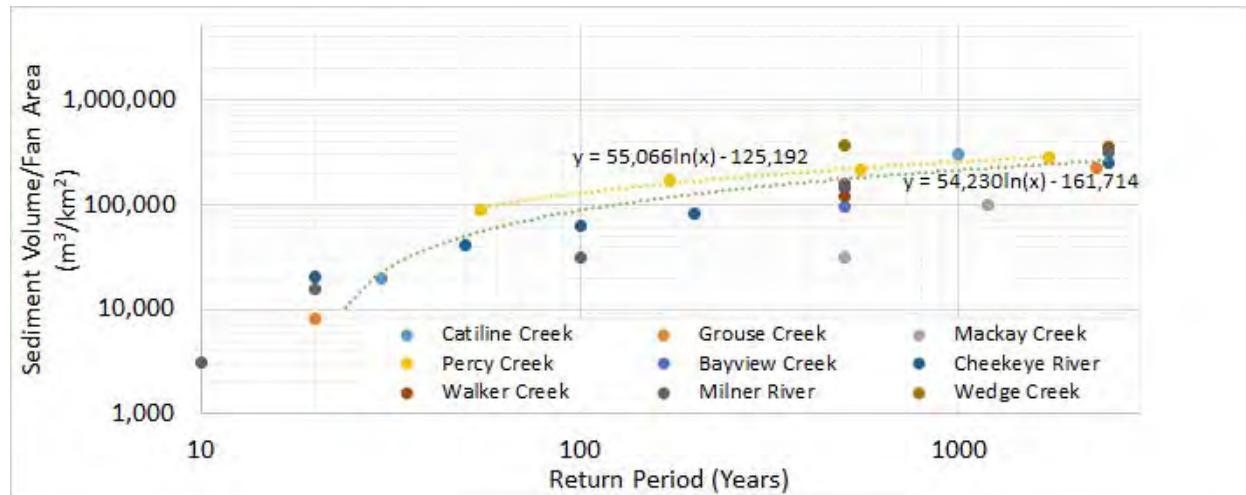
**Figure D-6.** Regional F-M relationship for debris flows in southwestern BC from Jakob et al. (2016). The green dotted line symbolizes the best fit of all creeks considered, while the yellow line shows the upper credible limit.

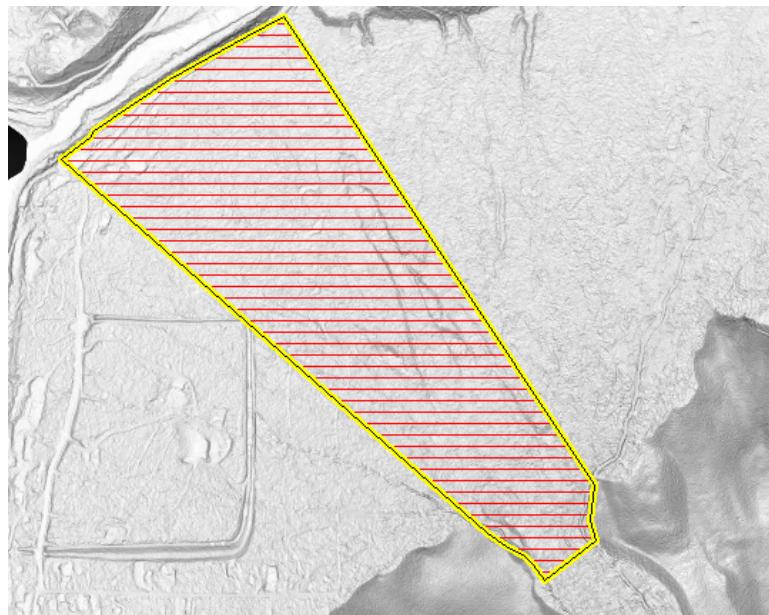
**Figure D-9.** Assumed “large” debris flow exposed in the Railroad Cut with an area of 290,000 m<sup>2</sup> and an average thickness of 1.2 m.

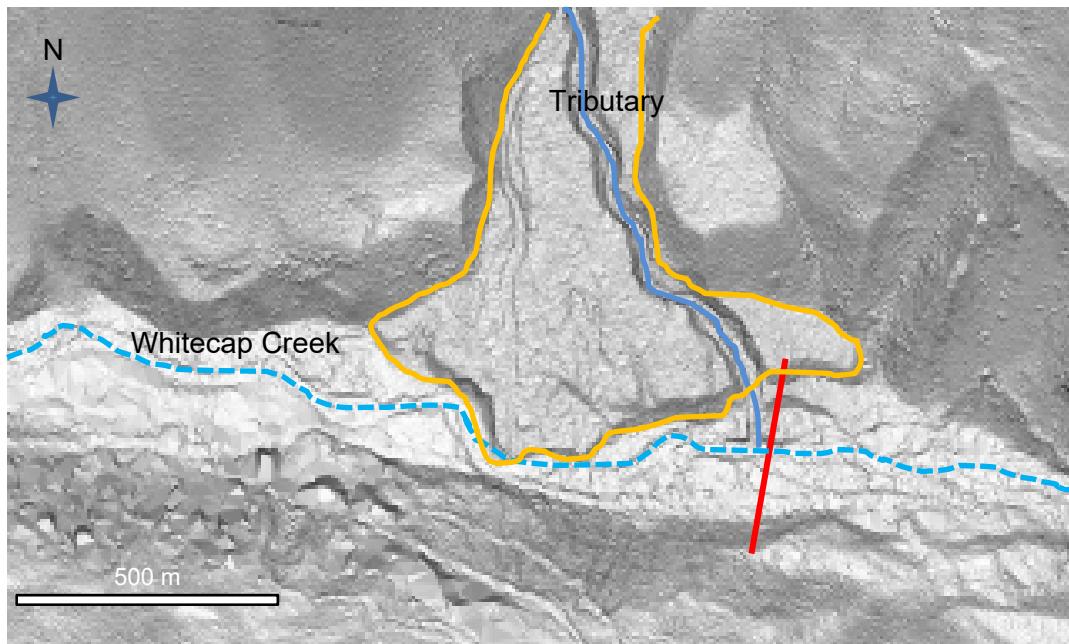
**Figure D-13. Location on Whitecap Creek where a tributary debris flow could impound the creek. The possible dam alignment is shown in red. The tributary fan (Dam 1) is outlined in orange.**

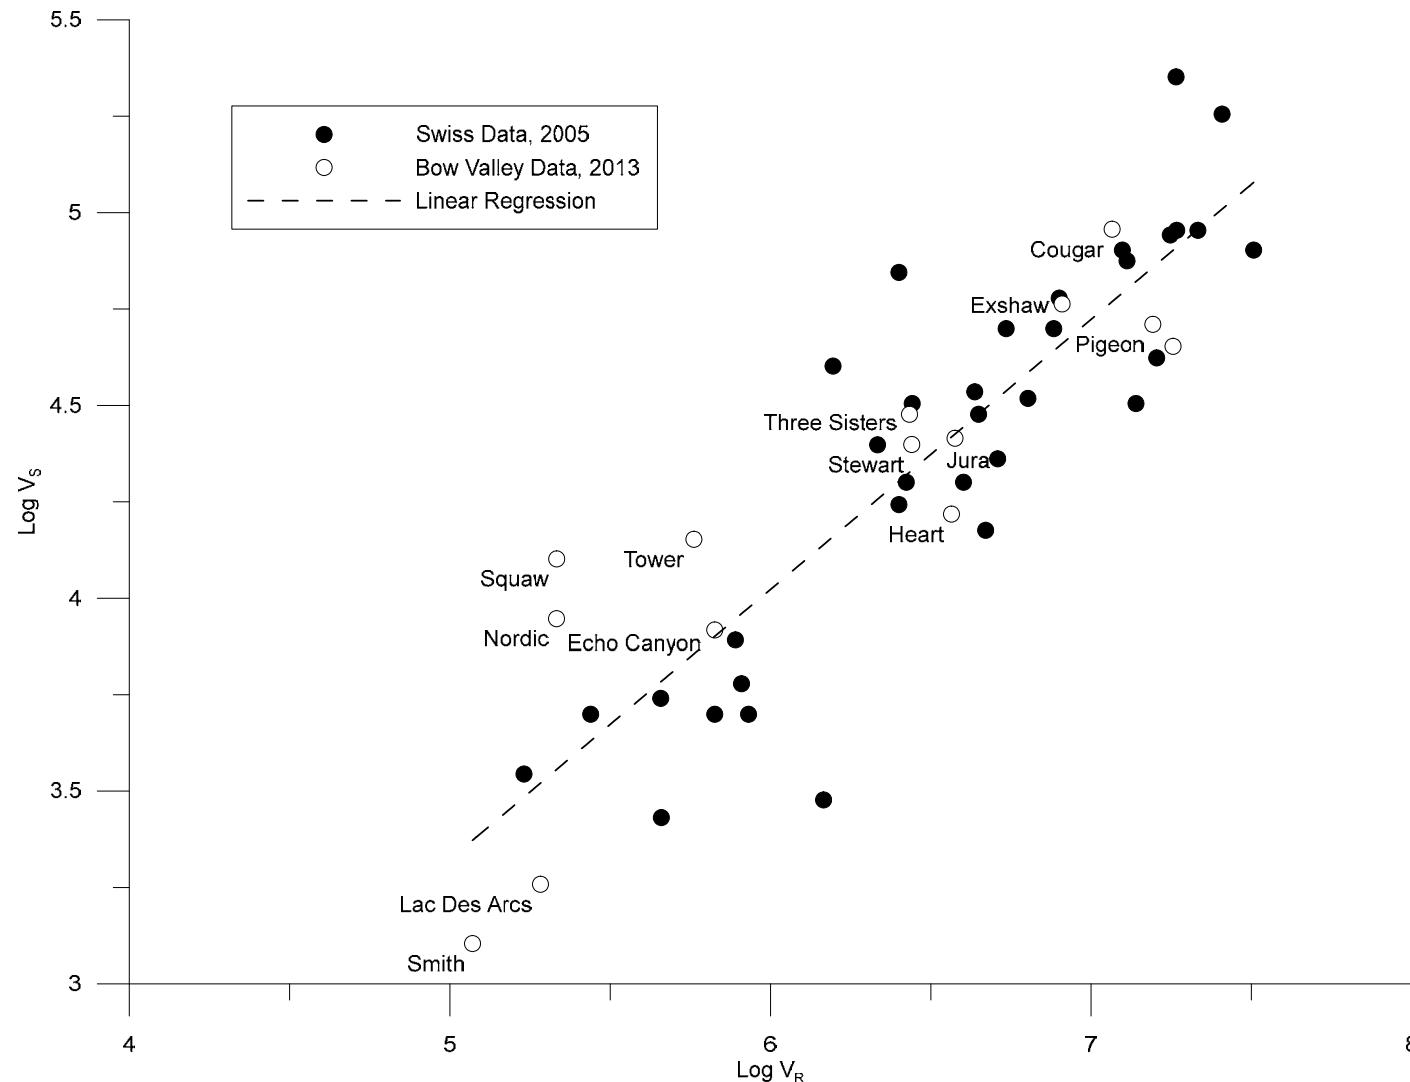
Figure D-14. Datasets complied by Rickenmann and Koschni (2010) and BGC.

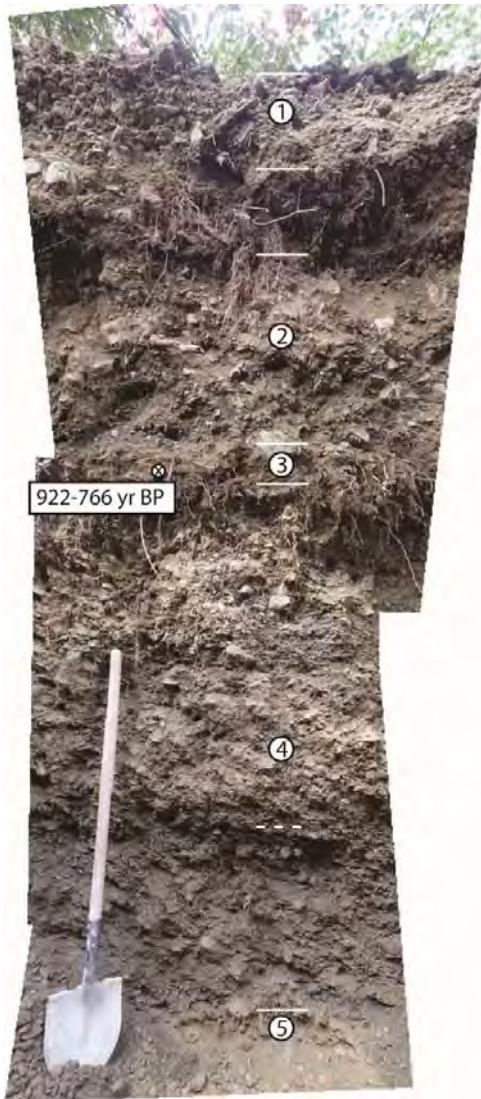
### TP1 – Bear Creek fan

Unit	Depth (cm)	Observations
Unit 1	0-30	Muddy rubble, 2016 debris flow
Unit 2	30-105	Litter, Folic, Humic (LFH <sup>1</sup> ) with rooted stump on muddy rubble
Unit 3	105-120	Silty sand with reddening from fire, charcoal sample from reddened zone at 120 cm gave 922-766 cal yr BP (Beta-474067)
Unit 4	120-300	Muddy rubble, single thick event, but lower 60 cm is darker and more washed, not as muddy
Unit 5	300-310	Muddy rubble
Base	-	Not seen

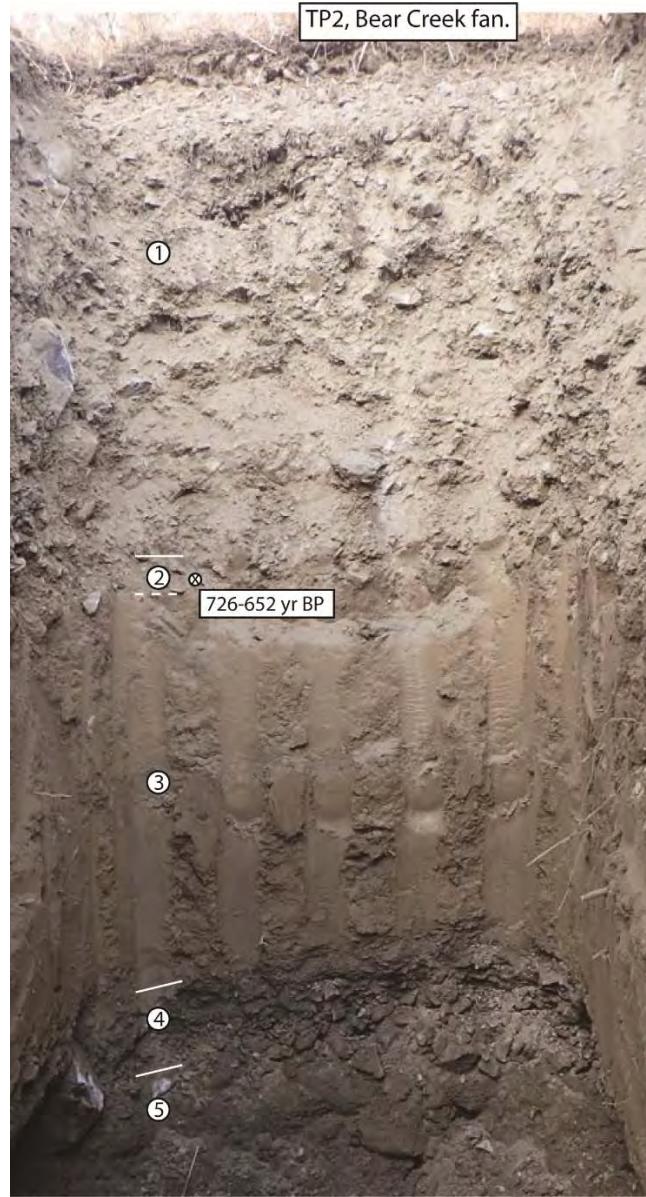
## TP2 - Bear Creek fan

Unit	Depth (cm)	Observations
Surface	0-5	LFH
Unit 1	5-135	Muddy rubble
Unit 2	135-145	Silty fine sand with brunisolic soil and charcoal fragments, dated as 726-652 cal yr BP (Beta-474068)
Unit 3	145-220	Overbank silty sand
Unit 4	220-285	Stratified granule gravel, occasional angular fine boulder
Unit 5	285-310	Pebble cobble gravel, mixed lithology, rounded to subround clasts
Base	-	Not seen

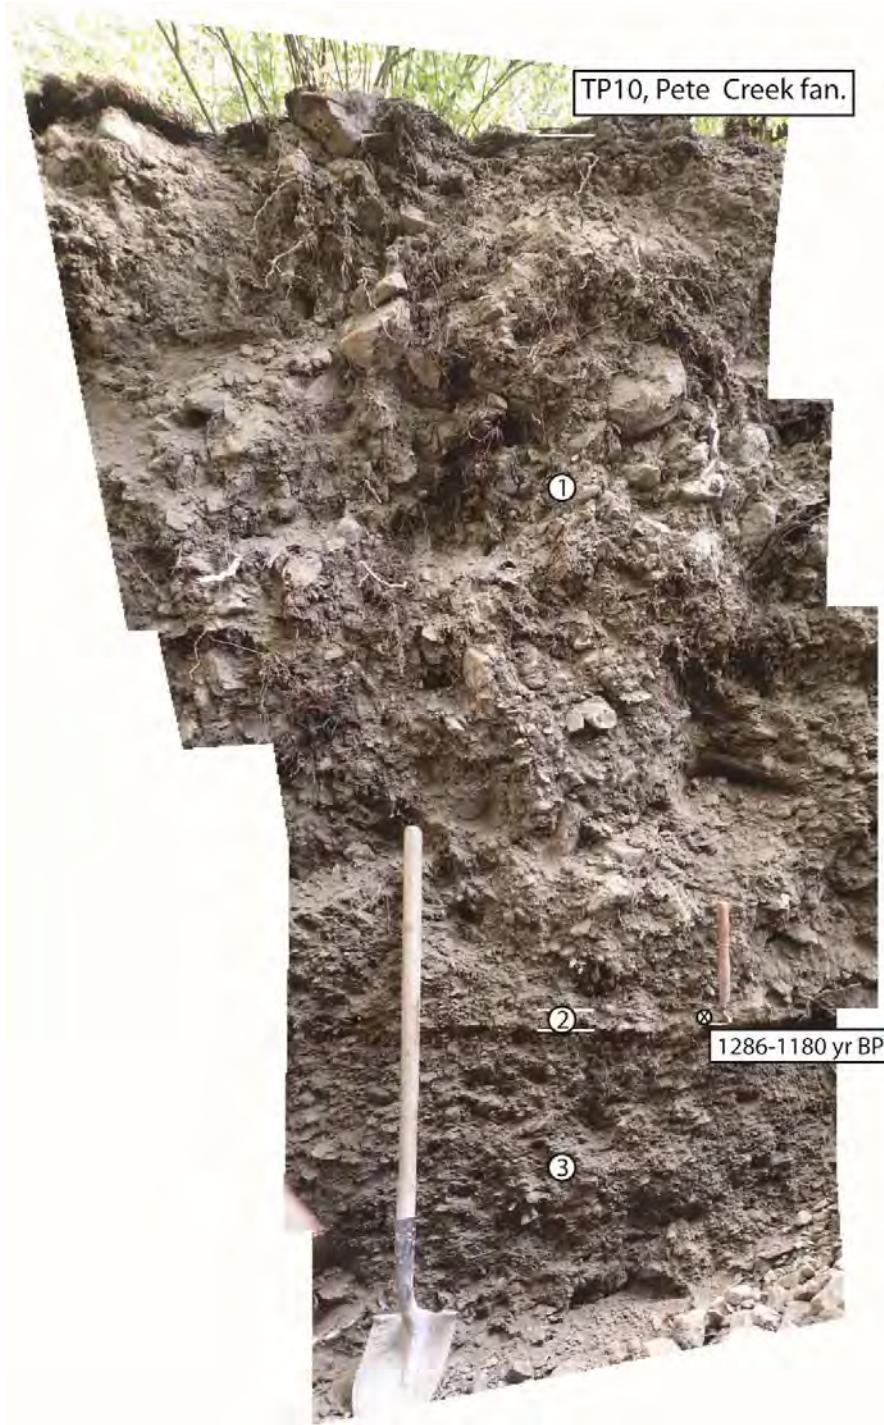
## TP10 - Pete's Creek fan

Unit	Depth (cm)	Observations
Unit 1	0-200	Rubble diamict, cobble pebble, occasional fine boulder, angular to subangular
Unit 2	200-210	Silty fine sand with charcoal, gave age of 1286-1180 cal yr BP (Beta-474078)
Unit 3	210-300	Rubble diamict
Base	-	Not seen

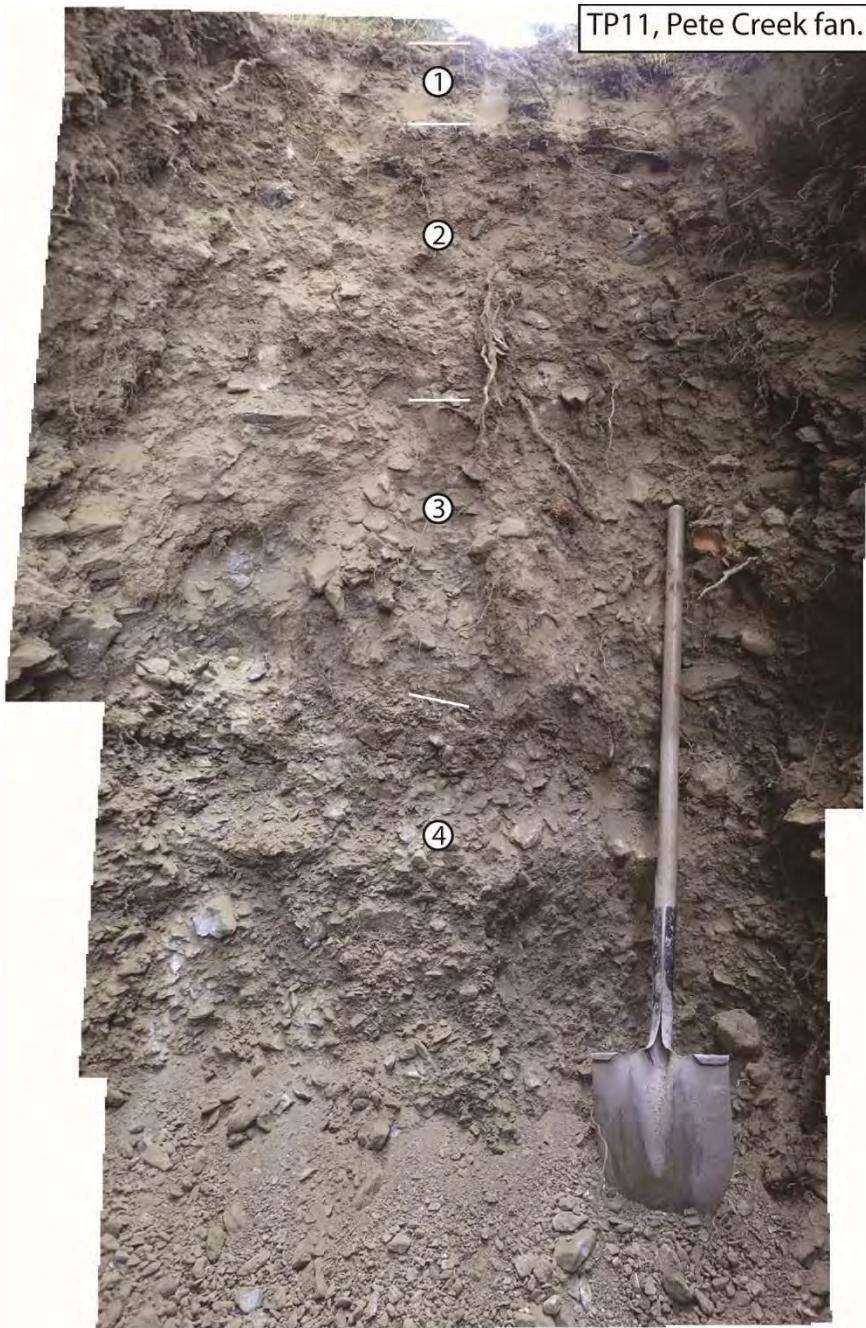
## TP11 – Pete's Creek fan

Unit	Depth (cm)	Observations
Unit 1	0-25	Road fill
Unit 2	25-120	Matrix to clast supported rubble diamict, muddy matrix;
Unit 3	120-205	Rubble diamict
Unit 4	205-285	Rubble diamict, mostly pebble size, less cobble, rare fine boulder
Base	-	Not seen

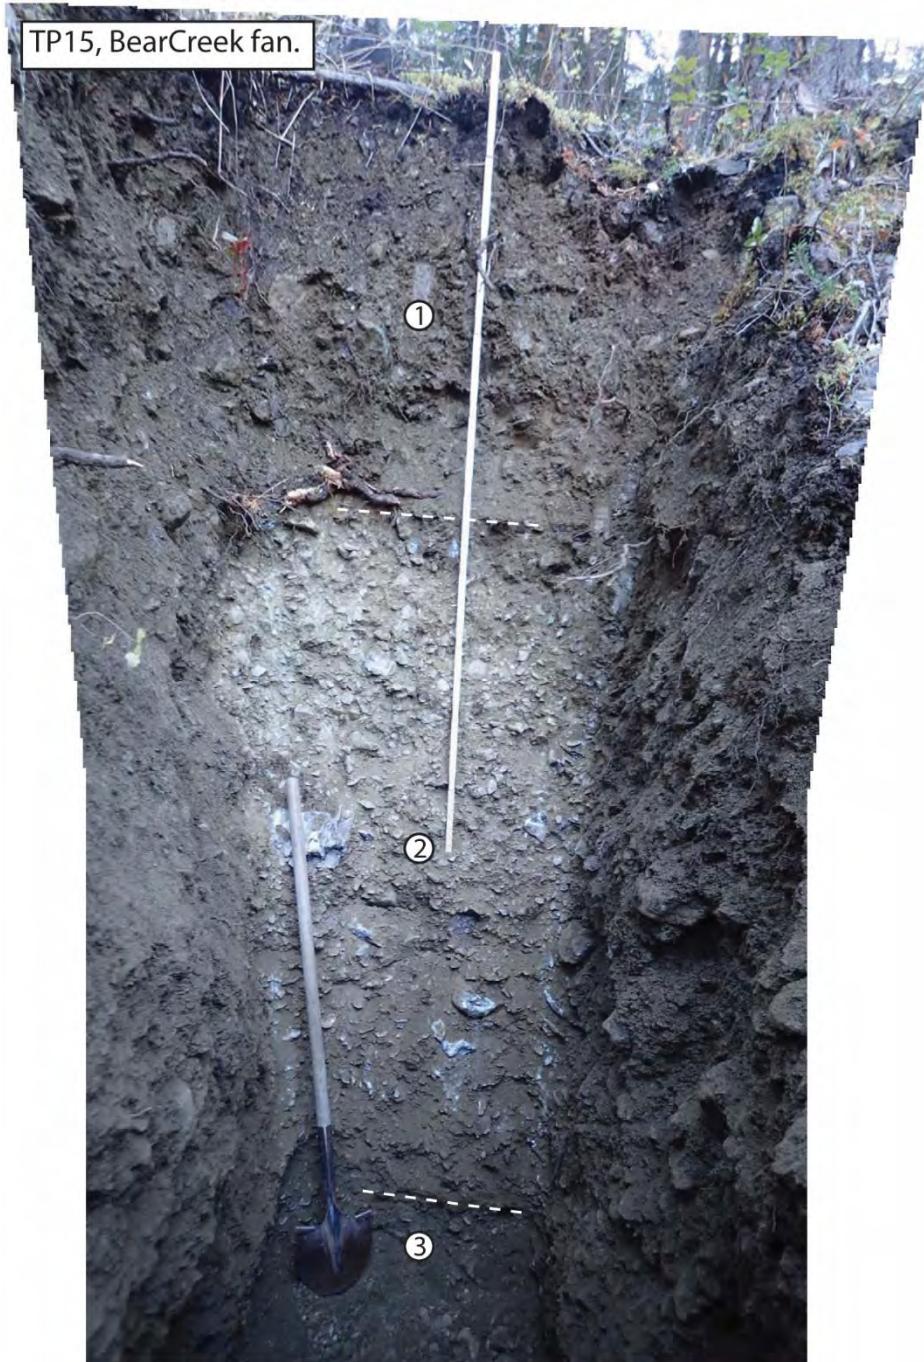
## TP15 – Bear Creek fan

Unit	Depth (cm)	Observations
Unit 1	0-105	Rubble diamict, lower contact marked by root horizon
Unit 2	105-300	Rubble diamict
Unit 3	300-325	Rubble diamict, upper contact marked by discontinuous sandy layer, unconformable
Base	-	Not seen

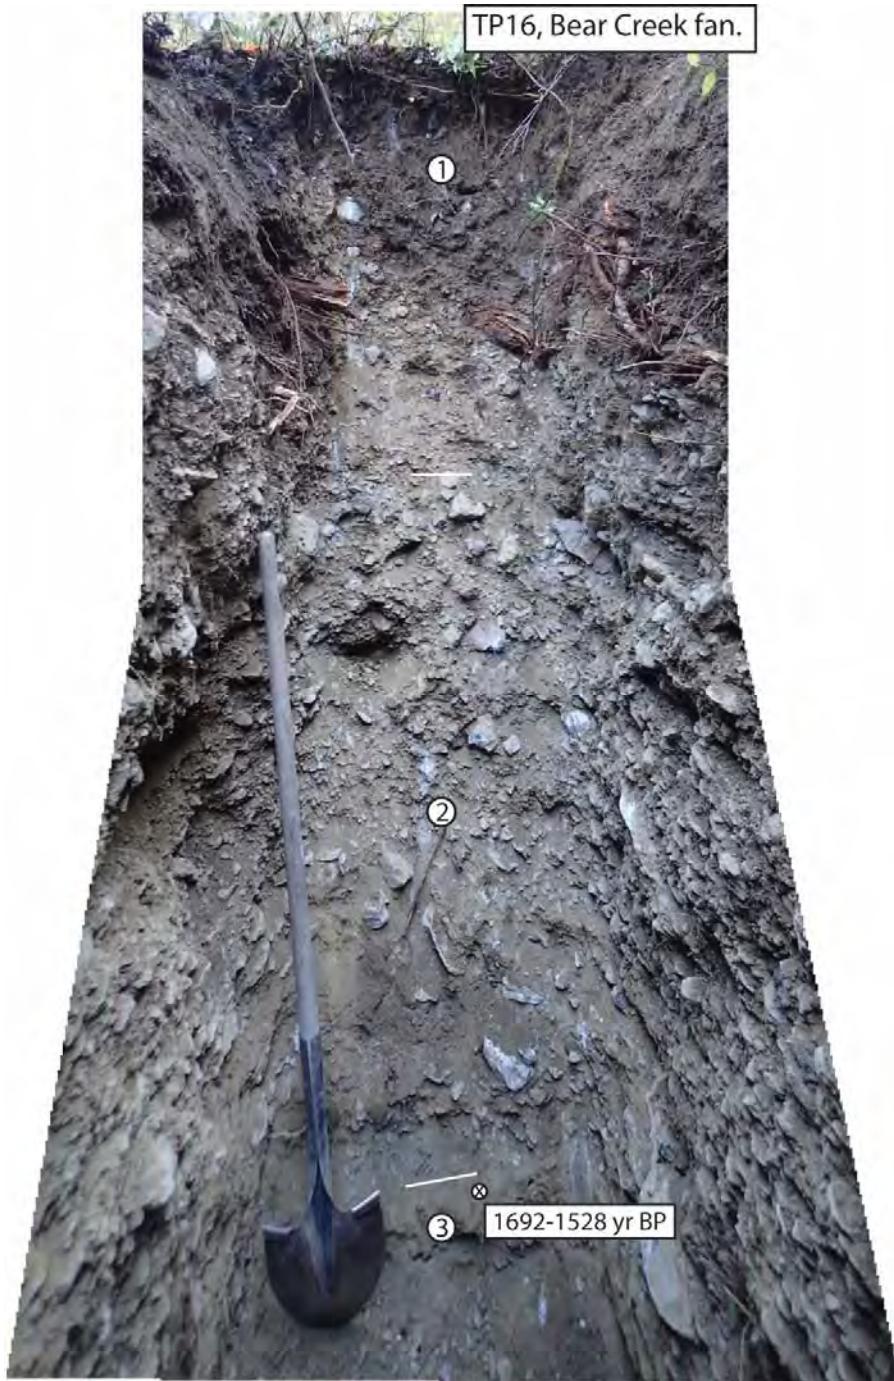
## TP16 – Bear Creek fan

Unit	Depth (cm)	Observations
Unit 1	0-149	Rubble diamict
Unit 2	140-255	Rubble diamict
Unit 3	255-285	Rubble diamict, upper 10 cm, silt/sand, slightly oxidized, sample at 260 cm yielded age of 1692-1528 BP (Beta-478123);
Base	-	Not seen

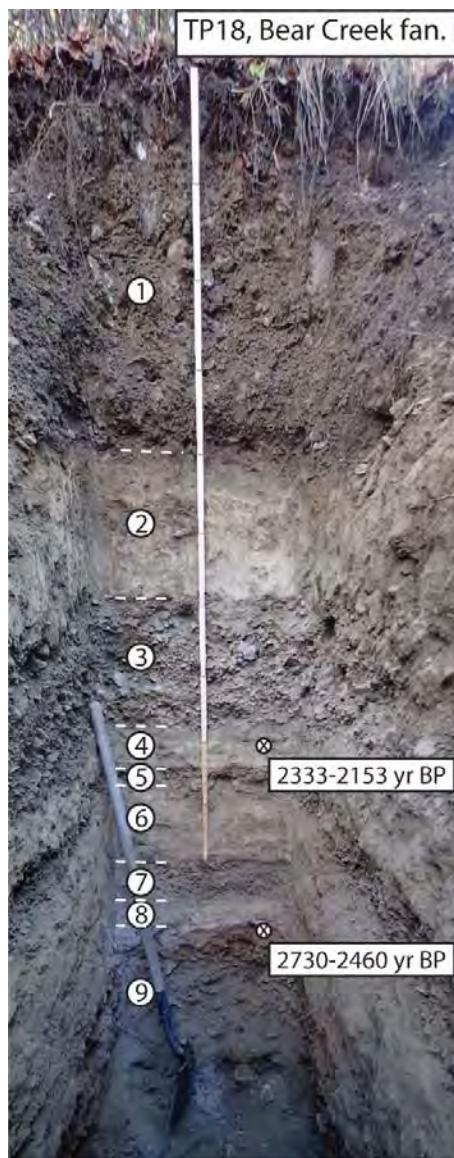
## TP18 – Bear Creek fan

Unit	Depth (cm)	Observations
Unit 1	0-80	Fill
Unit 2	80-118	Silty sand, 80-85 cm Bf zone
Unit 3	118-157	Muddy pebble gravel, subangular to subround, clast supported
Unit 4	157-170	Bedded silty sand and med to fine sand, at 165 cm charcoal sample yielded age of 2333-2153 BP (Beta-478127);
Unit 5	170-180	Erosion all lower contact, muddy pebble gravel, like previous gravel
Unit 6	180-200	Silty sand
Unit 7	200-215	Pebble gravel
Unit 8	215-215	Silty sand
Unit 9	225-350	Rubble diamict, upper 5-7 cm show reddening and charcoal lenses, sampled at 230 cm yielded age of 2730-2460 BP (Beta-478128)
Base	-	Not seen

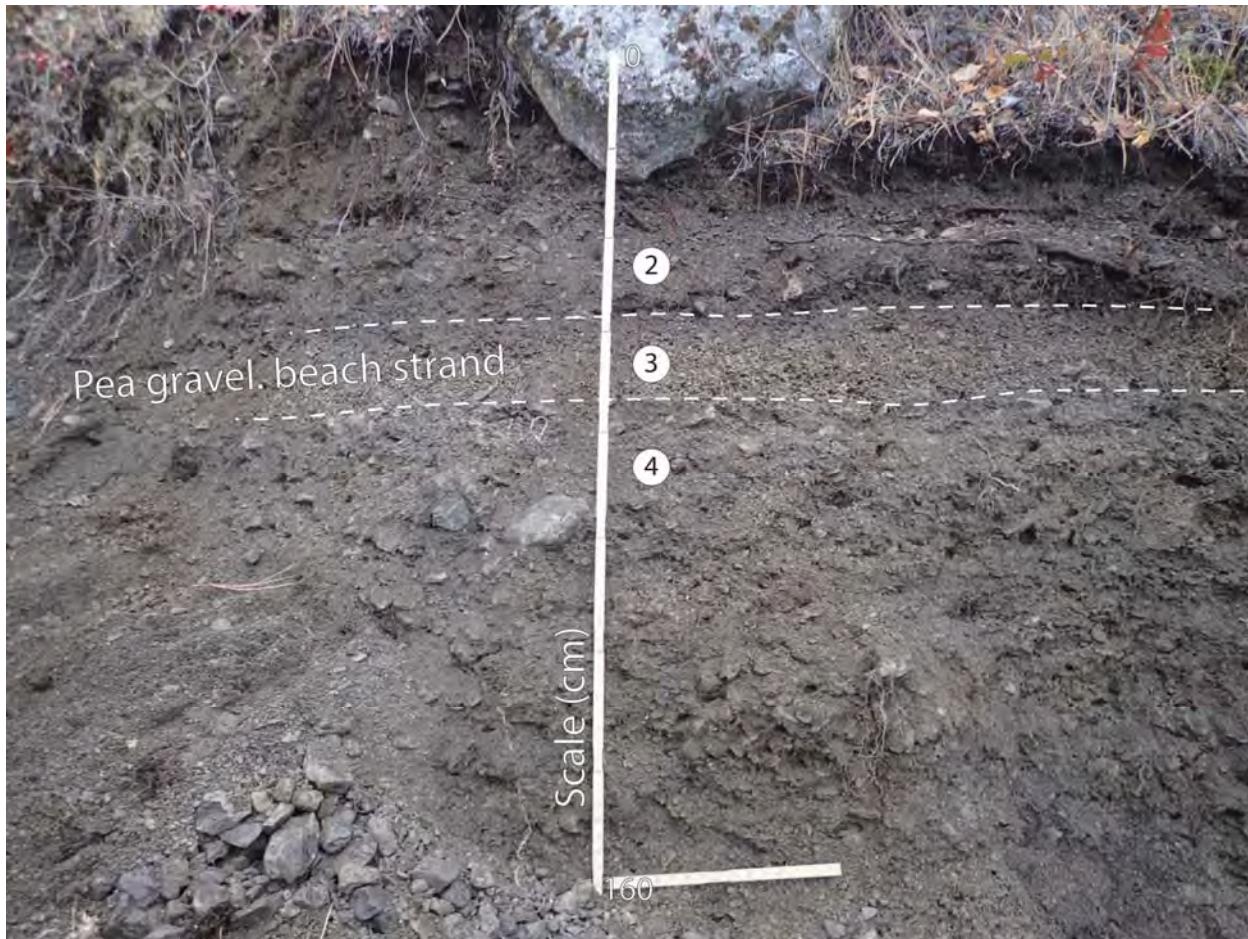
## TP19a - Anderson Lake

Modern back scarp below pit house. High water mark is 5.3 m below surface.

Unit	Depth (cm)	Observations
Unit 1	0 – 220	Pit house rim spoil over diamict, boulders to 750 mm
Unit 2	220 – 255	Interbedded pea gravel and mixed angular and rounded pebble gravel, beach strand
Unit 3	255 – 280	Pea gravel, beach strand
Unit 4	280 – 360	Rubble diamict, bns
