## **SQUAMISH-LILLOOET REGIONAL DISTRICT**

### **SETON PORTAGE AREA INTEGRATED HYDROGEOMORPHIC RISK ASSESSMENT**

**FINAL**

PROJECT NO.:	1358005	DISTRIBUTION:	
DATE:	April 6, 2018	SLRD:	digital copy
		BGC:	digital copy

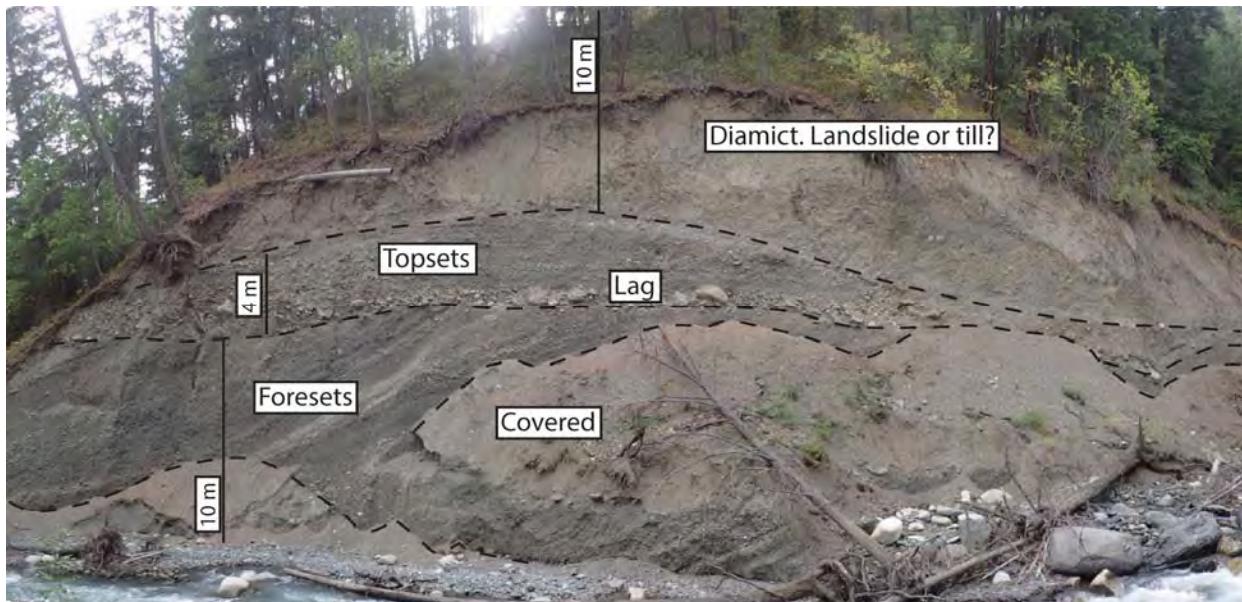
## Whitecap Glacial Section

Measured from base:

- 10 m sandy gravel foreset delta gravels, overlain by
- 4 m topset gravel with boulder lag on lower contact, upper contact erosional, wavy over 50 m distance, overlain by
- 10 m+ diamict, either till or perhaps landslide, genesis not confirmed.

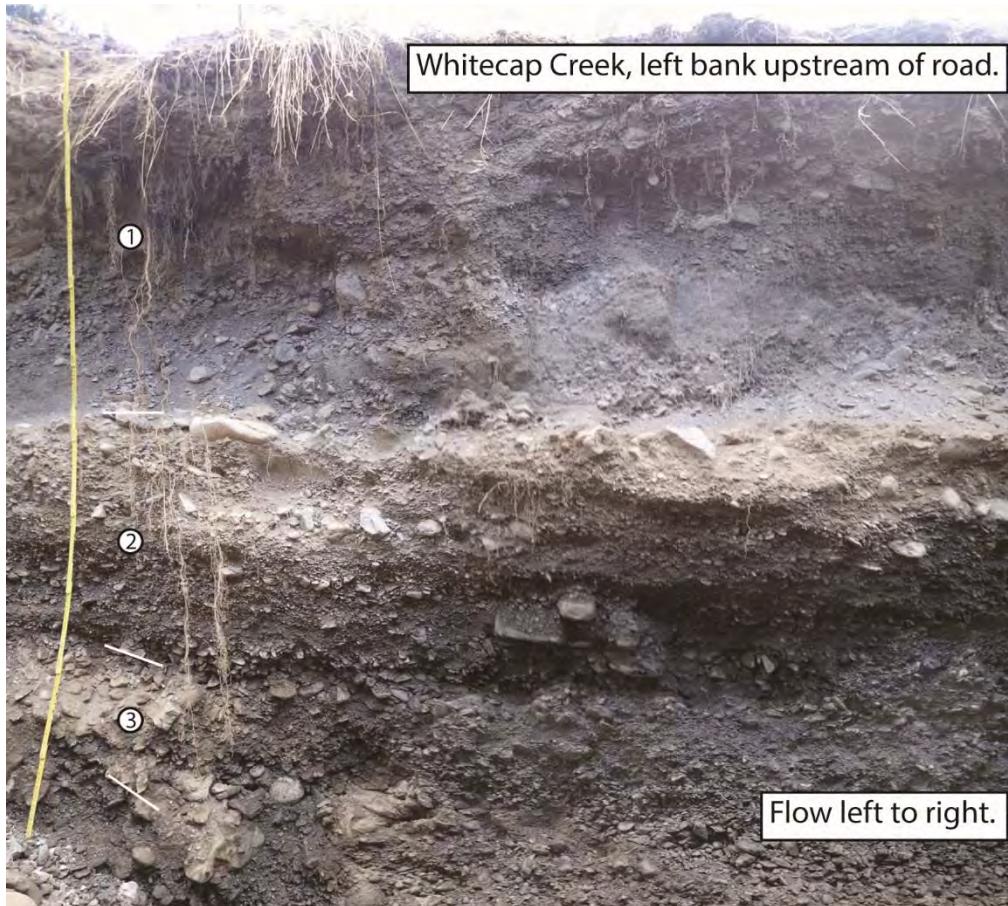
## Whitecap Upstream Section

Unit	Depth (cm)	Observations
Unit 1 & 2		Bouldery cobble/pebble, matrix supported diamict, largest clasts fine to med boulder, surround to round, mixed lithology
Unit 3		Muddy matrix to clast supported, granular to pebble rubble, angular to subangular, weakly stratified; interpreted hyperconcentrated

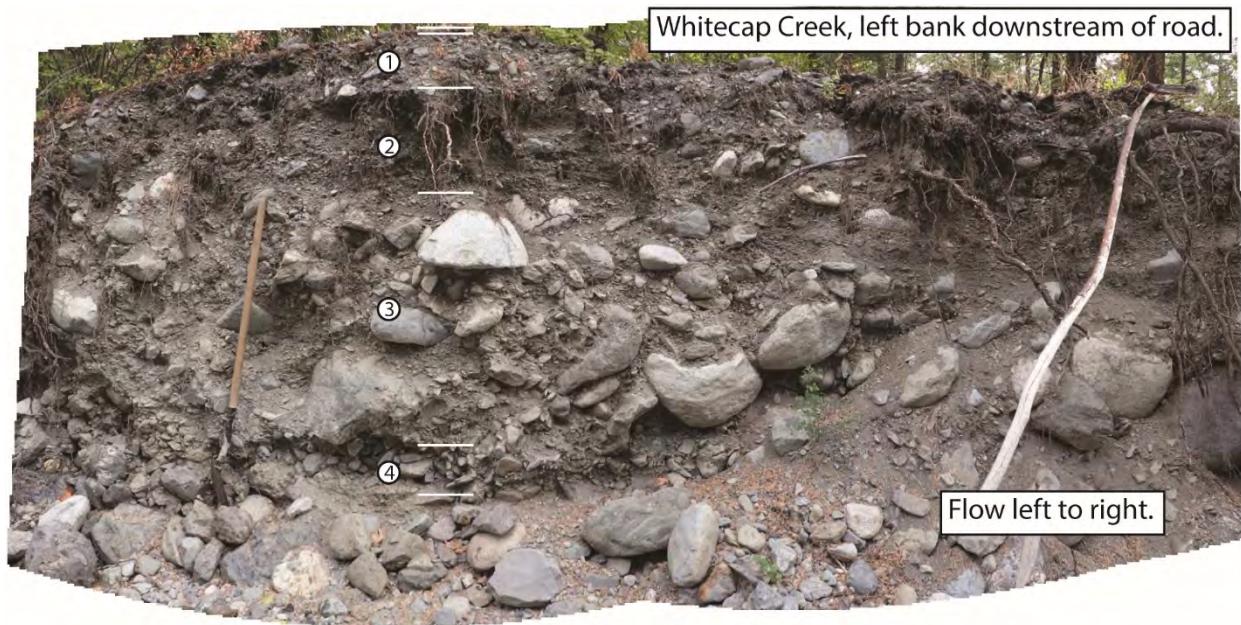
## Whitecap Downstream Section

Unit	Depth (cm)	Observations
Surface	0-3	LFH
Unit 1	3-25	Sandy cobble pebble gravel
Unit 2	25-75	Sandy granular matrix, supporting cobbles, weak trough cross beds over 3 m distance
Unit 3	75-170	Matrix supported silty boulder cobble diamict, angular to subround clasts, mixed lithologies
Unit 4	170-200	Openwork pebble cobble
Base	-	Not seen

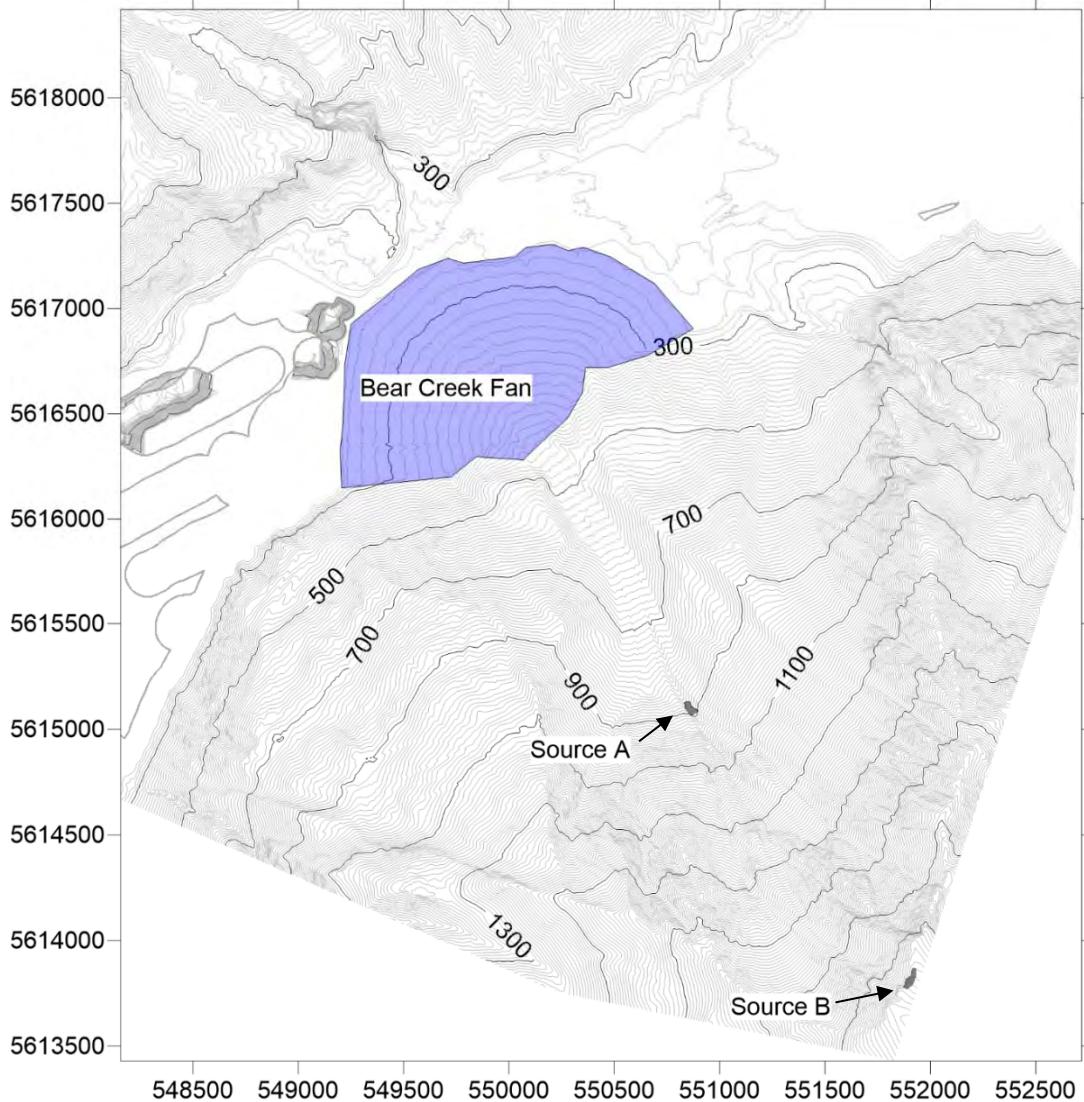
**Figure G-1. Source locations for DAN3D modelling.**

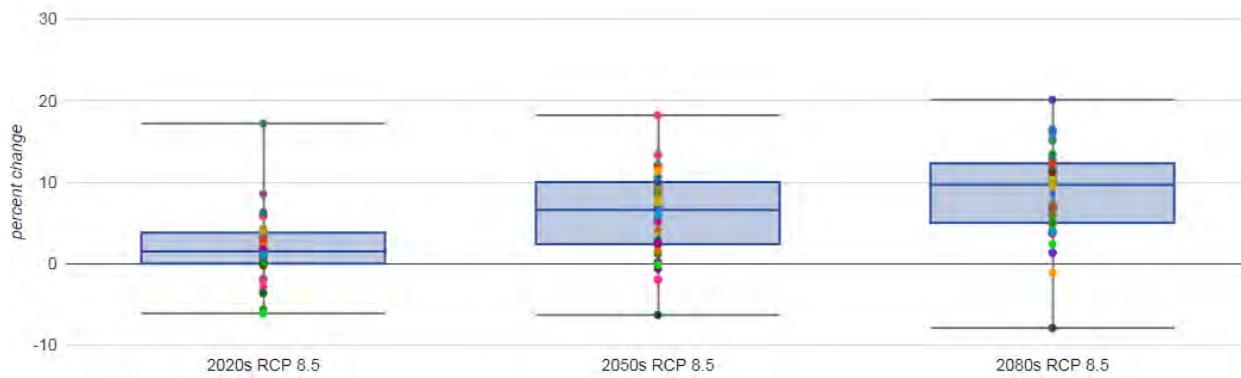
**Figure J-1.** Changes in annual precipitation for RCP 8.5 and a large number of model ensembles. For the purpose of this assessment the RCP 8.5 scenario was considered.

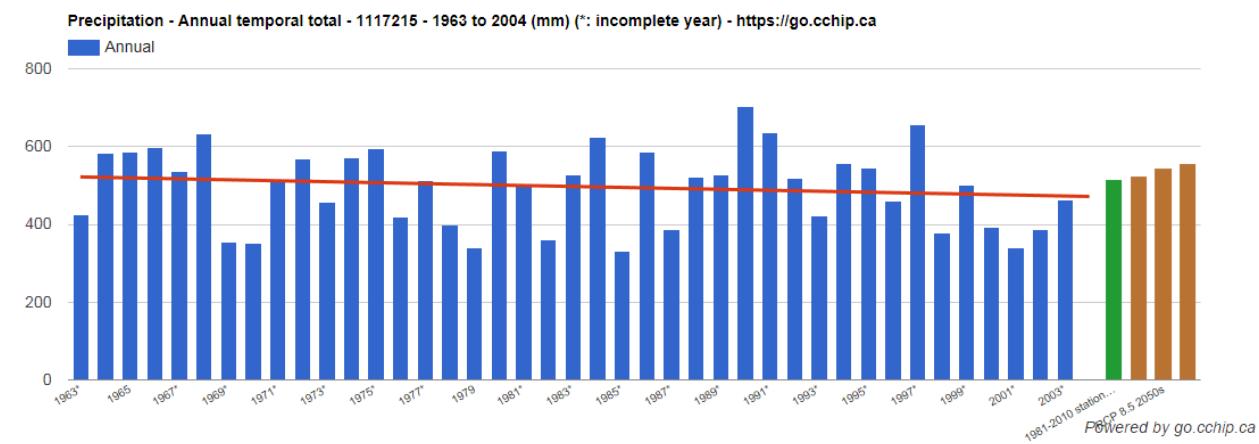
**Figure J-2.** Observed changes in annual precipitation and projected mean annual precipitation changes predicted to the 2080s for RCP 8.5.

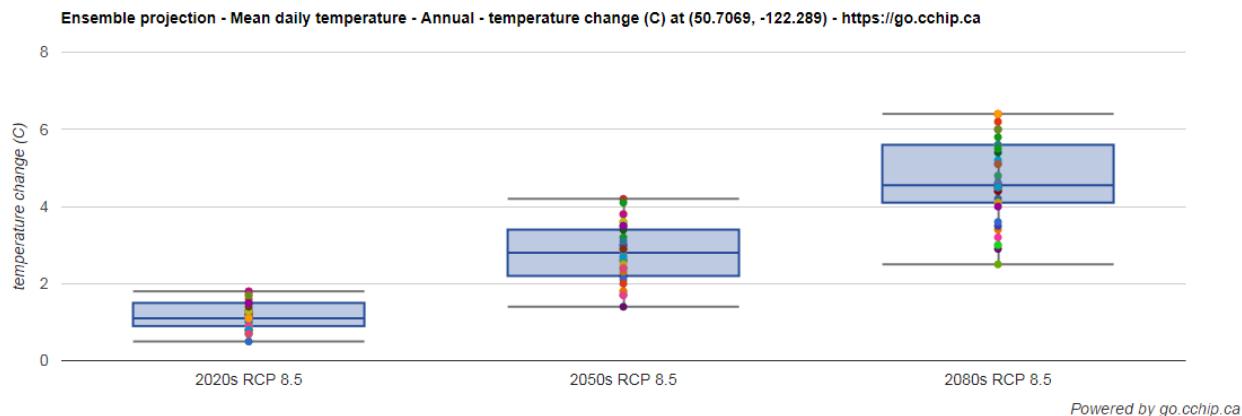
**Figure J-3. Projected increase in main daily temperature up to the 2080s for RCP 8.5.**

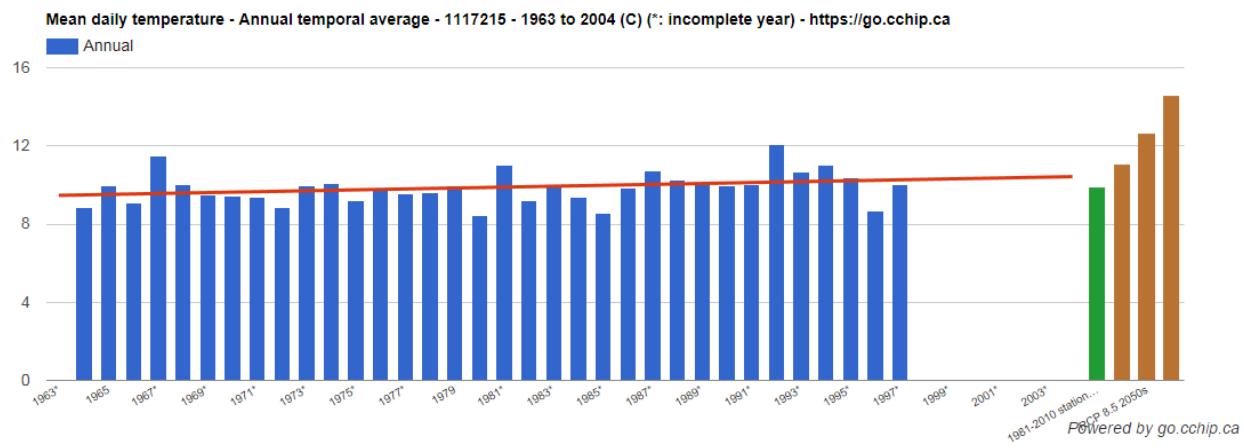
**Figure J-6.** Observed and projected changes in mean daily temperature at Seton Portage to the 2080s for RCP 8.5.

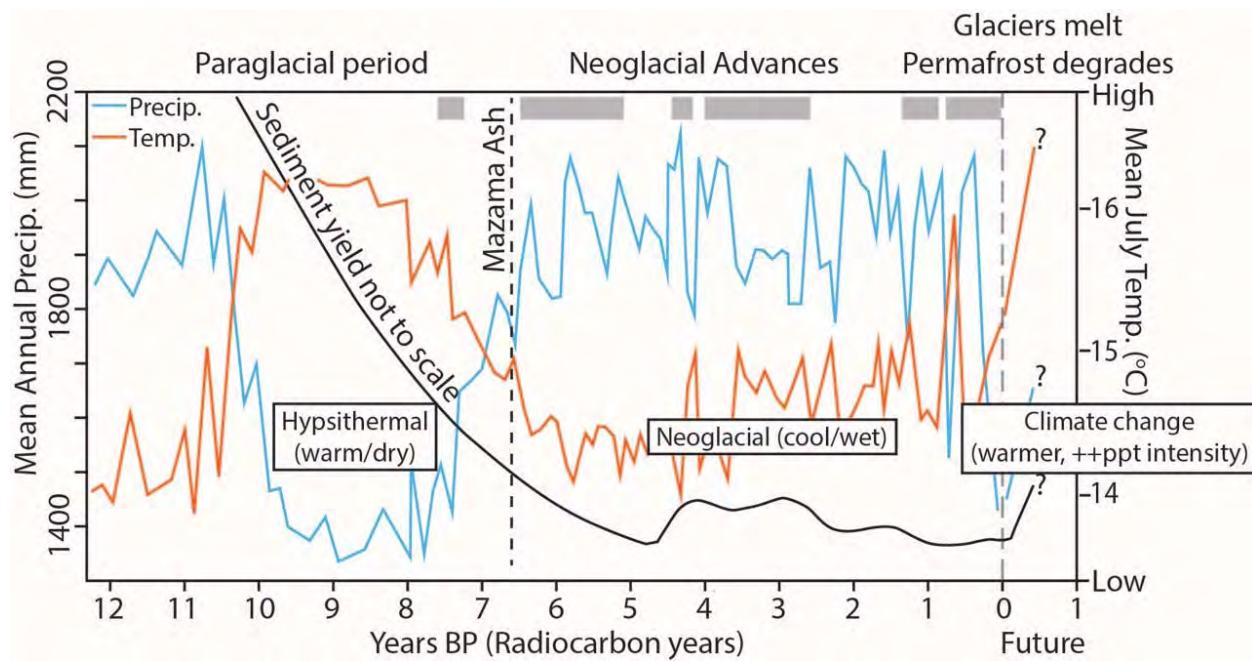
**Figure J-7. Sediment yield in relation to past and future climate and associated geomorphic drivers. Compiled by Friele et al. 2017.**
