**SQUAMISH-LILLOOET REGIONAL DISTRICT**

# **Geohazard Risk Prioritization**

**FINAL**  
**April 10, 2020**

Prepared by BGC Engineering Inc. for:  
**Squamish-Lillooet Regional District**

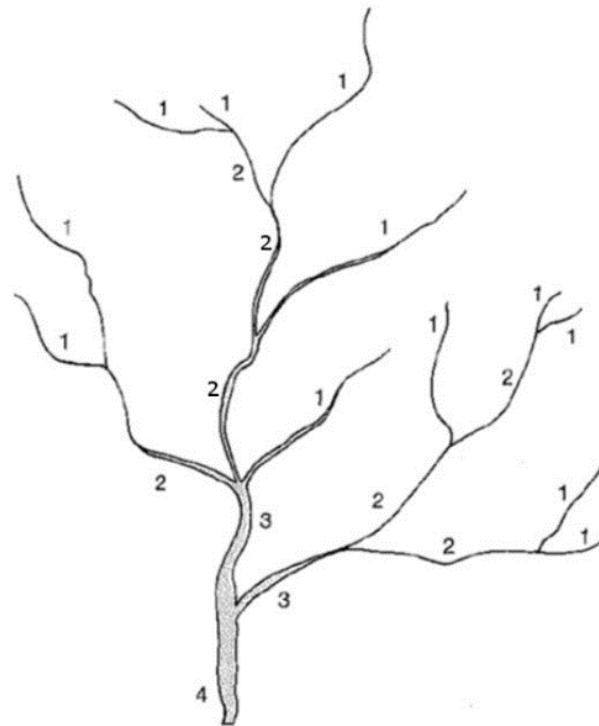
Figure 1-2. Illustration showing Strahler stream order (Montgomery, 1990).

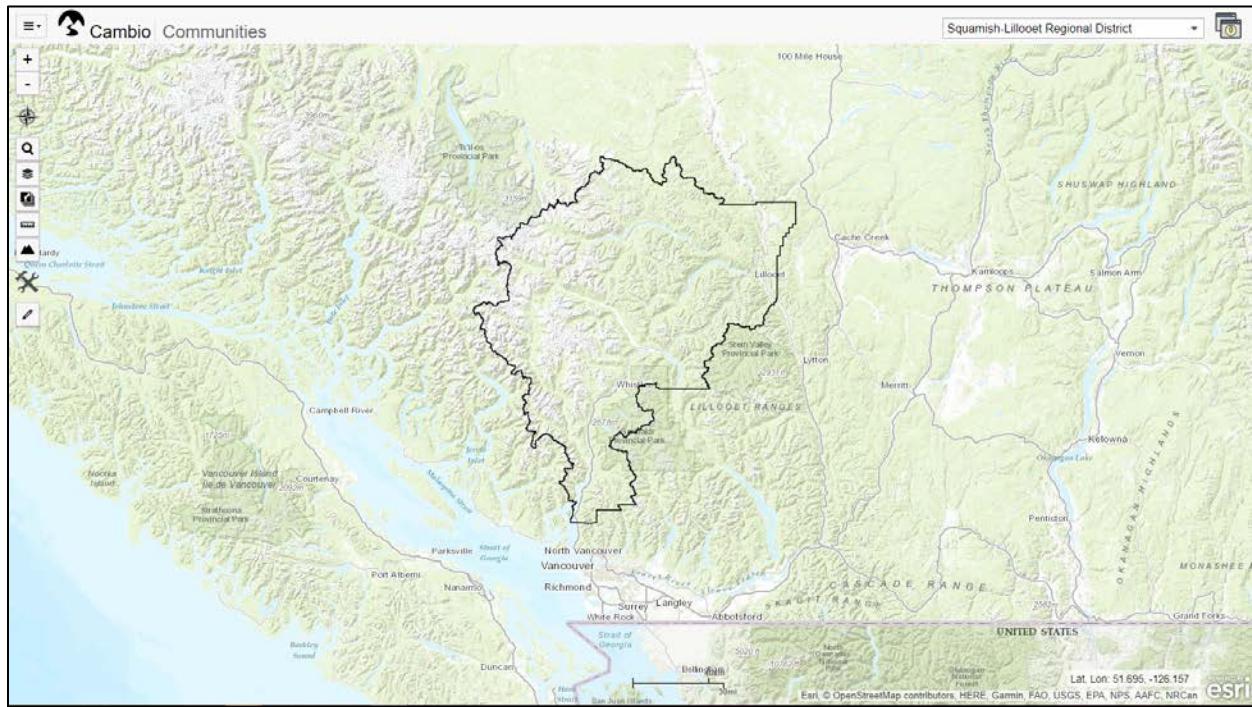
Figure 1-3. Example of *Cambio* web application.

Digital deliverables include geospatial information provided in a geodatabase (prioritized geohazard areas), and hazard area attributes provided in an excel spreadsheet. The prioritized hazard areas are presented on a secure web application, *Cambio* (Figure 1-3), at [www.cambiocommunities.ca](http://www.cambiocommunities.ca).

1. Prioritized geohazard areas and information (see Section 3).
2. Elements at risk (i.e., community assets; see Section 4).
3. Additional information provided for visual reference, including geohazard, hydrologic and topographic features.
4. Access to data from near-real time stream flow monitoring stations where existing.

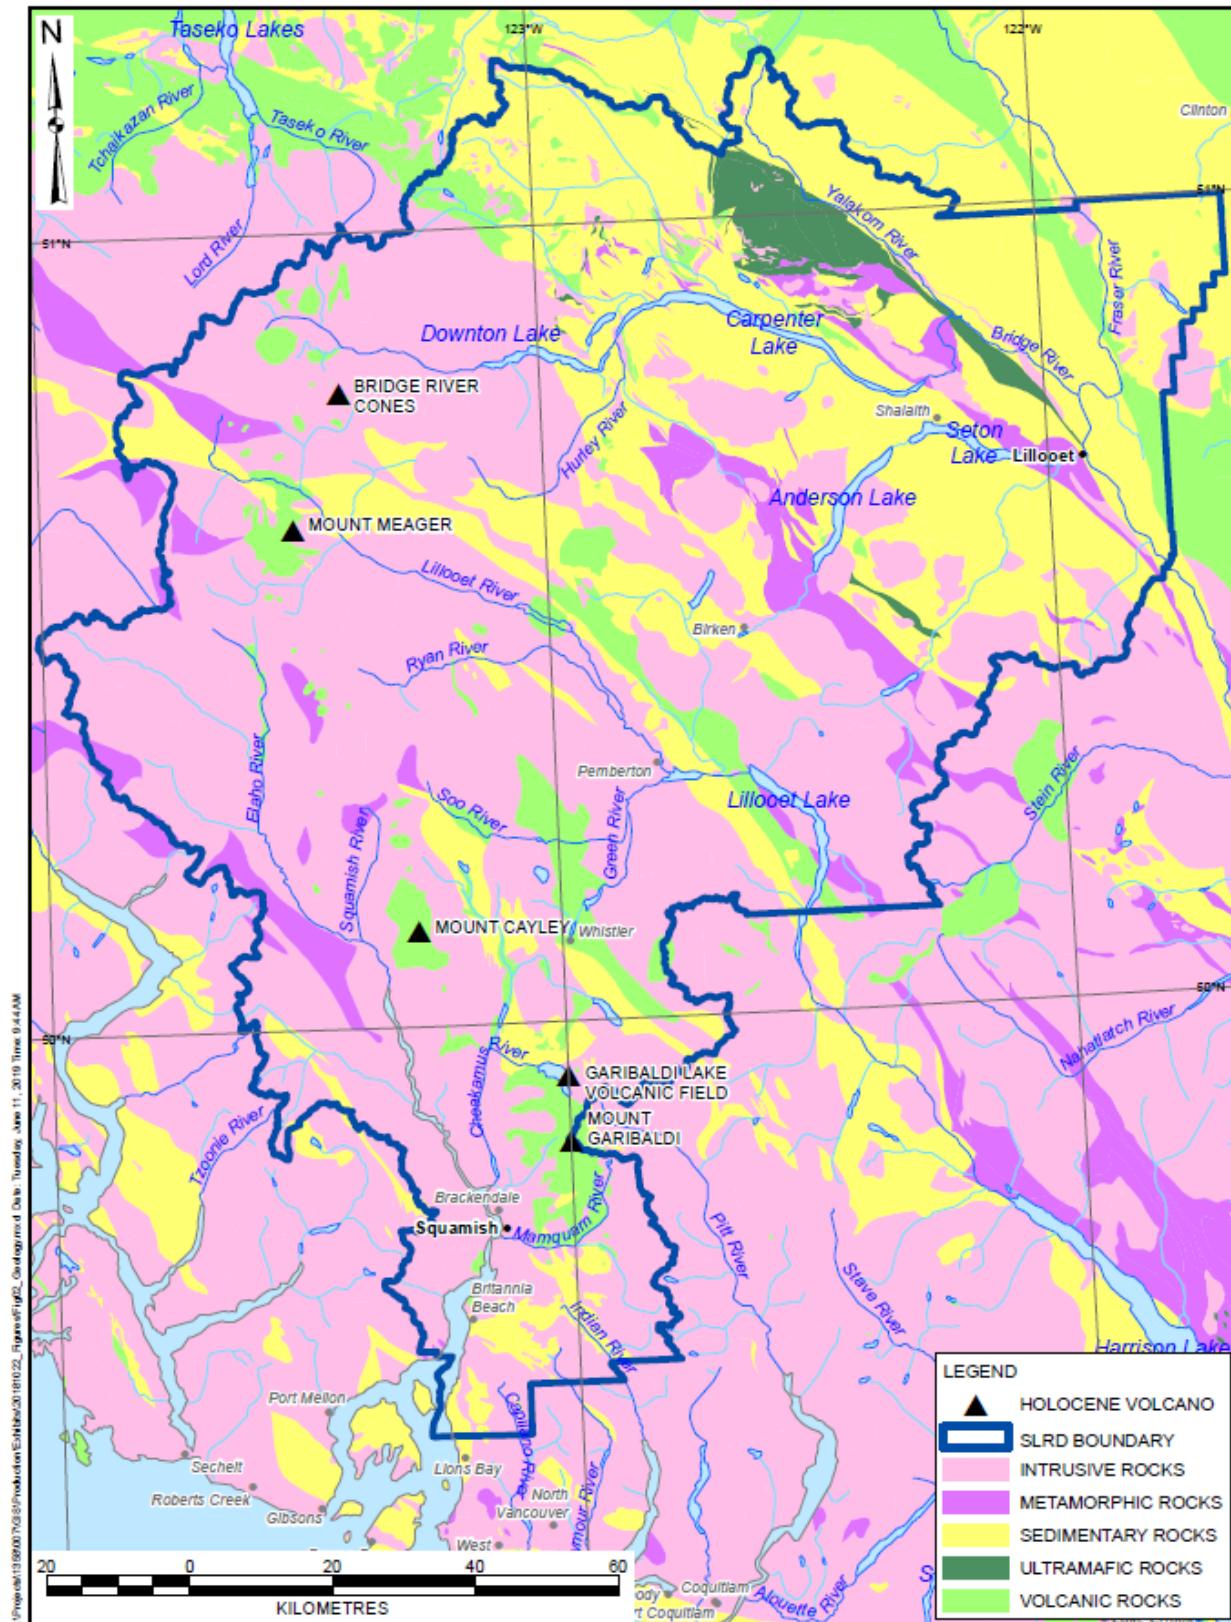
**Figure 2-2. Bedrock geology of the SLRD. Digital mapping and bedrock classes from Cui et al. (2015).**

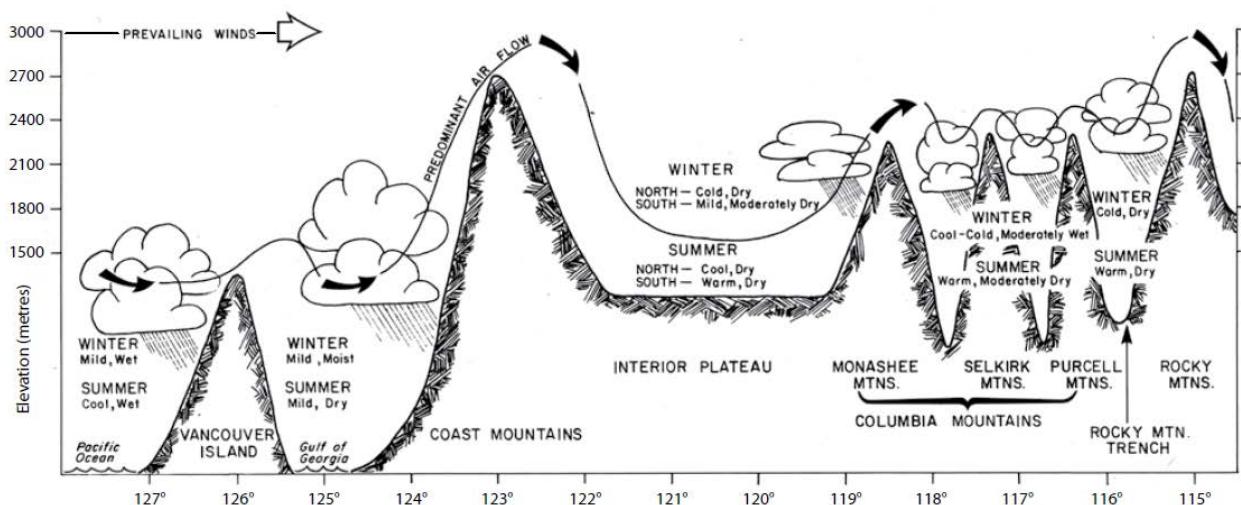
**Figure 2-3. Latitudinal cross-section through southern BC depicting physiographic diversity and resulting climatic regimes. The SLRD is associated with the Coast Mountains and a portion of the Interior Plateau. (From Moore et al., 2008).**

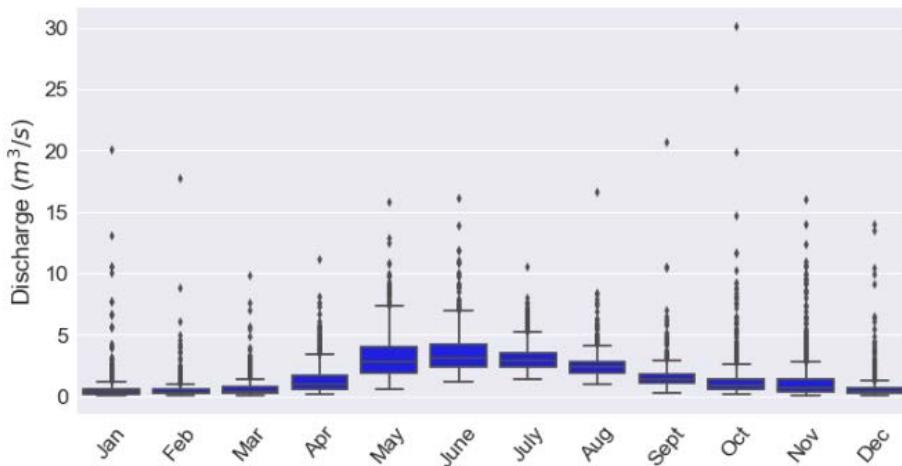
**Figure 2-8.** Boxplots of the monthly discharge data for WSC gauge 08MG025, *Pemberton Creek near Pemberton*. Pemberton Creek represents a pluvial-dominant hybrid regime.

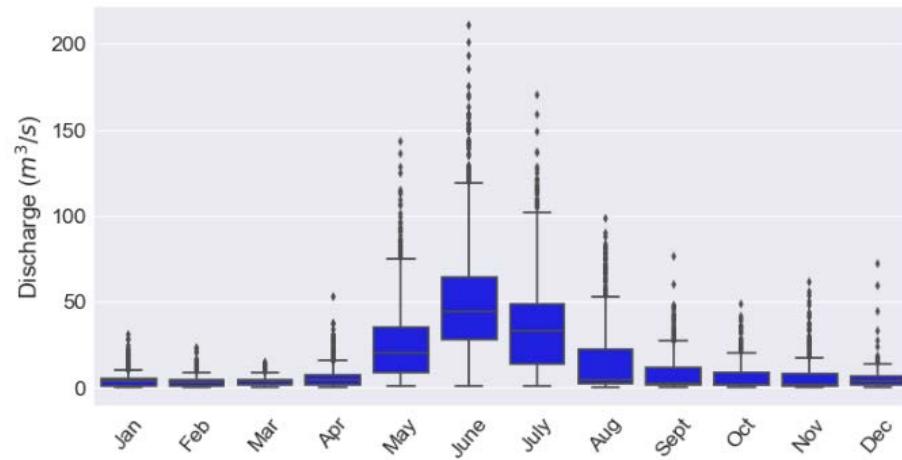
**Figure 2-9.** Boxplots of the monthly discharge for WSC gauge 08ME002, *Cayoosh Creek near Lillooet*. Cayoosh Creek represents a nival-dominant hybrid regime.

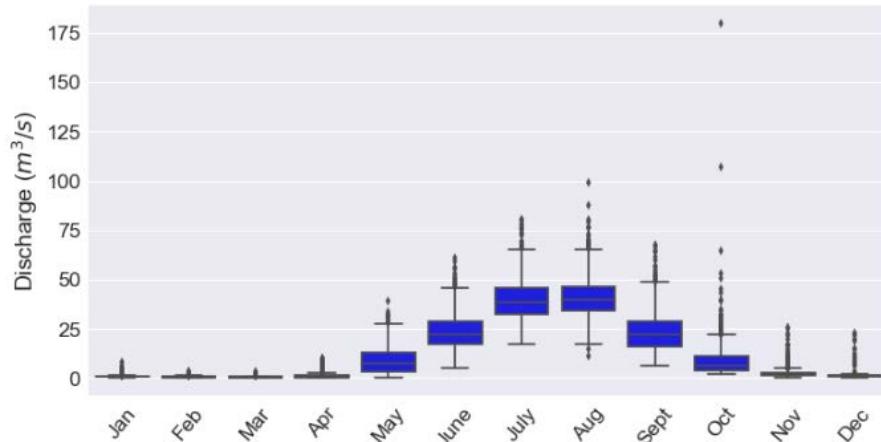
**Figure 2-10.** Boxplot of the monthly discharge for WSC gauge 08ME023, *Bridge River (South Branch) below Bridge Glacier*. Bridge River represents a glacial-supported nival regime.

- Figure 2-10 shows the monthly flows for WSC gauge 08ME023 (*Bridge River (South Branch) below Bridge Glacier*), which is located near the outlet of Bridge Glacier in the northwestern portion of the District at approximately 1,380 m elevation and drains 144 km<sup>2</sup>. Bridge River is an example of a glacial-supported nival flow regime with snowmelt driven in spring and glacial melt driven in summer.

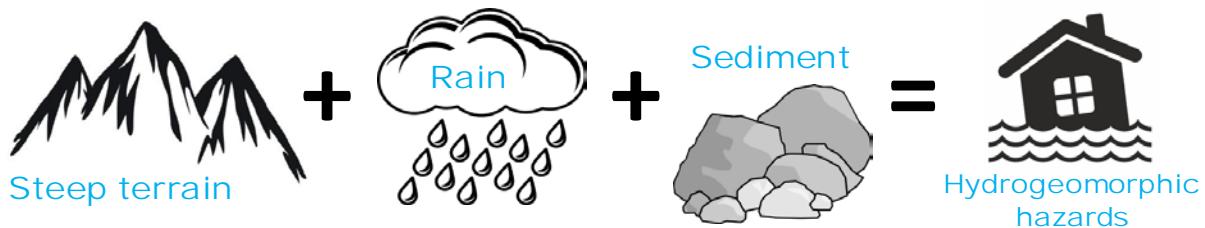
Figure 3-1. Main factors contributing to hydrogeomorphic hazards.

Steep creek or hydrogeomorphic hazards are natural hazards that involve a mixture of water ("hydro") and debris or sediment ("geo") (Figure 3-1). These hazards typically occur on creeks and steep rivers with small watersheds (usually less than 100 km<sup>2</sup>) in mountainous terrain, usually after intense or long rainfall events, sometimes aided by snowmelt and often worsened by previous forest fires.

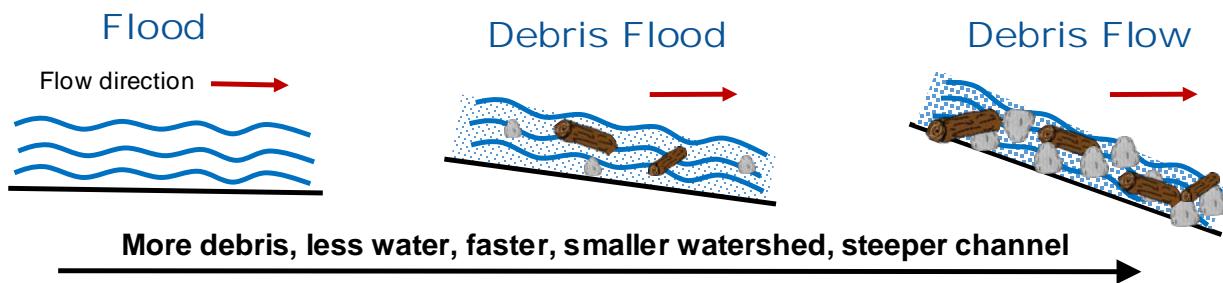
Figure 3-2. Main types of steep creek hazards.

The main types of steep creek hazards are debris floods and debris flows. Debris floods occur when large volumes of water in a creek or river entrain the gravel, cobbles and boulders on the channel bed; this is known as "full bed mobilization". Debris flows involve higher sediment concentrations than debris floods. They are technically classified as landslides rather than floods, because their high sediment content and viscosity allows them to deposit at angles when water will continue to flow. The best common analogy of the behaviour of debris flows is wet concrete. It is easiest to think about hydrogeomorphic hazards as occurring in a continuum, as shown in Figure 3-2. Further details about steep creek hazards are provided in Appendix E.

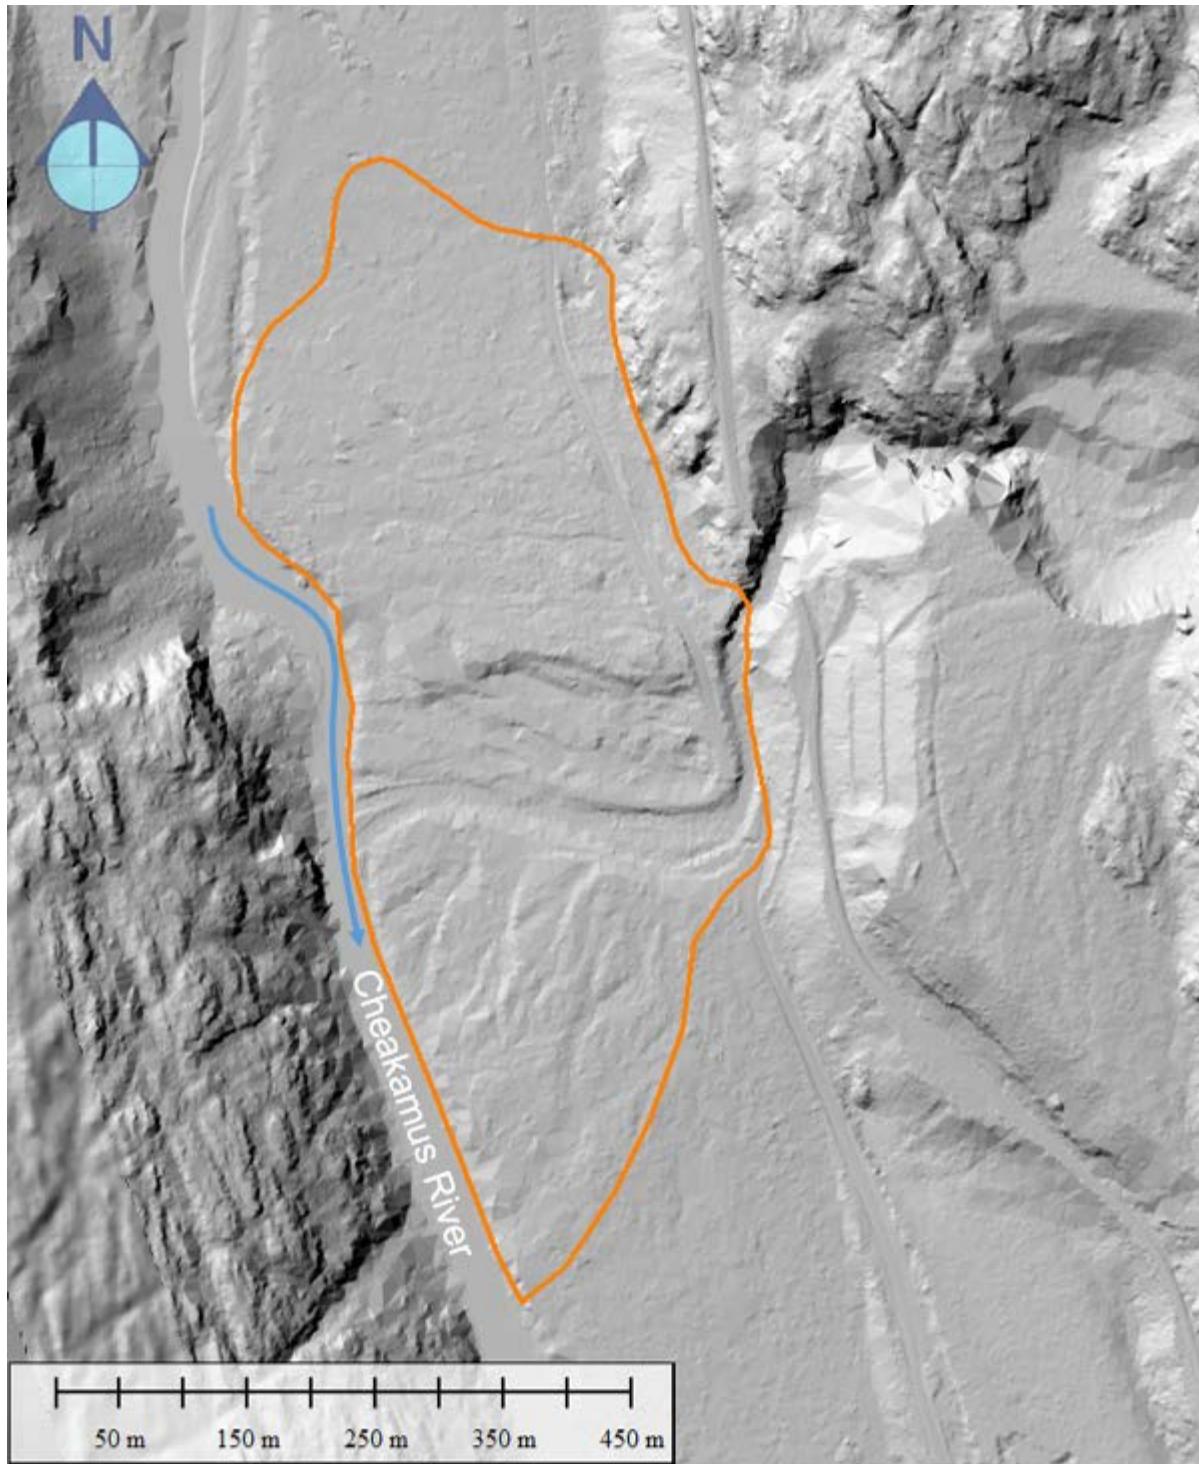
**Figure 3-3. Example alluvial fan boundary at Culliton Creek, north of Squamish on the Cheakamus River.**

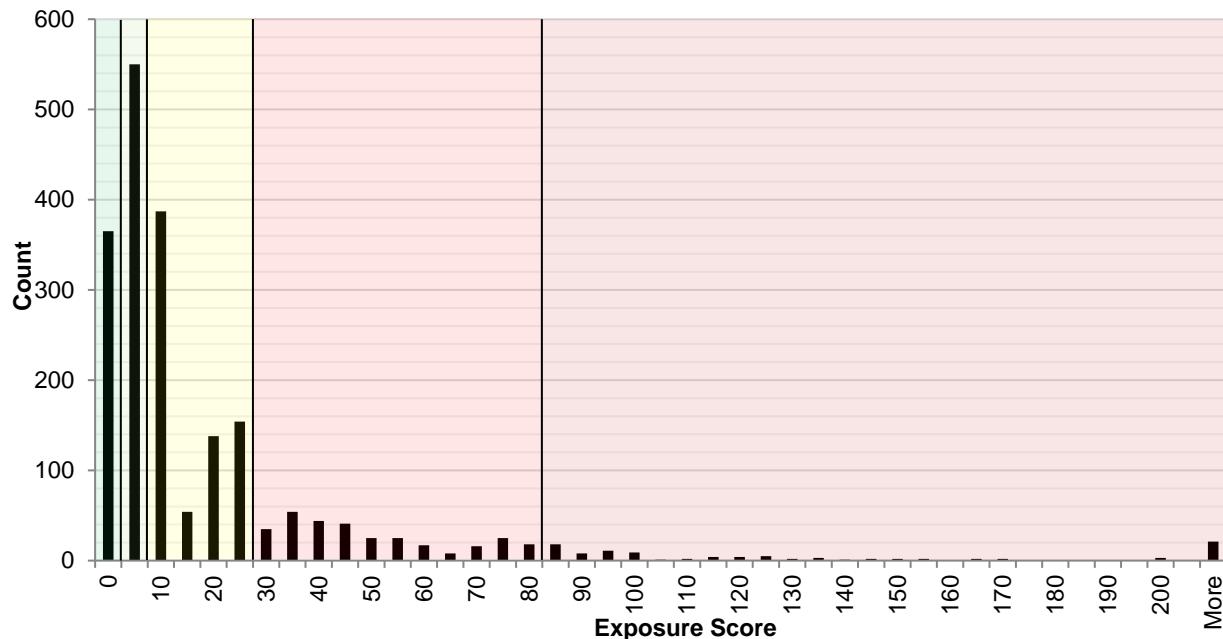
**Figure 4-1. Distribution of exposure scores in the SLRD and definition of associated exposure ratings.**

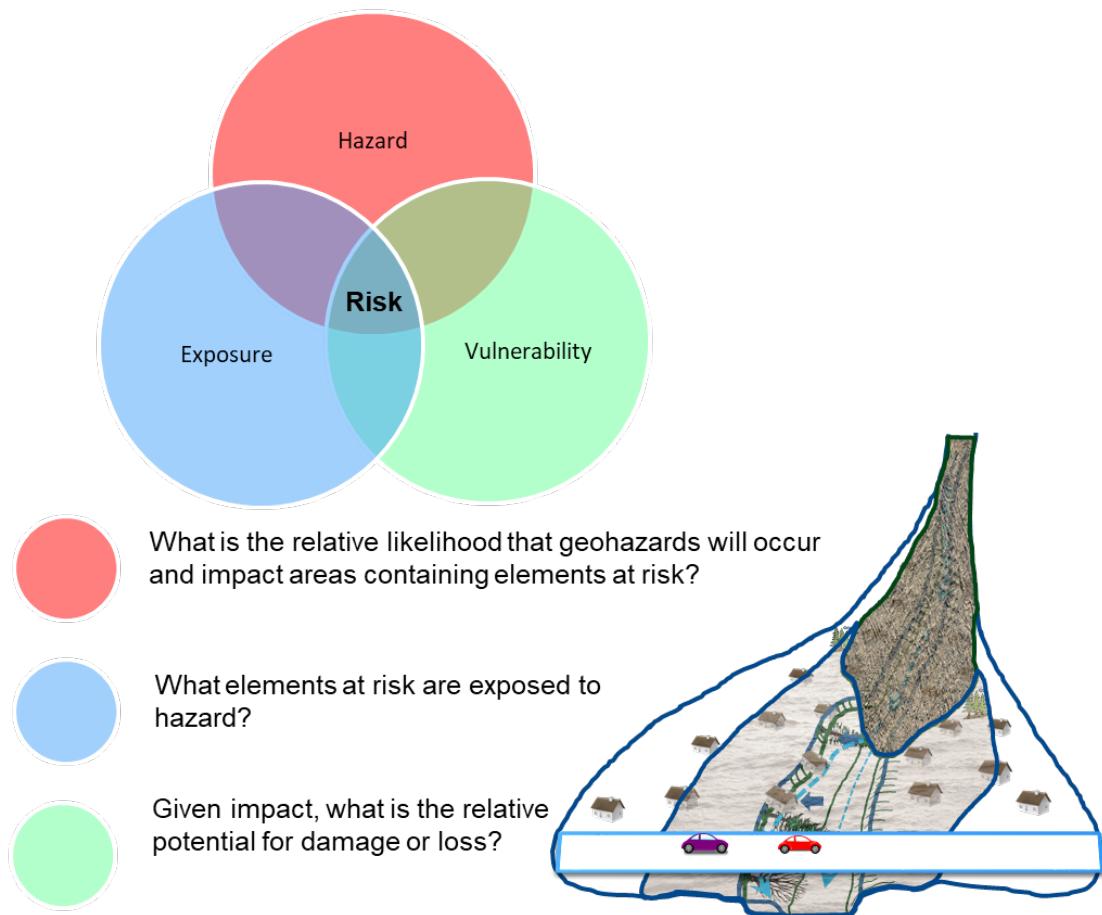
**Figure 5-1. Elements of the prioritization approach.**

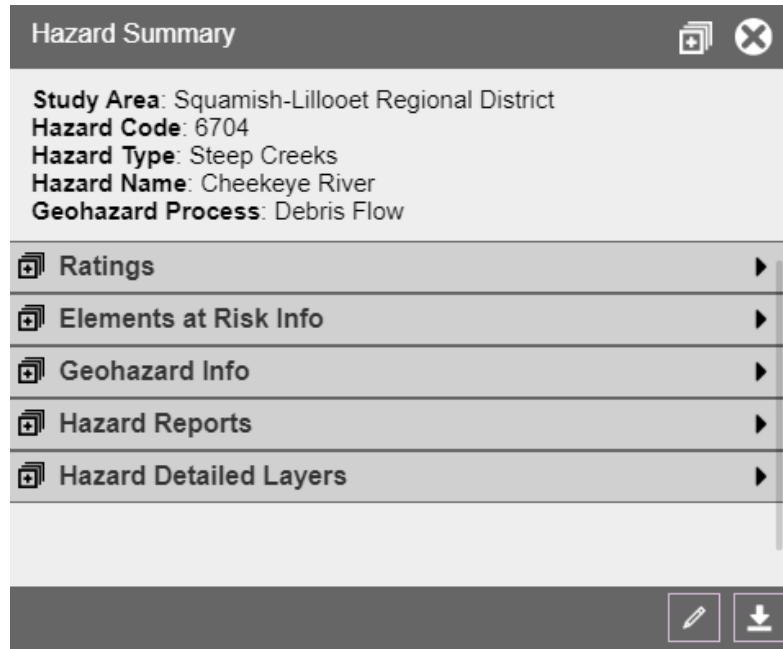
**Figure B.4-2. Additional information sidebar.**

Clicking a geohazard feature and then the “i” within the popup opens additional information in a sidebar on the right side of the screen (Figure B.4-2). Dropdown menus allow the user to view as much detail as required.

Table B-1 summarizes the information displayed within the sidebar. In summary, clicking Ratings reveals the site Priority, Consequence, and Hazard Ratings. See Chapter 5.0 of the main document for further description of these ratings. The geohazard, elements at risk, and hazard reports dropdowns display supporting information. Hover the mouse over the to the right of a row for further definition of the information displayed.

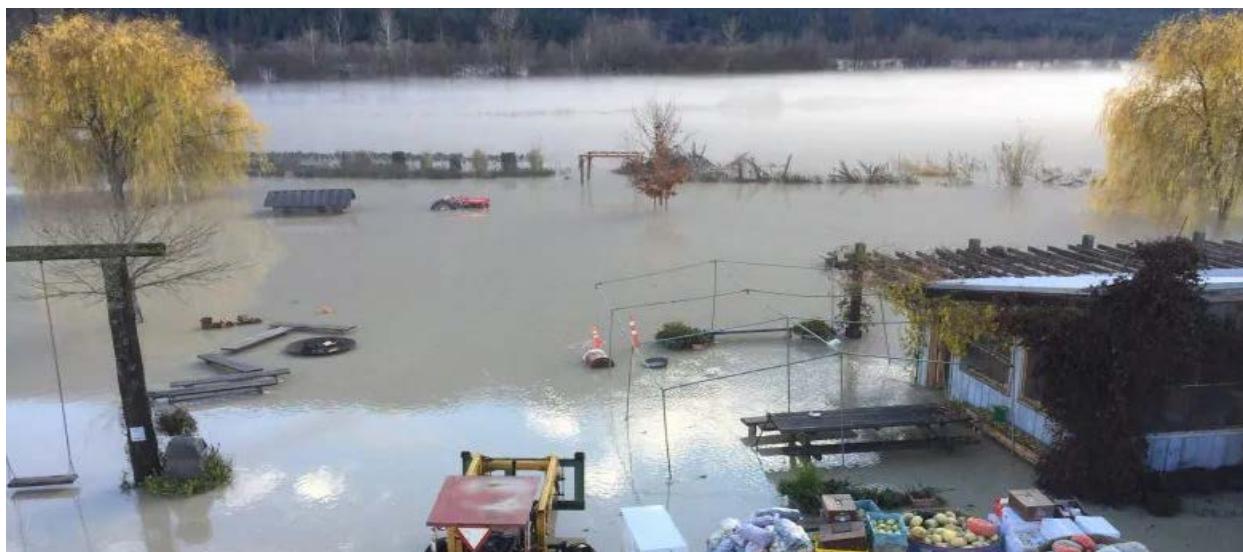
**Figure D-1. Damage from flooding of Lillooet River in Pemberton, BC (CBC, November 10, 2016).**

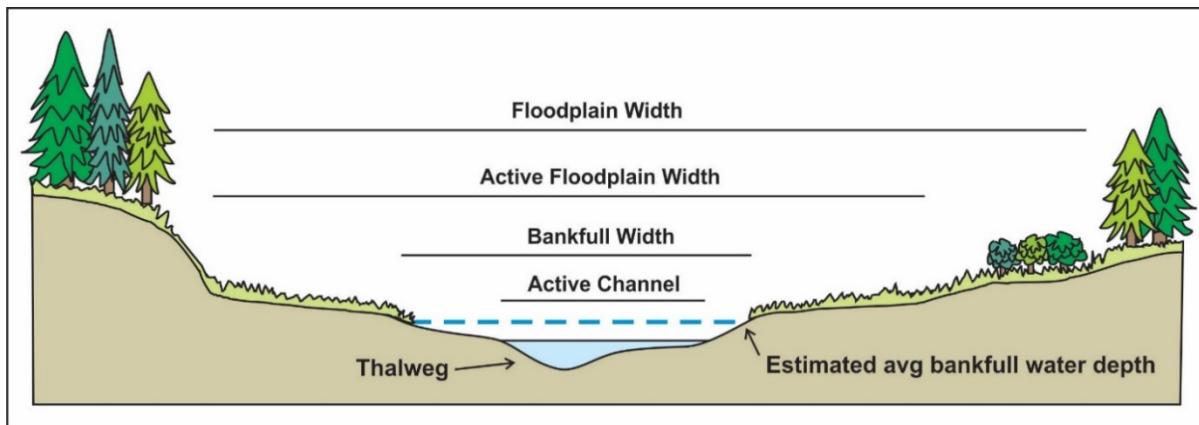
**Figure D-2. Conceptual channel cross-section in a typical river valley.**

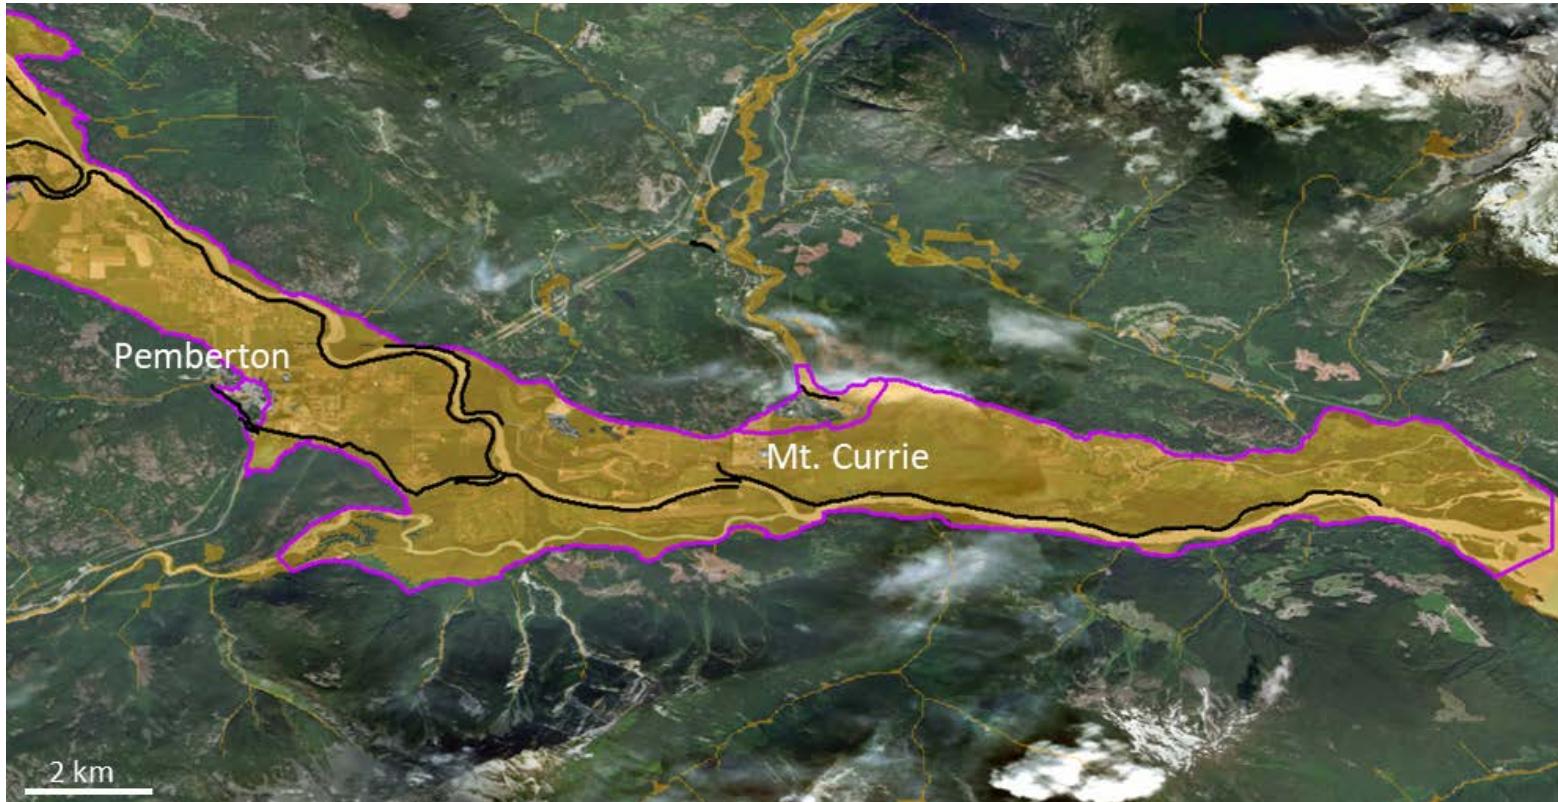
**Figure D-3.** Example spatial sources used to identify clear-water flood hazards in the SLRD including historical floodplain mapping (purple outlines) and predicted floodplain extents for streams and lakes without existing floodplain mapping (transparent orange areas). Locations of known flood protection structures (black line) were inventoried but not prioritized. Refer to Section D.2.4 for a description of the methods used for predicting floodplain extents.

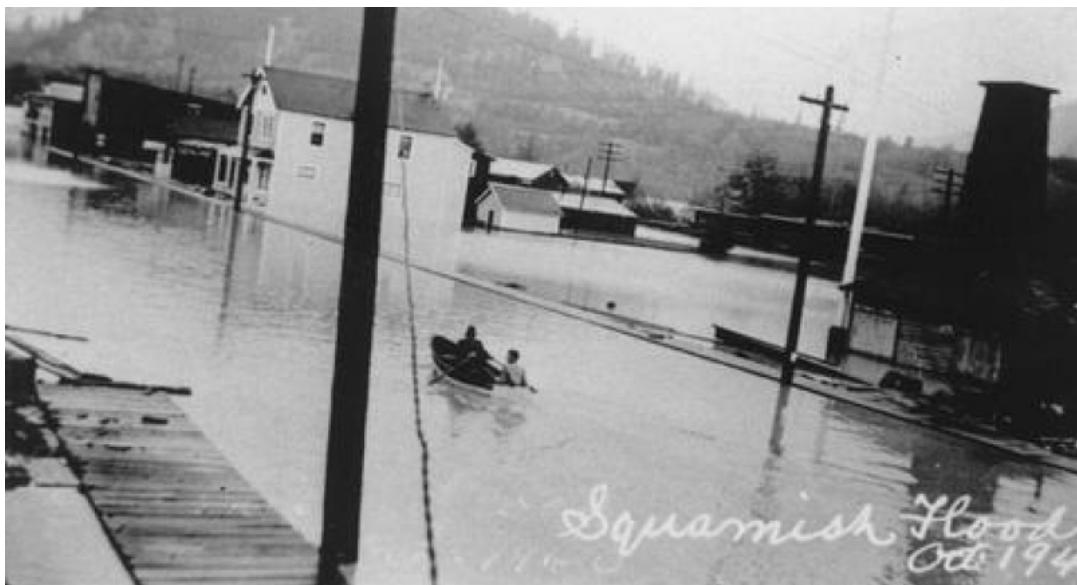
**Figure D-4. Flood event of October 1940 when the Squamish River topped its banks and sent flood water into downtown Squamish, BC after five inches of rain fell within 24 hours. (The Squamish Chief, November 8, 2018).**

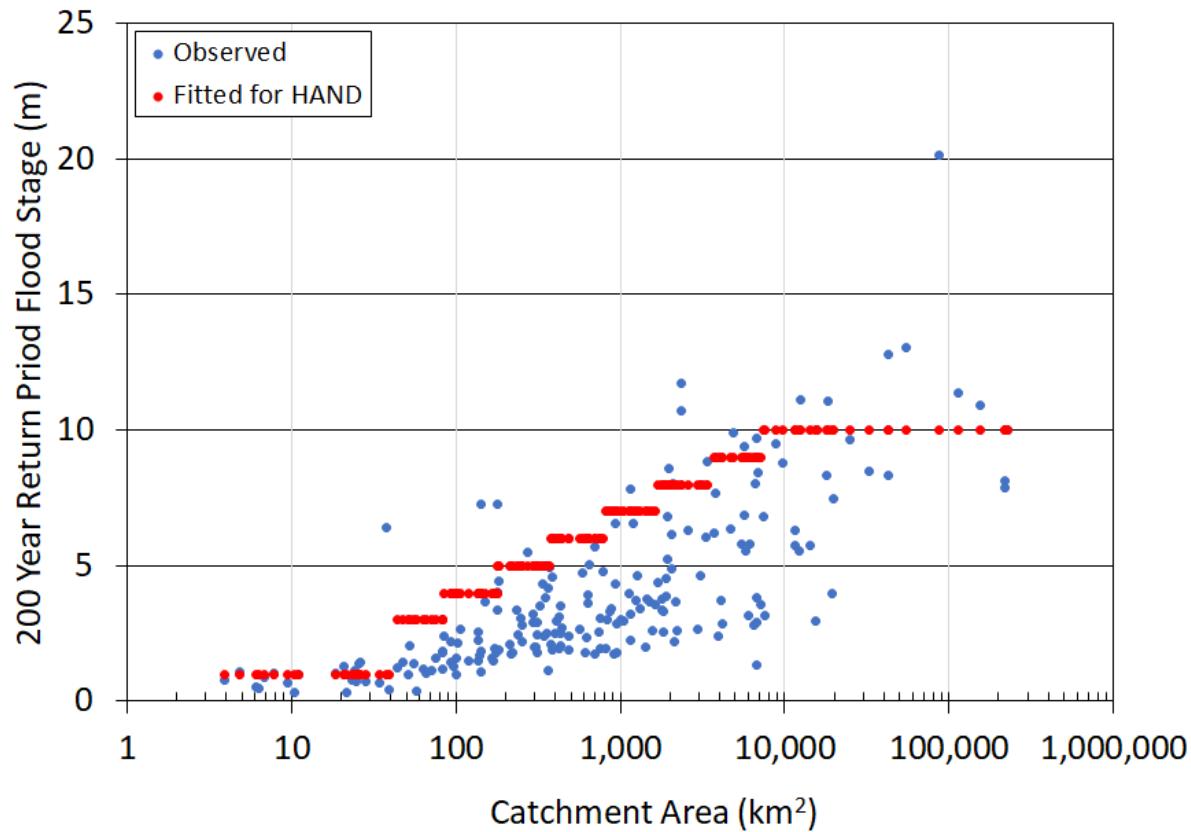
**Figure D-8.** 200-year return period flood stage versus catchment area for 205 WSC hydrometric gauging stations in southern BC. Red dots represent the curve fitted to observed values to relate catchment area to flood stage for estimating HAND flood depths.

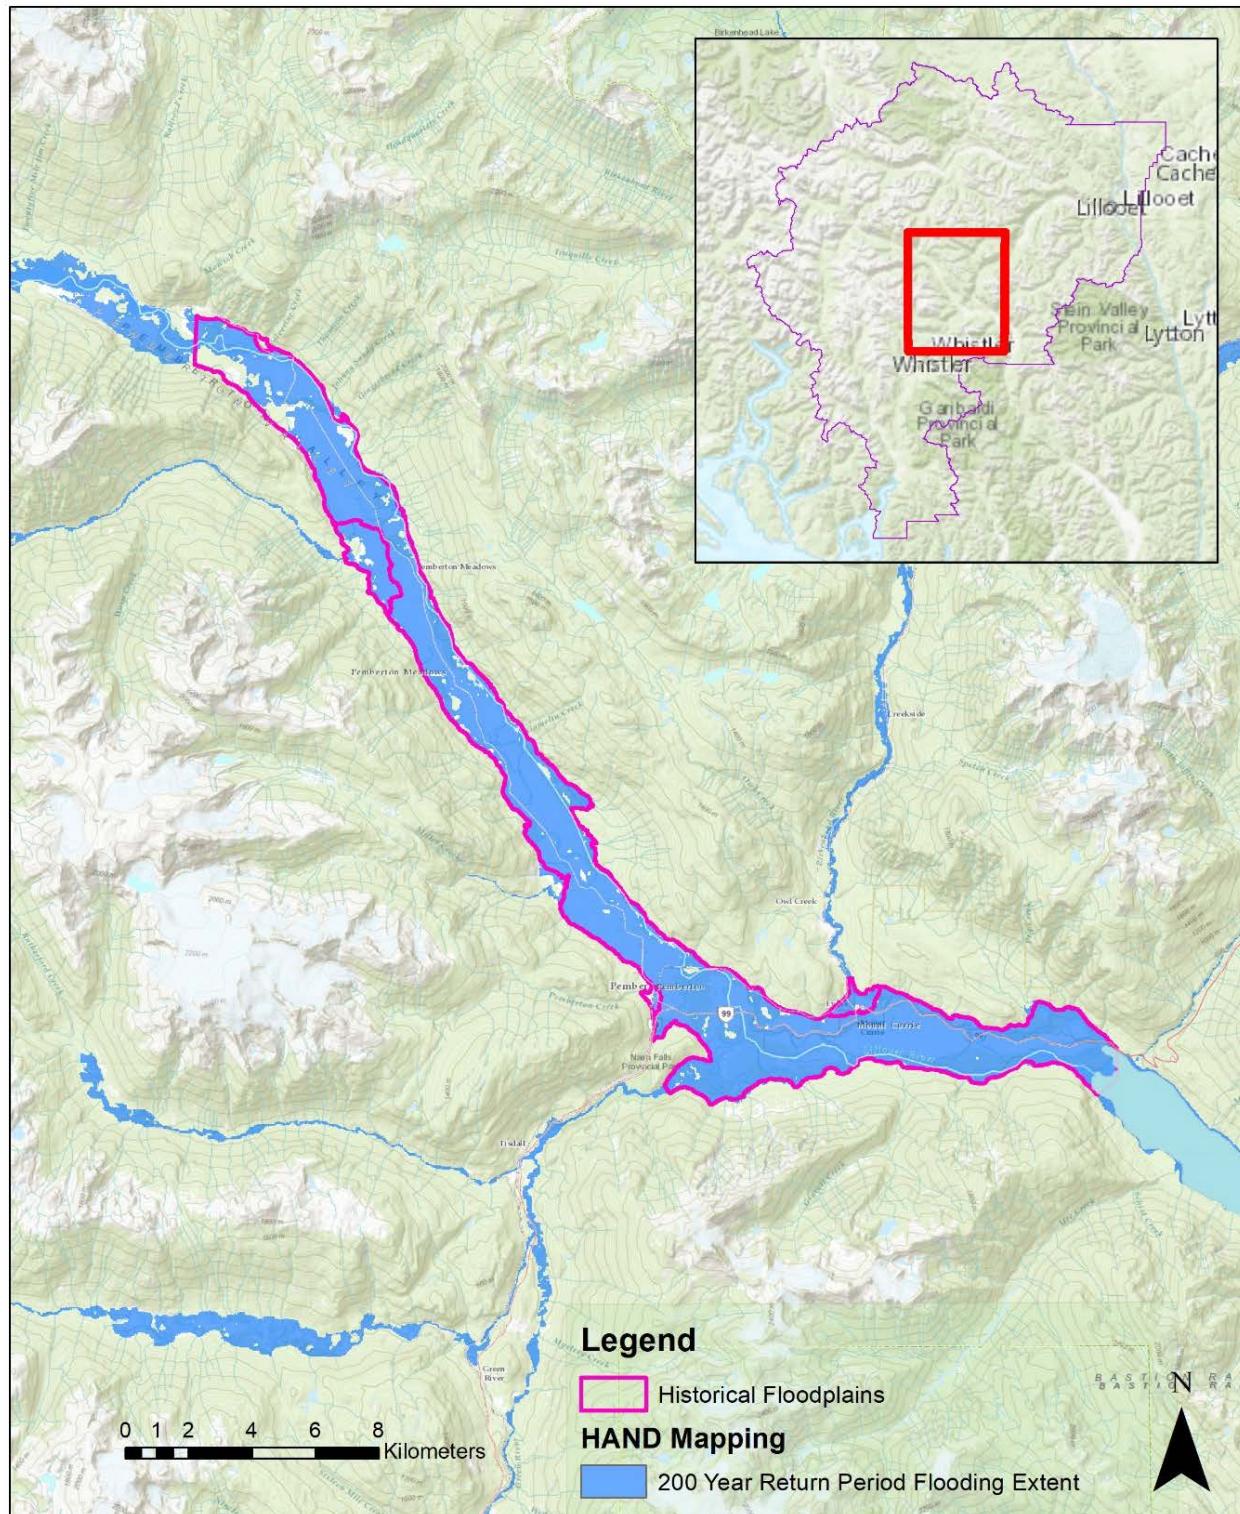
**Figure D-9. Comparison between the historical floodplain mapping and the 200-year return period flooding extents based on the HAND mapping for the Lillooet River.**

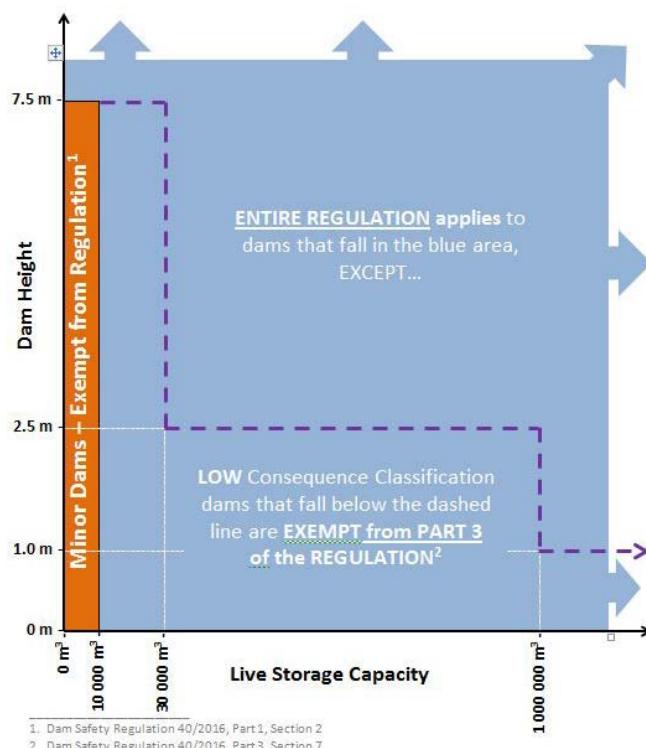
**Figure D-10. Dam height (m) versus dam live storage capacity (m<sup>3</sup>) as defined by the *Dam Safety Regulation*, BC Reg 40/2016, which along with the dam failure consequence classification determines which portion of the Regulation applies to the dam.**

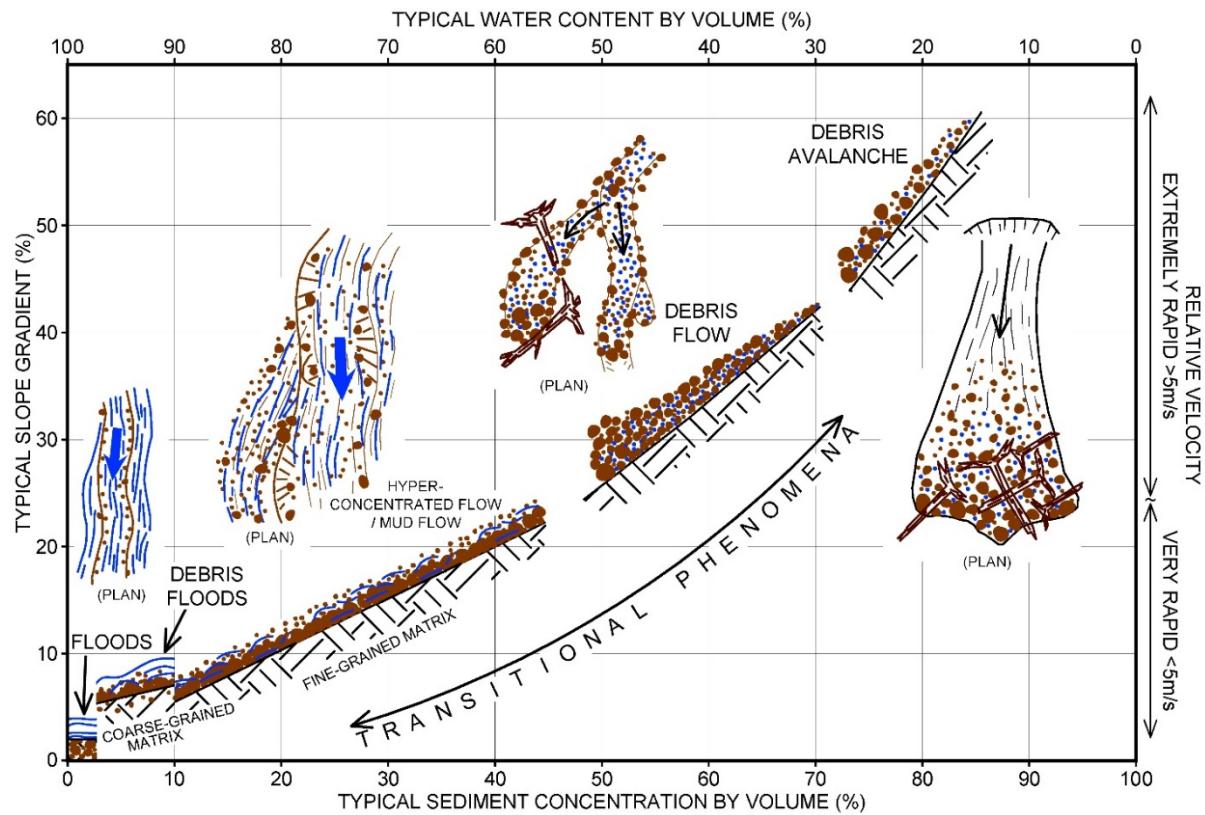
**Figure E-1. Hydrogeomorphic process classification by sediment concentration, slope velocity and planform appearance.**

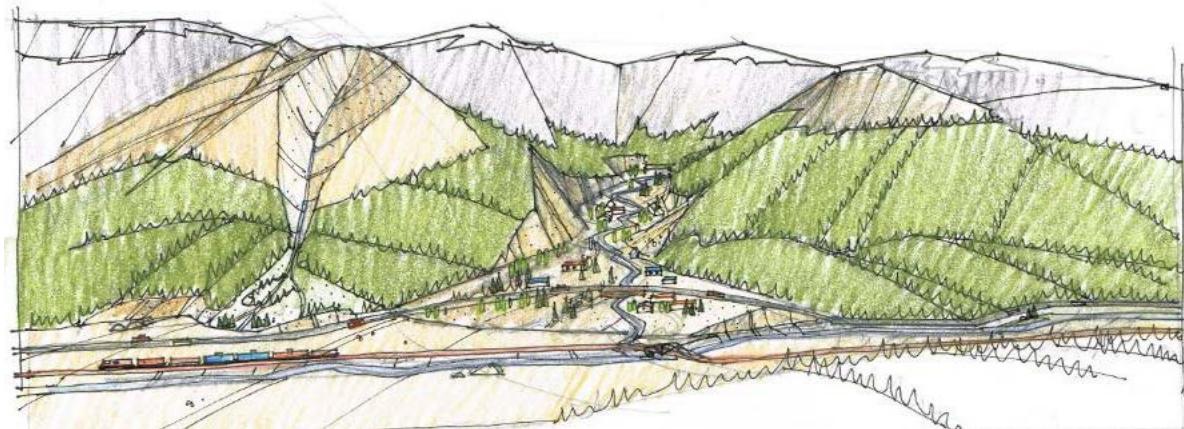
**Figure E-3.** Typical steep and low-gradient fans feeding into a broader floodplain. On the left a small watershed prone to debris flows has created a steep fan that may also be subject to rock fall processes. On the right a larger watershed prone to debris floods has created a lower gradient fan. Development and infrastructure are shown to illustrate their interaction with steep creek geohazard events. Artwork: Derrill Shuttleworth.

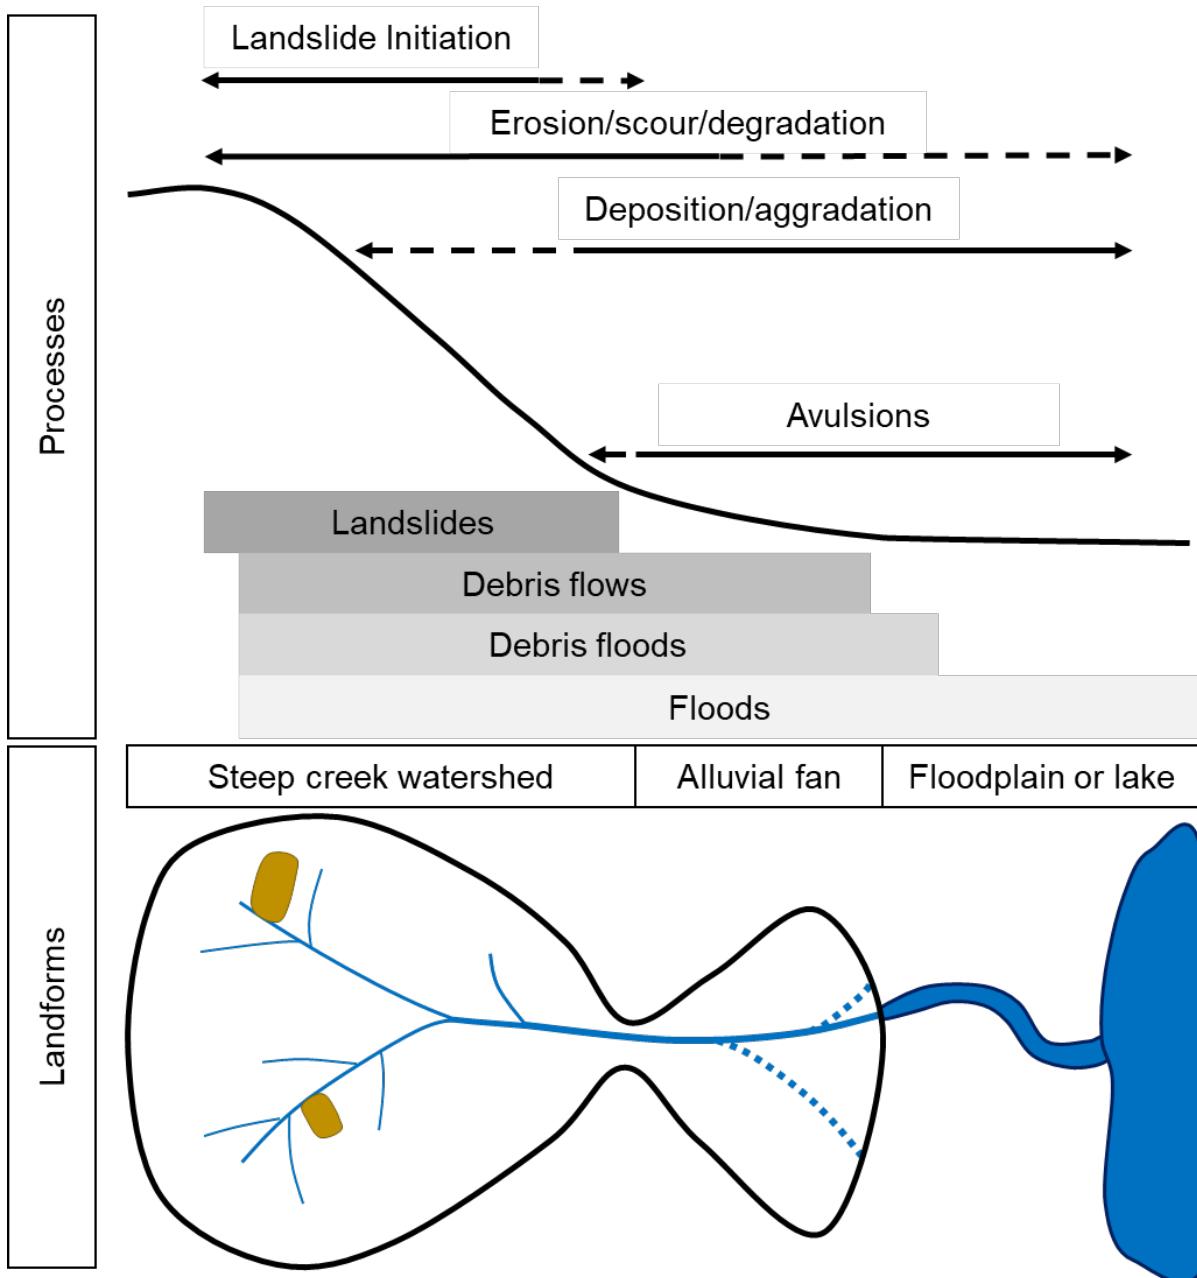
**Figure E-4.** Schematic diagram of a steep creek watershed system that shows the principal zones of distinctive processes and sediment behaviour. The alluvial fan is thought of as the long-term storage landform with a time scale of thousands to tens of thousands of years. Sketch developed by BGC from concepts produced by Schumm (1977), Montgomery & Buffington (1997), and Church (2013).

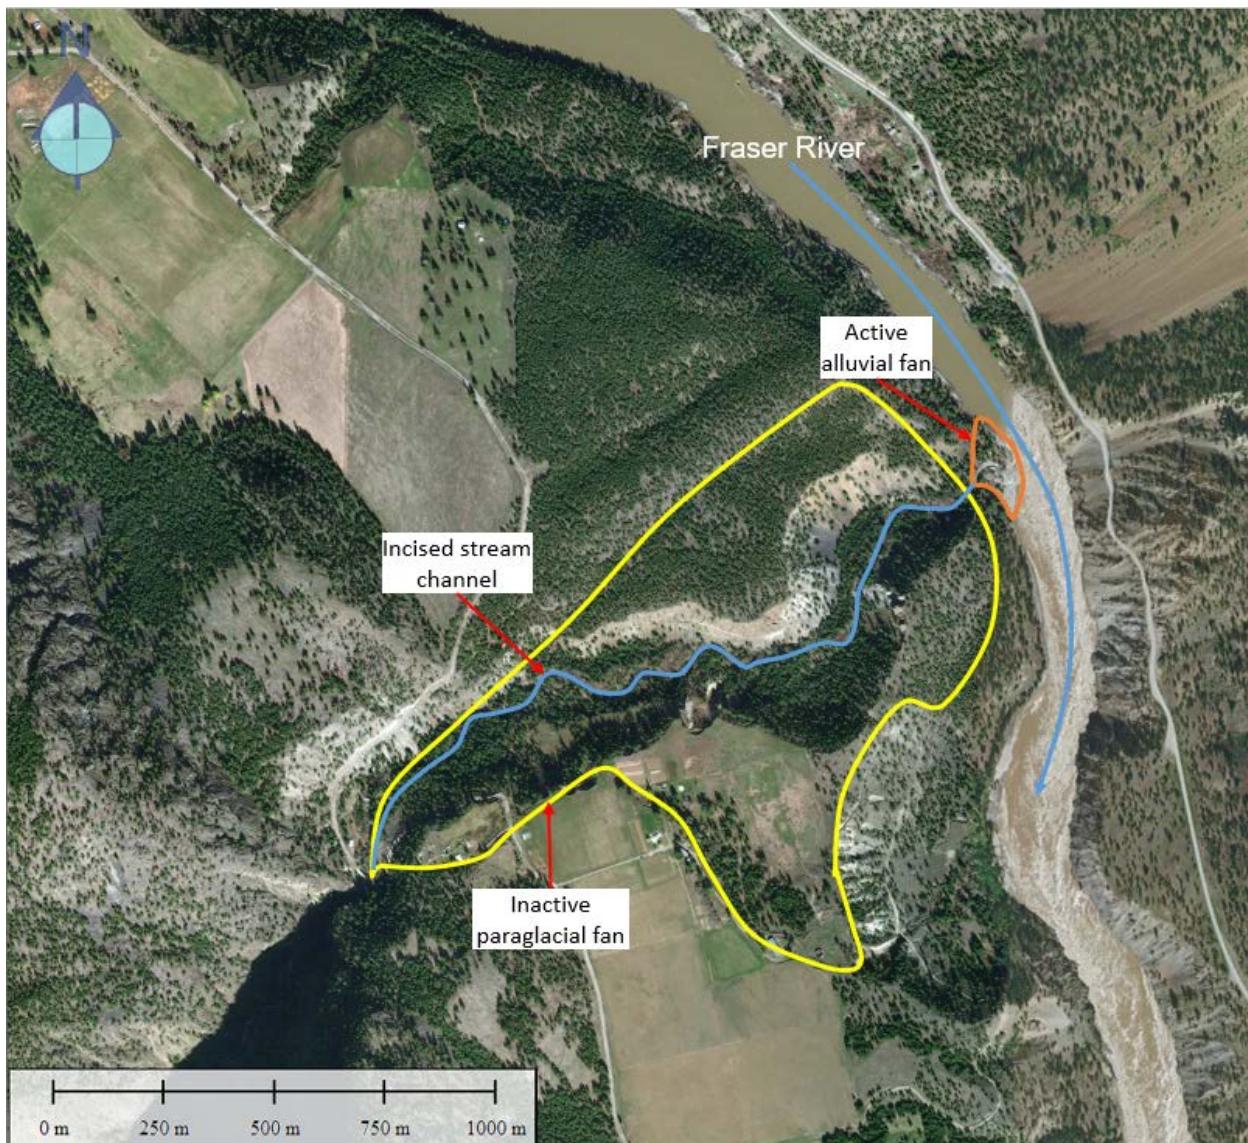
**Figure E-5.** Example of an inactive paraglacial fan and active alluvial fan on Texas Creek, near Lillooet. The distinction of the paraglacial fan being classified as an inactive paleofan is due to the incised stream channel. The inactive paraglacial fan and active alluvial fan delineated in this example are for illustration only and are not part of the inventory.
