**SQUAMISH-LILLOOET REGIONAL DISTRICT**

# **Geohazard Risk Prioritization**

**FINAL**  
**April 10, 2020**

Prepared by BGC Engineering Inc. for:  
**Squamish-Lillooet Regional District**

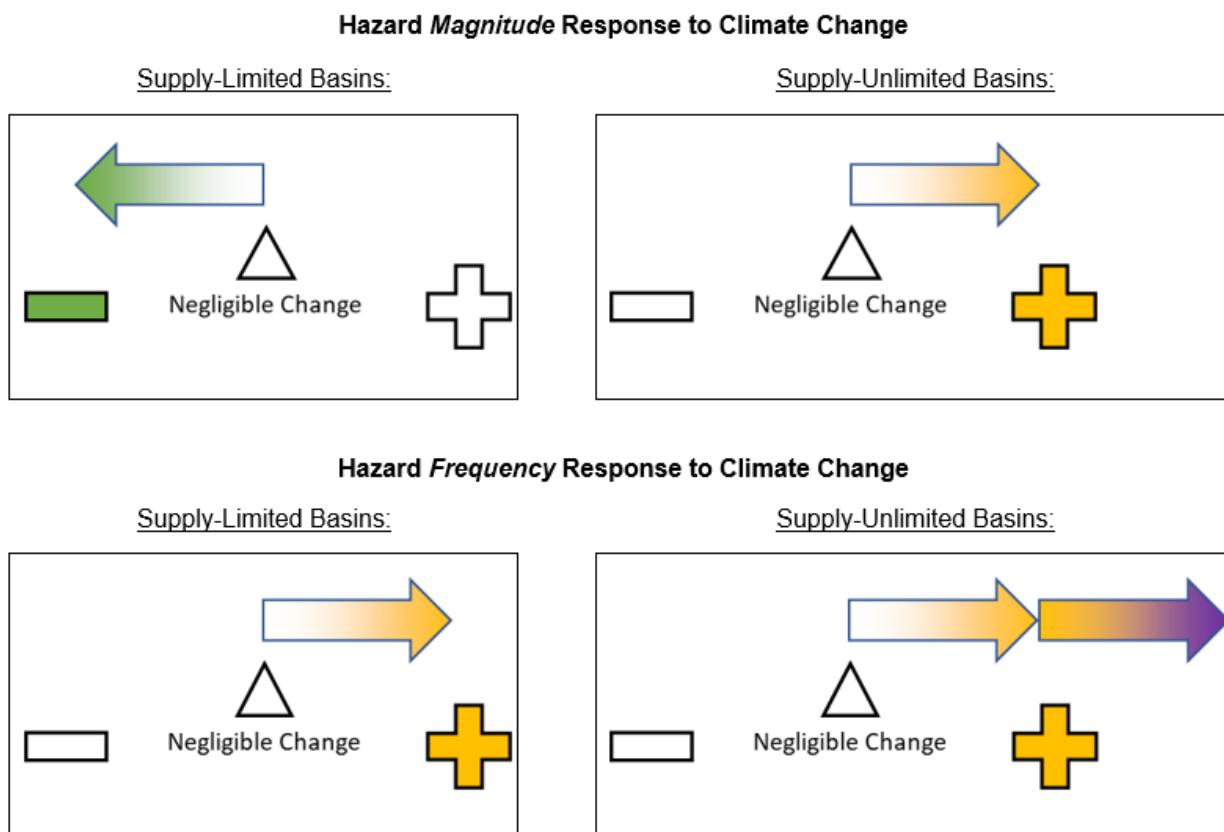
**Figure E-6. Steep creek hazard sensitivity to climate change – supply-limited and supply unlimited basins.**

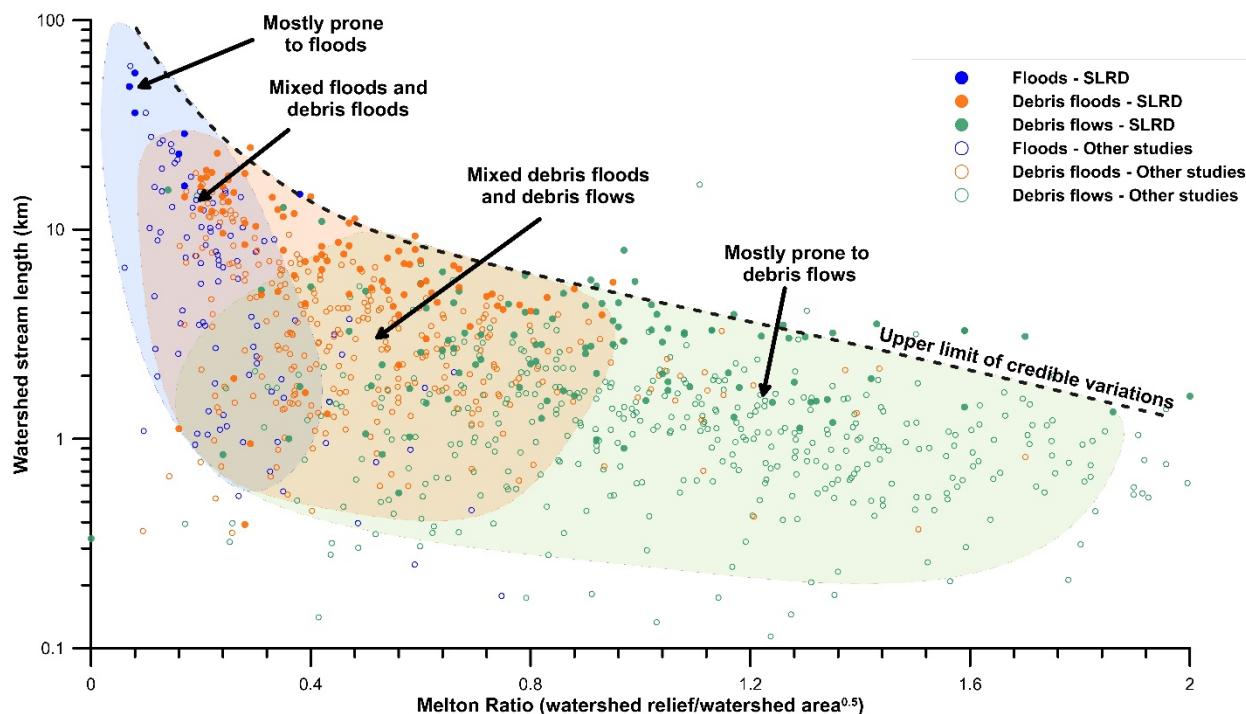
**Figure E-10. Steep creek processes in the SLRD as a function of Melton Ratio and stream length. Process boundaries are derived from this study and additional fans in Alberta and BC (Holm et al., 2016, Lau, 2017).**

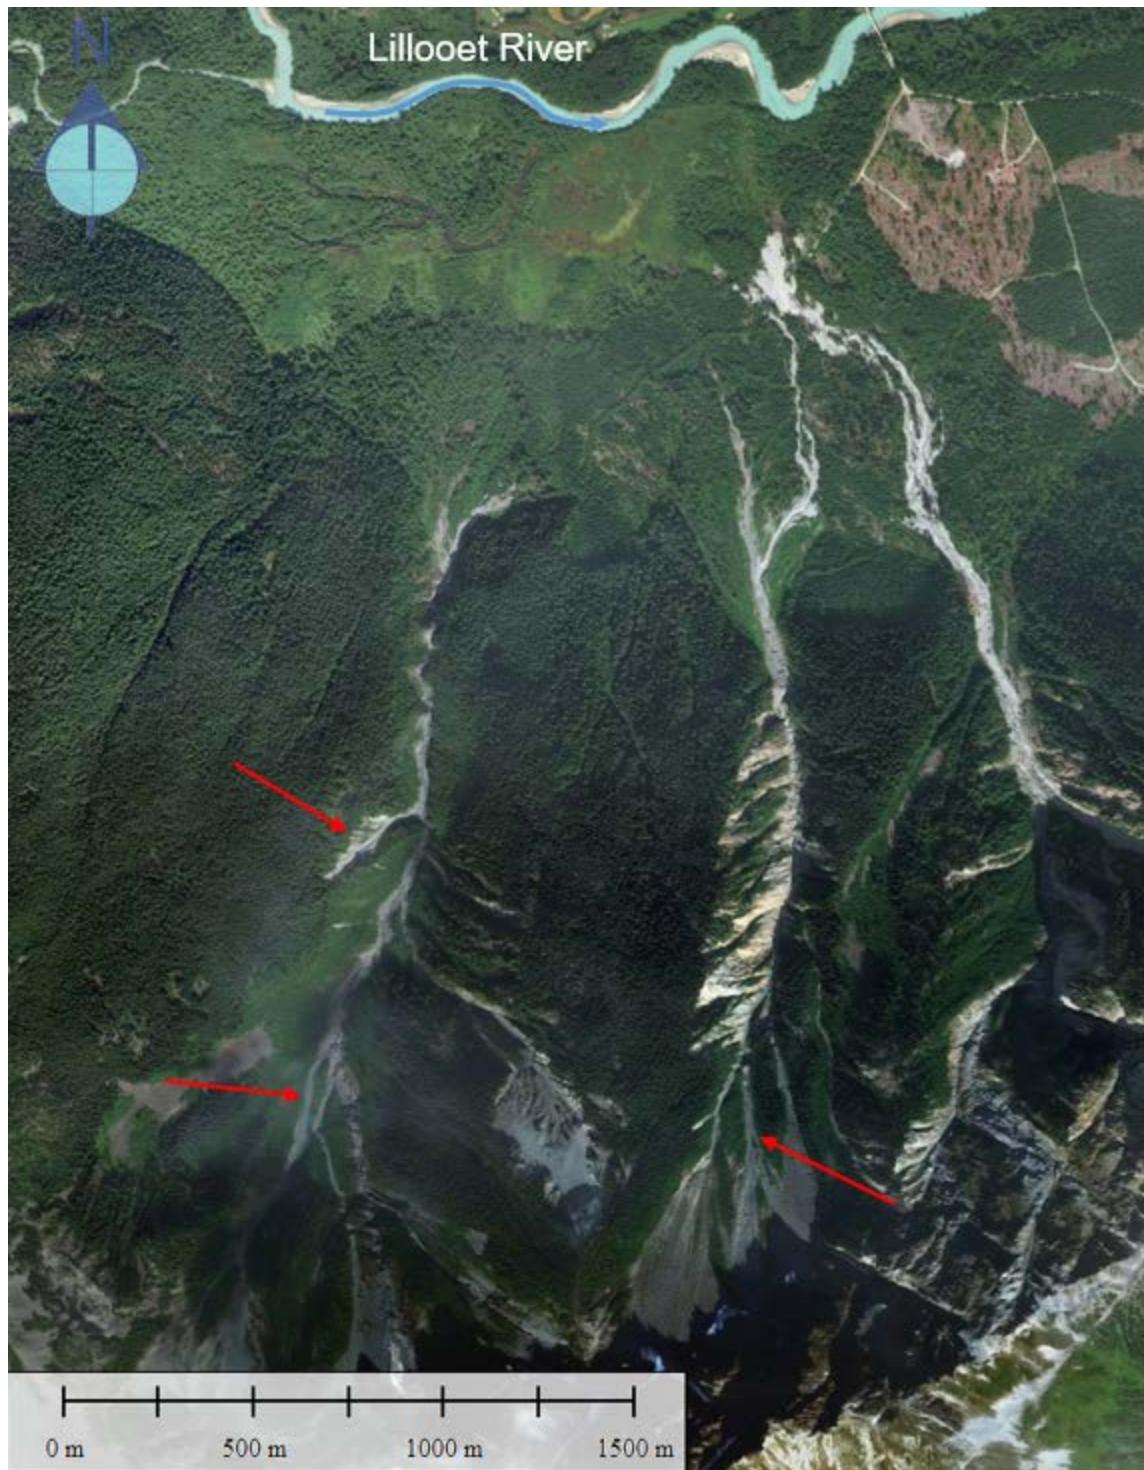
**Figure E-11.** Example of evidence for recent landslide or in-channel debris-flow initiation (red arrows) within the basin of unnamed creeks on Mount Currie, south of Pemberton (Imagery: DigitalGlobe, 2014).

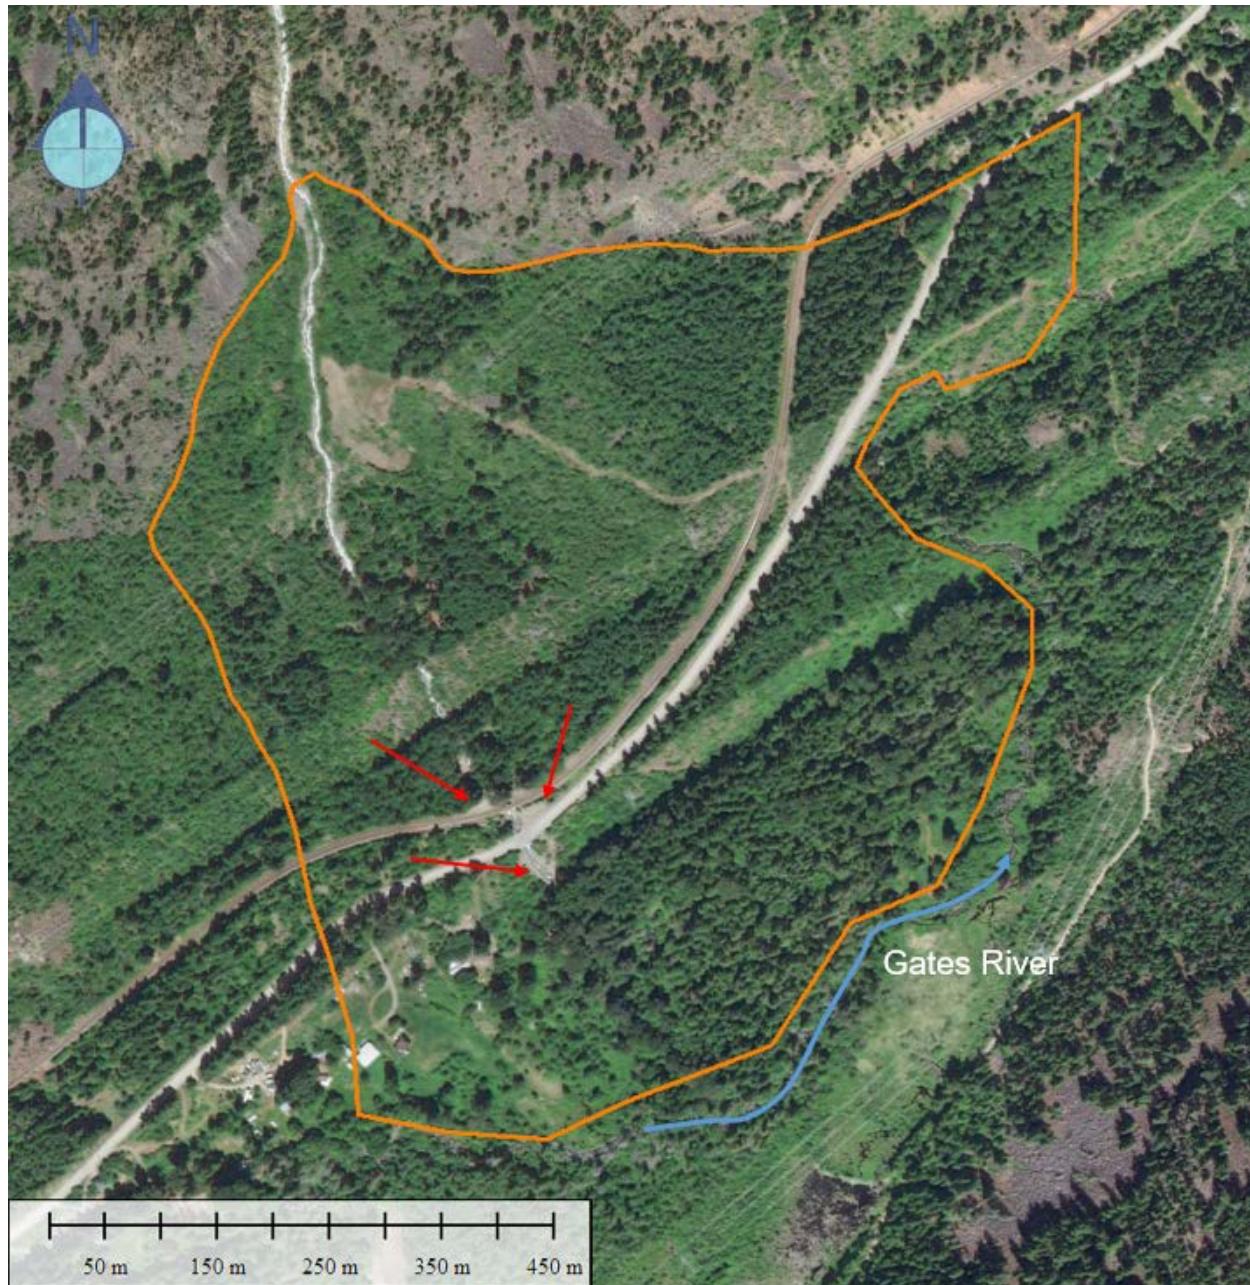
**Figure E-12.** Example of evidence (red arrows) for a recent (2015) debris-flow deposit on Neff Creek, located north of Pemberton. The approximate alluvial fan boundary is shown in orange (Imagery: DigitalGlobe, 2015).

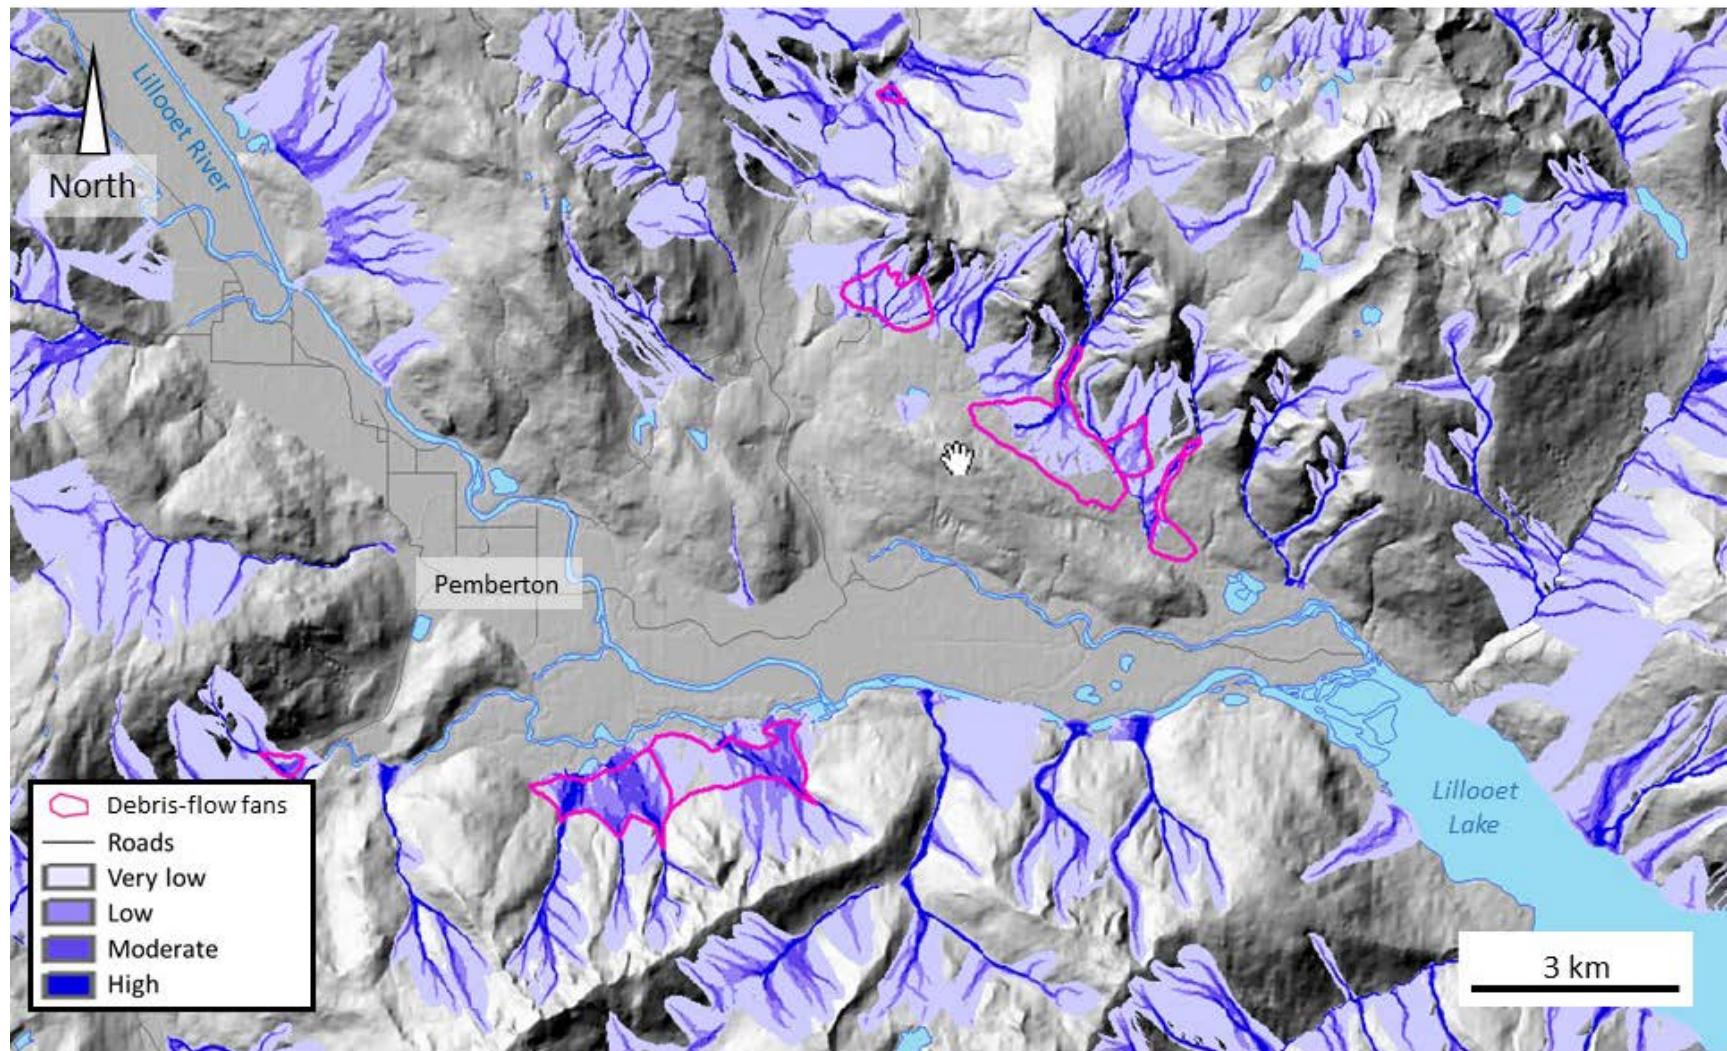
Figure E-14. Debris-flow susceptibility map for a section of the study area showing the spatial distribution of the four different susceptibility classes and developed debris-flow fans.

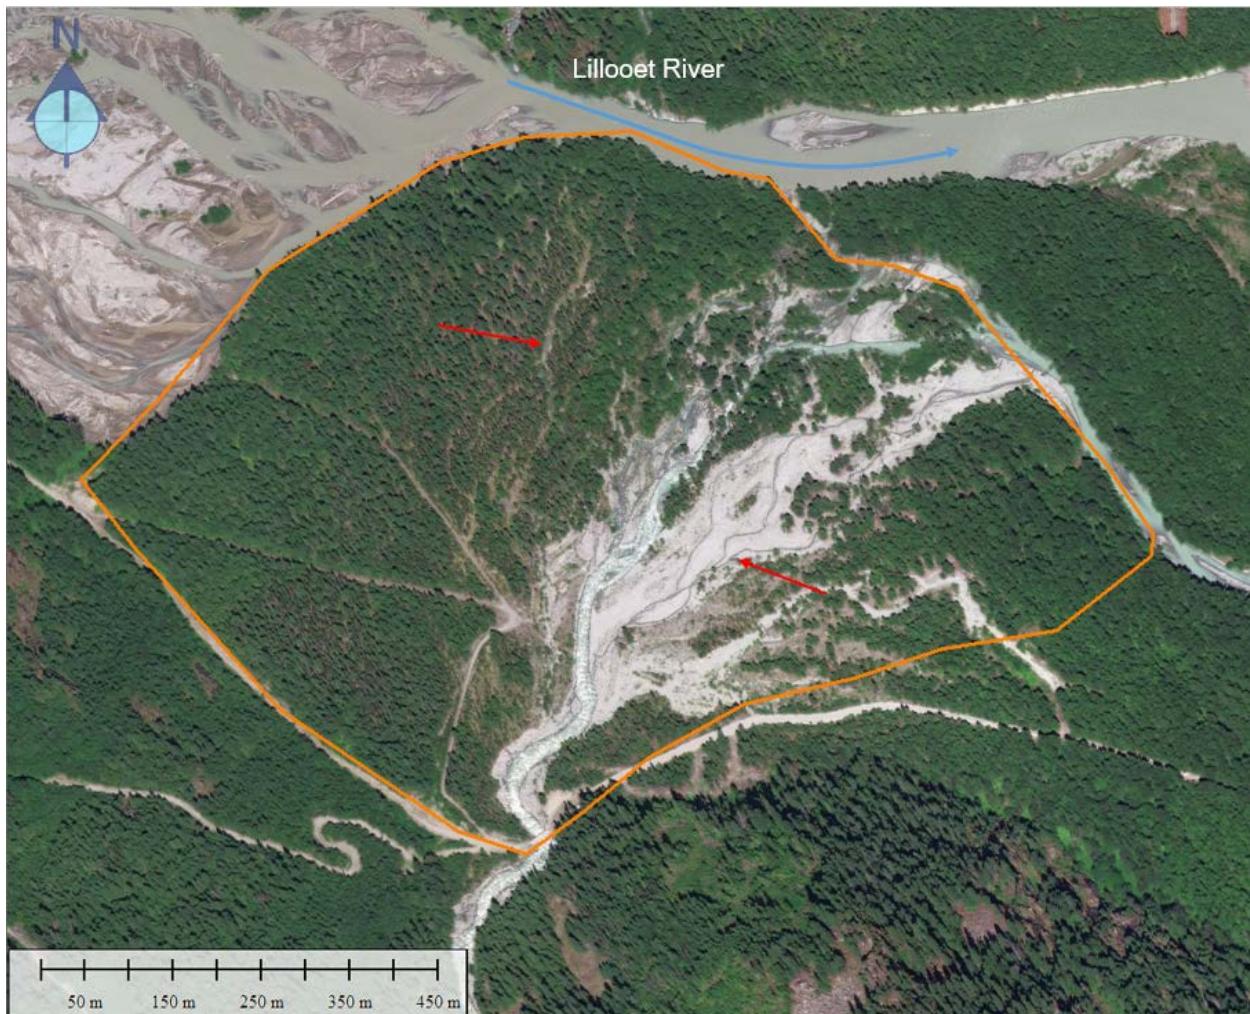
**Figure E-15. Example of high evidence for previous avulsion on South Creek, located west of Pemberton. The approximate fan boundary is shown in orange.**

BGC used terrain interpretations of evidence of previous avulsions and description of potential avulsion mechanisms to assess the potential for avulsion to impact elements at risk at each fan. Surface evidence for previous avulsions includes vegetation and the presence of relict channels, lobes and deposits on the fan surface (Table E-13; Figure E-15). These features are usually detectable on lidar hillshades; interpretations are less certain for areas without lidar coverage. The rating is subject to greater uncertainty where development has obscured previous evidence for flow avulsions (e.g., channel modification or highly developed fans).

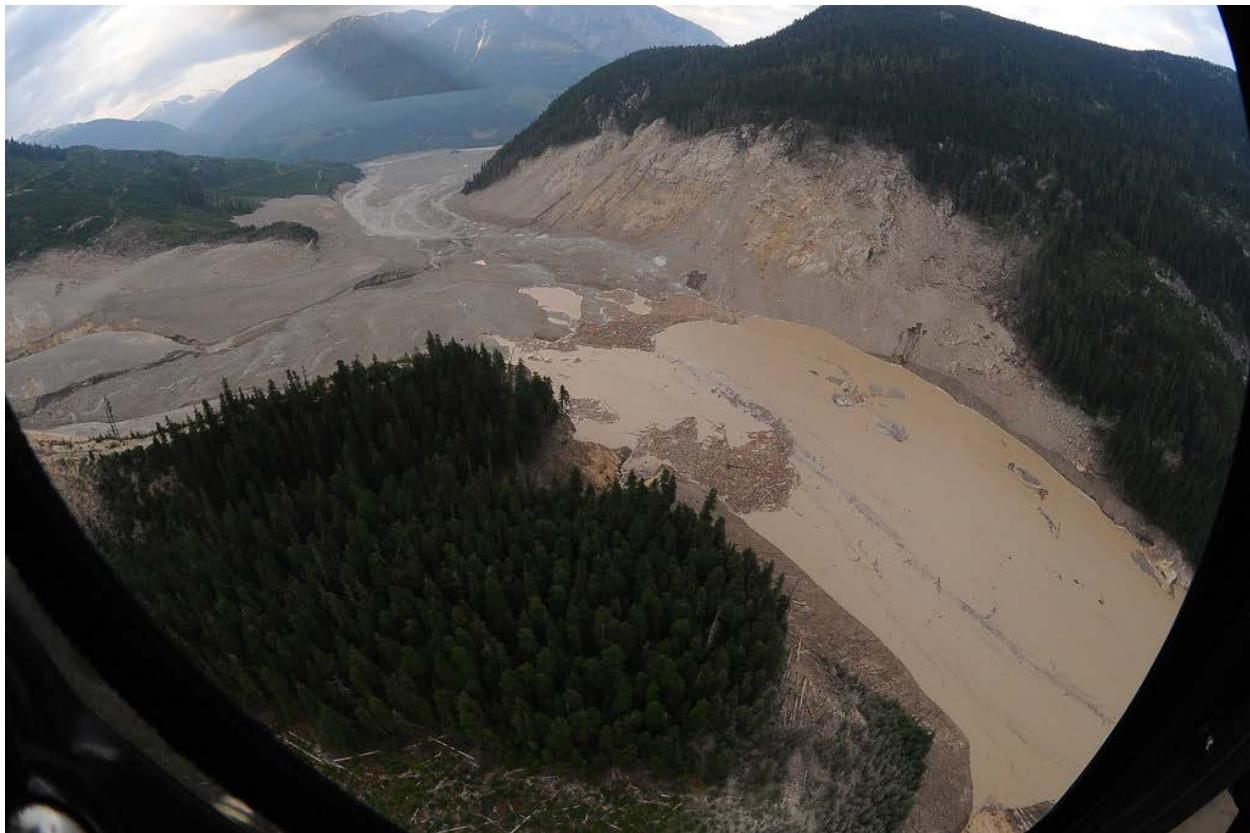
**Figure E-16. Landslide dam on Meager Creek from the August 6, 2010 rockslide-debris flow from Capricorn Creek. The dam impounded Meager Creek for some time. Photo by D. Steers.**

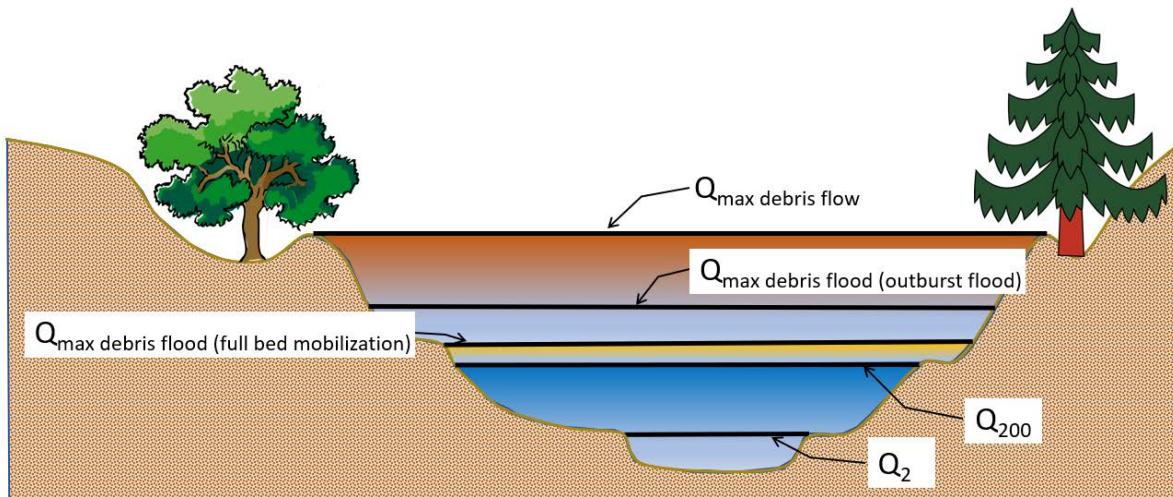
**Figure E-17. Steep creek flood profile showing schematically peak flow levels for different events.**

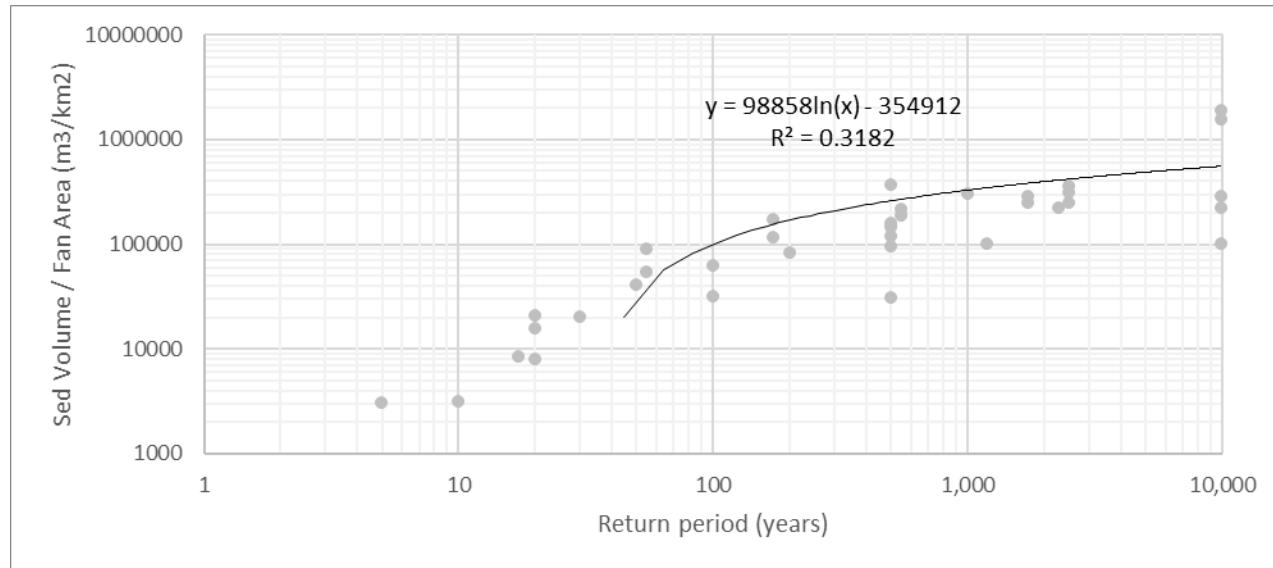
**Figure E-19. F-M curve for debris flows in southwestern British Columbia using data from ten study creeks. Curves are truncated at the 40-year return period (Jakob et al., 2020).**

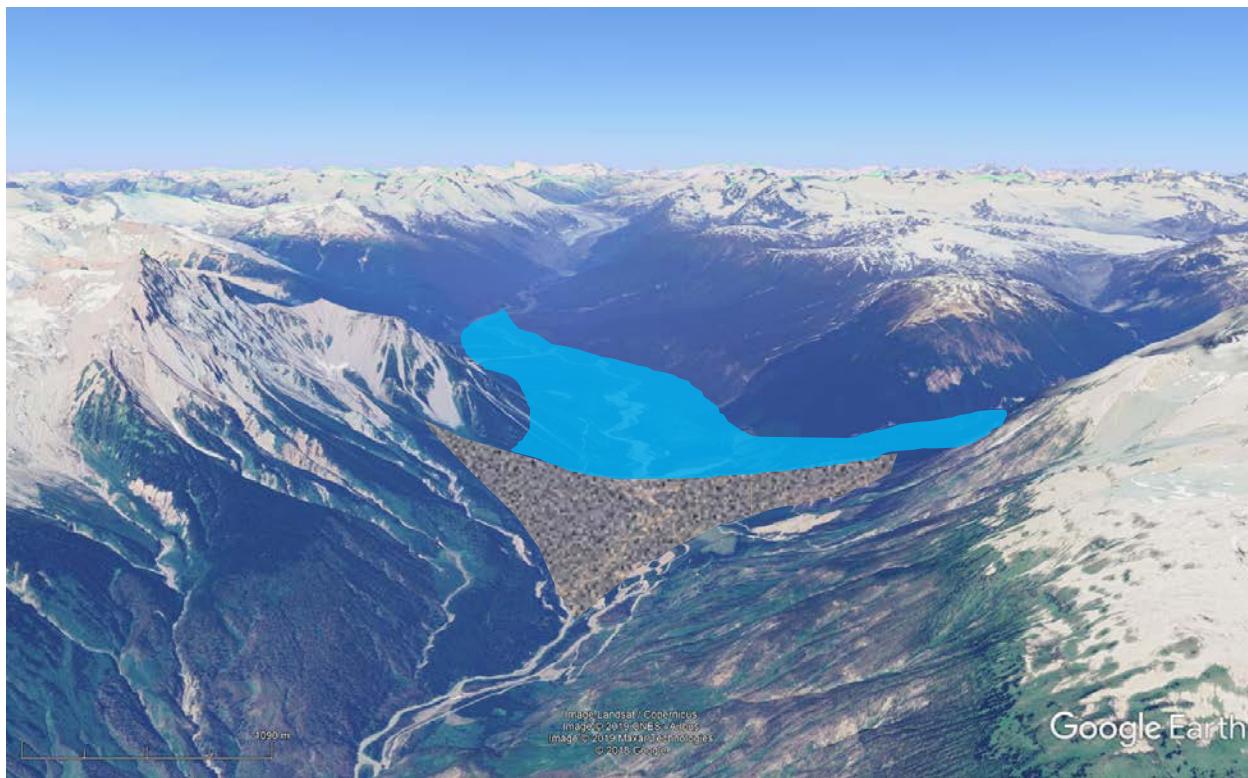
**Figure F-1. Upper Lillooet River Valley with Plinth Peak on the left. The sketched outline shows a past landslide dam and the possible extent of a rock avalanche from the north flanks of Plinth Peak.**

An LDOF is a flooding event that can occur when a landslide blocks the flow of a watercourse (e.g., stream or river) leading to the impoundment of water on the upstream side of the dam and potentially the rapid release of the impounded water due to dam failure. Figure F-1 provides an example in the upper Lillooet River valley. The formation and failure of a landslide dam is a complex geomorphic process because it involves the interaction of multiple geomorphic hazards. For this part of the project, the 'geohazard' is landslide-dam flooding (both upstream inundation floods and downstream outburst floods). Landslide source areas are considered as part of hazard source identification but are not otherwise characterized or prioritized.

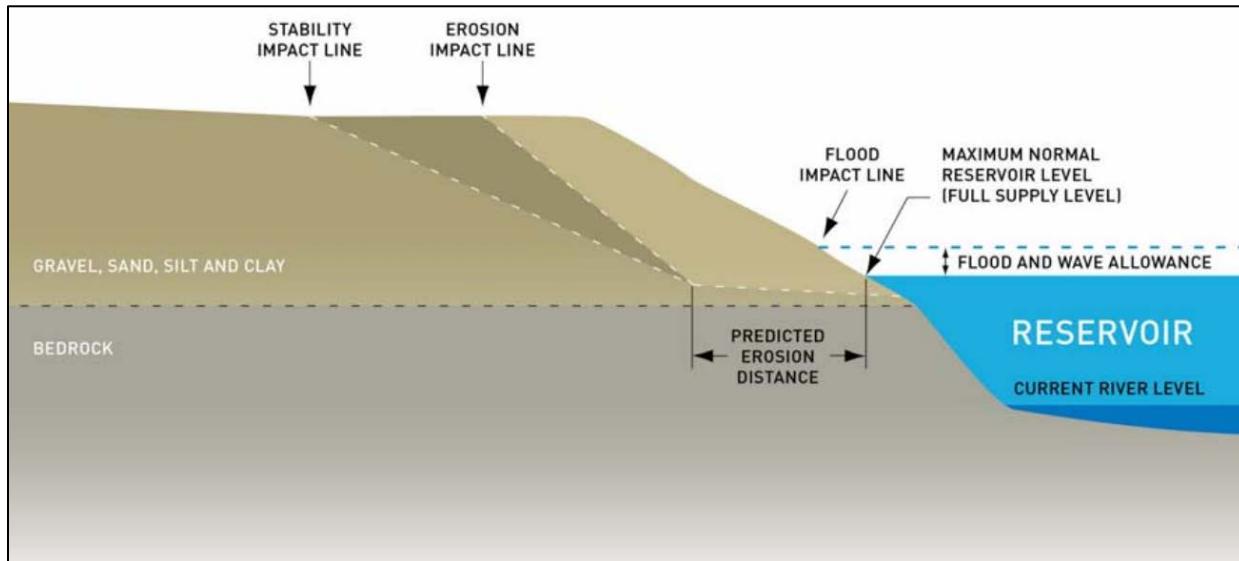
**Figure I-1. Schematic illustration of the Flood, Erosion, and Stability Impact Lines for a typical low bank (top graphic) and high bank (lower graphic) slope (adapted from McDougall et al., 2015).**
