CATILINE CREEK

DEBRIS-FLOW HAZARD AND RISK ASSESSMENT

PROJECT NO.: 1358001
DATE: January 22, 2015
DOCUMENT NO.: 1358-001

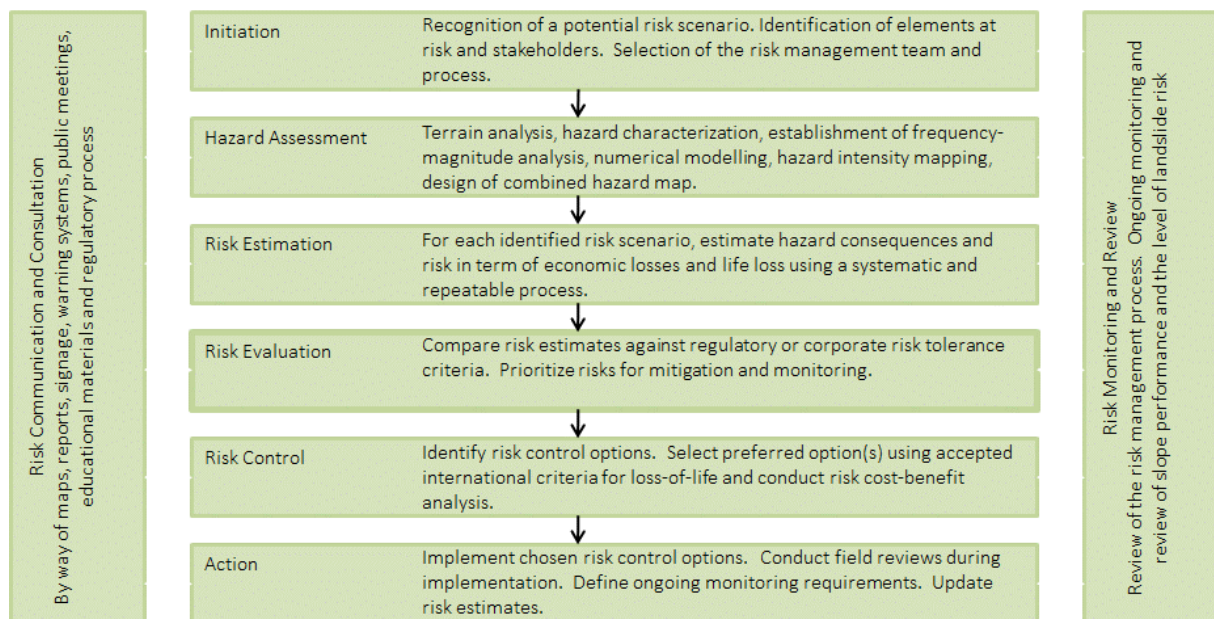
Figure 1-1. Risk management framework (adopted after CSA 1997, AGS 2007, and ISO 31000:2009).

Figure 1-1 provides an overview of a risk management framework, after Canadian Standards Association (CSA 1997), AGS (2007), and ISO 31000:2009. This report includes the first 4 phases and the first part of the 5th phase, identification of risk control options.

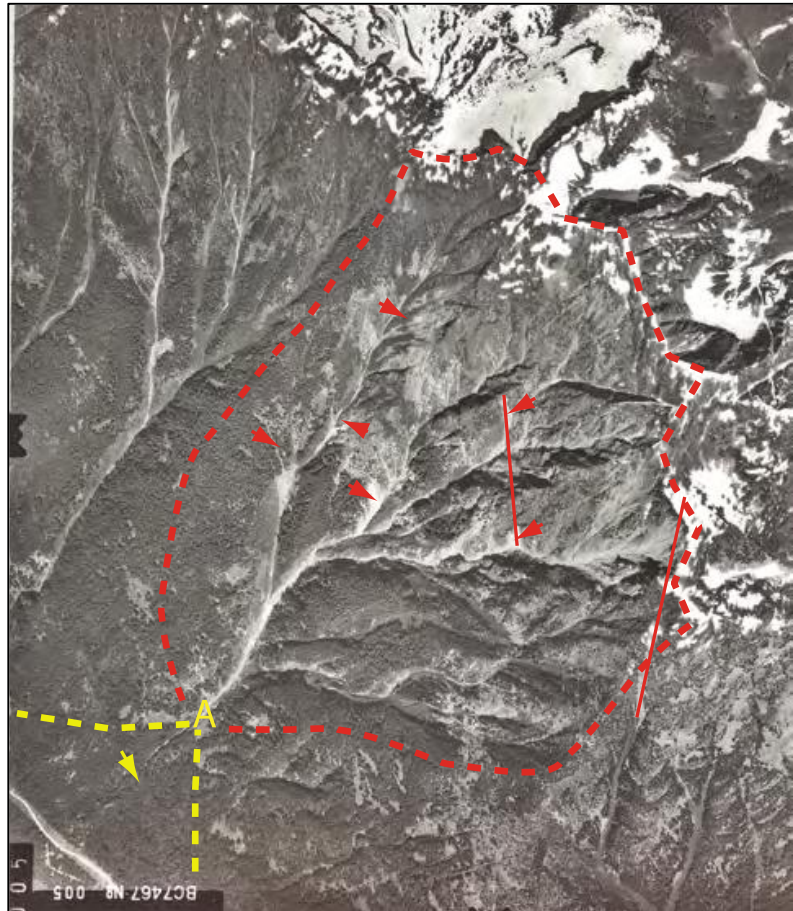
Figure 4-1. View of Catiline Creek basin (red dashed line) and fan (yellow dashed line, A is fan apex) from 1973 airphotos BC7467:4-6 (original scale 1:15,000).

Note fresh scars (red arrows) and bright (whitest) track areas. Disturbance reaches to upper third of fan (yellow arrow). Red lines are bedrock lineations.

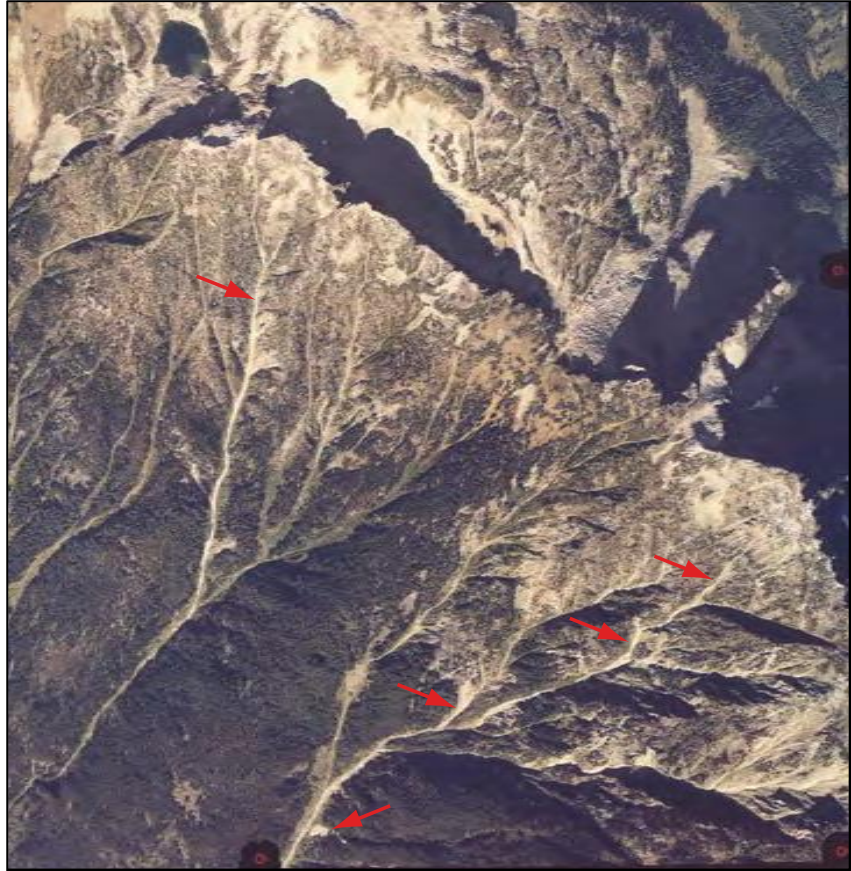
Figure 4-2. Stereo airphoto from October 4, 2004. Debris flow was in July 2004 (see Section 4.4.1).

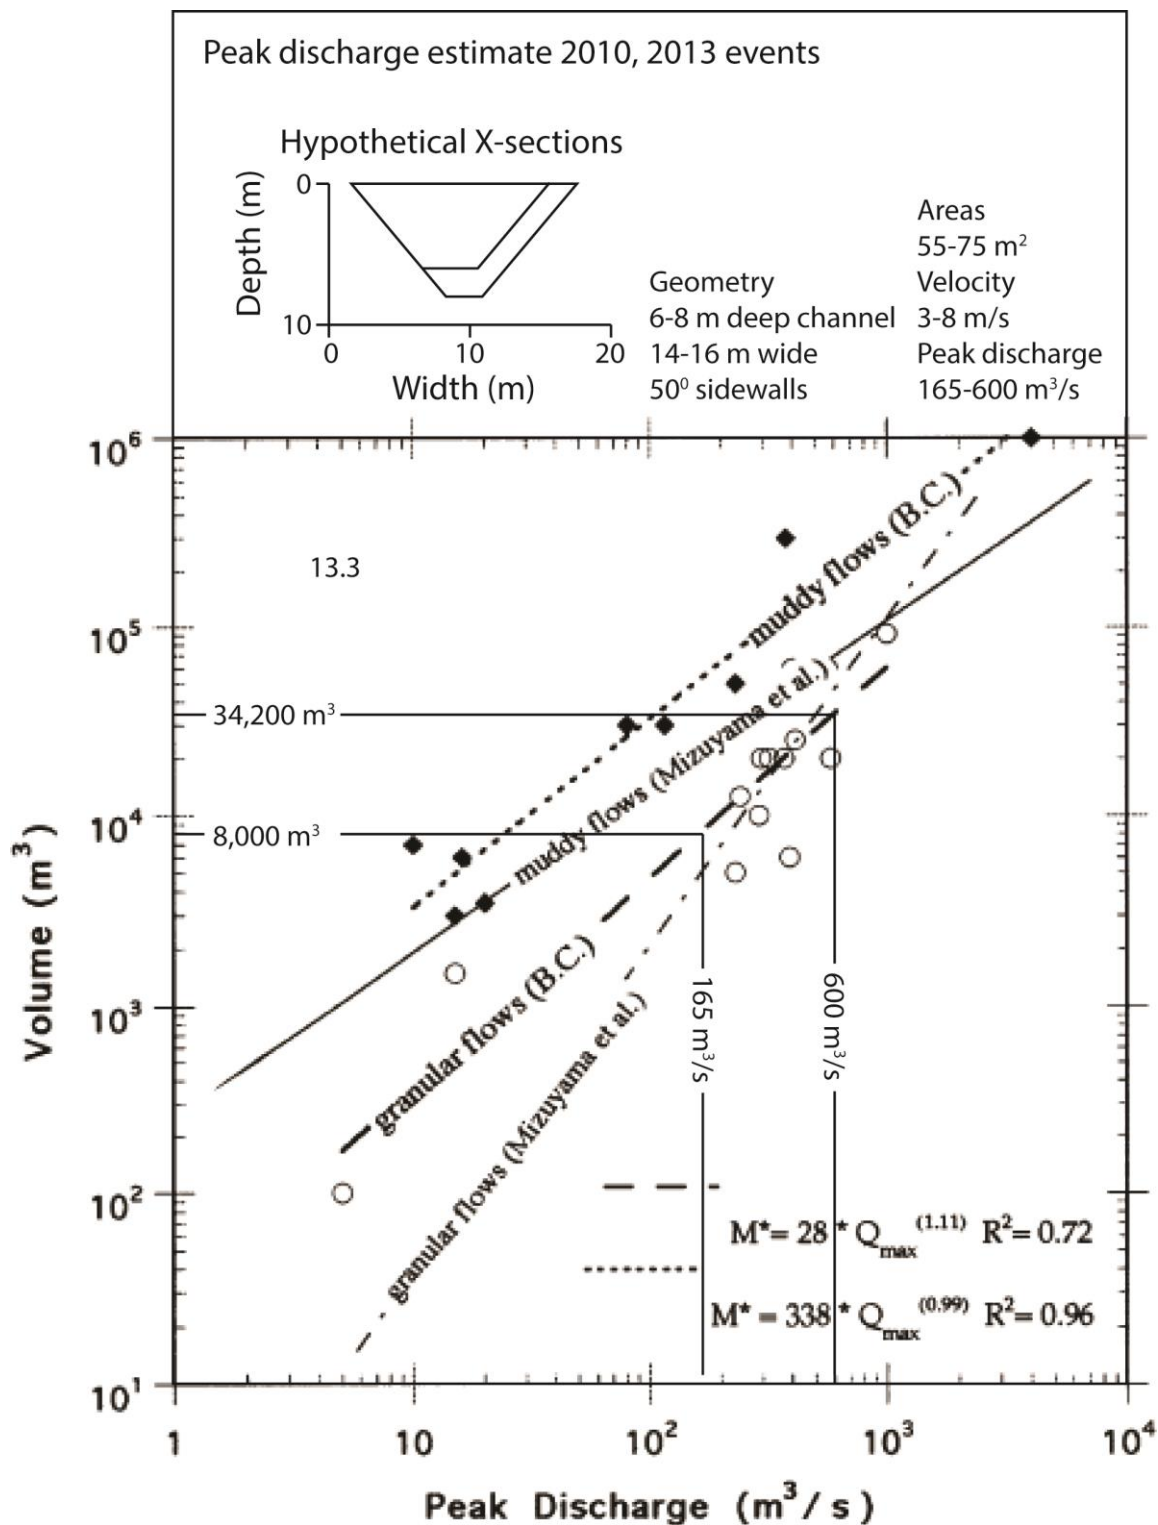
Figure 4-3. Peak discharge-volume estimate for small channelised debris flows on the Catiline Creek fan. Source: Bovis and Jakob (1999).

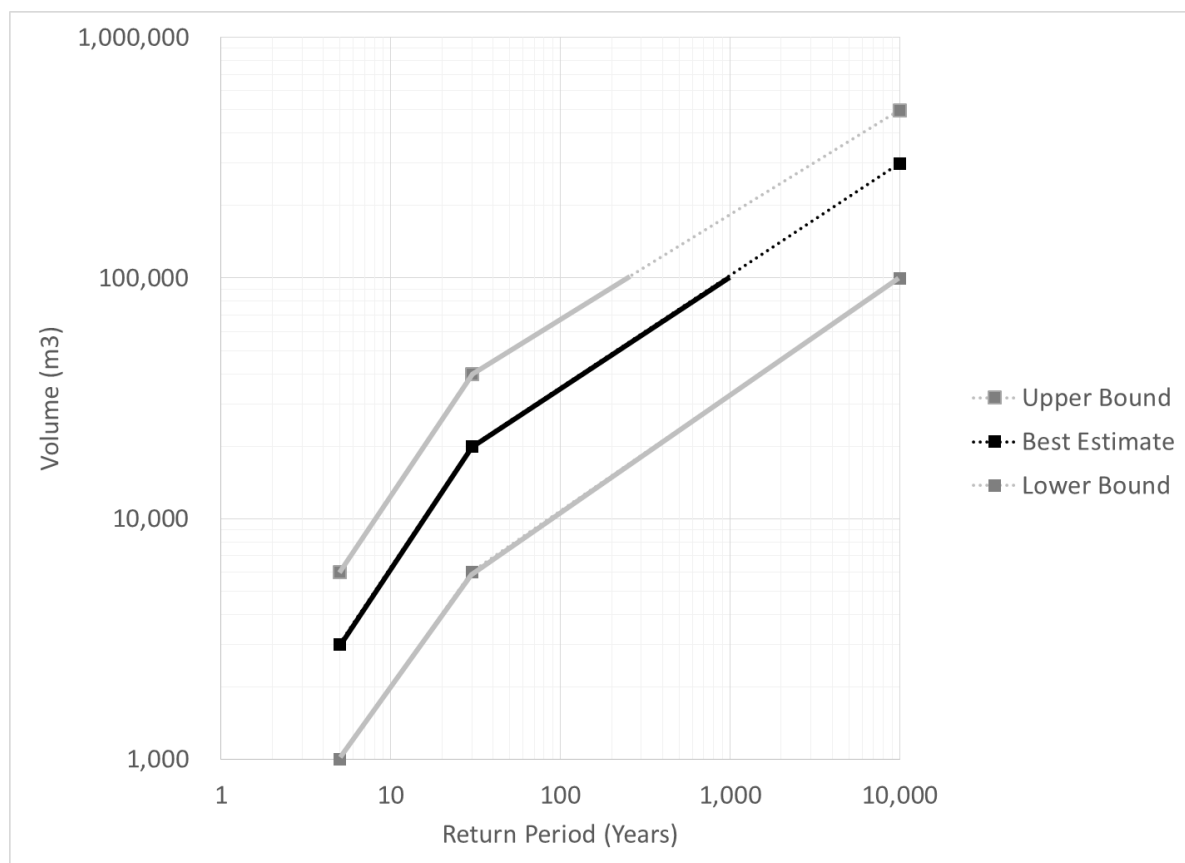
Figure 4-4. Frequency-Magnitude relationship for Catiline Creek.

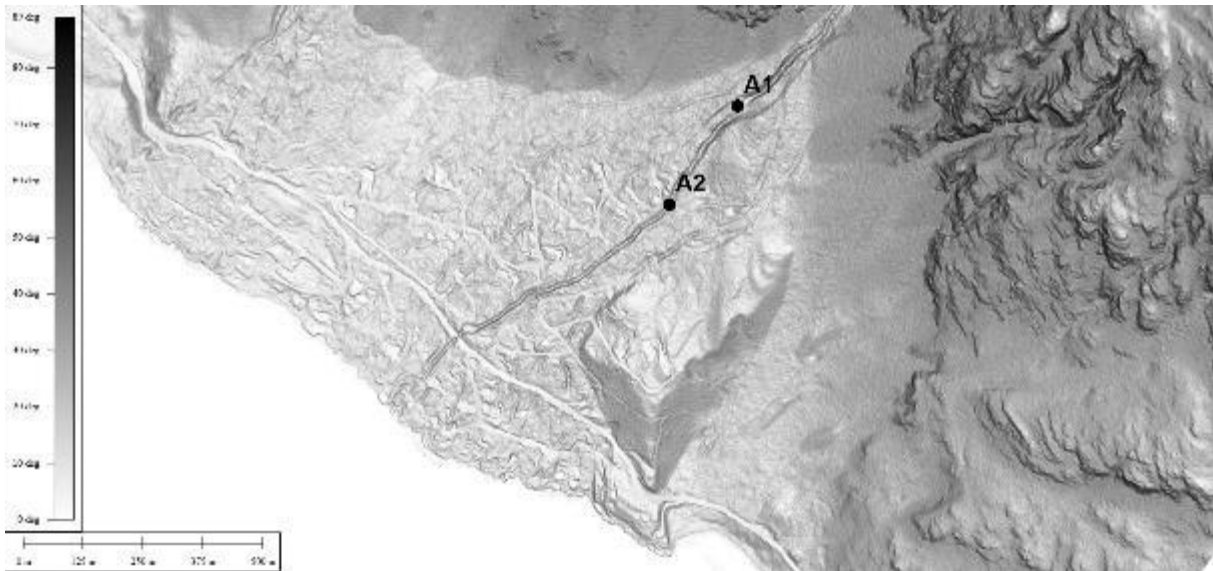
Figure 5-1. Simulated flow avulsion locations A1 and A2 (on shaded slope LiDAR image).

Under existing conditions, the two most likely locations upstream of the FSR for avulsions to occur during future events, denoted A1 and A2 on Figure 5-1, were identified using LiDAR imagery and verified during field reconnaissance. The A2 location corresponds closely with the avulsions that occurred during the 2010 debris flow (Drawing 5), and the A1 location corresponds to where partial channel plugging was observed in the field. A channel blockage at location A1 would likely cause an avulsion to the north of the active creek channel, whereas a blockage at location A2 would likely cause an avulsion to the south.

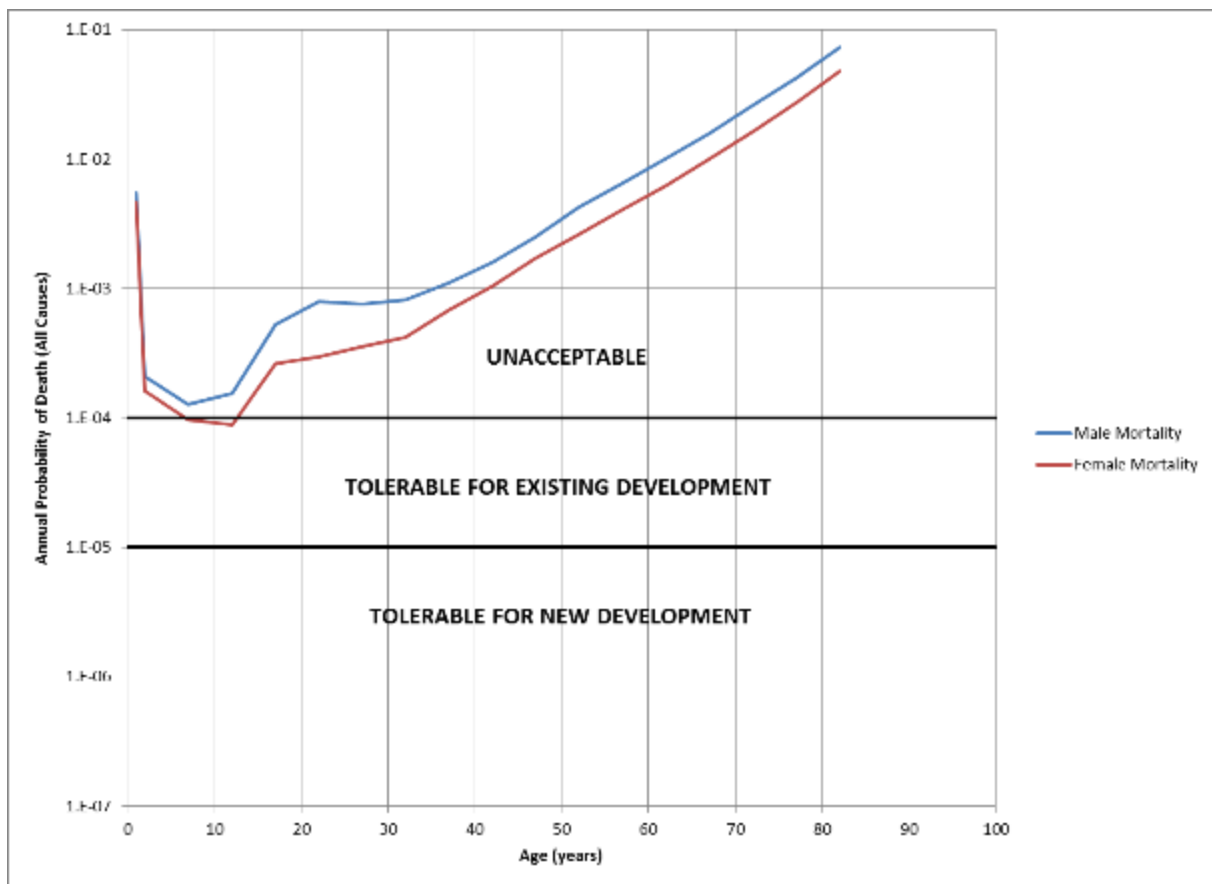
Figure 6-1. DNV individual risk tolerance criteria for landslides compared with Canadian mortality rates in 2008.

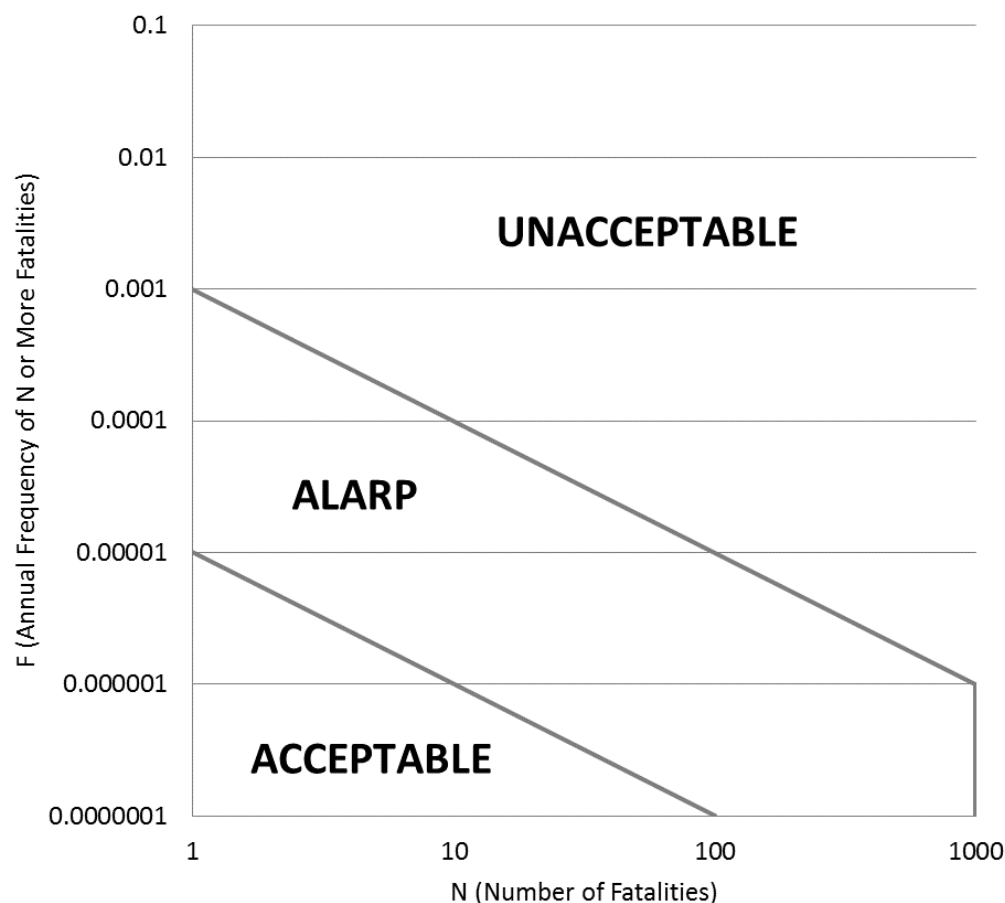
Figure 6-2. Group risk tolerance criteria as defined by GEO (1998).

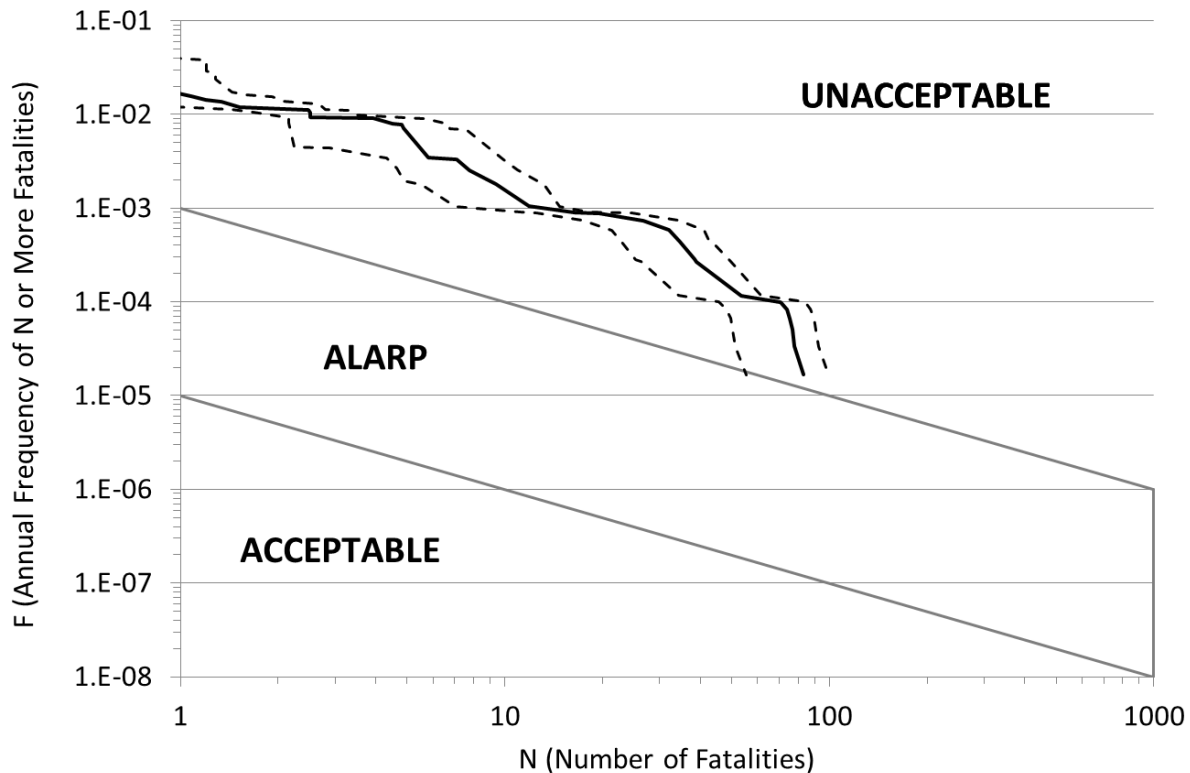
Figure 6-3. F-N curve showing the results of the Catiline Creek risk analysis for groups.

Table 6-8 lists the range of expected fatalities for each main debris flow scenario. Values in the table above 5 are rounded to the nearest 5 to reflect uncertainties. Similarly to the F-N curve, the table shows lower, best, and upper estimates based on ranges in vulnerability estimates. The values in each column are also shown as ranges. These ranges reflect the spectrum of different runout extents possible for a given volume class (e.g. for a given volume class, a longer runout event is less likely, but would impact more buildings and result in higher expected fatalities). It is important to note that the debris-flow return periods listed in Table 6-8 indicate the recurrence interval of the scenario, not the likelihood of fatalities (which is lower, as shown on Figure 6-3).

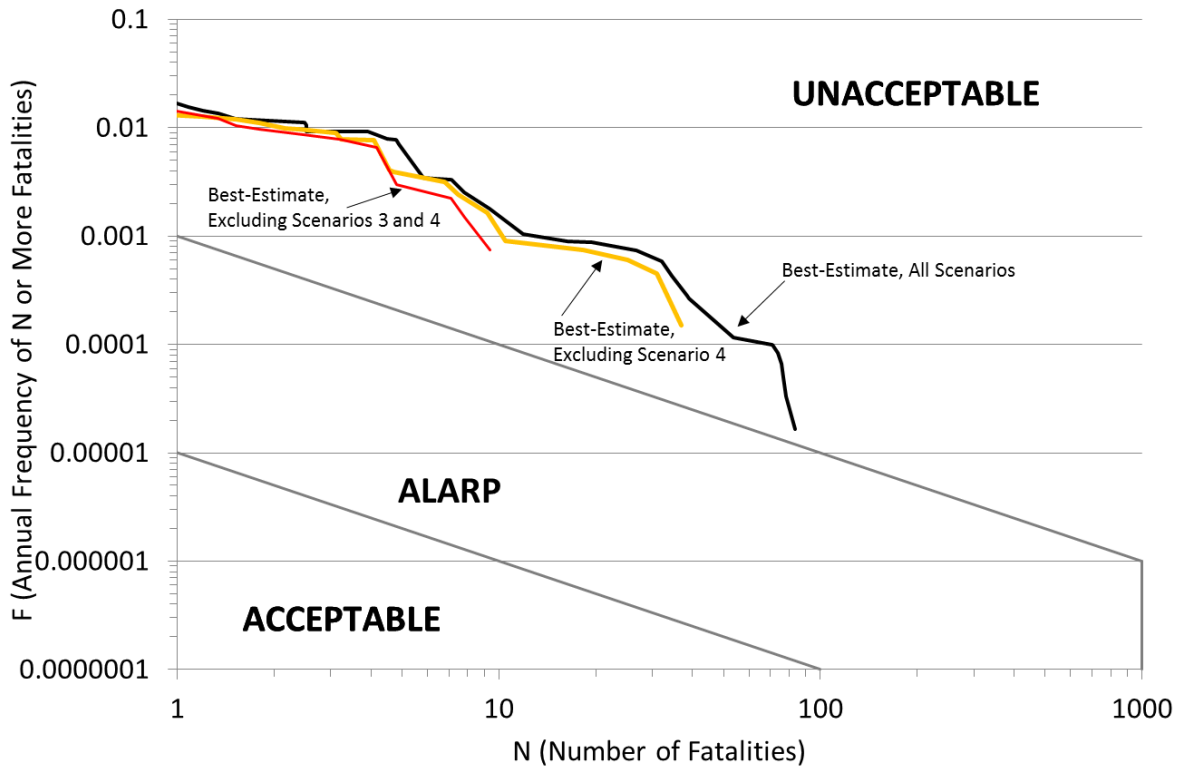
Figure 7-1. Group risk for different groups of scenarios

This indicates that reducing risk for the smaller events will provide the greatest risk reduction cost-benefit. It does not imply that mitigation targeting only the smaller events (e.g. Scenarios 1 and 2) would reduce risk to tolerable levels according to international standards. However, this may guide discussion on the level of residual risk to accept if risk reduction to tolerable levels according to international standards is not practicable.

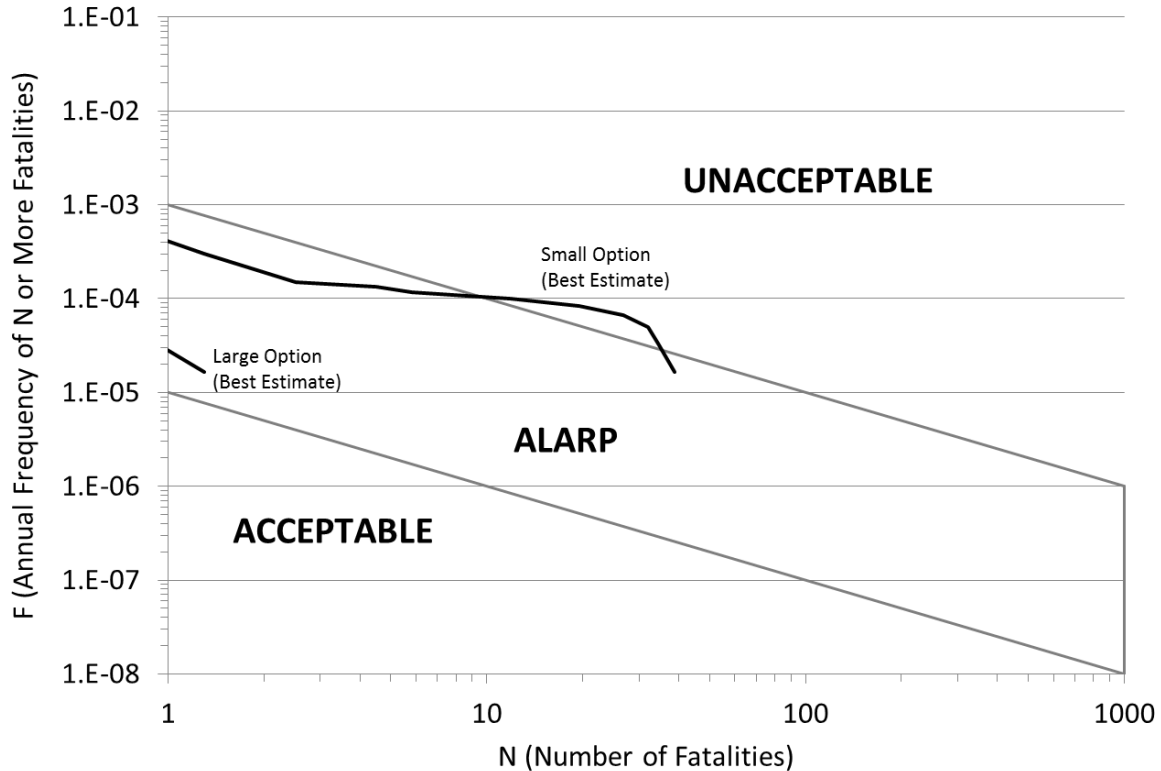
Figure 7-2. Preliminary best-estimate of group risk for small and large upgrade levels of mitigation. This estimate is subject to change during detailed design.

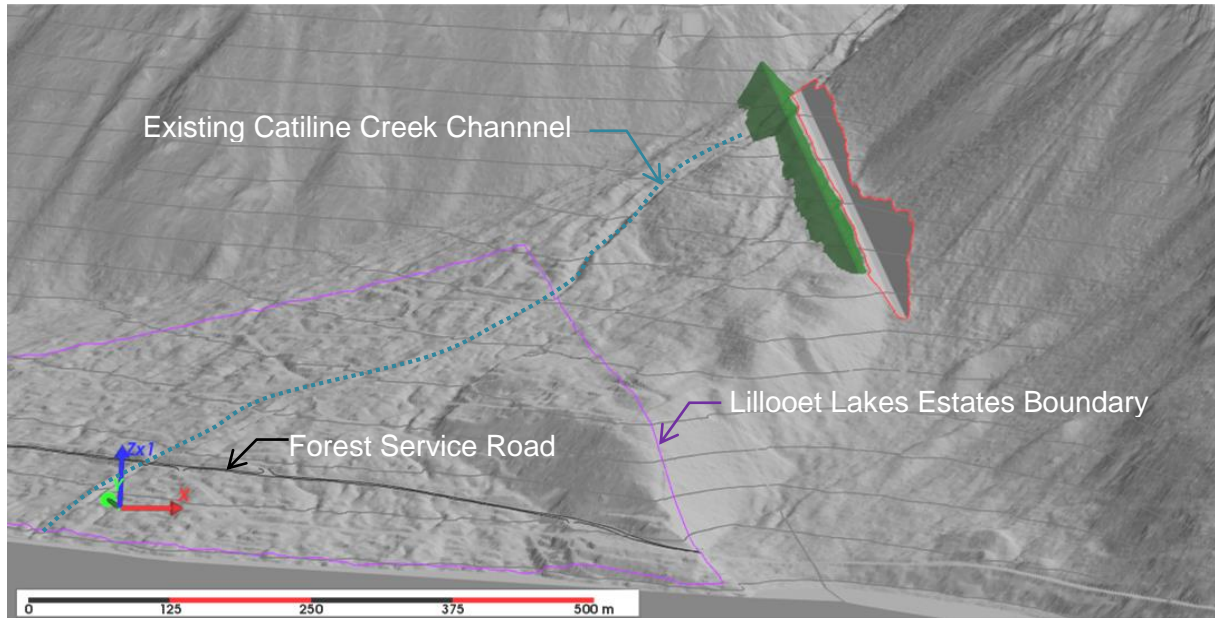
Figure 7-2. Three-dimensional model of the proposed diversion structure that is sized for 300,000 m³ event associated with 10,000 year return period.

The second risk reduction option considered is to construct a diversion ditch and berm at the fan apex that directs debris flows out of the main channel towards undeveloped land on the east margin of Catiline Creek fan which is naturally incised (Drawing 10, Figure 7-2). This could be achieved by constructing a large barrier in the existing channel to a height that is above the existing channel crest and which would account for flow superelevation as it is being deflected away from a straight line. The barrier would be oriented oblique to the existing channel to direct debris flows towards a 500 m long diversion channel oriented north-south and connecting the fan apex to an undeveloped gully created by the eastern edge of the Kame Terrace (Drawing 5). The diversion channel would be constructed by excavating a trench at the margin of the Catiline Creek fan, and placing the excavated material as an engineered berm on the west side of the trench. The berm would increase the channel capacity, and be sized to prevent flow avulsion toward developed portions of Catiline Creek fan and the Kame Terrace. The conceptual design assumes that the diversion channel would end at the head of the Kame Terrace gully, and flow would continue uncontrolled down the gully some 500 m slope distance (180 m in elevation) to Lillooet Lake.

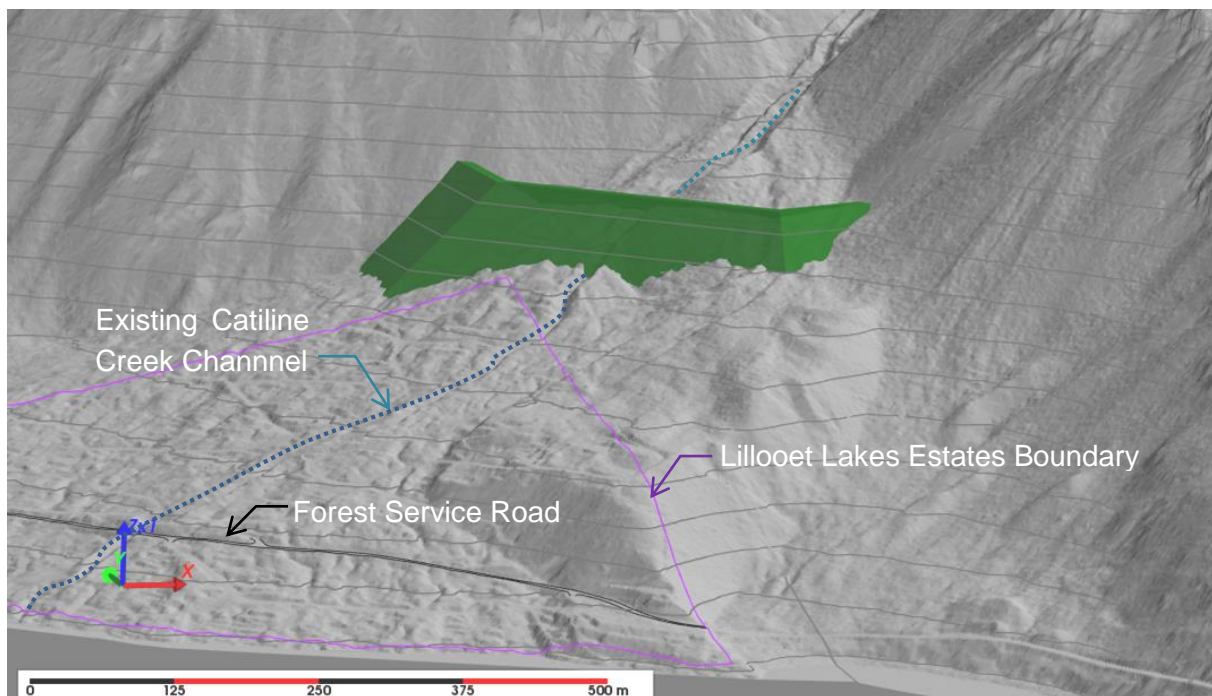
Figure 7-3. Three-dimensional model of the proposed retention barrier structure that is sized for 300,000 m³ event associated with 10,000 year return period.

The third risk reduction option considered is a large debris retention barrier located on the fan, near the fan apex (Drawing 11, Figure 7-3). The intent of the barrier is to capture debris during a debris flow before it reaches developed portions of the fan. The barrier would include an outlet slot or grillage structure in the existing channel that allows annual water flood flow to pass the barrier under typical conditions, but traps coarse sediment and debris during the initial surge of a debris flow. The outlet structure would also act as a spillway that would contain any debris that overtops the structure and direct it towards the existing channel. Access to the debris storage area on the upslope side of the barrier would need to be maintained to allow for removal of debris following debris flow and flood events. It is expected that frequent maintenance and debris removal would be required to maintain the design debris storage volume, and to ensure that the outlet structure remains open for typical stream flows.

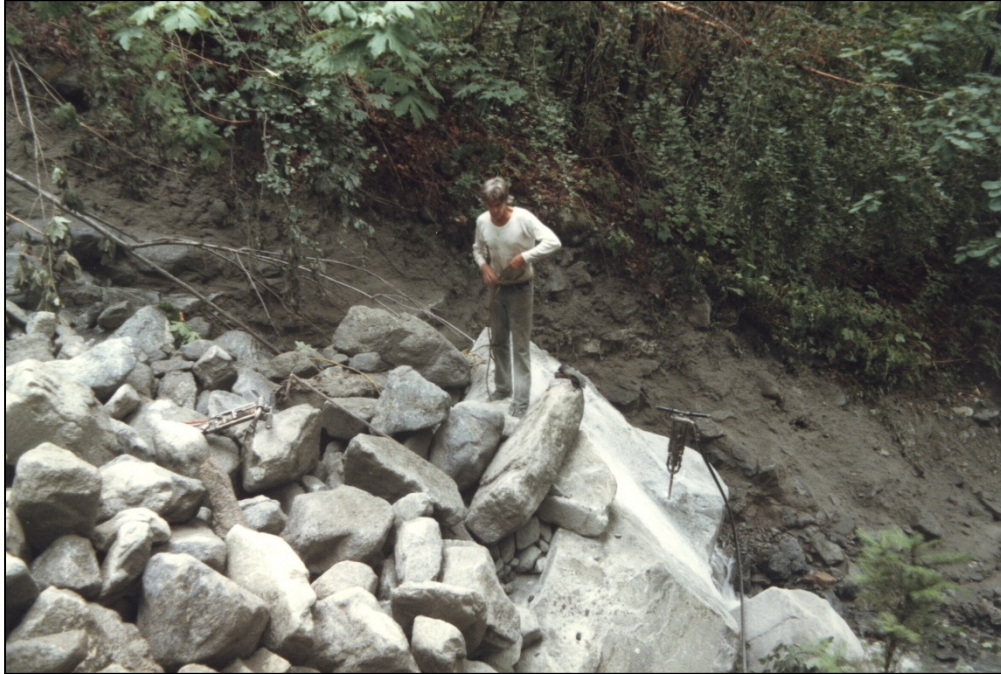
Photograph 1. Breaking of large boulders along the upper portion of Catiline Creek following 1986 debris flow event. Photograph taken by the Hills Family provided by Gary Young dated July 25, 1987.

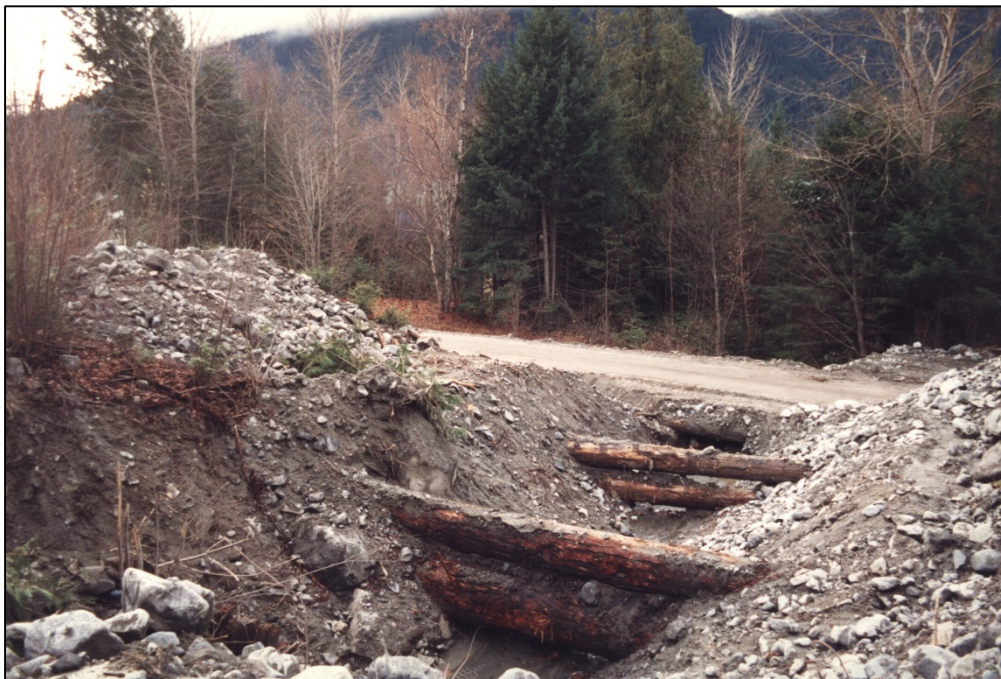
Photograph 2. Looking downstream at debris check dam constructed of wood (no longer existing). Photograph taken by the Hills family, provided by Gary Young dated November 12, 1986.

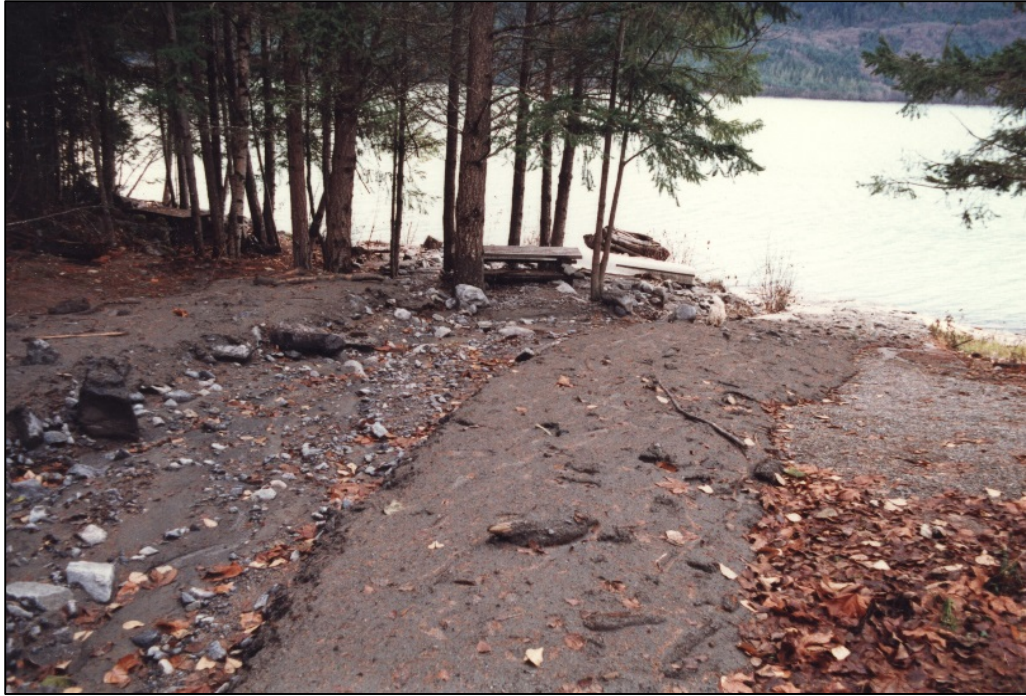
Photograph 3. Debris lobe at boat launch area at Lillooet Lake following 1986 event. Photograph taken by Gary Young dated October 26, 1986.

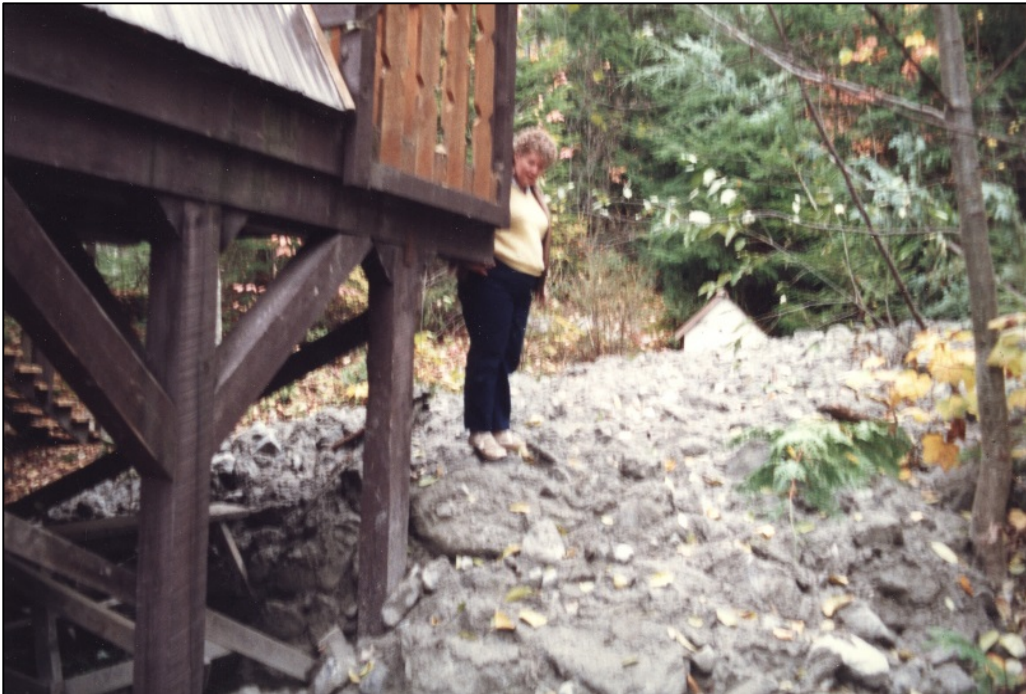
Photograph 4. Debris affecting A-frame house. Photograph taken by the Hills family and provided by Gary Young dated October 26, 1986.

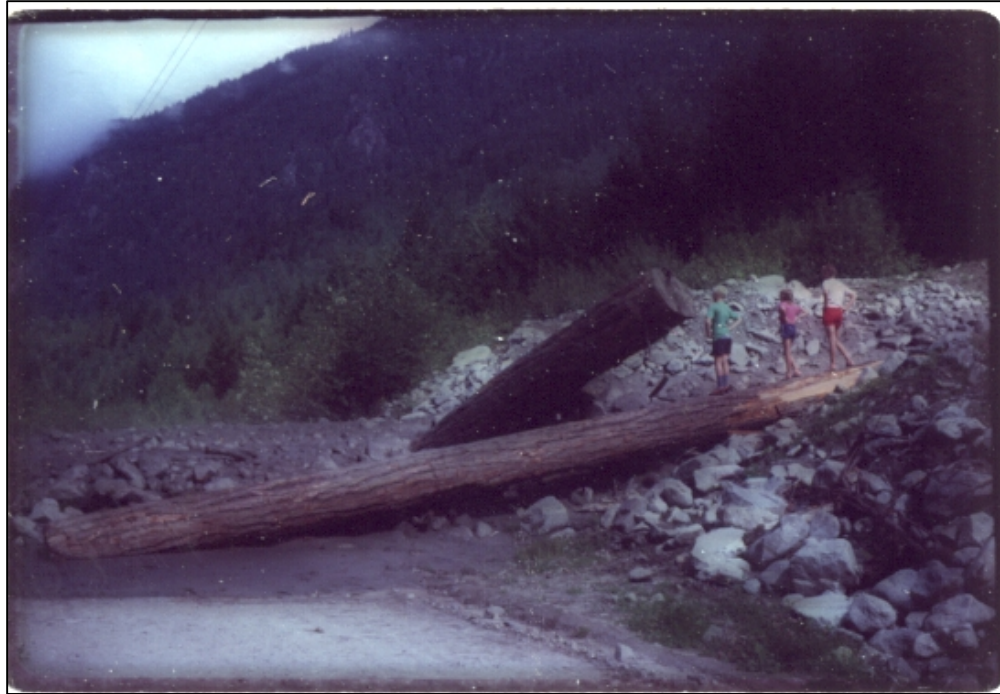
Photograph 5. August 1987 debris flow deposits. Photo provided by the Klassen family. The logs are likely the remains of the check dam shown in Photo 2.

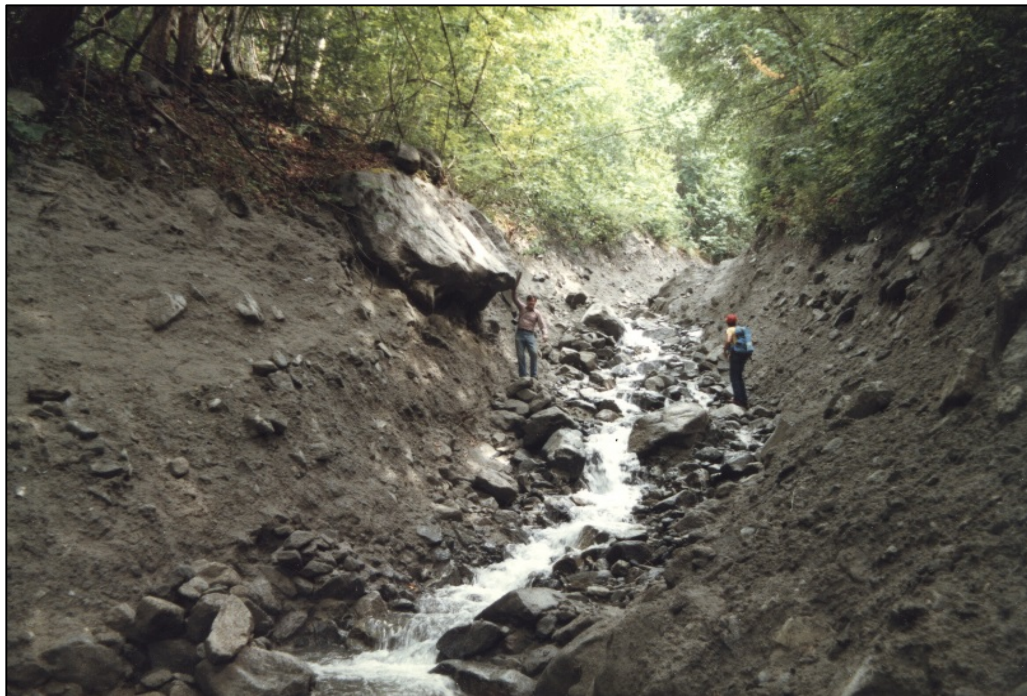
Photograph 6. Looking upstream at Catiline Creek channel showing large boulder on left bank. Photograph provided by the Hills family dated July 25, 1987.

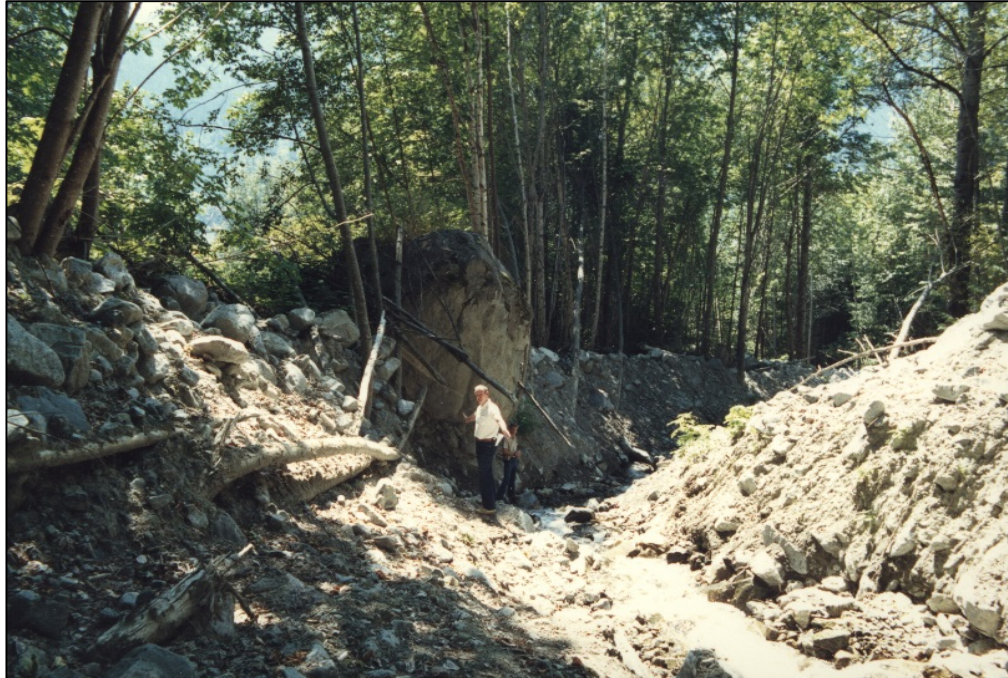
Photograph 7. Estimated 20 tonne boulder in Catiline Creek channel. Photograph provided by the Hills family dated July 30, 1987.

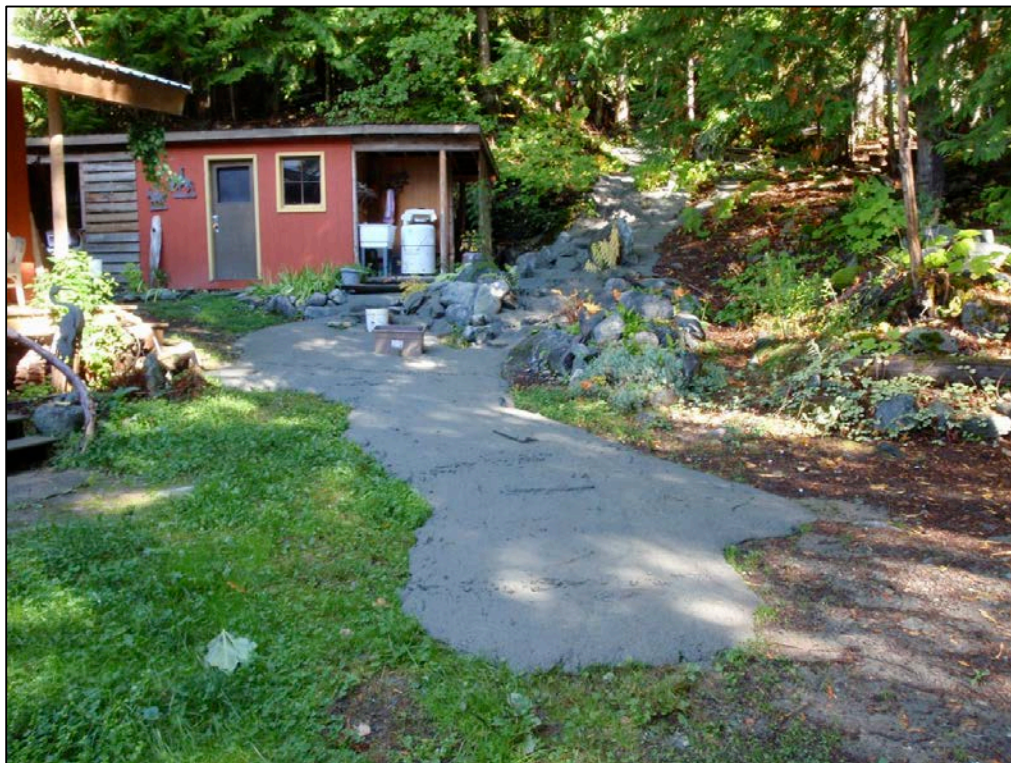
Photograph 8. Lower fan left lobe from 2010 debris flow.

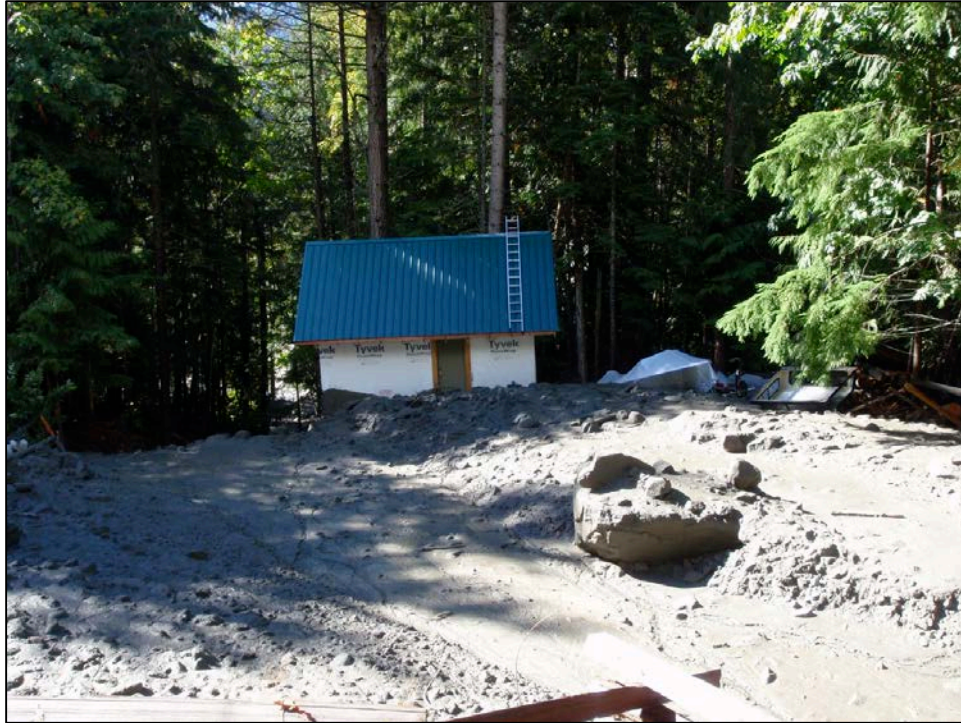
Photograph 9. Lower fan left lobe from 2010 debris flow.

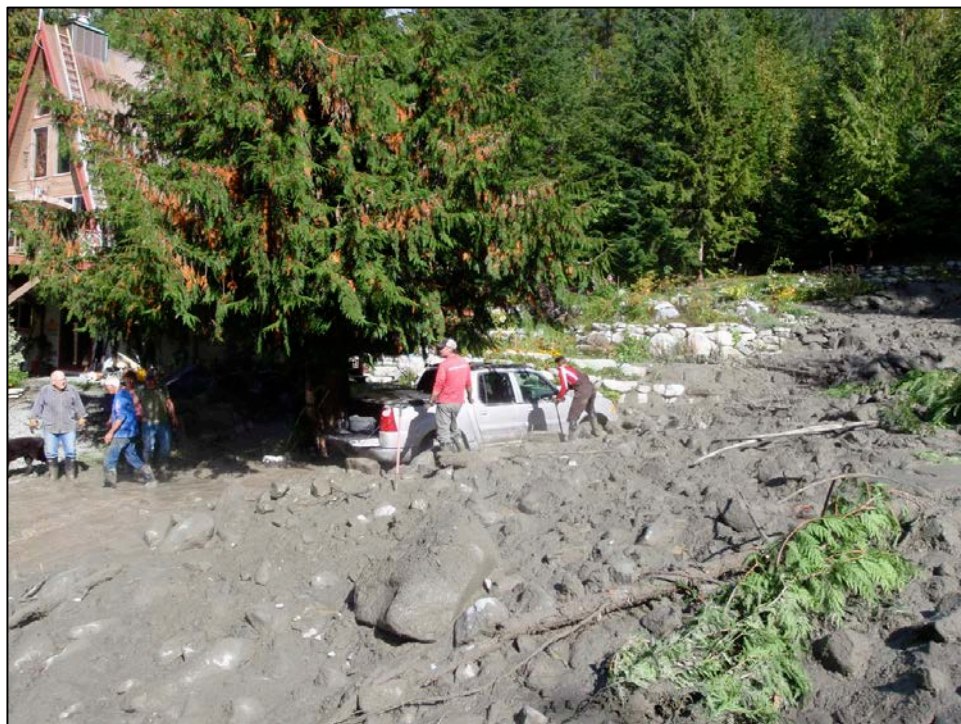
Photograph 10. 2010. Yard of A-Frame house just downstream of FSR on right bank. Truck partially buried in 2010. This same truck was destroyed in 2013.

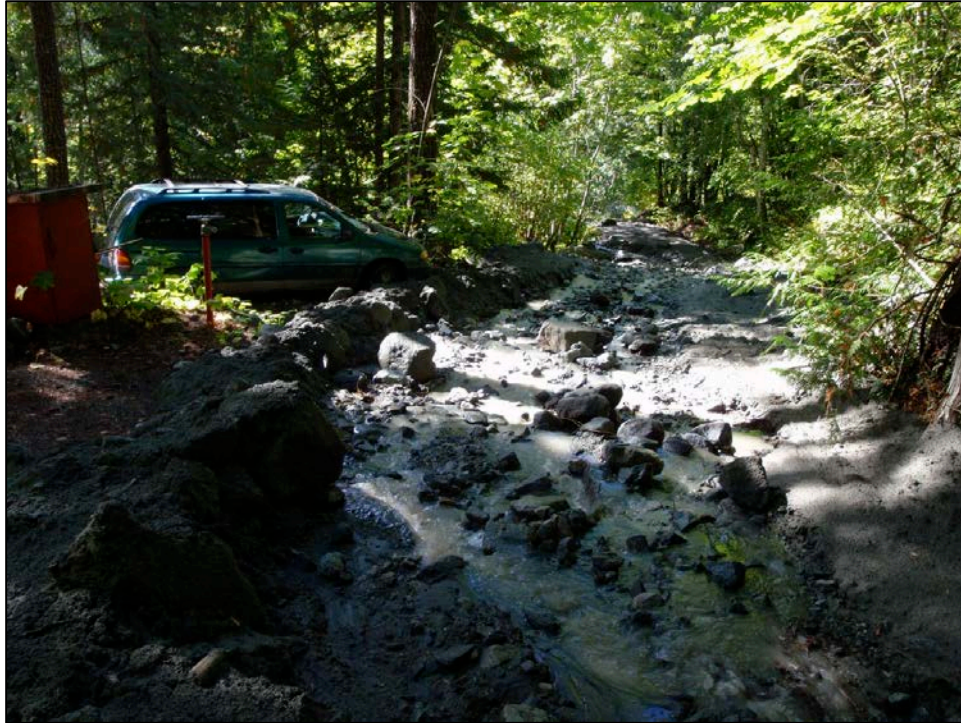
Photograph 11. Left bank avulsion lobe from 2010 debris flow just misses vehicle.

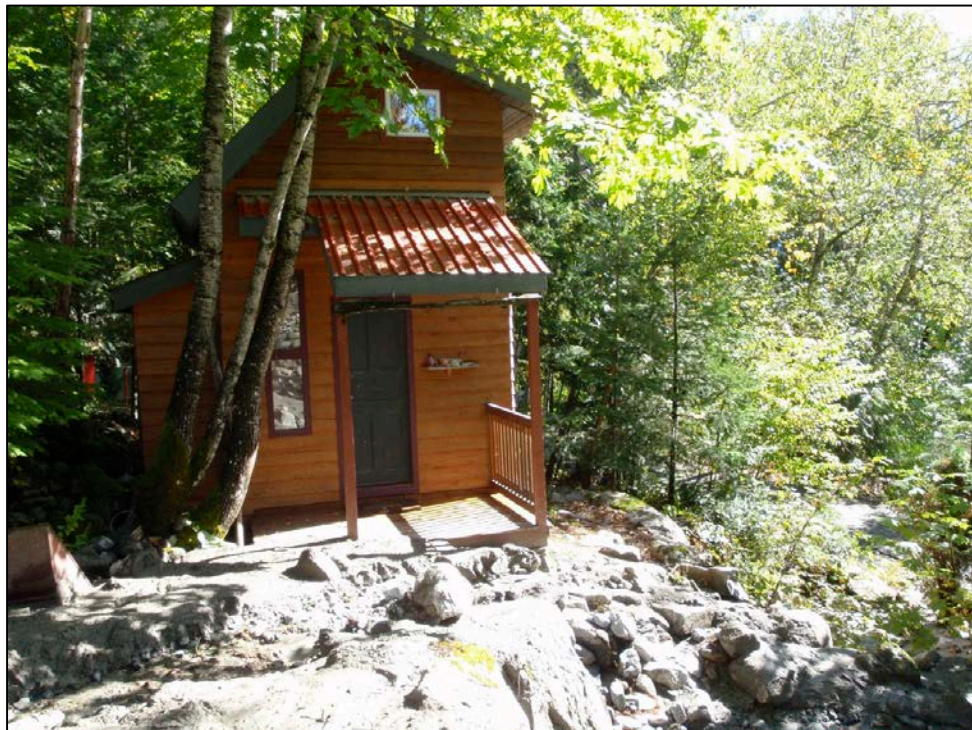
Photograph 12. Debris from 2010 debris flow event that narrowly missed a guest house.
