CATILINE CREEK

DEBRIS-FLOW HAZARD AND RISK ASSESSMENT

PROJECT NO.: 1358001
DATE: January 22, 2015
DOCUMENT NO.: 1358-001

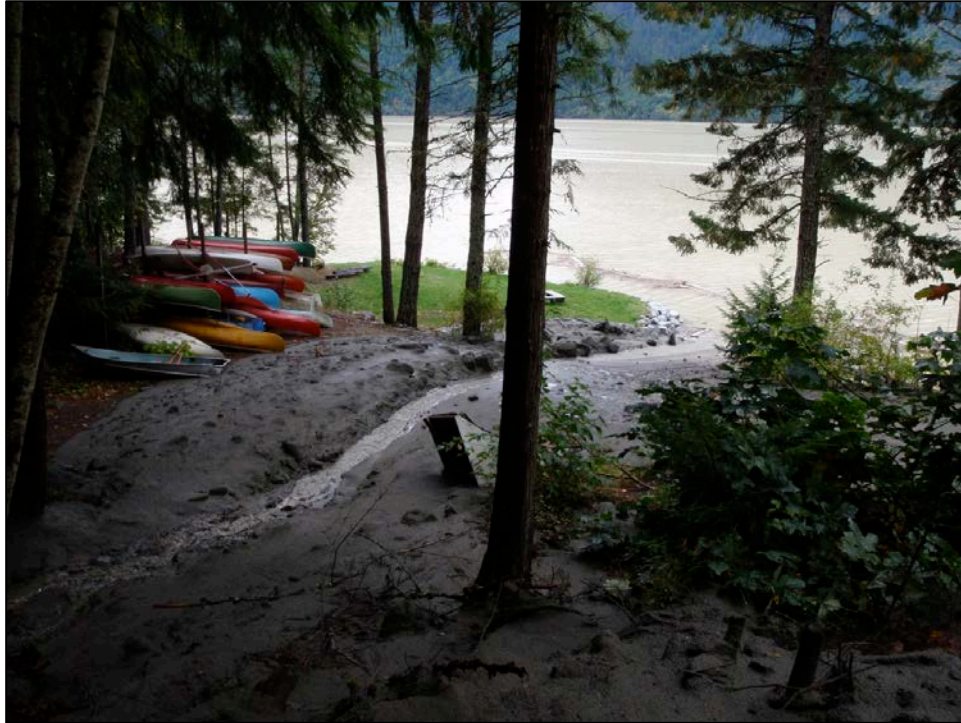
Photograph 13. Canoe rack narrowly missed by debris from 2010 debris flow event.

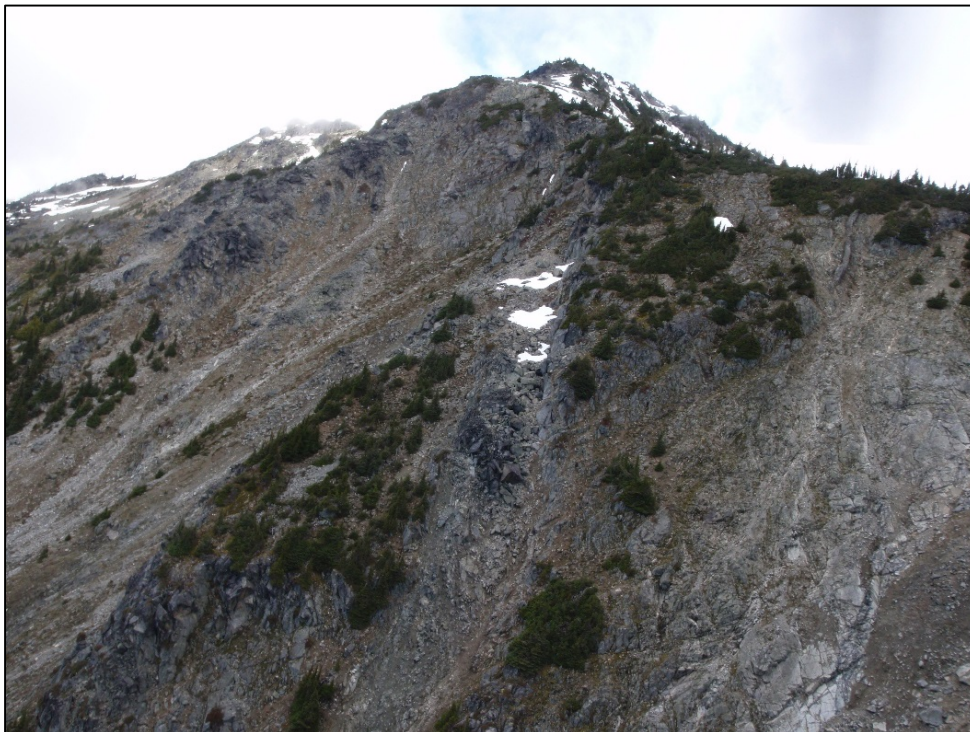
**Photograph 14. Looking east at structural features in subbasin 3 (P617092 on Drawing 7).
Photograph taken by Pierre Friele dated June 17, 2014.**

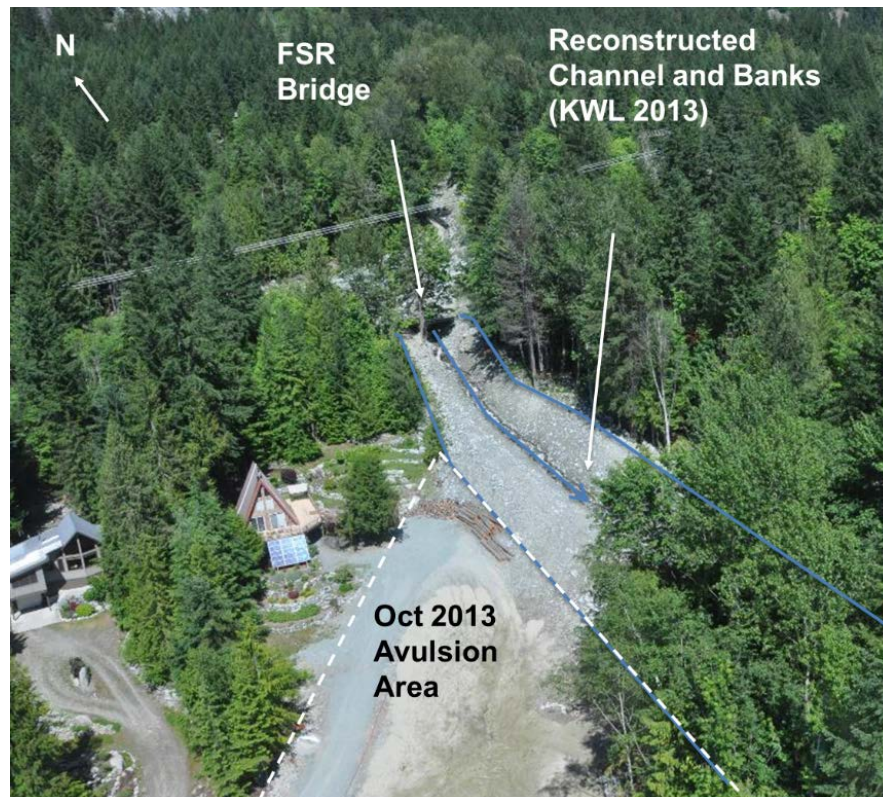
Photograph 15. Looking northeast at channel downstream of the FSR, showing the area of avulsion in October 2013. Photograph taken by Matthias Jakob dated June 17, 2014.

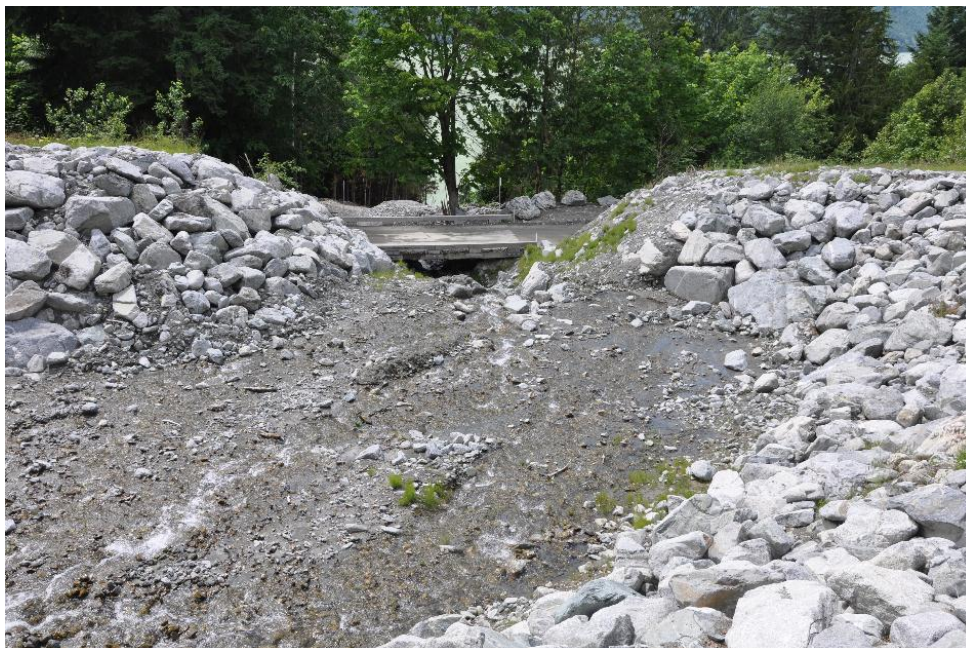
Photograph 16. Looking downstream at “basin” immediately upstream of the FSR. Photograph taken by Matthias Jakob dated June 18, 2014.

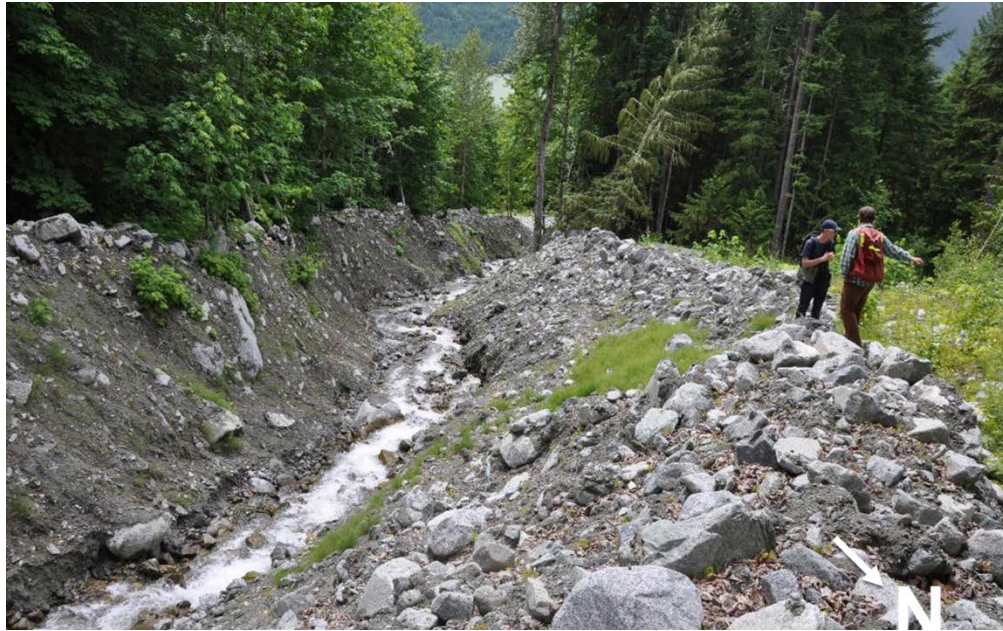
Photograph 17. Looking downstream at the channel section immediately upstream of the FSR. Photograph taken by Matthias Jakob dated June 18, 2014.

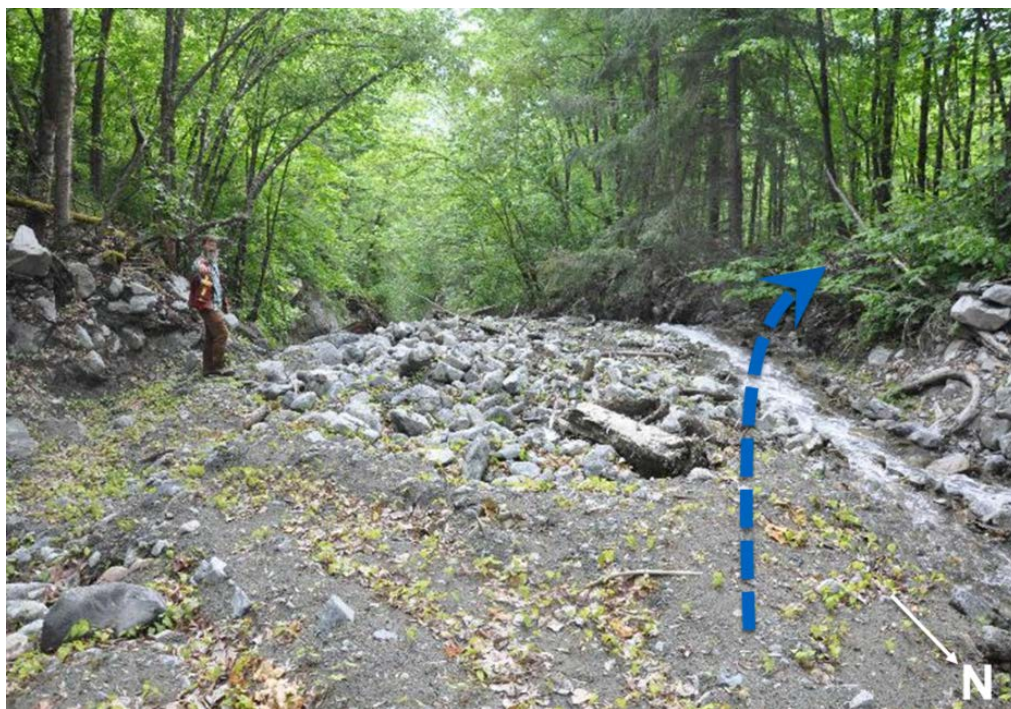
Photograph 18. Looking downstream at a plugged channel section at about 420 m elevation, marked as “AV” (potential avulsion) on Drawing 6. The potential avulsion point to the right (northwest) channel is noted with a blue dashed arrow. Photograph taken by Matthias Jakob dated June 18, 2014.

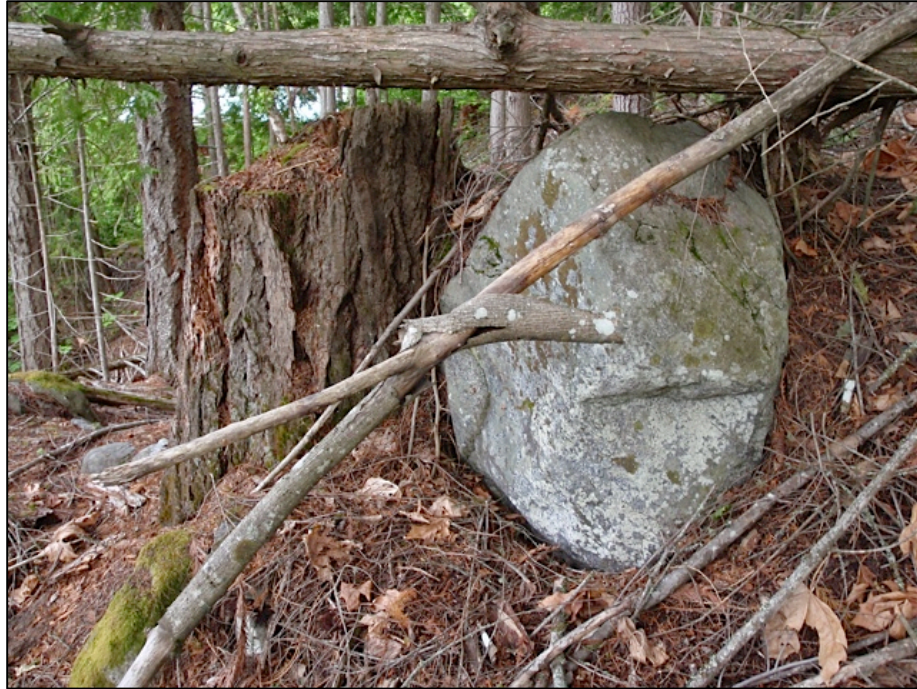
Photograph 19. Logged (1949-1952) tree stump impacted by debris flows, southeast fan sector (adjacent to Test Pit No. 5, Drawing 6). Photograph taken by Matthias Jakob dated June 18, 2014

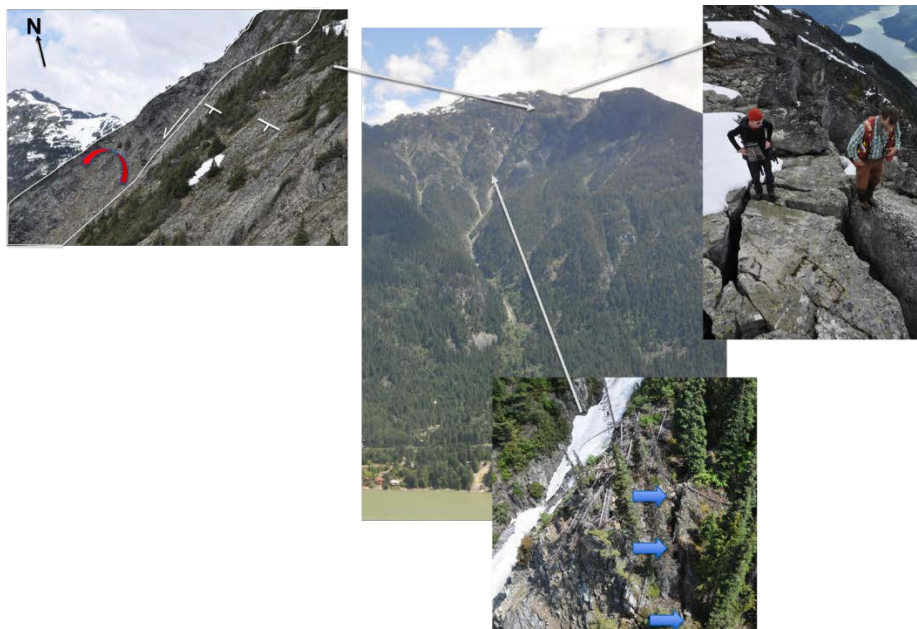
Photograph 20. Annotated photos showing potential landslide sources in upper basin area. White arrows show the location of the photos taken. Upper left: potential rock slide source on Lone Goat Peak. Upper right. Tension cracks on ridge crest. Lower center: toppling trees and tension cracks (arrowed) showing bedrock instability in the mid-basin area. Photograph taken by Matthias Jakob dated June 18, 2014

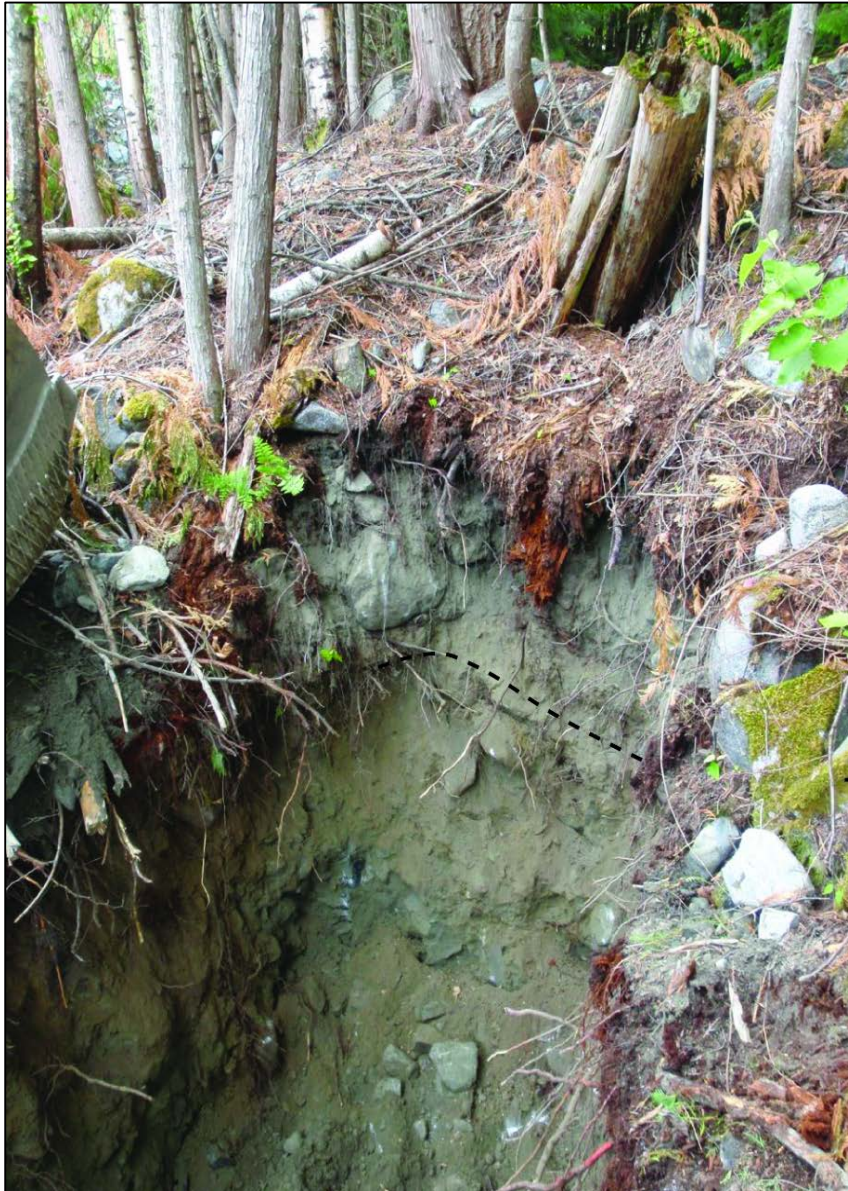
Depth (cm)	Observations
0-120	Historic debris levee with buried & scarred cedar stem.
120-300	Diamicton, massive, matrix supported. Weak soil development at top and fading with depth.
300	Base not seen.

Scarred, pushed
& buried stem

Grey debris
levee associated
with stem burial.
— 120

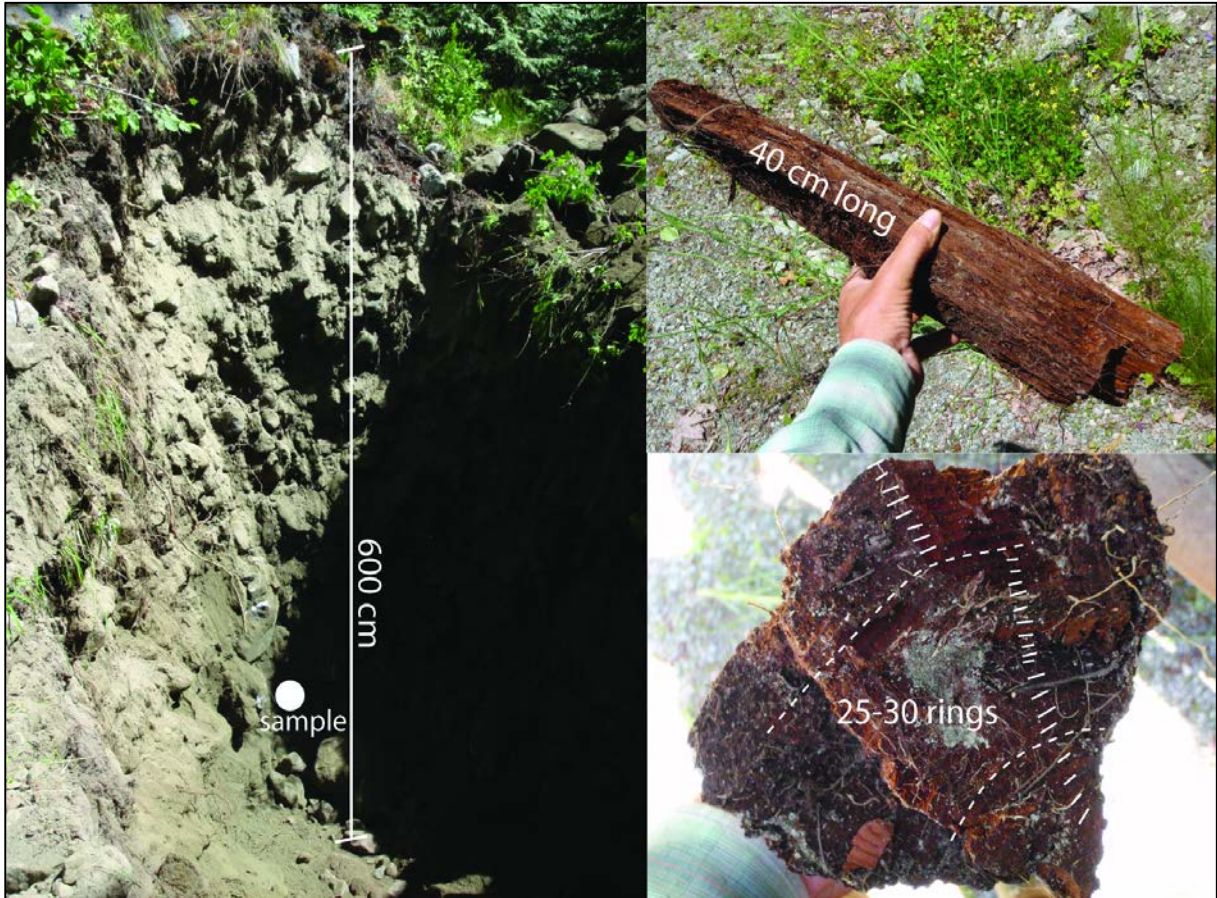
Test Pit 6

Depth (cm)	Observations
0-10	Organic horizon.
10-100	Diamicton, massive, matrix supported. Cobble to fine boulder.
100-125	Sandy pebble gravel.
125-150	Medium to fine gravel, slightly oxidized with humic layer. Bulk organic sampled for radiocarbon dating.
150-600	Diamicton, massive, matrix supported. Large boulders. At 5 m wood fragment sampled for radiocarbon.
600	Base not seen.
