It recently came to the Ministry of Forests' attention that Catalina Creek is prone to debris flows and channel avulsions. The hazard came to the ministry's attention following a relatively small debris flow at the site on the evening of July 6-7, 2004. Attached photographs one to four illustrate the site and debris flow in question. The site is at approximately kilometre 8.5 of the In-SHUCK-ch Forest Service Road (FSR).

Ministry of Forests engineering staff investigated the recent slide on July 7 and 8, 2004. The objective of the ministry's site assessment was to assure worker and public safety during emergency repairs of the bridge illustrated in photograph four. It appears the creek has a long history of debris flow/avulsion activity and mitigative works. There is a high probability there will be further debris flow and avulsion activity within the drainage. The recent slide may have reduced the effectiveness of historical protective measures at the site (see photograph five). If so, the FSR and the properties upon the fan may be unusually vulnerable to future debris flow or flood damage.

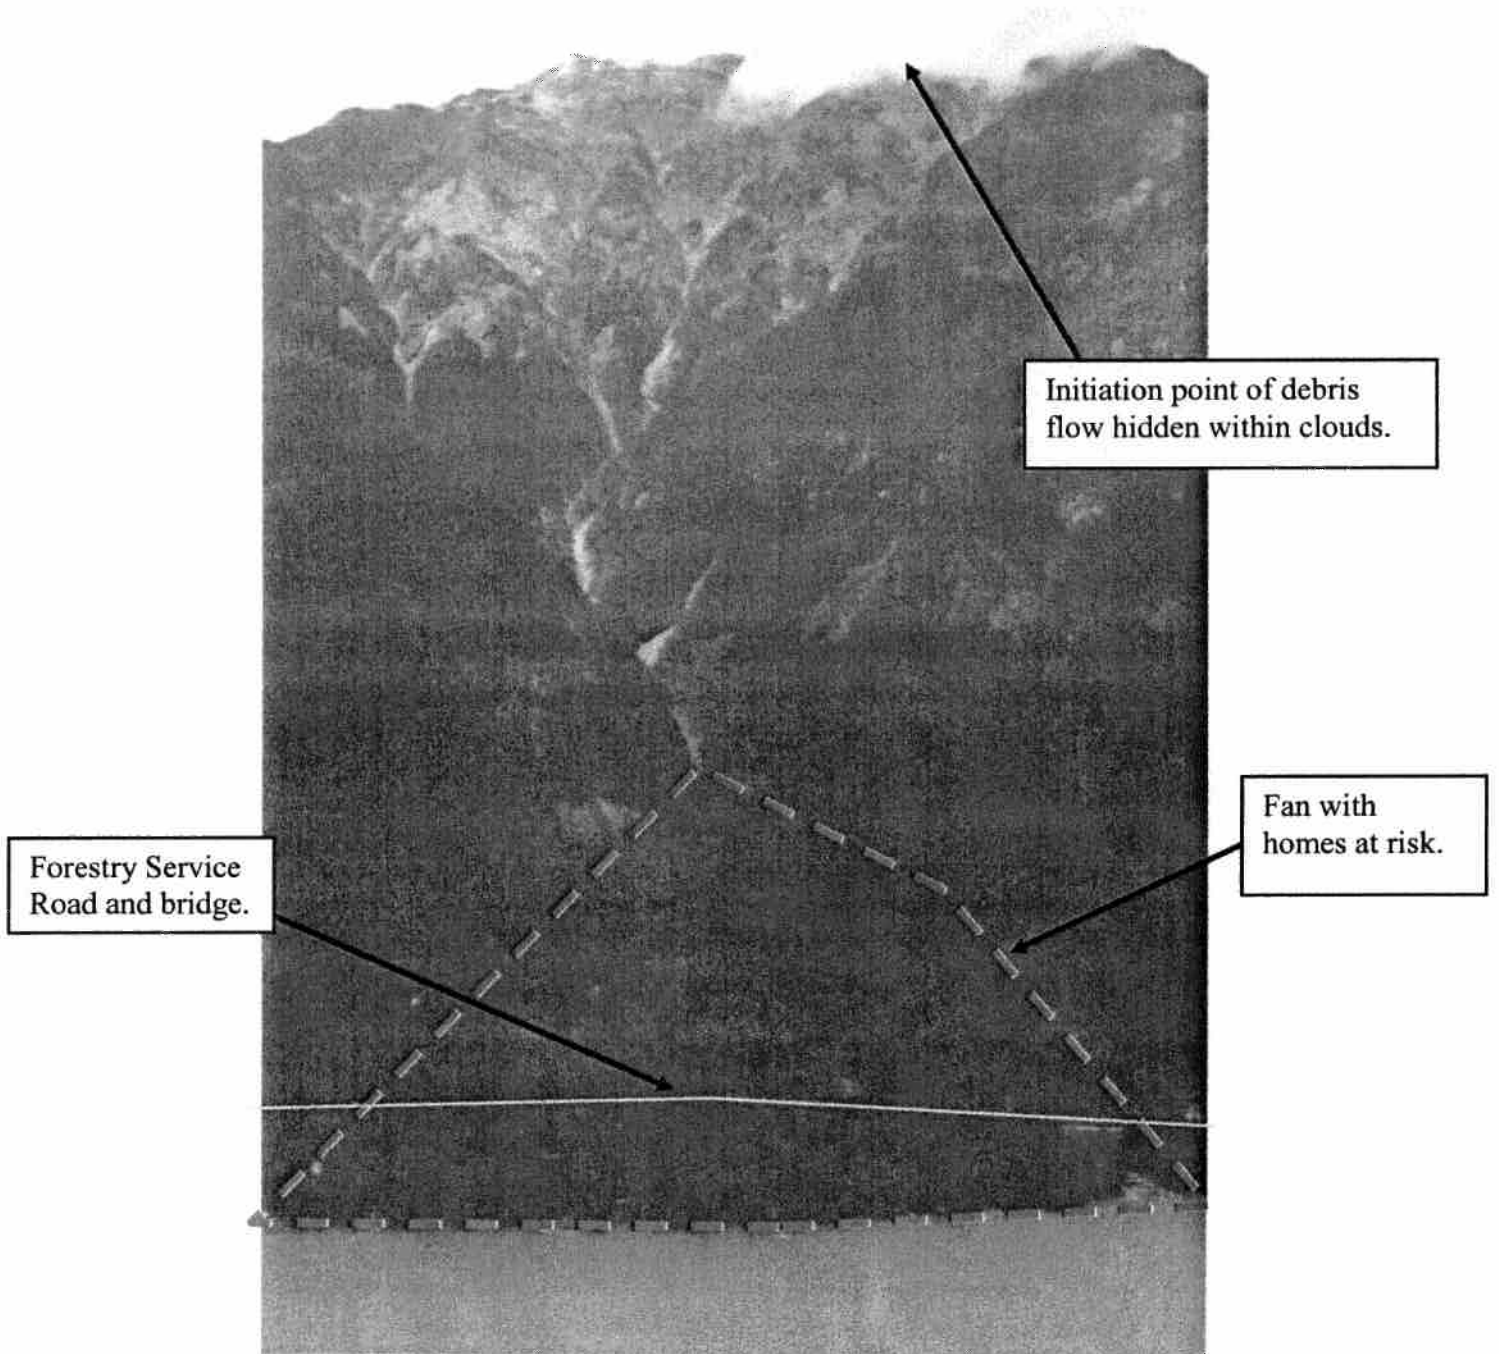
Photograph 1

Overview of Catalina Creek
Approximately kilometre 8.5 of the In-Shuck-Ch FSR

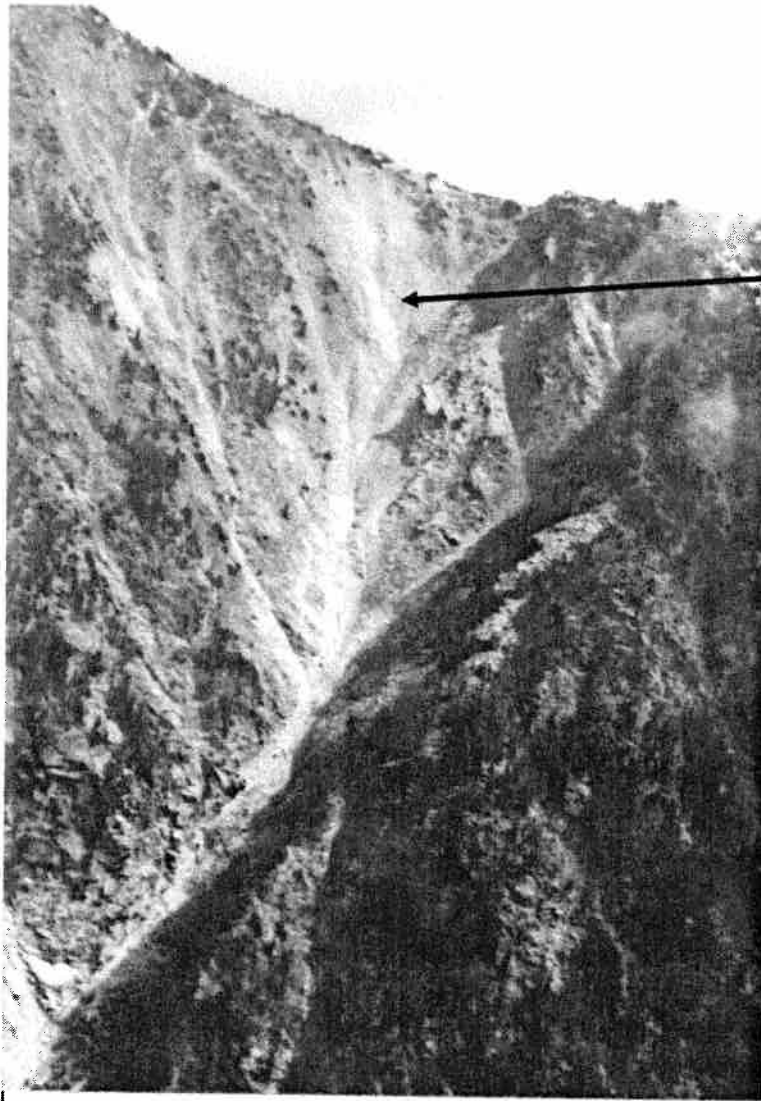
Photograph 2

Initiation point of slide.

Slide initiated at an elevation of approximately 6300 feet.

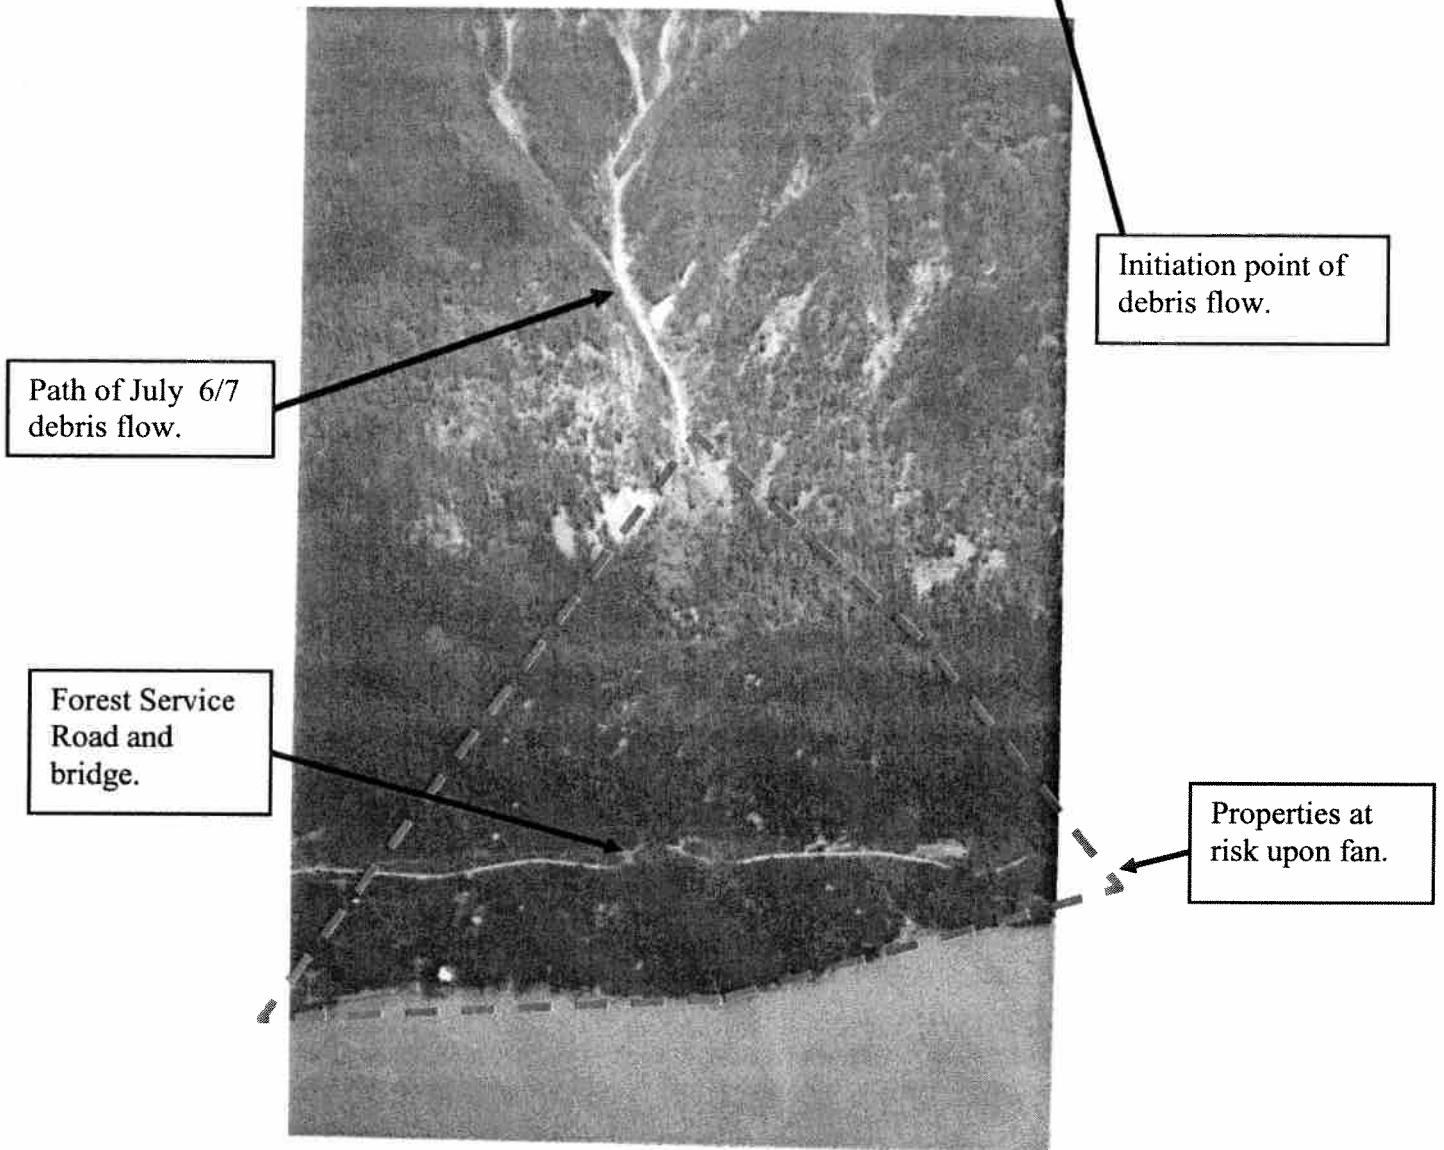
Photograph 3

Close up of fan and community at risk.

We intend to complete our repairs of the FSR in the days and weeks ahead; however, we strongly recommend the creek and the existing protective measures along the creek be reviewed by a qualified registered professional (QRP - a registered professional with debris flow and flood expertise). Any repairs or improvements of protective works recommended by the QRP should be completed in a timely manner.

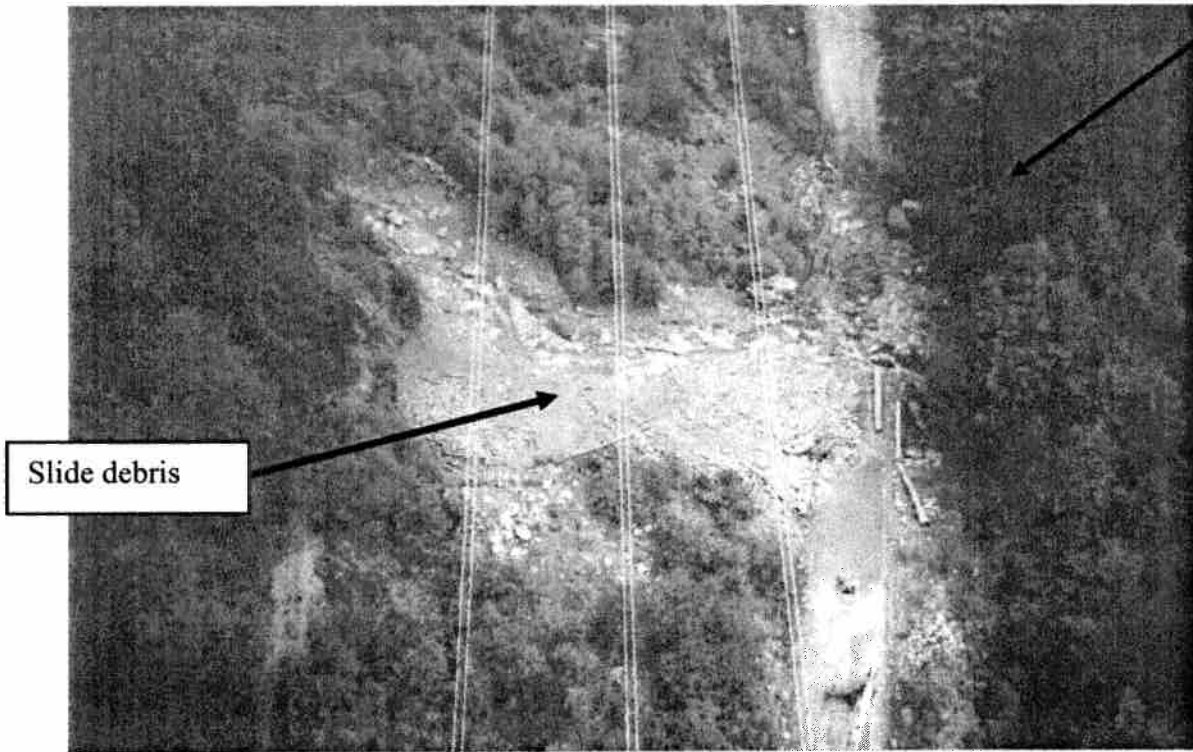
Photograph 4

Helicopter overview of bridge.

Cabin hidden within trees.

Slide debris

Contact with the bridge appears to have triggered deposit of some slide debris. Some debris appears to have flowed beneath the bridge and into the lake.

A larger debris flow could overwhelm the storage capacity of the bridge or entrain the bridge within the moving slide debris.

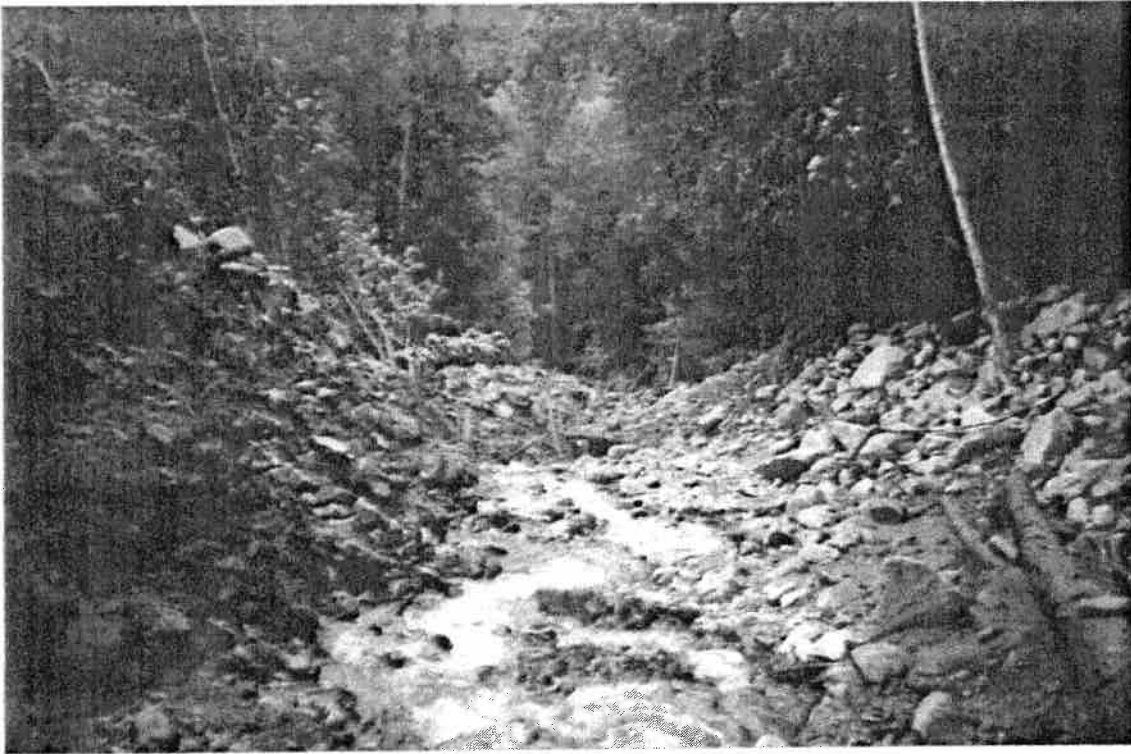
Photograph 5

Slide debris along creek channel above FSR.

Notice the abundance of loose debris.

Similar channel conditions exist for at least 350 metres above the FSR.

Such accumulations of debris may increase the probability that future debris flows will escape the creek channel and impact the adjacent community.

Sloughing and remobilization of the slide debris may result in a creek avulsion and flood damage to the surrounding properties.
