NHC Ref. No. 3005515

Lil'wat Nation321 No. 10 IR Road,
Mount Currie, BC,
V0N 2L0Attn: **Tom Laviolette, RPP**
tom.laviolette@lilwat.ca**Re: Mount Currie Main Street Development Site
Flood Hazard Assessment**

This letter report summarizes the flood hazard assessment (FHA) conducted for the Lil'wat property *Block A (Plan B4086) SW ¼ DL209, Lillooet District, except plans 5959, 7170, 8847, 9639, and Lot B, DL 209 Lillooet District, Plan 35172*. The development site is located in Mount Currie, BC, near the Birkenhead and Lillooet River. This flood hazard assessment was prepared to assess and address the flood hazard from these two rivers.

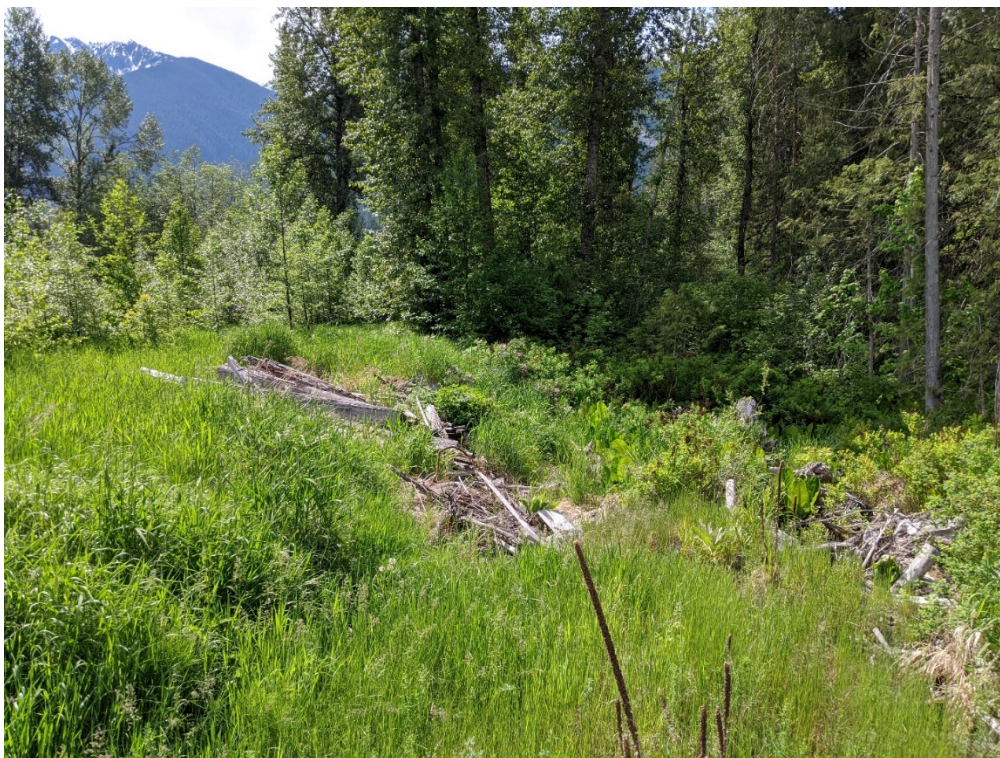
Figure 13 West side of Development site looking southwest, large (~1m) drop to surrounding grade. Trace amounts of water in depression / ditch

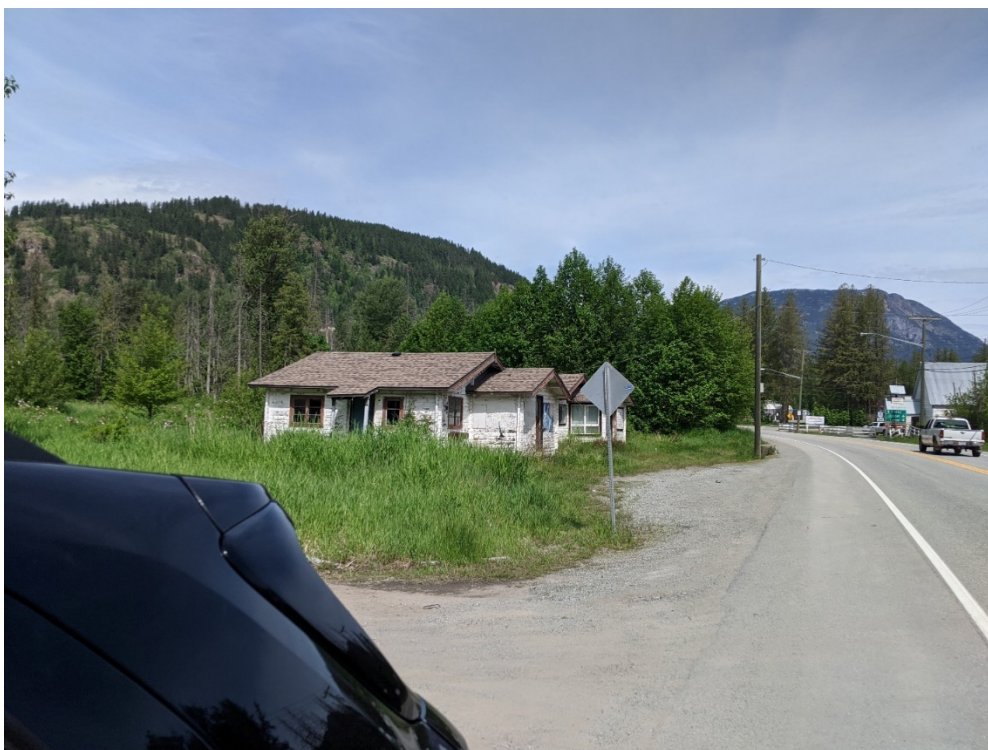
Figure 14 East side of Development site looking north at 2 and 3 of 3 existing structures. Water would flow from north and follow Hwy 99 south across the site

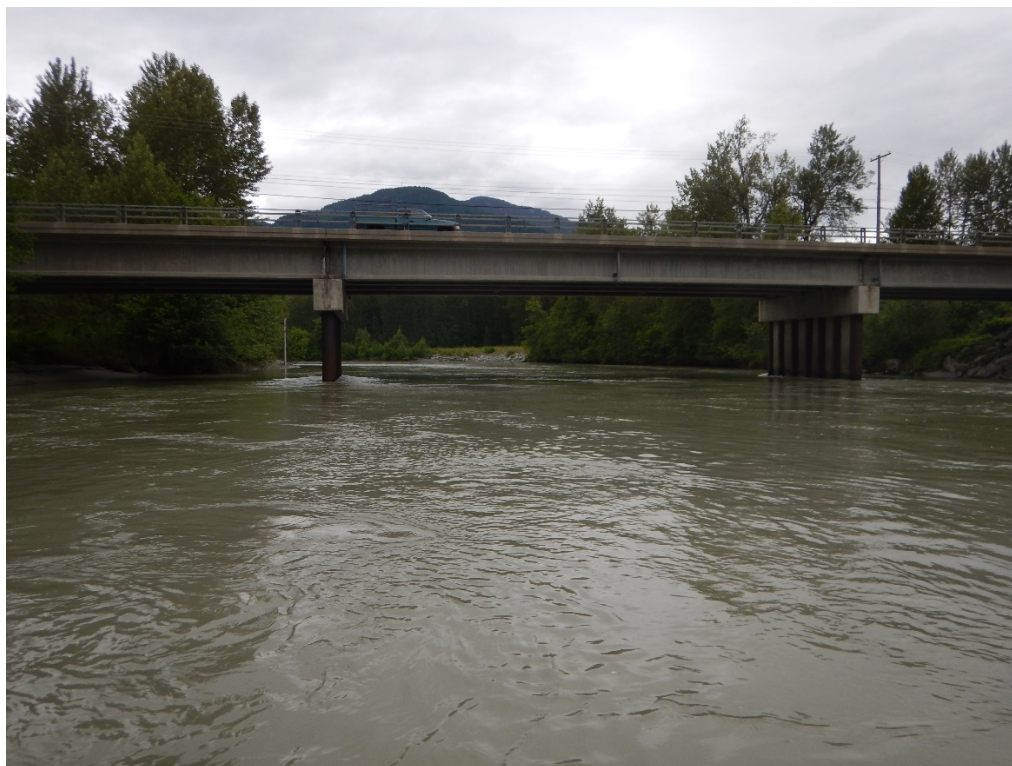
Figure 15 Lillooet River at Hwy 99 bridge, Ayers dike seen past bridge on left bank (river facing downstream)

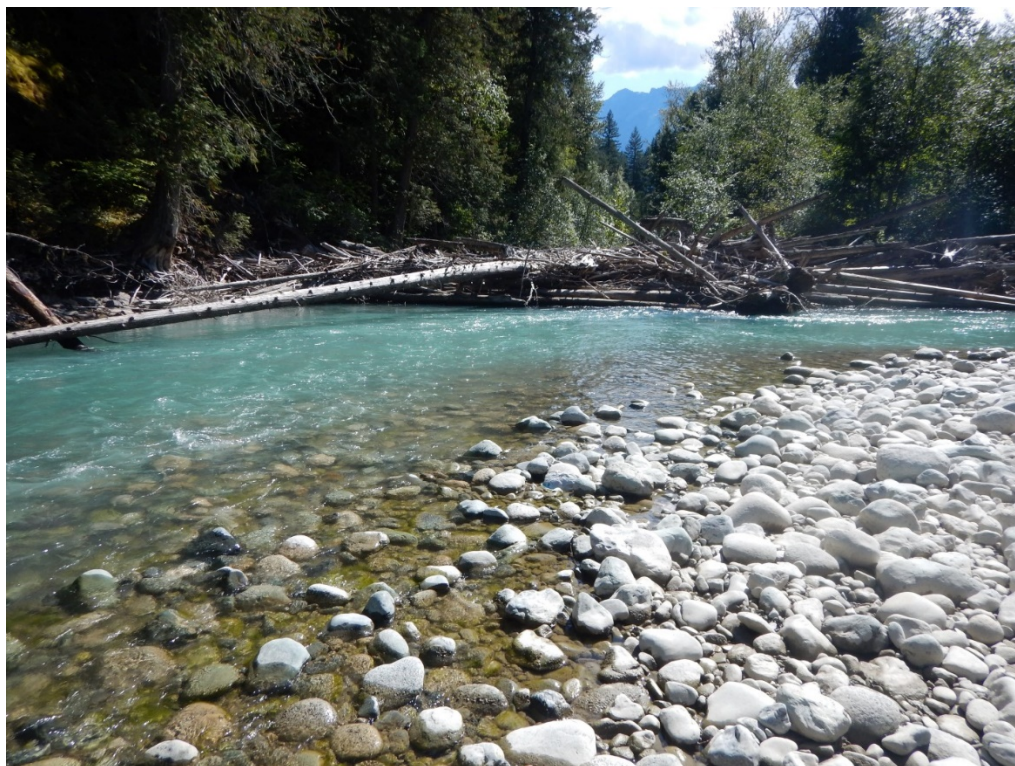
Figure 17 Debris hazard caught on left bank of Birkenhead River (facing south)

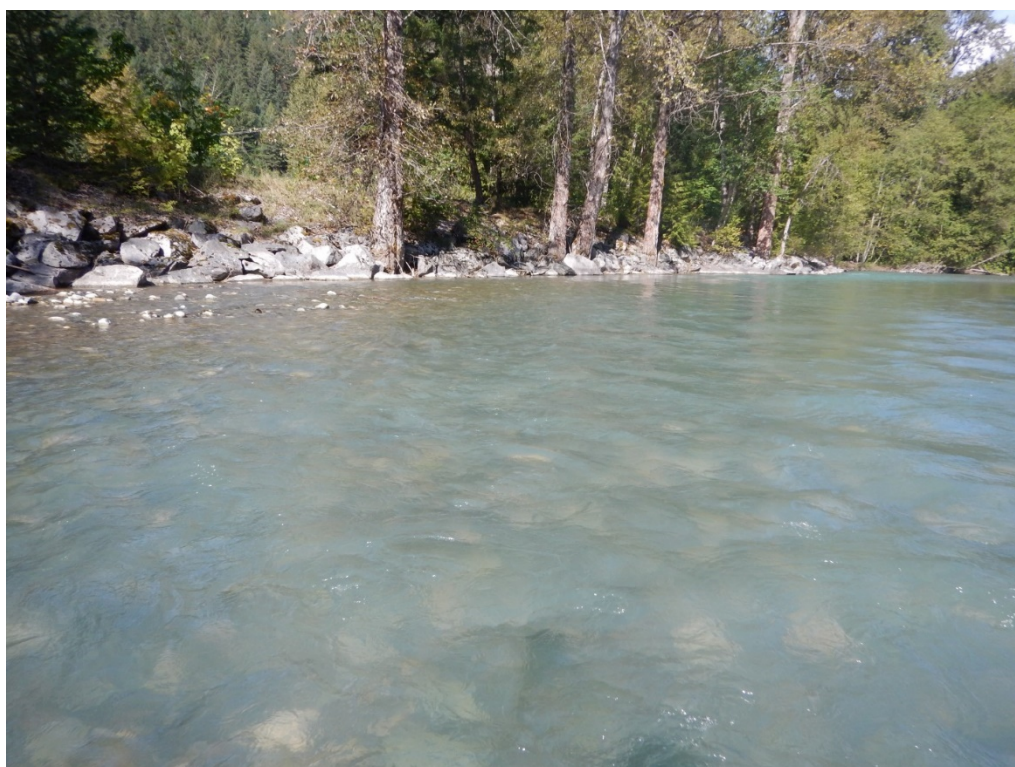
Figure 18 Some armoured and erosion protection on Poleyard Dike and Birkenhead River facing northwest

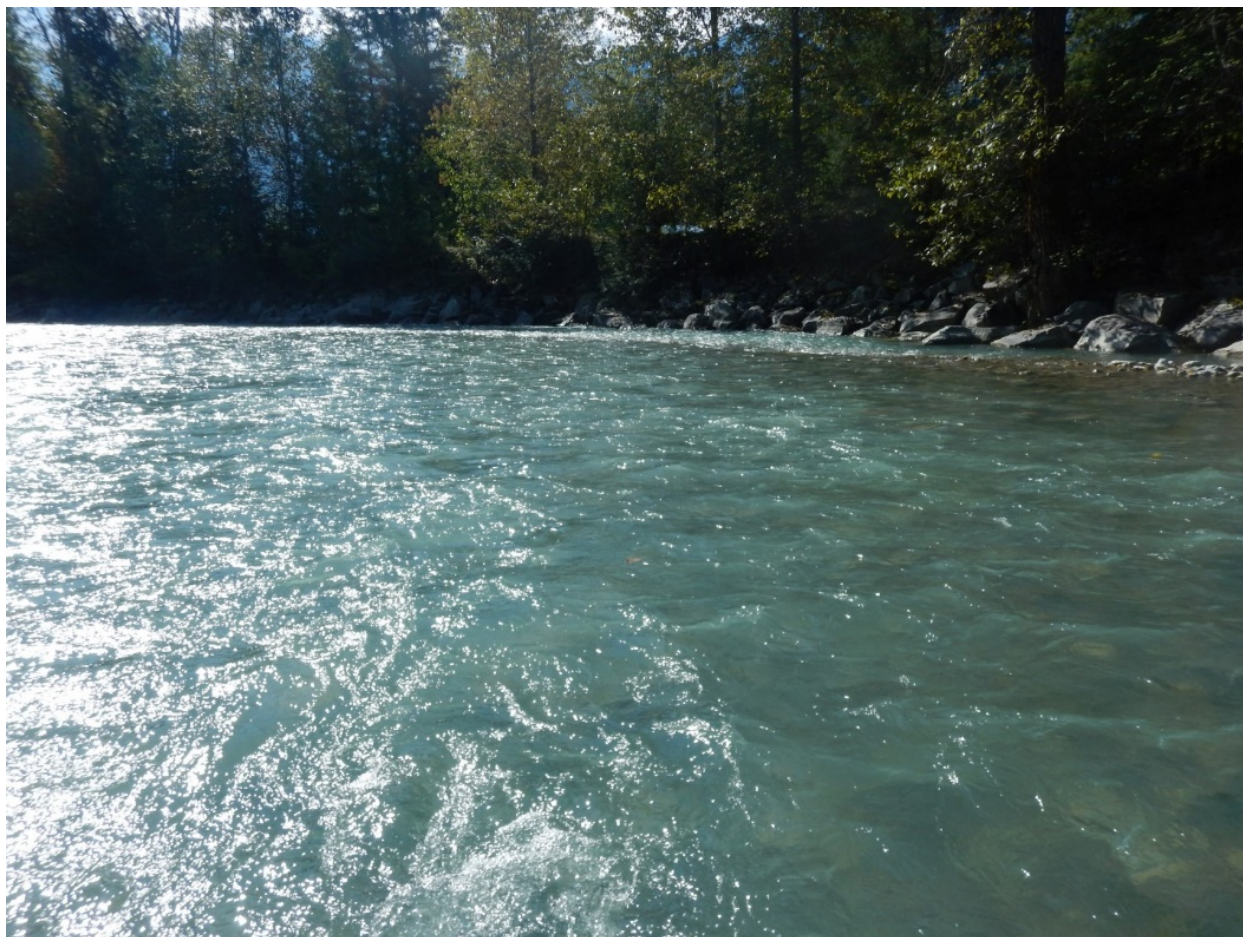
Figure 19 Birkenhead River facing south at Poleyard Dike where river bends left, just upstream of modelled breach location

The Birkenhead River design events used to assess the hazard at the development site is the 200-year flood event with and without failure of the Poleyard Dike. Potential failure was approximated as a 100 m wide breach. The location was selected based on likelihood of failure (at a low point in the dike, at the outside bend in river), and consequence (where breach flow is expected to reach Mount Currie).
