Place Glacier Hazard Assessment Report

Debris Flood and Flow Hazards

October 16, 2025

Squamish-Lillooet Regional District

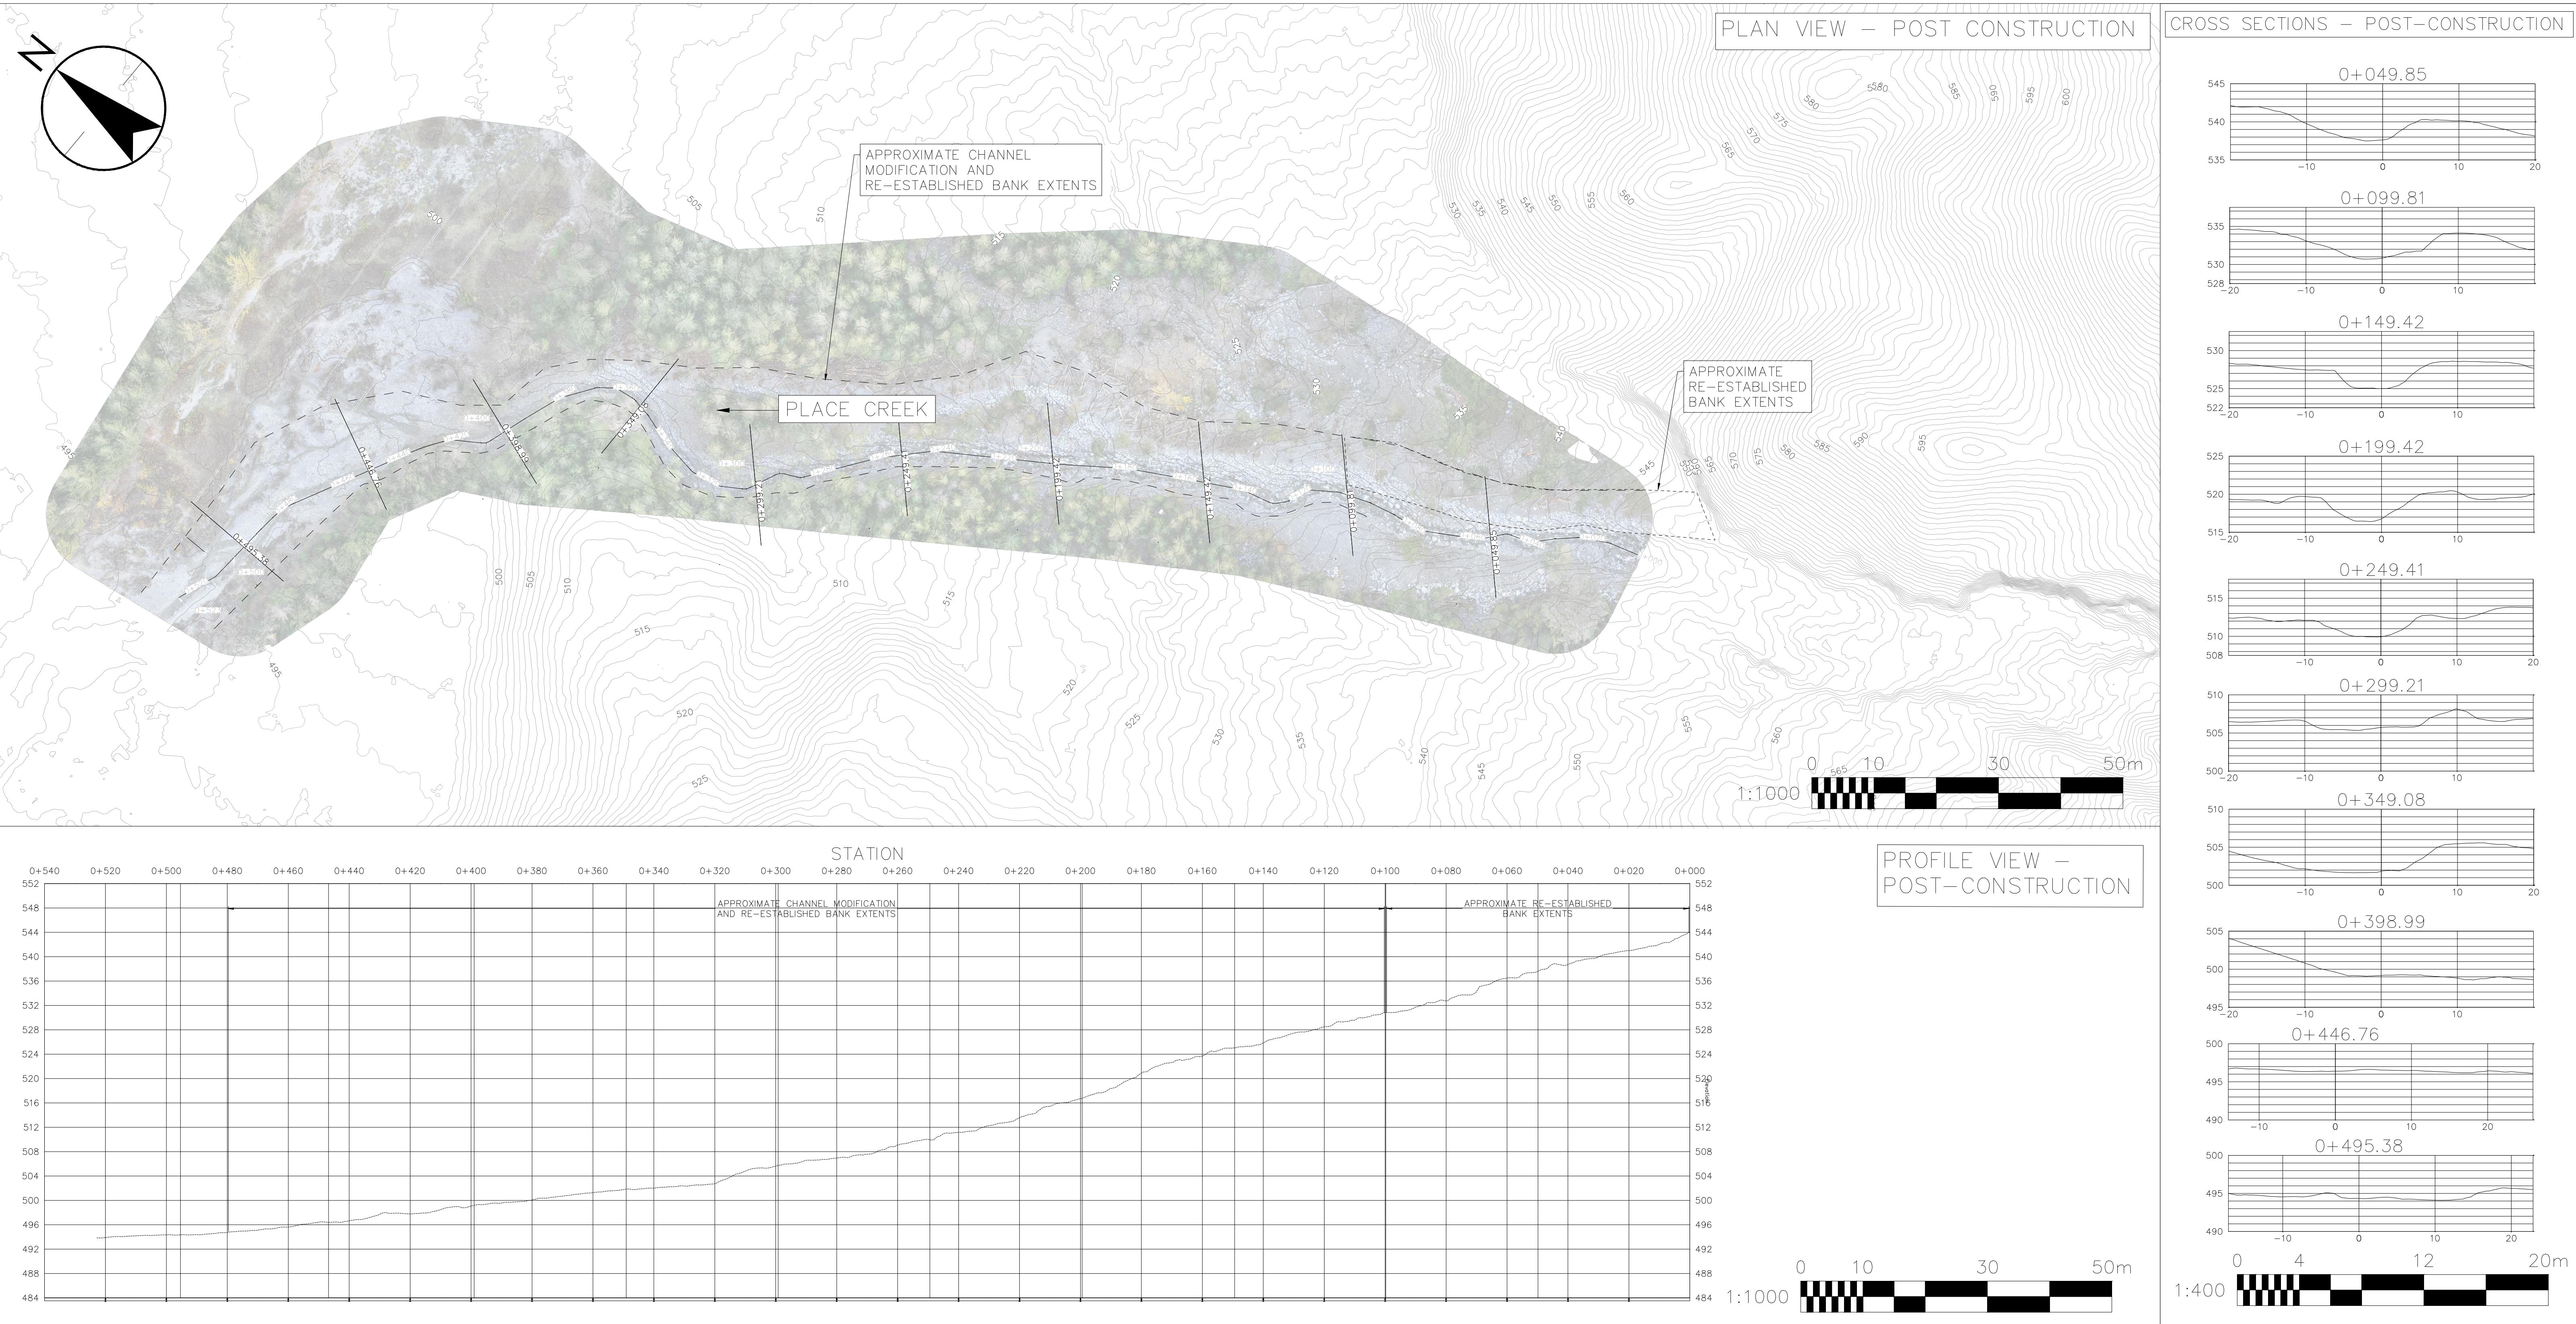
Figure 2-2. Record Drawings of 2024 Mitigative Work (Stantec, 2024)

Based on these criteria Stantec developed a mitigative action concept that involved removing large woody debris jams within the previous Place Creek channel alignment, excavating a channel and re-establishing the previous Place Creek east embankment. Large boulders were sourced from the debris and placed along the east embankment to provide some form of erosion protection from high flow events. The channel works were completed on September 26, 2024, Figure 2-2 presents the record drawings of the constructed mitigative works (Stantec, 2024b).

2. THE PURPOSE OF THE CHANNEL MODIFICATION AND RE-ESTABLISHED EMBANKMENT WAS TO ALLEVIATE THE IMMEDIATE DEBRIS FLOOD AND FLOOD HAZARDS POSED TO THE PROPERTIES AROUND GATES LAKE AND PORTION OF GATES RIVER IMMEDIATELY DOWNSTREAM OF GATES LAKE PRIOR TO THE IMMINENT EXTREME RAINFALL EVENTS GENERALLY EXPERIENCED IN THE FALL. THE CHANNEL MODIFICATIONS ARE DEEMED "EMERGENCY RESPONSE MEASURES"; AS SUCH, NO DESIGN LIFE OR DESIGN FLOW IS ASSOCIATED WITH THE CHANNEL MODIFICATIONS. DUE TO THE LOCATION, PHYSIOGRAPHY, AND GEOGRAPHY PLACE CREEK WILL LIKELY CONTINUE TO BE PRONE TO AVULSION AND LATERAL MIGRATION WITHOUT IMPLEMENTATION OF AN ENGINEER DESIGNED STRUCTURE THAT COULD PROVIDE LONG-TERM PROTECTION FROM DEBRIS FLOOD AND DEBRIS FLOW EVENTS.

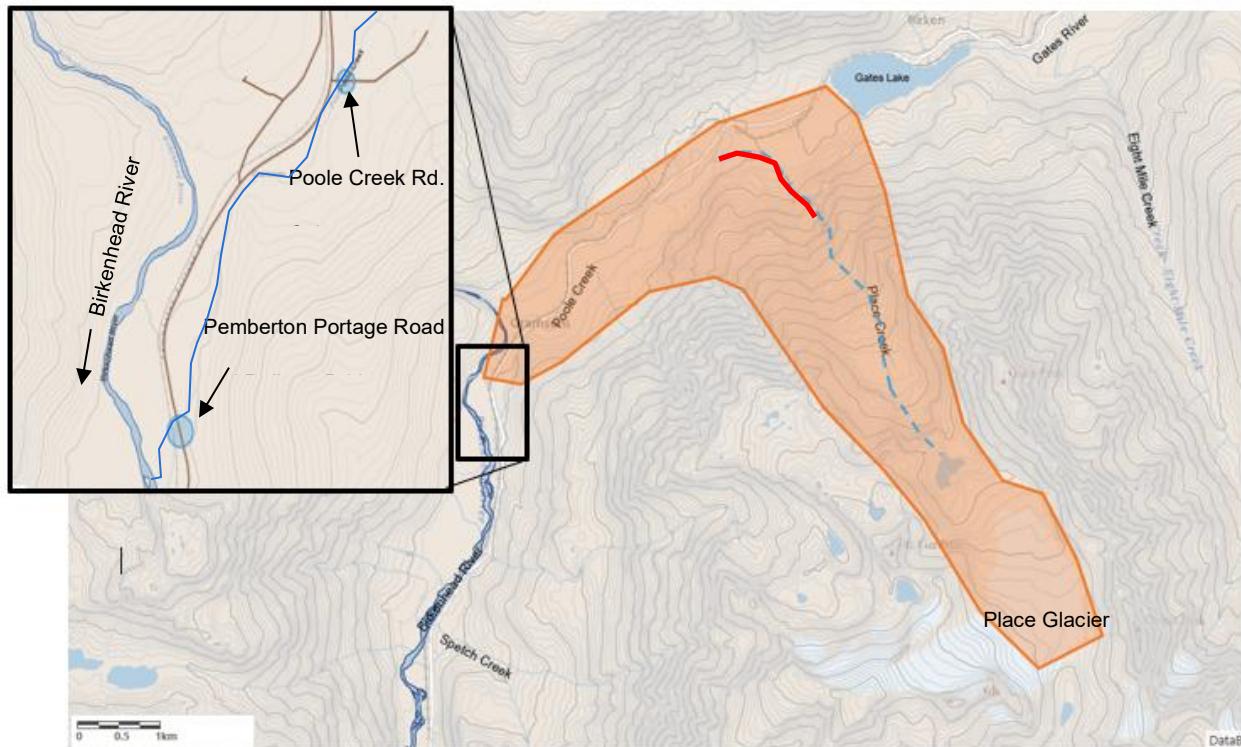
Figure 2-4. Extents of aerial (orange area) and ground based (red line and solid blue circles) visual assessments.

The aerial based debris flow hazard assessment observed evidence of debris flows having occurred in the upper watershed immediately downstream of the Place Glacier. NRCAN has indicated to Stantec and SLRD that now that the ice-marginal lake has gone through an outburst event, further meltwater is unlikely to refill the lake in 2025; rather, it will be conveyed downstream to Place Creek. NRCAN does not anticipate the lake refilling until 2026. In the absence of another outburst event there was observed to be low hazard of another debris flow event occurring in the immediate future (i.e. summer months).

The ground-based debris flow hazard assessment found that the 2024 emergency response works had been damaged as a result of the 2025 Outburst Event. Within the steep mountainous section near the upstream extent of the 2024 emergency response works, sections of the embankment riprap had failed and the embankment had retreated back 2 to 3 m. At the location where the channel avulsed in 2024 only 2 to 3 m of crest width remain (Figure 2-5). Scouring of the bed occurred and the channel has incised down into the deposited 2024 sediments leaving the toe of the bank riprap undercut and perched in some locations.

Flow within the flatter Pemberton Pass section is largely within a single channel but secondary flood channels branch out from the main channel in places and convey small portion of flow or pooled water. Along this segment there was evidence of finer sediment being deposited and the channel incising into that material; however, it does not appear that flow avulsed from the main channel towards the lower BC Hydro right of way. Deposition of large woody debris was observed; however, large log jams blocking the entire channel similar to what was observed and removed in 2024 was not observed.

The culverts and bridges investigated were free from debris but there was evidence of recent backwatering upstream of the Poole Creek Road culvert crossing and site conditions indicated the culvert is undersized. Based on these observations it was determined there was low debris flow and debris flood hazards immediately posed to the downstream communities (i.e. during the summer months prior to more extreme rainfall that historically occurs during the fall and winter).

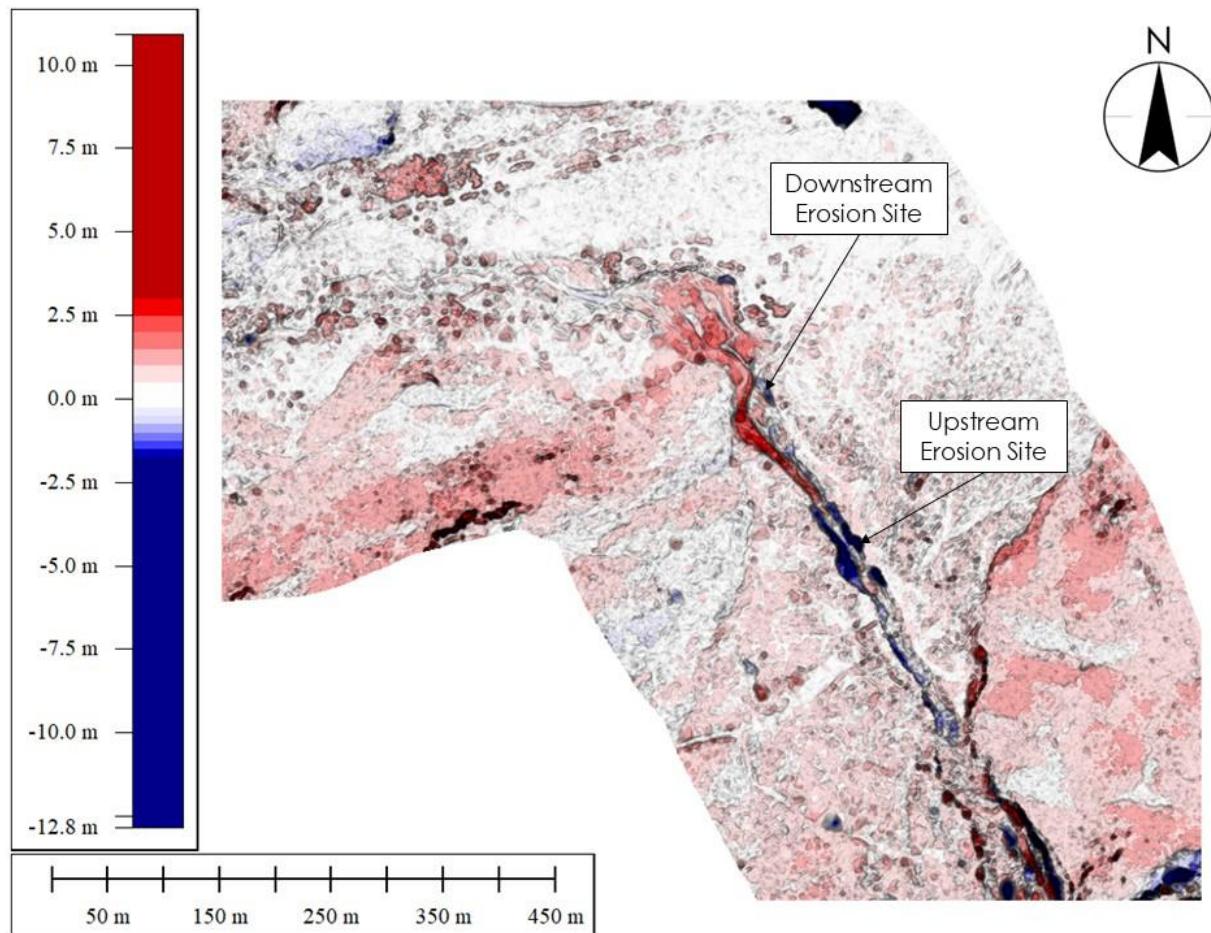
Figure 2-7. 2024-2025 LiDAR Differential Map

A differential map comparing the 2025 LiDAR to the post-construction LiDAR from 2024 (Figure 2-7) confirms the observations recorded during the visual assessment, where red represents aggradation³ and blue represents degradation⁴. Moreover, the differential map visualizes in red the location where Place Creek transitions from the steep mountains section to the flatter Pemberton Pass region and where debris flood sediment had deposited, filling the 2024 emergency works channel.

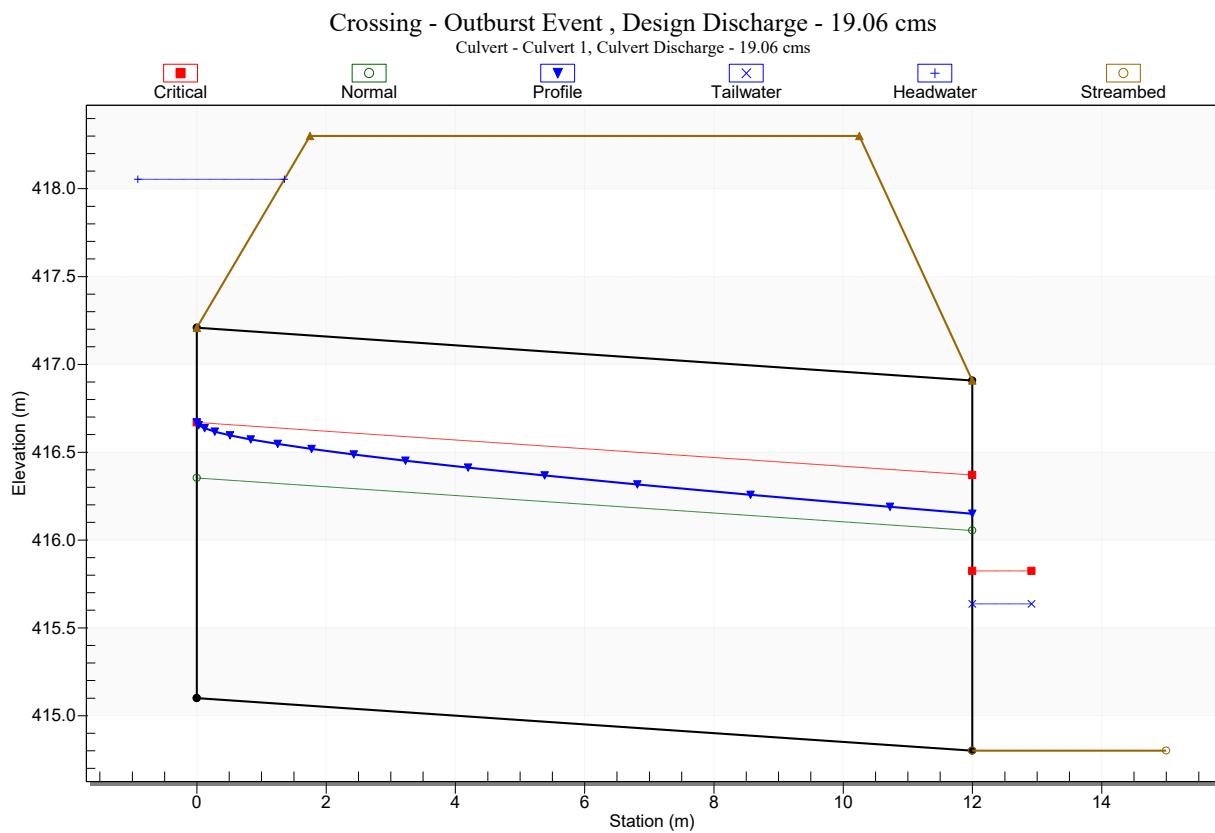
Figure 5-6. HY-8 Results for the 2025 Outburst Event

Hydraulics at the Poole Creek Road culvert associated with all three model flow scenarios were analysed using HY-8 software. The HY-8 results aligned with the 2D HEC-RAS model results, i.e. surcharging of the culverts and backwatering upstream but no overtopping of Poole Creek Road during the 2025 Outburst Event and overtopping during the Post-2025 Outburst Event 200-year Fall Clearwater and Debris Flood flows. Profiles presenting water surface elevation through the culvert for each scenario are presented in Figure 5-6, Figure 5-7, and Figure 5-8.

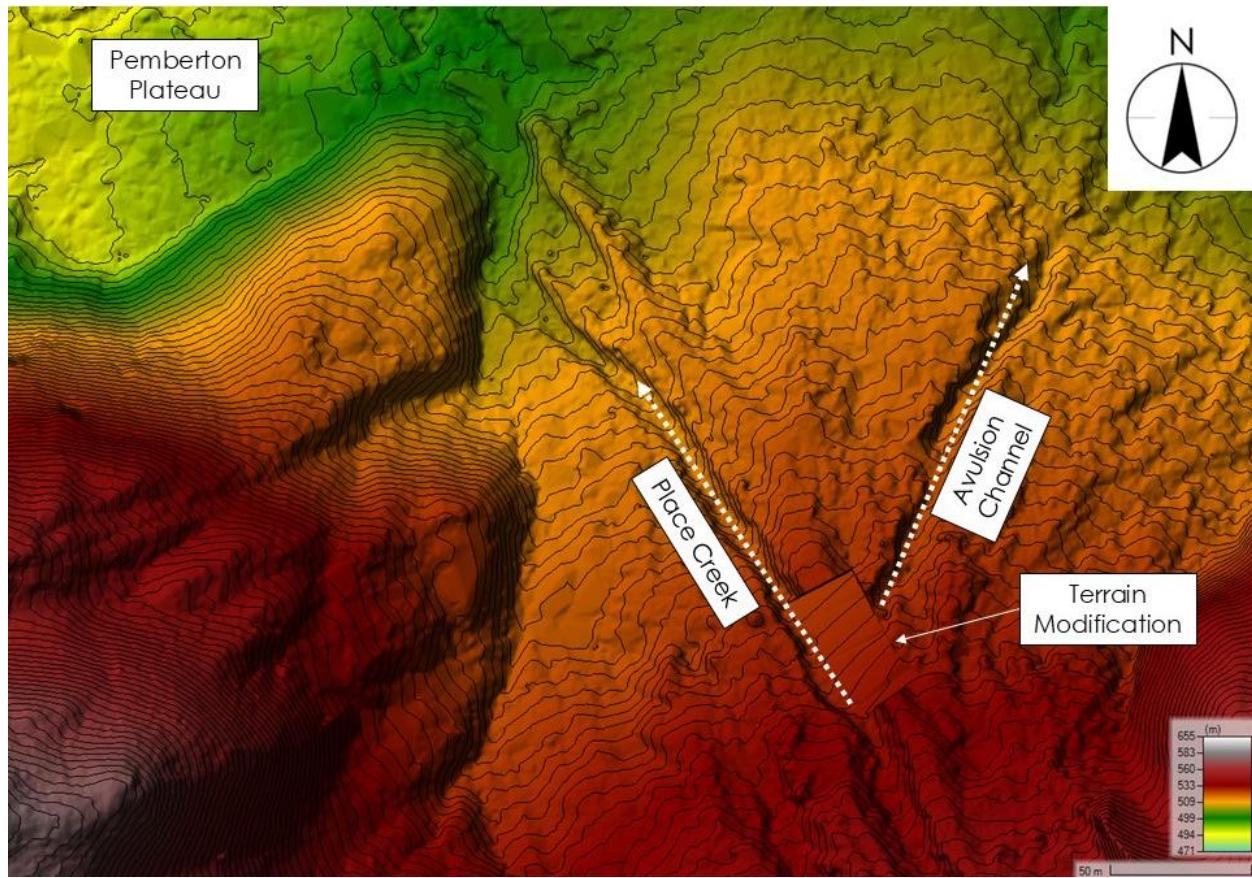
Figure 5-9. Terrain Modification For Full Erosion of Bank at 2024 Avulsion Point

The re-established embankment constructed following the 2024 Outburst event (further details in Section 2.2) was eroded and damaged due to the 2025 Outburst Event (further details in Sections 2.4). If the erosion site is left unprotected, further bank retreat at this location could result in an avulsion and routing of flow potentially back along the 2024 Outburst Event avulsion alignment towards Gates Lake. To determine whether remedial actions are required to mitigate the potential for an avulsion to occur in response to peak fall flows, terrain modifications were made to the 2D HEC-RAS model to account for potential further bank retreat towards the 2024 avulsion channel (Figure 5-9). The results show that if the bank is left unprotected and eroded further back there is low probability of an avulsion occurring in 2025 during the Post-2025 Outburst Event 200-year Fall Clearwater or Debris Flood Flow events (Figure 5-10 & Figure 5-11). The 2025 Outburst Event flow was also run through the modified terrain model which showed that there was a higher potential for an avulsion to occur at this location routing flow back through the 2024 avulsion channel towards Gates Lake (Figure 5-12).

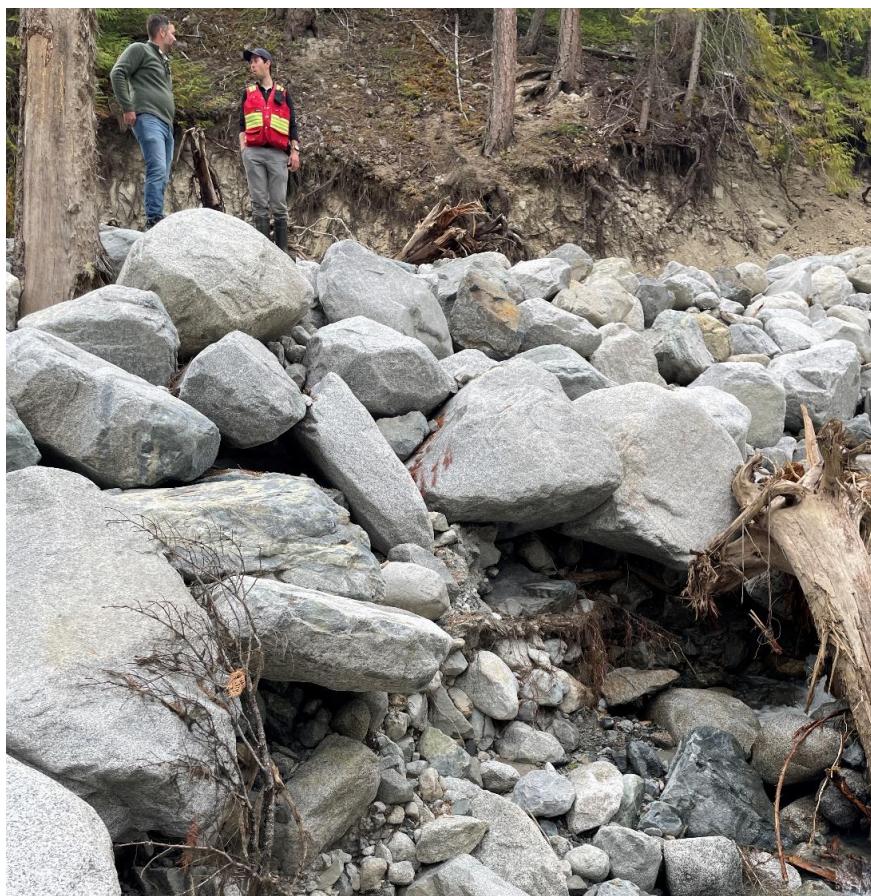
At the furthest upstream extent of the 2024 emergency response works the channel had scoured and incised down into the sediments deposited during the 2024 outburst event which had resulted in undermining of the right bank riprap toe in localised areas. In these areas the riprap was perched above the channel bed and unstable (Figure 3-10); however, the majority of the riprap was in good condition with tightly interlocked stones, minimal voids and little evidence of slumping or displacement – a comparison of 2025 to 2024 conditions is provided in Figure 3-9. The unprotected left bank of the channel experienced erosion and retreat resulting in near vertical 2 to 5 m high bank slopes (Figure 3-11).

Figure 3-10 Localised areas where scour and incising of channel has undermined right bank riprap

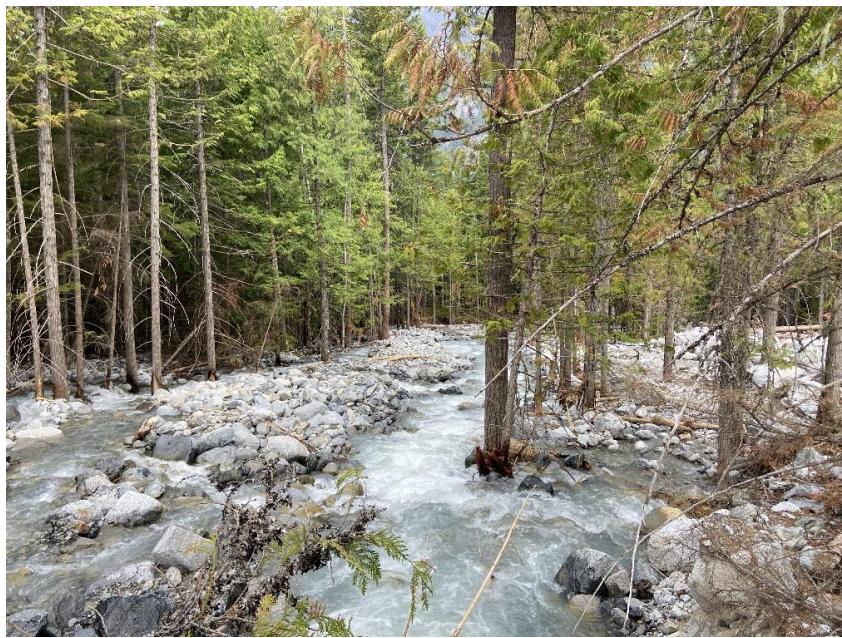
The channel continues downstream from this location a further 40 m with the right bank riprap in good condition and channel incised down into the 2024 outburst sediment. At this location the gradient flattens out and 2025 outburst sediment appears to have deposited, filling the 2024 emergency response channel (Figure 3-14). Flow is now being conveyed through multiple channels incised into the 2025 outburst sediment extending from the left valley wall to the 2024 emergency response east embankment (Figure 3-15).

Figure 3-15 Looking downstream at deposited 2025 outburst sediment and multi-channel flow.

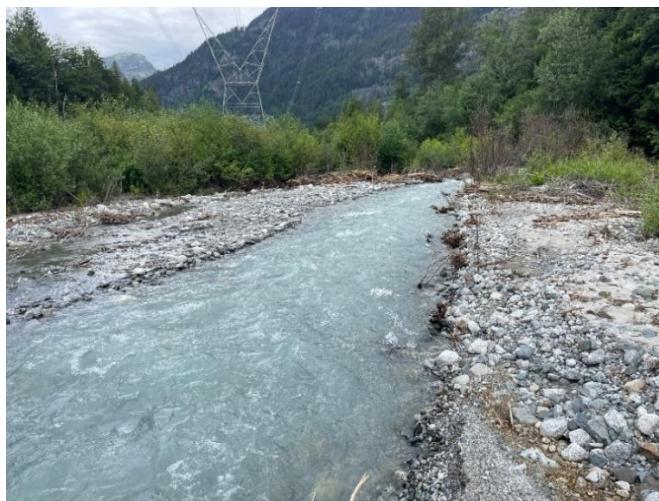
Figure 3-19 Looking downstream at Place Creek through the Pemberton Plateau

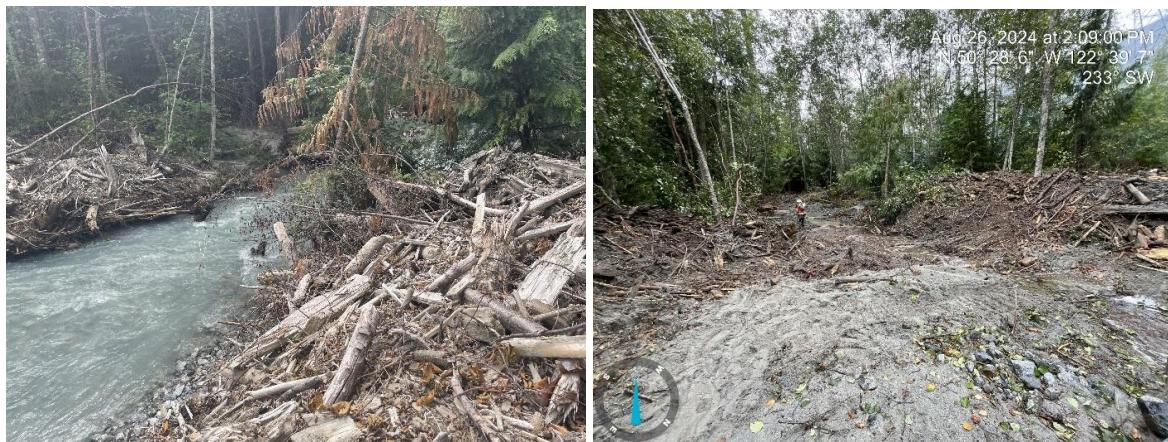
Within the reach of Place Creek that extends downstream along the Pemberton Plateau to the confluence with Poole Creek flow following the 2025 outburst event appears to be conveyed through the 2024 emergency recovery channel alignment. There is evidence of sediment deposition along the flood plains of the channel; however, it is difficult to determine whether this was deposited due to the 2024 or 2025 outburst events (Figure 3-19). Some large woody debris may have been deposited at the two large woody debris sites that were cleared from the channel as part of the 2024 emergency recovery works but based on photo comparison it does not appear that conveyance through the channel has been impacted (Figure 3-20 and 3-21).

Figure 3-20 Place Creek flow through 2024 large woody debris jam site (left image 2025, right image 2024)

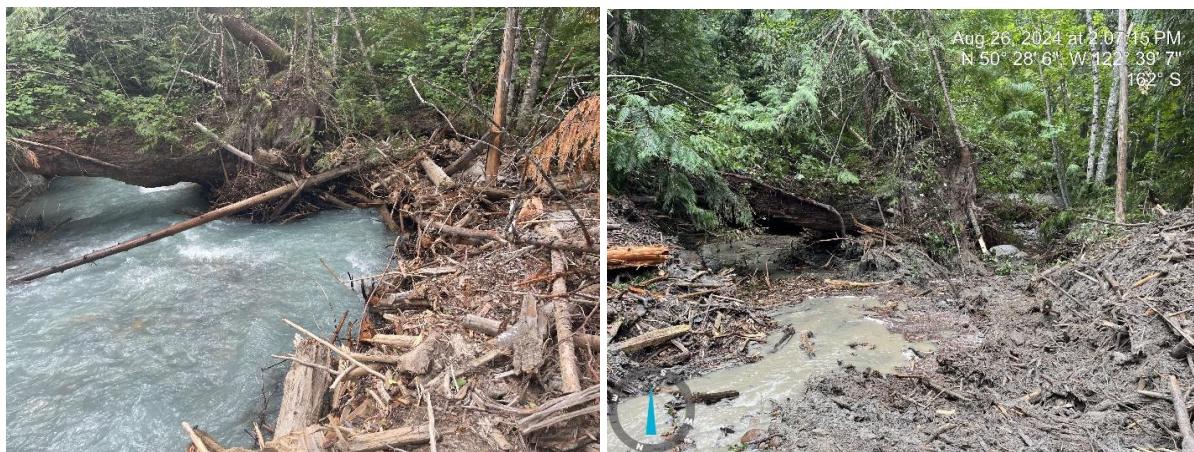
Figure 3-21 Place Creek flow through 2024 large woody debris jam site (left image 2025, right image 2024)

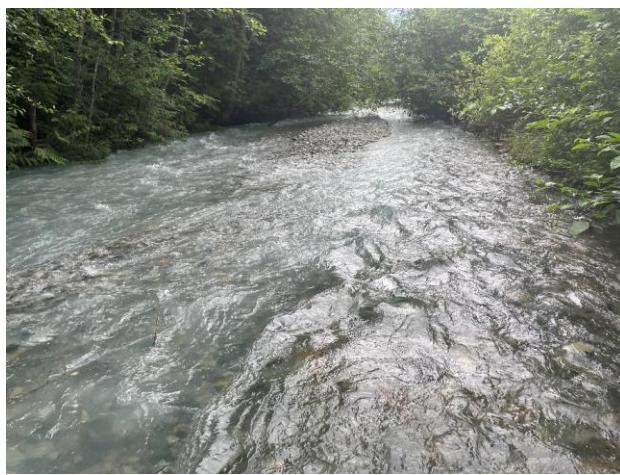
There was no evidence of sediment deposition or bank erosion along the Poole Creek immediately downstream of the confluence with Place Creek (Figure 3-22).

Figure 3-22 Looking downstream at Poole Creek at confluence with Place Creek

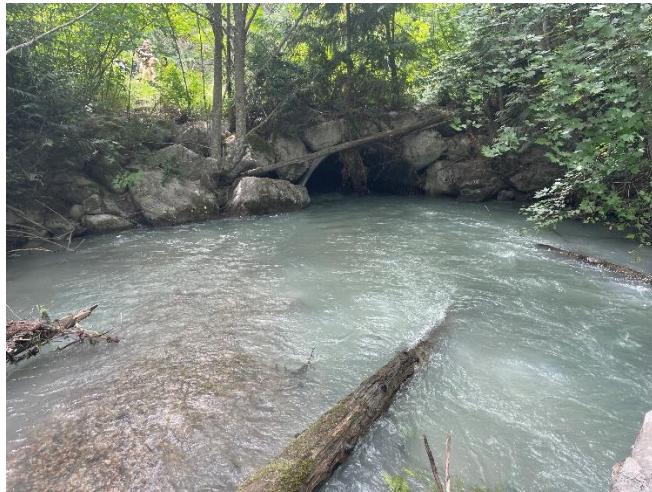
The Poole Creek Road culvert is comprised of a 2160 mm rise, 3500mm span corrugated multi-plate steel pipe arch that is approximately 12 m long with a slope of approximately 2-3%. The head slope of the culvert and adjacent embankment slopes are armoured with approximately 500kg to 1000kg Ministry of Transport and Transit (MOTT) class riprap (Figure 3-23).

Figure 3-23 Looking downstream to inlet of Poole Creek Road culvert

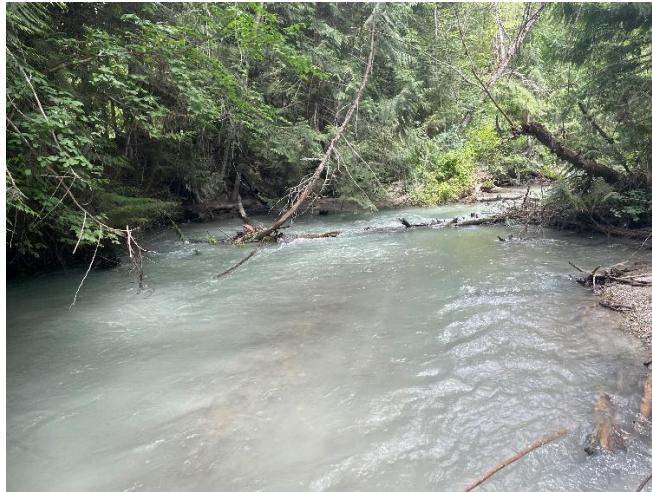
The channel upstream of the culvert has a channel gradient of approximately 2-3% (Figure 3-24) with a densely vegetated right bank with mature timber that extends approximately 2 to 3 m up from the channel bed (Figure 3-25) and a poorly defined left bank that extends approximately 0.5 m up from the channel bed and transitions to a wide shallow, densely vegetated floodplain with mature timber (Figure 3-26).

Figure 3-24 Looking upstream to channel upstream of Poole Creek Road culvert inlet

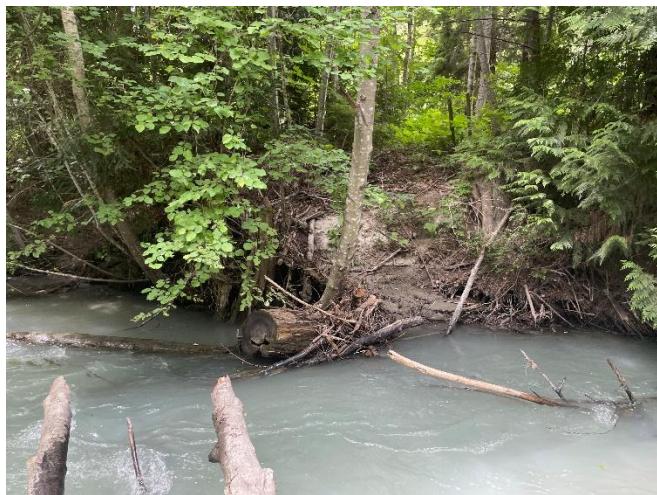
Figure 3-25 Right bank upstream of Poole Creek Road culvert

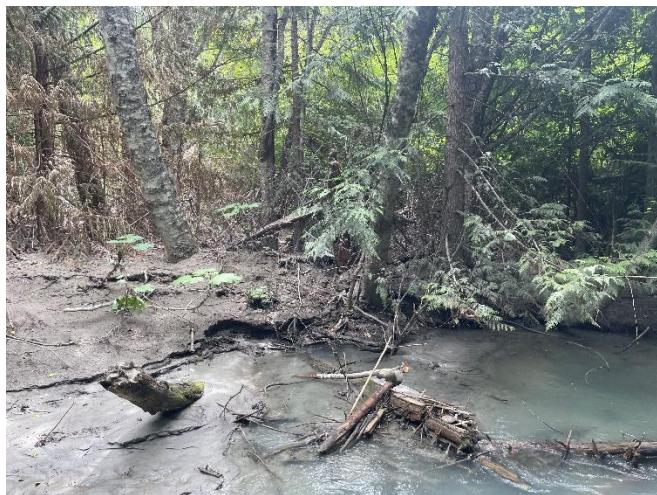
Figure 3-26 Left bank upstream of Poole Creek Road culvert

Fine sediments and both large and small woody debris are placed along the left floodplain extending more than 10 m from the poorly defined bankline. It is difficult to determine the extents of the 2025 outburst sediment deposition compared to the 2024 outburst sediment deposition; however, sediments near the left bank were loose, saturated and free from established vegetation which would indicate a recent high flow event inundated the area. Sediment and small woody debris were present along the right crest of bank and the adjacent floodplain; however, the material was compact with young vegetation established indicative that this was likely deposited during the 2024 outburst event.

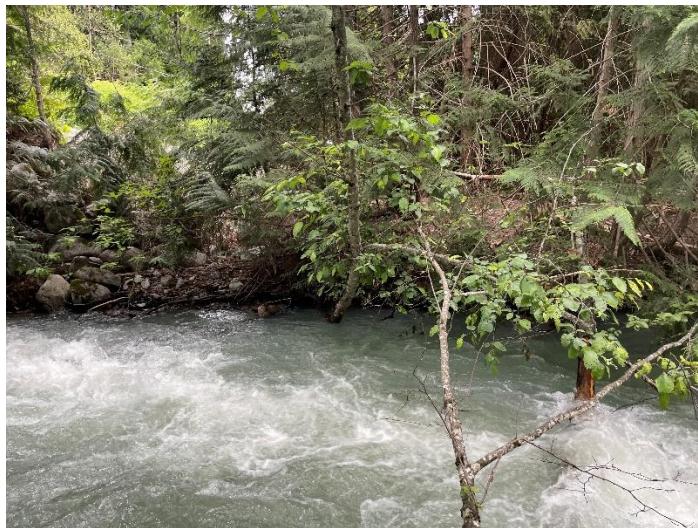
Both channel banks immediately adjacent to the culvert outlet are eroding and near vertical approximately 1 to 2 m high with densely vegetated floodplains extending away from the channel (Figure 3-28). There was no evidence of recent overtopping of the banks downstream of the culvert outlet; however, there is large amounts of large woody debris collecting within the channel approximately 20 m downstream of the culvert outlet (Figure 3-29).

Figure 3-28 Looking towards left bank downstream of Poole Creek Road culvert outlet

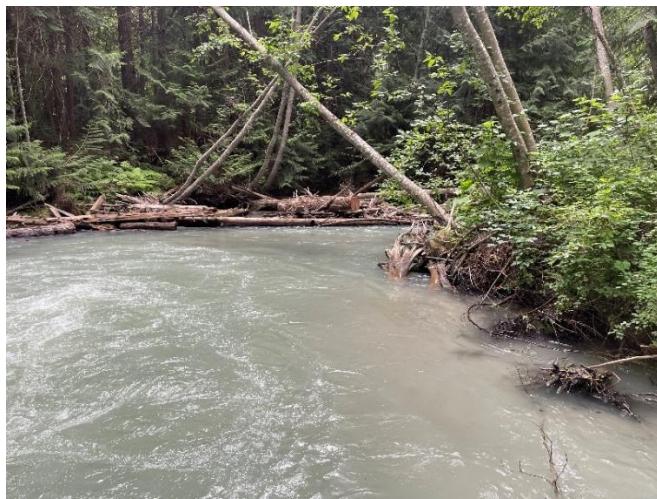
Figure 3-29 Looking towards large woody debris collected within channel approximately 20 m downstream from Poole Creek Road culvert outlet

These observed conditions are indicative of an undersized culvert; however, to confirm this a quantitative assessment would need to be conducted.

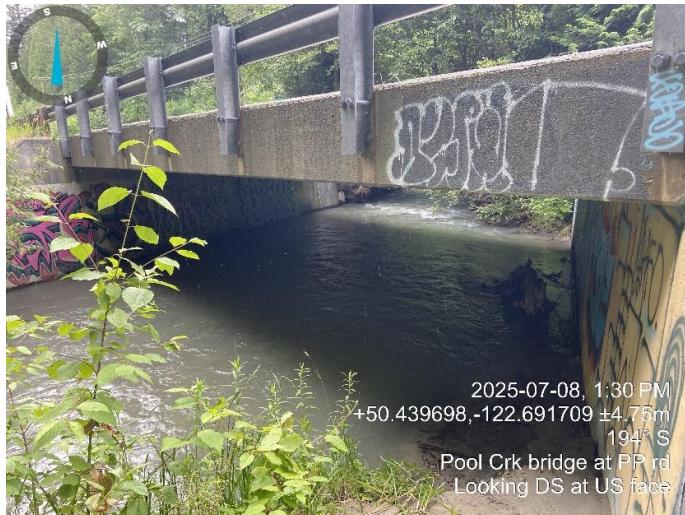
The abutments are comprised of vertical concrete walls (unknown whether spread footing or piles) with concrete wing wall extending approximately 2 m both upstream and downstream from the abutments (Figure 3-31). Estimated 250-kg MOTT class riprap ties into the backside of the wing walls and extend an unknown distance upstream and downstream along the banks. No scour holes were observed along the faces of the abutments, wingwalls, or riprap and the riprap appeared to be oversteepened (approximately 1H:1V slope) but stable with tight interlocking and free from displacement or slumping (Figure 3-32). One piece of large woody debris was observed along the face of the right wingwall but otherwise the bridge opening was free from debris (Figure 3-33).

Figure 3-31 Looking downstream from upstream face of Pemberton Portage Road Bridge

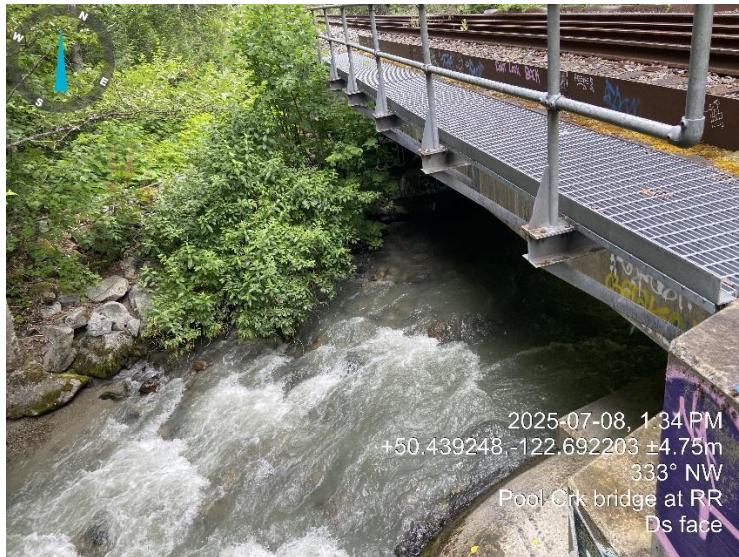
The Railway Bridge crossing of Poole Creek is located approximately 30 m downstream from the Pemberton Portage Road Bridge. It has a span of 11.7 m span and a distance from the low chord to the channel bed of 2.7 to 3 m (approximately the same as the Pemberton Portage Road Bridge – Figure 3-34).

Figure 3-34 Looking upstream towards downstream face of Railway Bridge

The abutments are comprised of vertical concrete walls founded on what is assumed to be a concrete spread footing (Figure 3-34). Estimated 250-kg MOTT class riprap extends upstream and downstream from both abutments an unknown distance along the banks. No scour holes were observed along the faces of the abutments or riprap and the riprap appeared to be oversteepened (approximately 1H:1V slope) but stable with tight interlocking and free from displacement or slumping. The bridge opening was free from debris or sedimentation.
