*Pierre A. Friele, MSc, PGeo*  
*P.O. Box 612*  
*1021 Raven Drive*  
*Squamish, BC V8B-0A5*  
*Ph. (604) 849-0250*  
*email. pfriele@gmail.com*

Sarah Morgan  
SLRD EOC Director  
P: 604-894-6371  
[www.slrd.bc.ca](http://www.slrd.bc.ca)

V1 December 10, 2021; V2 December 13, 2021

During the recent atmospheric river events (Nov 14-15; Nov 27-29; Nov 30-Dec 1; 2021), Jason Creek, at Ivey Lake, near Pemberton, BC experienced three extreme hydrogeomorphic events and washed out the Jason Creek culvert at Reid Road two times. The events were accompanied by overland flow flooding of several properties, localised bank erosion, minor damage to Portage Road, and threatened the CN Rail line.

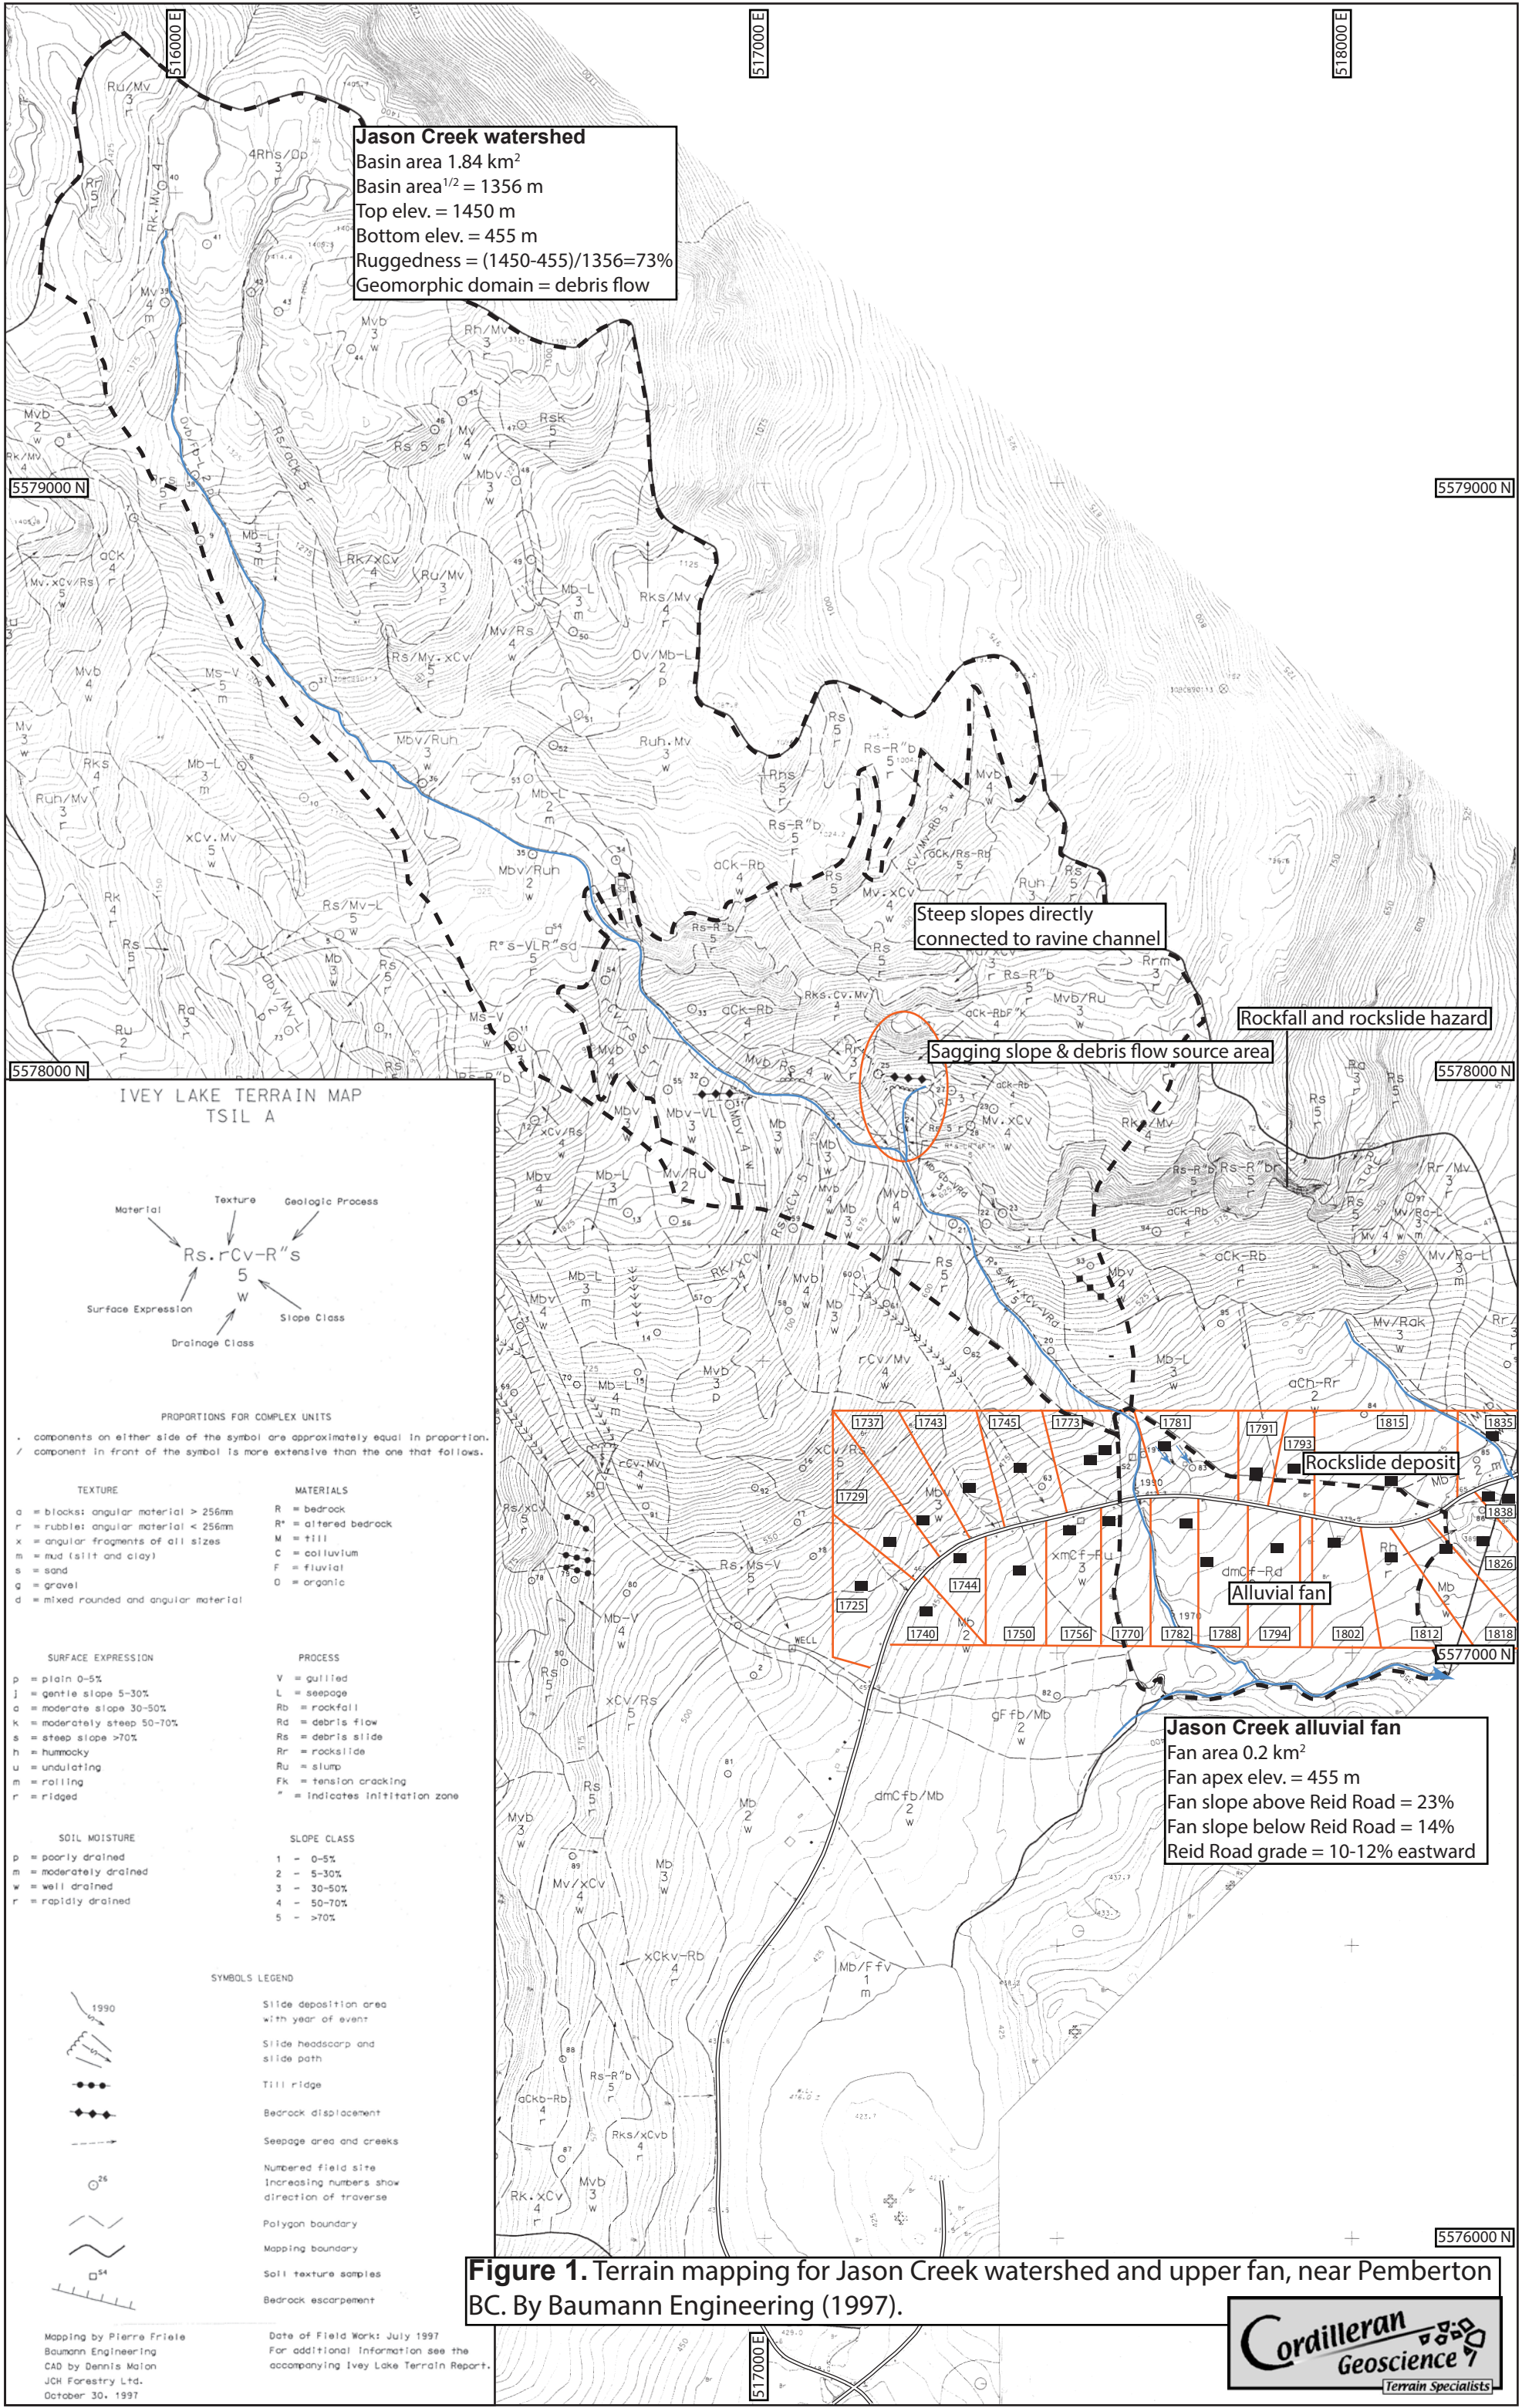
**Figure 2.** Long profile of Jason Creek watershed and upper fan, near Pemberton BC. By Baumann Engineering (1997).

The Jason Creek ravine, extending from the fan apex at 455 m to 1000 m elevation, was mapped and found to contain evidence of both smaller scale sidewall slumping and larger scale bedrock instability (Figures 1 & 2). In particular, at 650 m elevation there is the confluence of the main Jason Creek ravine and a tributary from the east. Between these channels, extending up to about 800 m elevation, an unstable bedrock area was identified consisting of a slow moving or sagging slope (Figure 1). At the crest is a bedrock bluff that is deeply fractured and appears to be spreading southward (Photo 3); below the bluff is a talus slope that has been truncated across the contour by a normal fault, resulting from slow failure of the material below into Jason Creek (Figures 1, 3). These lower failing slopes are the source for the 1990 debris flow, and were recognised by Blunden in 1981 (this is also the source for one or more events in 2021). At two other sites, lineaments in bedrock were noted that were suspect potential instabilities (Figure 1).

The Jason Creek watershed has a convex long profile (Figure 2), with the lower half of the watershed below 1000 m elevation being much steeper than the upper half. These lower slopes are directly connected to the ravine sidewalls. Hence any instability in this lower slope area will enter the ravine and become conveyed to the fan apex. It is the ravine in this lower part of the watershed that was investigated December 1 & 12, 2021.

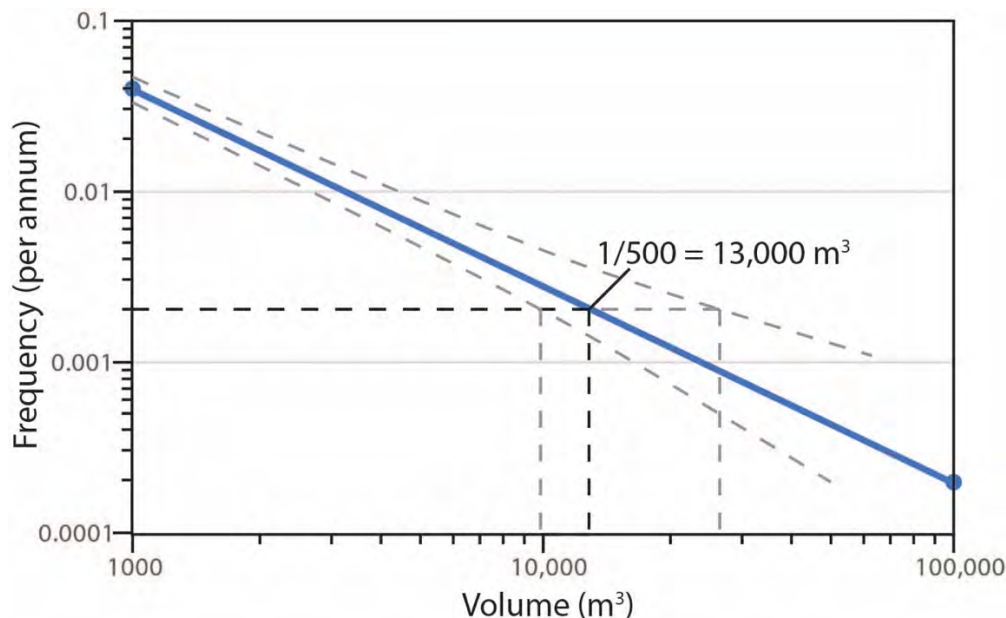
Based on these preliminary judgements, a Frequency-Magnitude model can be developed for example purposes (Figure 4). Two end-member frequency-magnitude pairs are plotted on a Log-Log chart: a 1/25-year event with 1000 m<sup>3</sup> volume and a 1/5000-year event with 100,000 m<sup>3</sup> volume. A straight line between is assumed. The 1/500-year event volume can then be interpolated as ~13,000 m<sup>3</sup>; with uncertainty, this may vary from 10,000-25,000 m<sup>3</sup>. A 1/100-year event is estimated to have a volume of ~3000 m<sup>3</sup>.

**Figure 4.** Hypothetical F-M diagram for debris flow affecting upper Jason Creek fan. Volumes are based on estimates from field observation of likely failure scenarios; the frequency for small events is based on historical record; while the frequency-magnitude of larger events is uncertain, as reflected by the widening confidence bands.

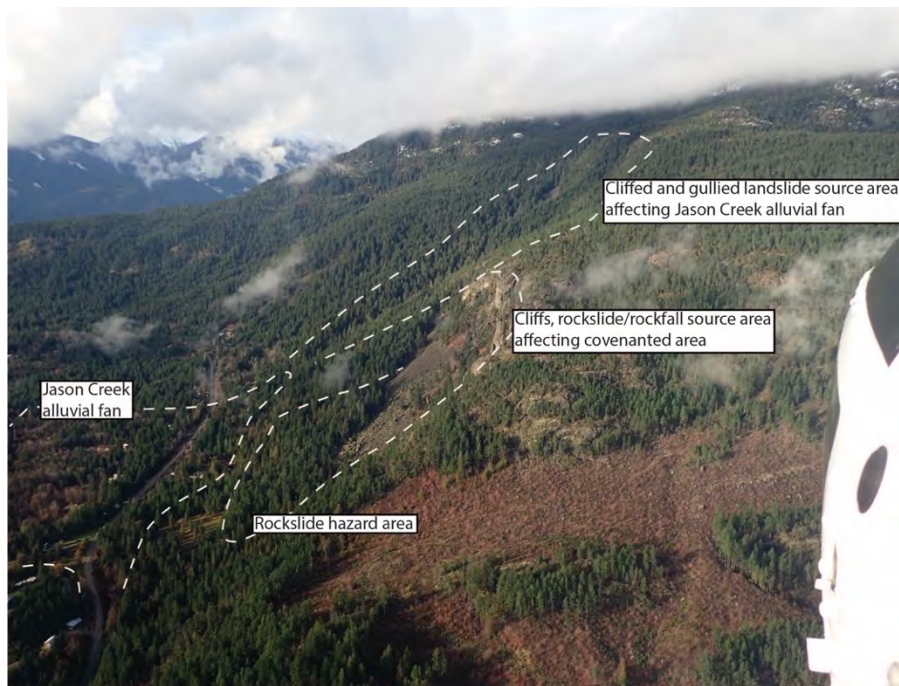
As part of the subdivision approval process for DL2679, Piteau Associates (May 1981) provided an assessment of the rockfall & landslide hazard associated with the prominent rock bluffs above Reid Road (Photo 1). They noted ongoing rockfall activity affecting the talus slopes, and identified a prehistoric rockslide deposit that had run out onto the base of slope (Photo 2). They described the toe of the deposit as having reached/filled a NW-SE trending trough. Although they did not identify it as such, this trough is the east margin of the Jason Creek alluvial fan. They believed that the landslide risk was significant enough that a hazard covenant area should be delimited affecting all or part of proposed lots 8-11 (note: not final numbering system).

**Photo 1.** View west over Ivey Lake watershed delineating hazard areas discussed in report.

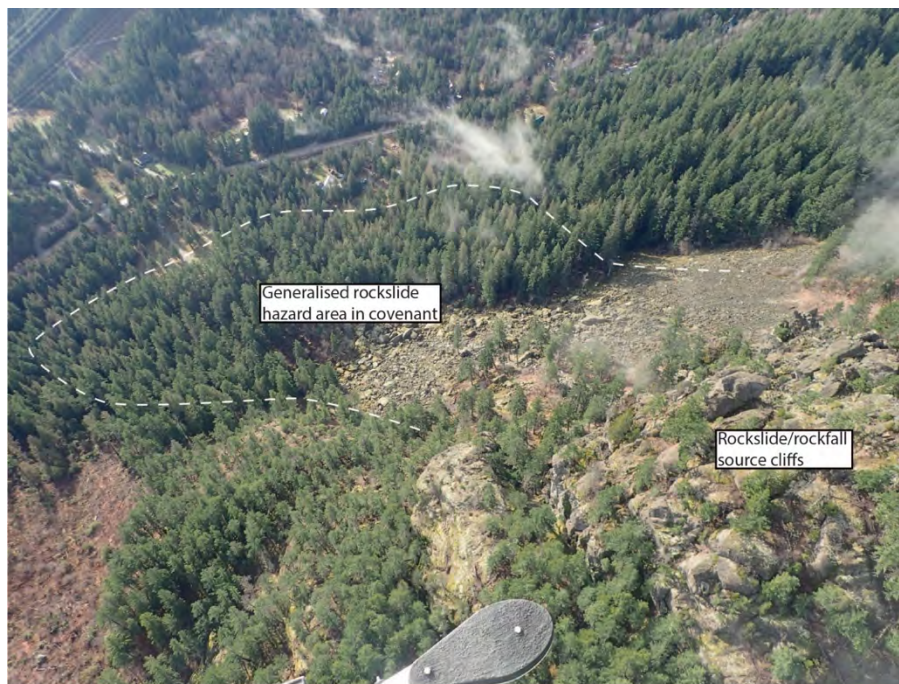
**Photo 2.** View southwest over cliffs to rockslide hazard area affecting lots 1791, 1793, 1815 & 1835 Reid Road.

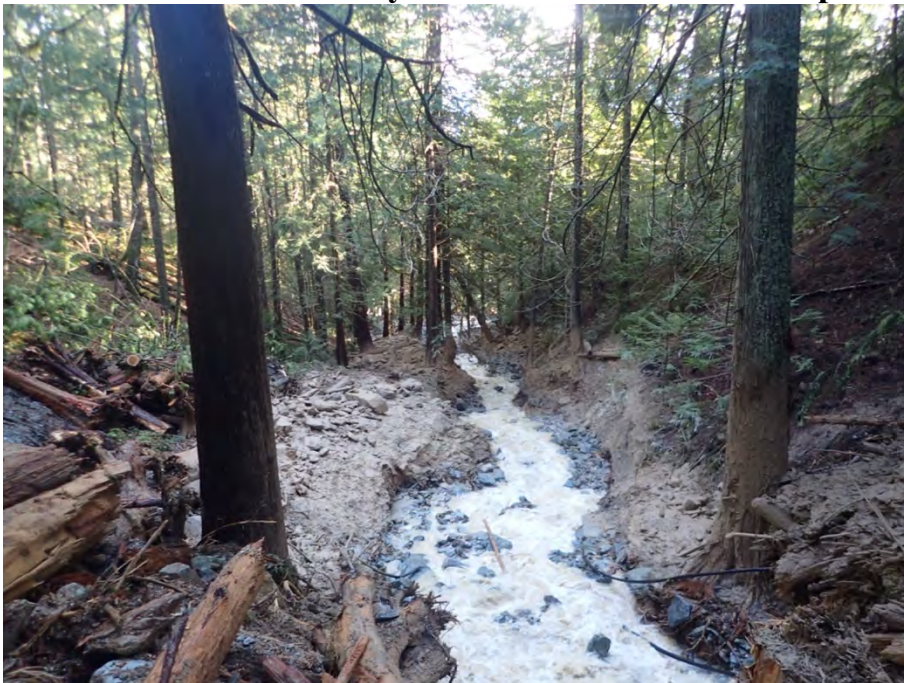
Jason Creek experienced two possibly three debris flow events (Photos 10, 11) resulting in partial stream avulsion at the apex above Reid Road (Photos 12, 13, 14), damage to the Reid Road crossing structure on Jason Creek (Photo 15), and overland flow flooding down Reid Road (Photos 16, 17) and affecting eight properties (Table 3). The damages were most extensive and severe on the upper fan area (Photos 18-23). No impacts were documented in the middle fan. On the lower fan, Jason Creek remained confined (Photos 24-32), but caused erosion where a driveway culvert became plugged forcing road overtopping and bank undermining (Photo 33). High flows ponding at the Portage Road and CN Rail culverts threatened those crossings (Photos 34-37).

**Photo 10.** December 1, 2021 debris flow on Jason Creek. View downstream showing muddy trimlines defining an area 12 m wide by 3 m deep; channel bottom about 4-5 m wide. Using a “Spider” excavator, this area was cleared of debris jams between the November 15 and November 30 washout events.

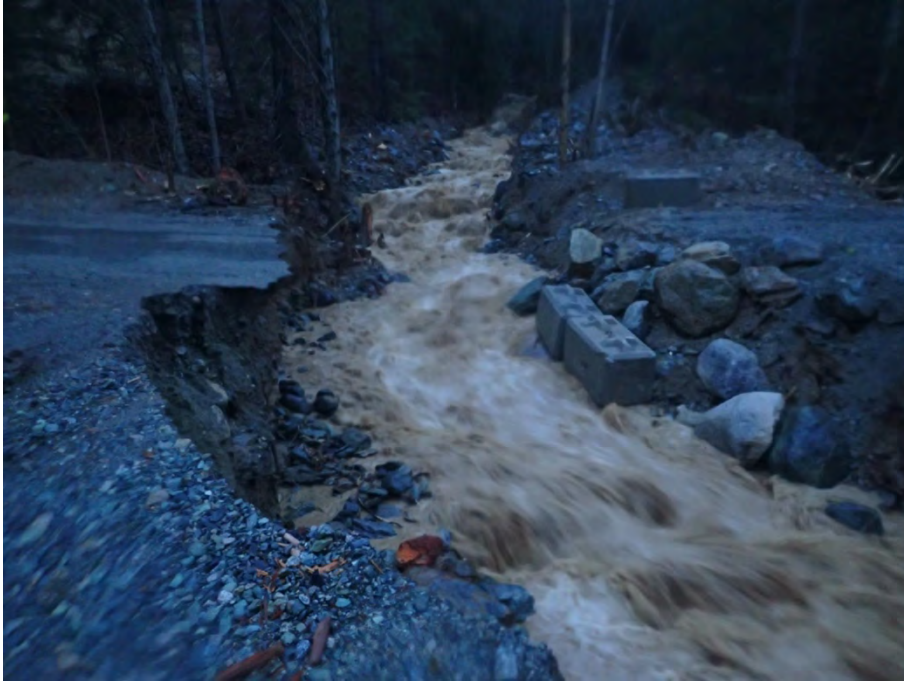
**Photo 15.** WP43. View upstream to Jason Creek at Reid Road, December 1, 2021 at 4 pm. Note that channel upstream has been recently cleared by the “Spider” hoe.

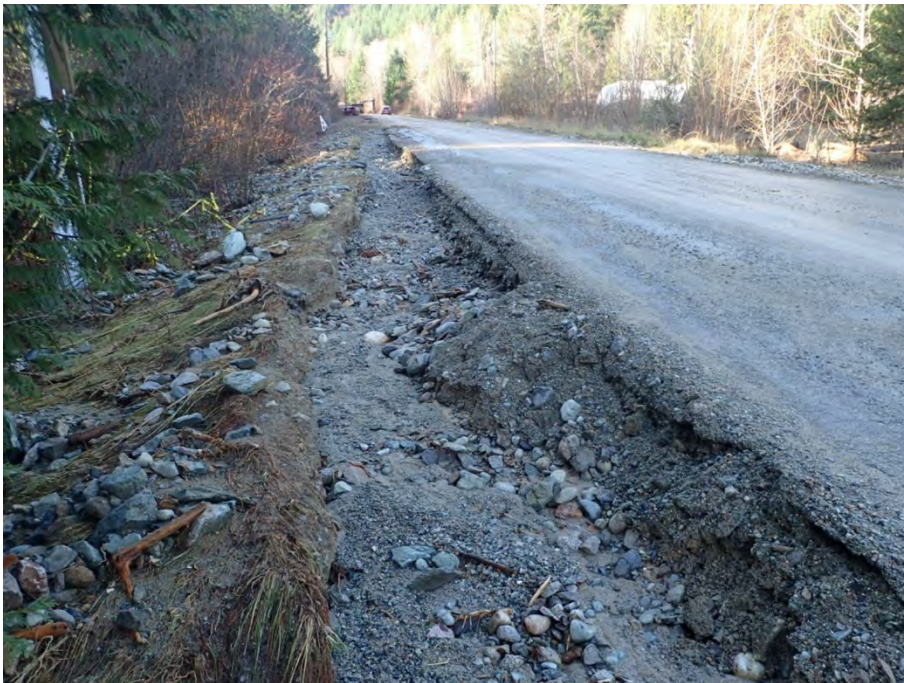
**Photo 16.** WP62. View up (east) along south side Reid Road, eroded shoulder. On north side at this point overflow from hillslope tributary (WPs 67-70) follows 1791 Reid Road driveway to join Reid Road.

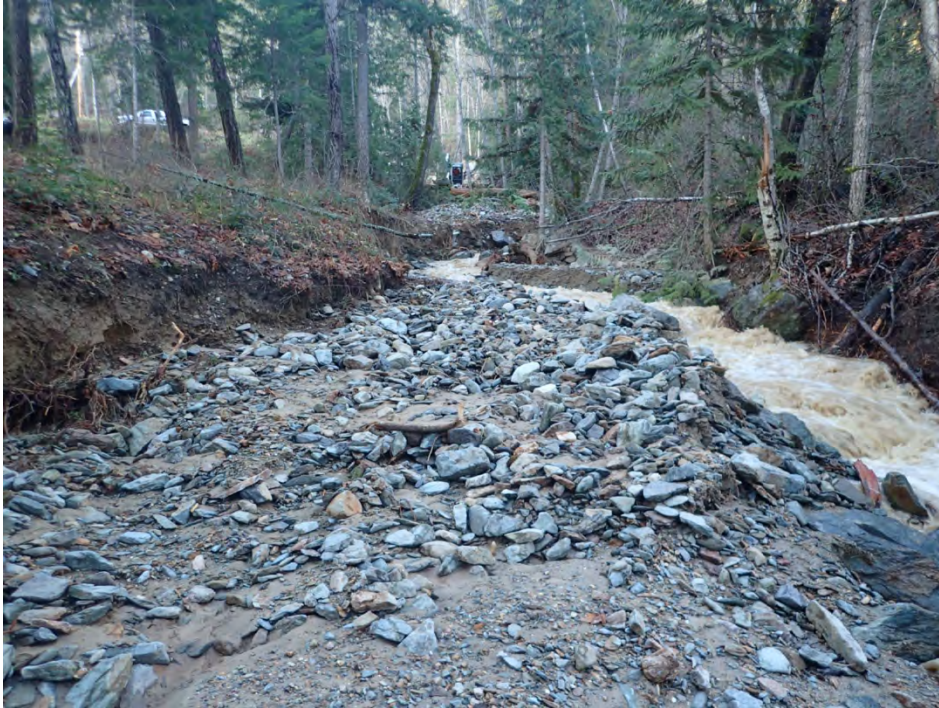
**Photo 18.** WP105. View upstream along Jason Creek in 10 m wide channel, incised 2 m into fan surface.

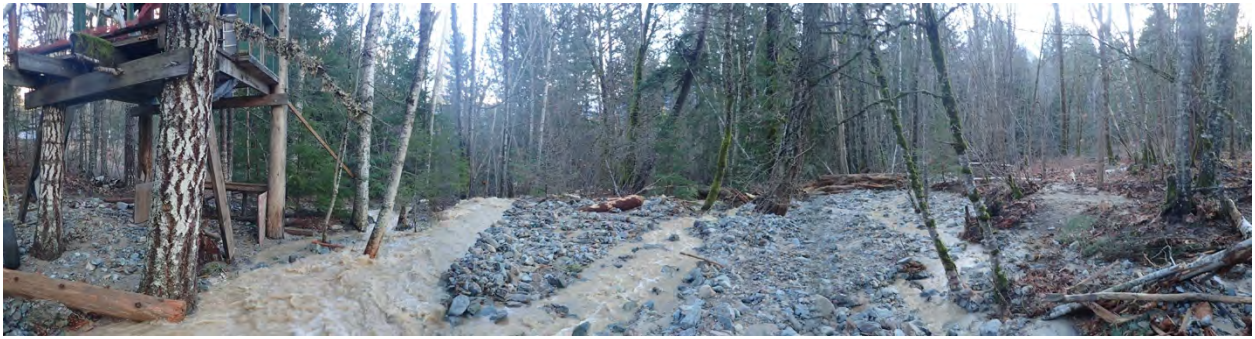
**Photo 19.** WPs 81, 104. View downstream, treehouse on left. Unconfined debris deposition area, Jason Creek spreads over 20 m width.

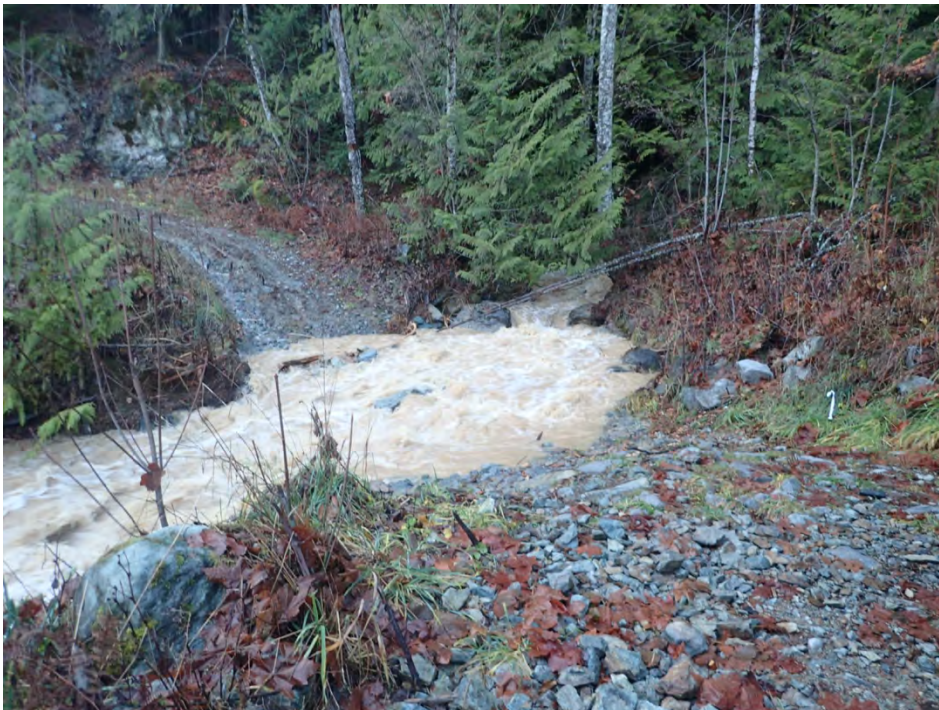
**Photo 24.** WP15. Jason Creek in bedrock ravine.

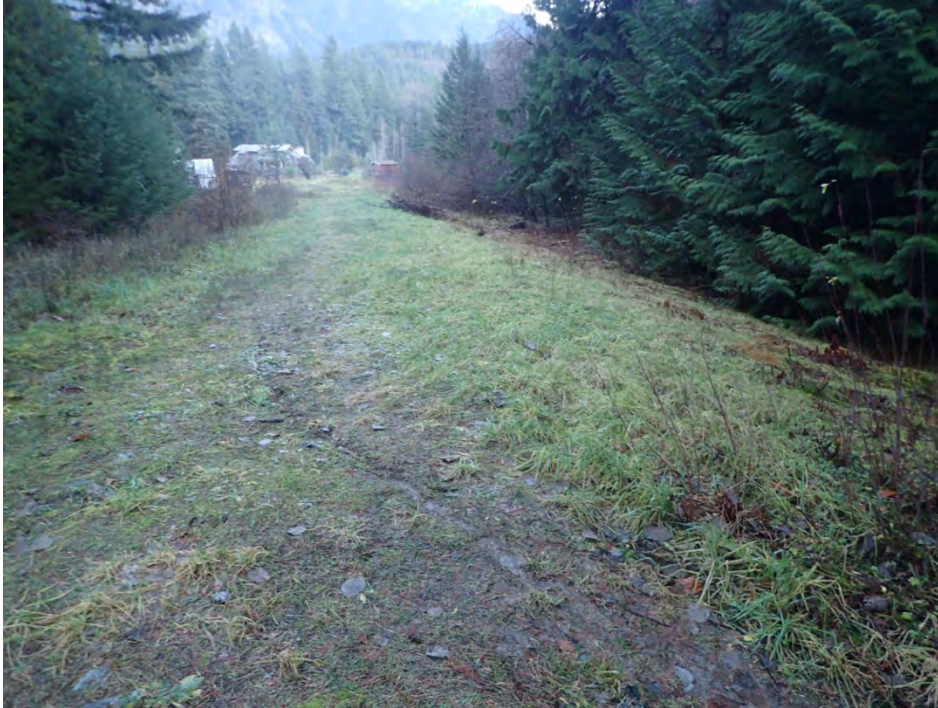
- An adhoc setback dike exists on 1876 Reid Road (Photos 25, 26). It is not known if this was built following an engineered design, to a designated flood level, or if other hydrogeomorphic processes were considered. Given the bank armouring, the dike crest height above the creek, and its setback condition it appears more than enough protection for regular clear water flooding on the main channel of Jason Creek. However, should a significant hydrogeomorphic event become directed down Reid Road to the middle fan, then the apex of this dike could be bypassed and areas on the landside could be affected by flood waters and debris flowing down Reid Road.

**Photo 25.** WP117. View downslope along adhoc dike on west side of 1876 Reid Road. Creek on right (east) in the trees. Dike ties into Reid Road near lower fan apex.

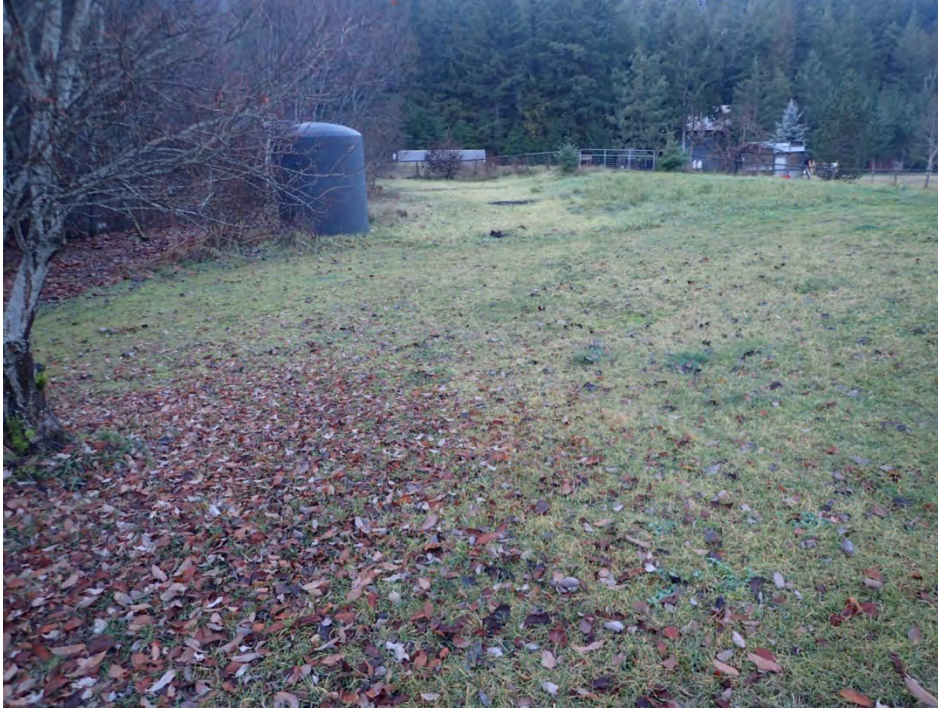
**Photo 26.** WP119. View upslope along adhoc dike on west side of 1876 Reid Road. Creek on left (east) in the trees. Dike ends at uphill side of house at 7701 Portage Road.

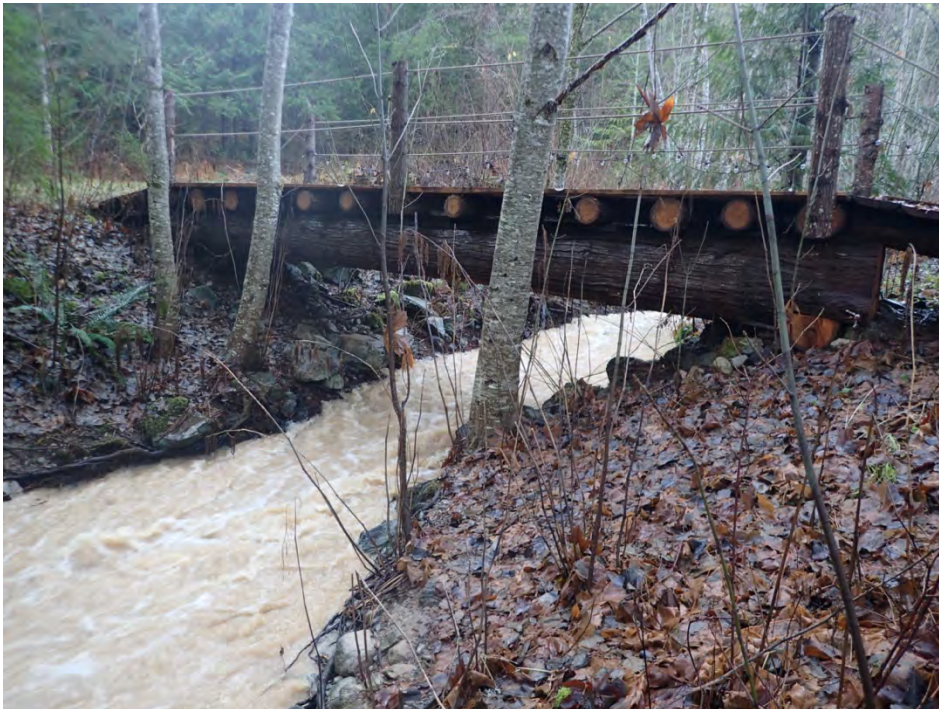
**Photo 32.** WP52. View upstream to log footbridge over Jason Creek, 7701 Portage Road.

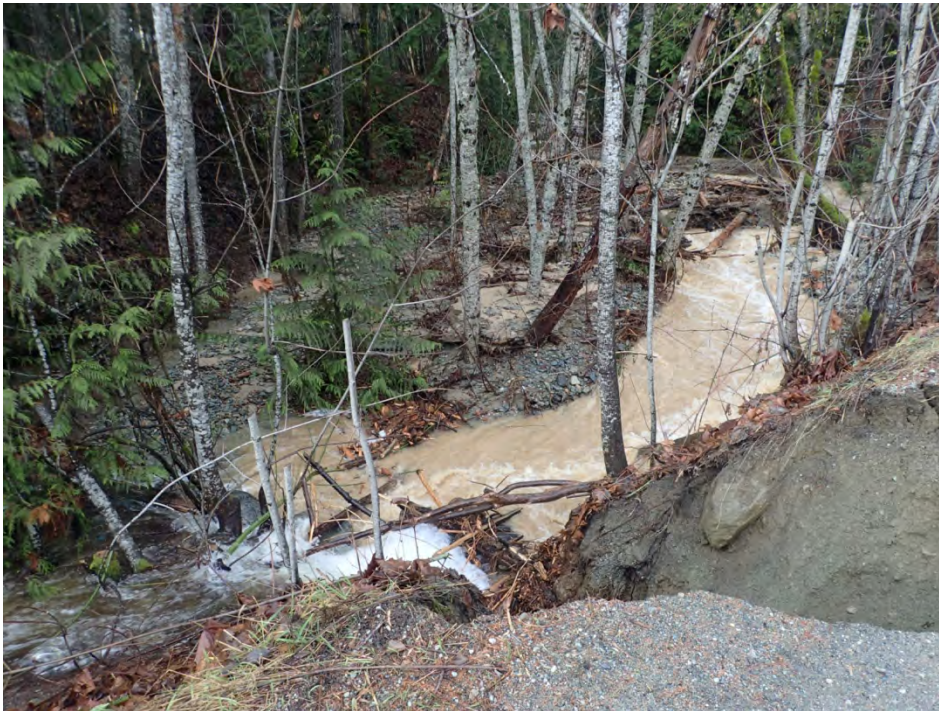
**Photo 34.** WP46. View upstream along Jason Creek from Portage Road.

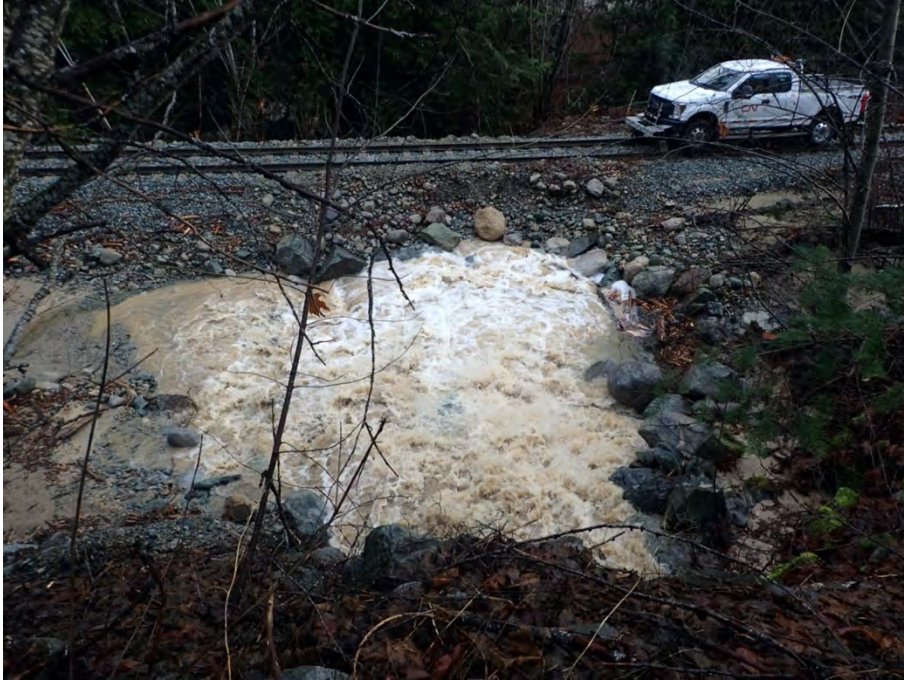
**Photo 37.** WP46. Jason Creek ponding on uphill side of CN Rail tracks. Highwater wracklines show rail line was almost overtopped.

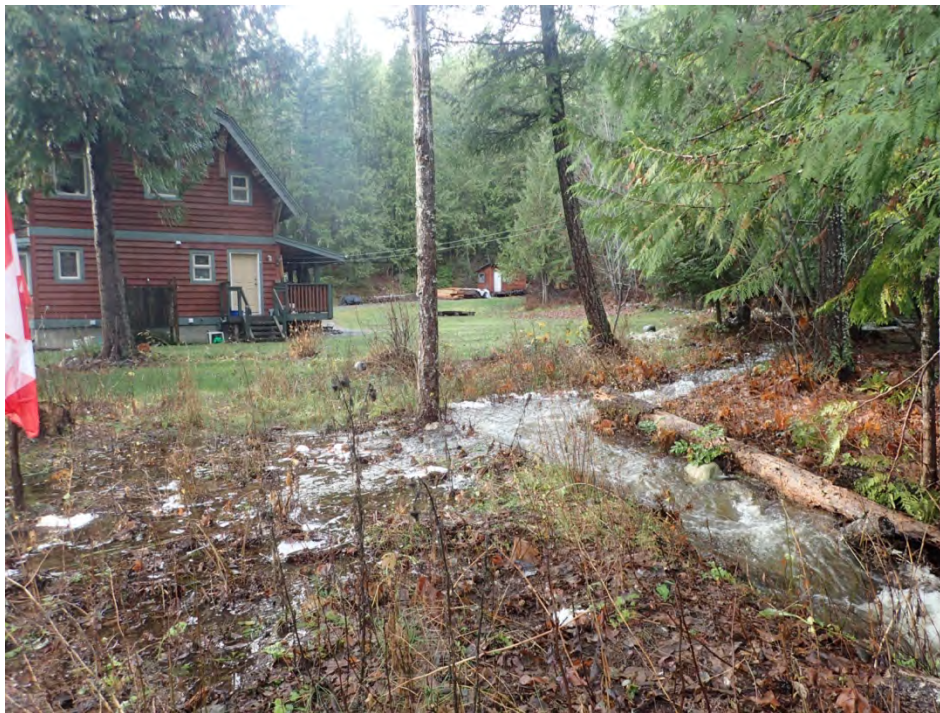
- WLAP (2004) provides provincial guidance for proposed residential development on fans. Generally, it is discouraged, but where the hazard can be shown to be Low (<1/500-year; Table 4), then a minimum standard is to raise the main floor 1-m above finished grade on a concrete foundation. All of the existing residential structures observed on the Jason Creek fan (Photos 39-42, 45, 46, 49-51, 53-55, 57), aside from that at #1 Walkerville (Photo 58), were built with the main floor at grade, and as a result are highly vulnerable to damages arising from hydrogeomorphic impacts. The home at #1 Walkerville is raised above grade on a concrete foundation and is resilient to overland flow flooding.

**Photo 58.** 1 Walkerville. House raised 60 cm on reinforced concrete foundation. Only house noted in entire area to be so constructed. House is resilient to floodwater. Note overland flow from side creek.

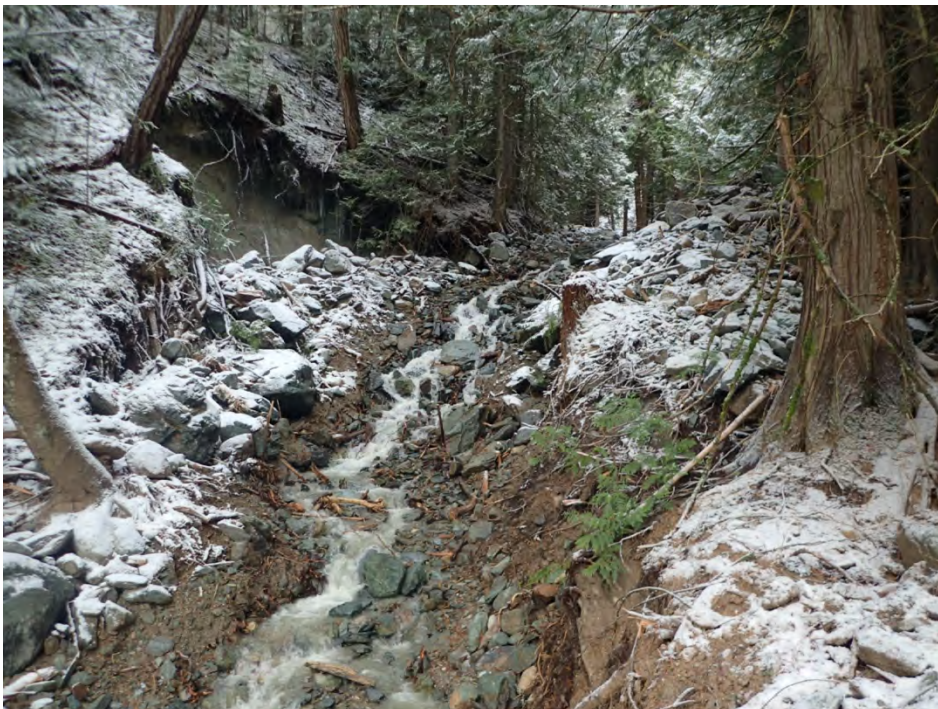
**Photo 62.** WP132. View upstream to short step in channel. Bank slump on north sidewall.

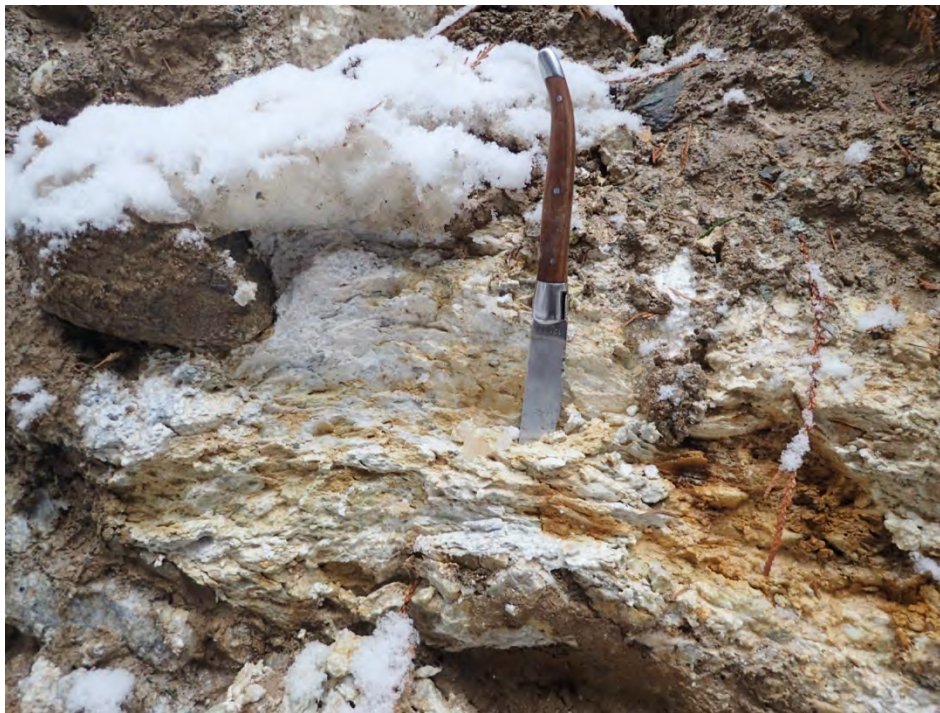
**Photo 68.** WPs 144-145. Altered ripups in colluvium.

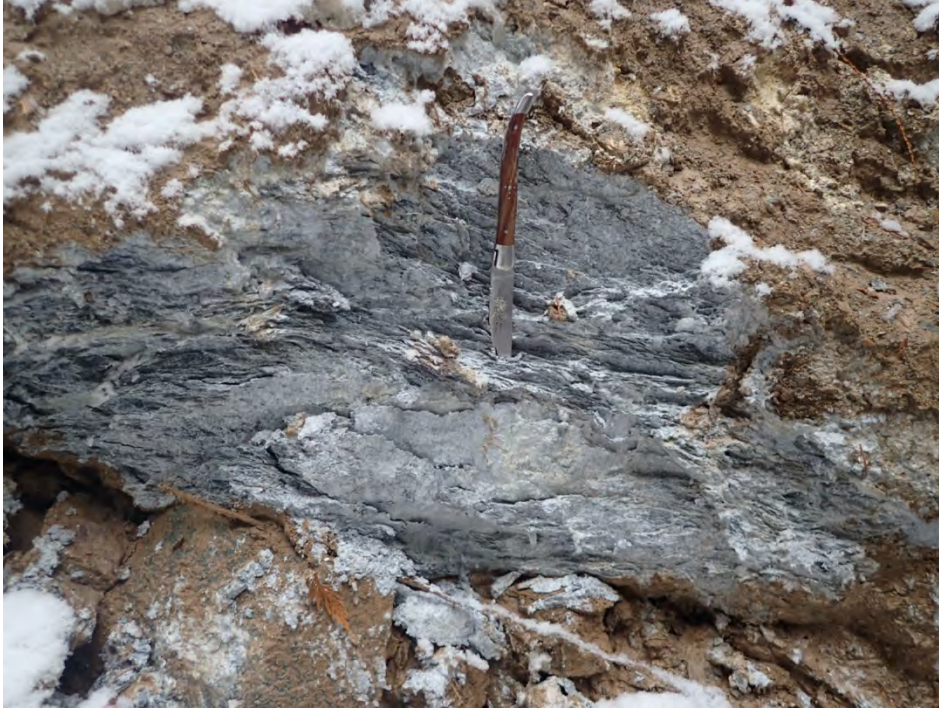
**Photo 69.** WPs 144-145. Altered ripups in colluvium.

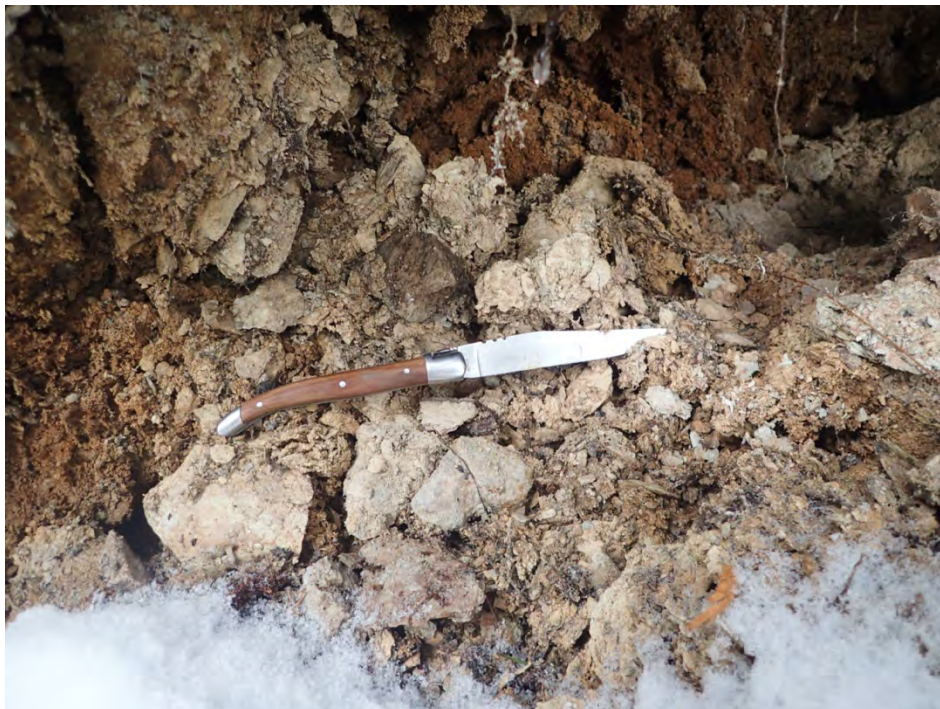
**Photo 74.** WP151. Altered materials exposed in fresh scarps.

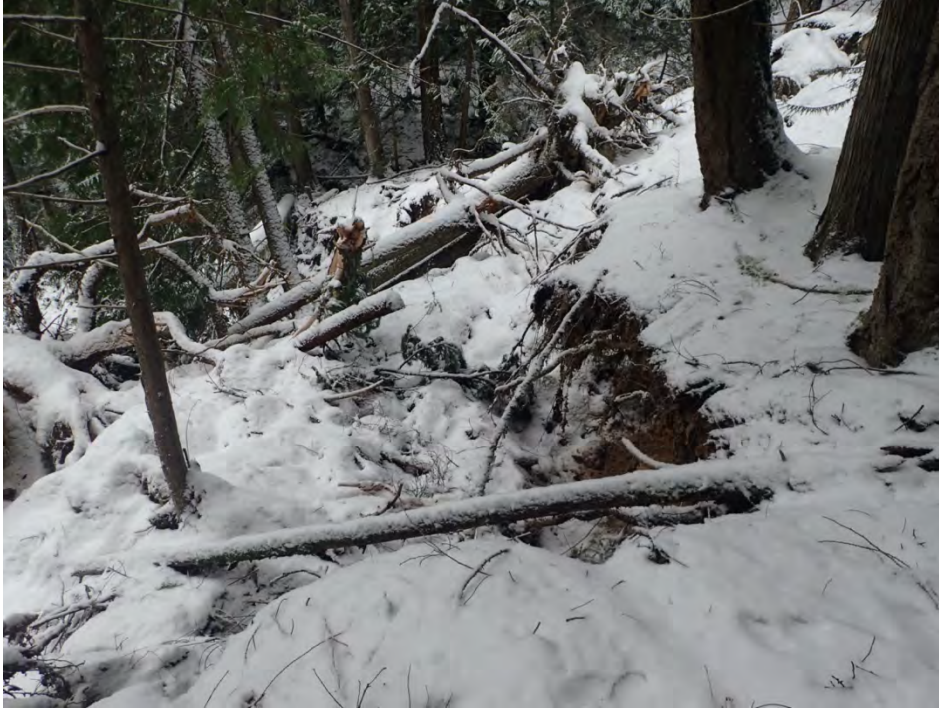
**Photo 75.** WP152. View west across fresh down-dropped blocks.

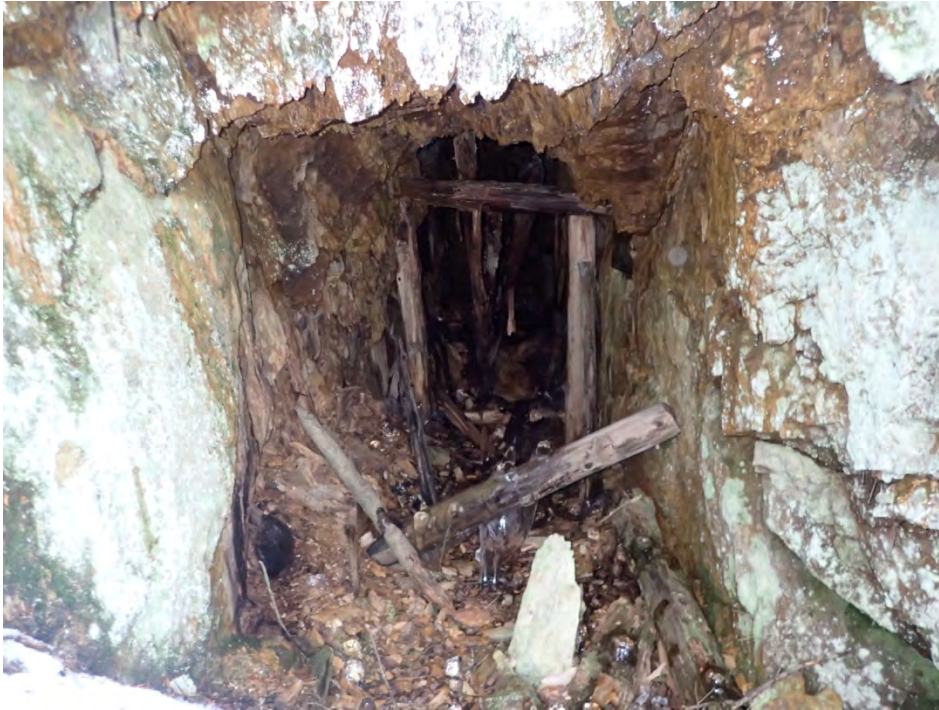
Bedrock in the Ivey Lake area consists of Gambier Group (IKGP) Mesozoic to Lower Cretaceous, metamorphosed marine sedimentary and volcanic rocks. The rock ranges from hard, blocky to phyllitic, and in many areas, especially along Jason Creek, it is deeply altered (clayey), limonitic with grey, cream to orange colours (Photos 68, 69). The dominant structural strike is NW-SE parallel with the Owl Creek fault. Jason Creek evidently follows a shear zone resulting in the heavy alteration of the bedrock in this area and contributing to the instability in the Jason Creek ravine, as discussed below. The potential mineralization in the shear zone was targeted by prospectors years ago (Photo 77).

**Photo 77.** WP155. Mine adit.
