BC Ministry of Forests, Lands and Natural Resource Operations Thompson Okanagan Region

Bear and Pete's Creek Debris Flows on the Seton Portage Alluvial Fan

December 15, 2016

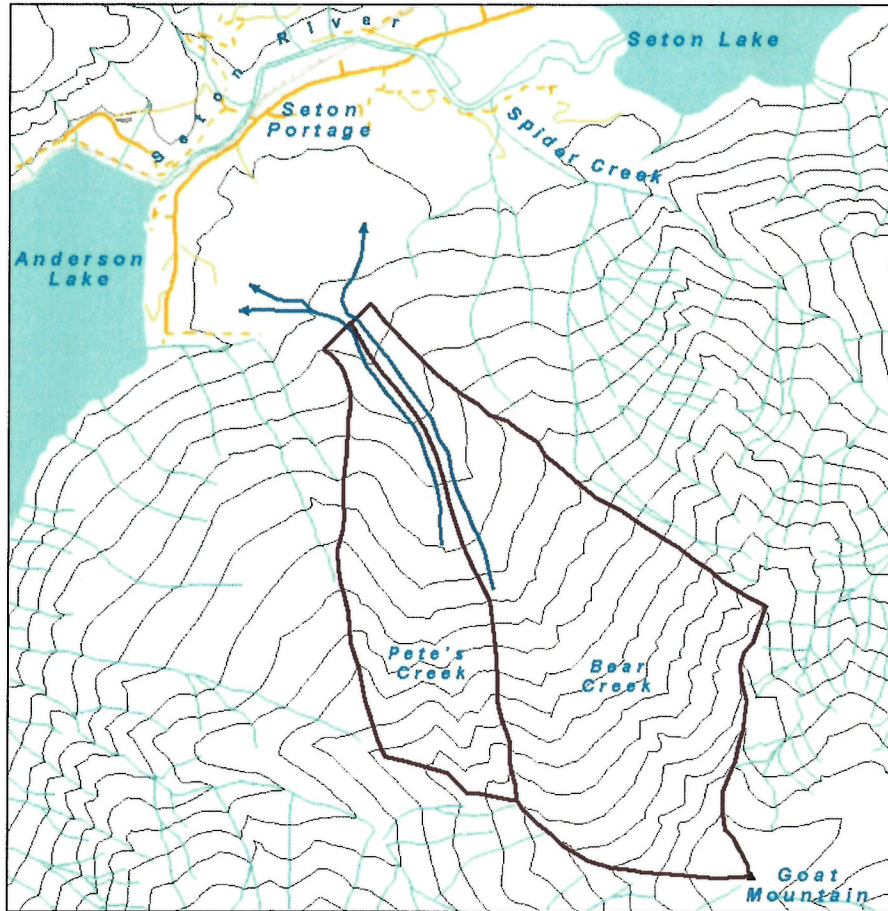
Figure 1: Bear Creek and Pete's Creek watersheds and their main channels as they come onto the alluvial fan complex, Seton Portage area.
