**Post-Wildfire Natural Hazard Risk Assessment  
Casper Creek Fire K71535  
Seton Portage, BC**

**Prepared for:  
Gareth Wells, P.Geo  
Trevor Bohay, P.Geo  
Ministry of Forests  
Kamloops, BC**

**January 16, 2024  
File: 20-138**

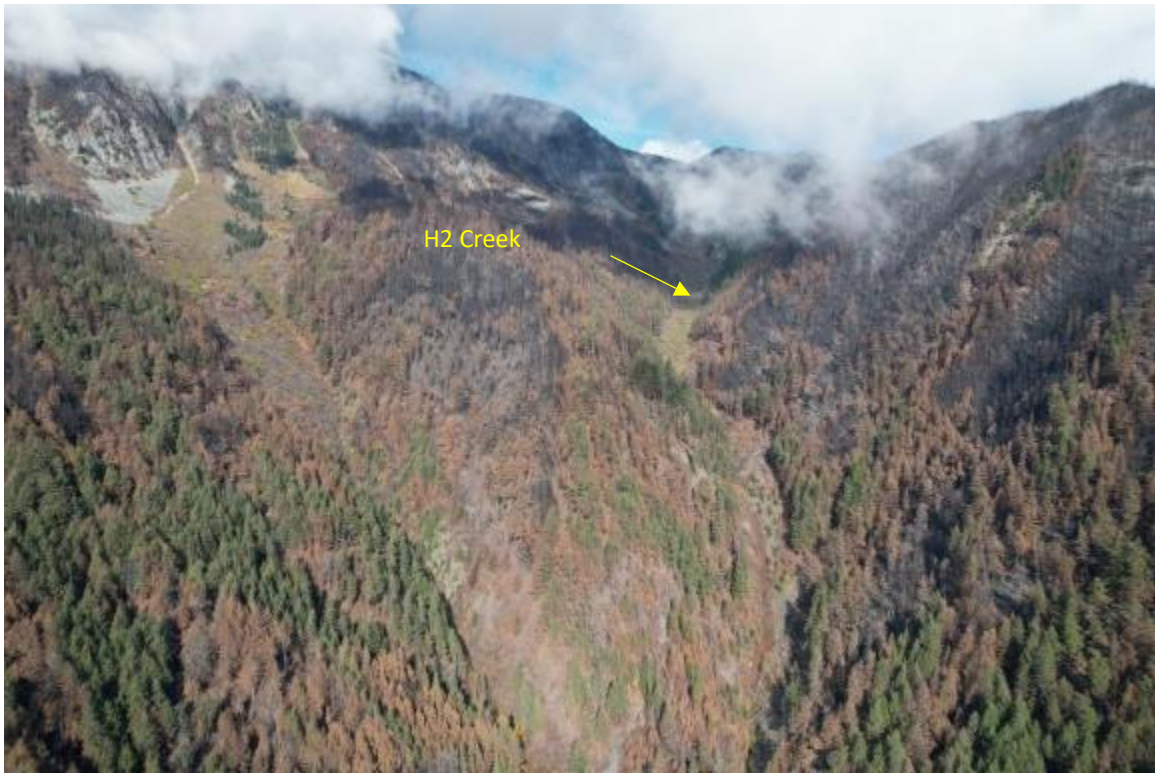
**Photo 7** Upper H2 watershed, looking north.

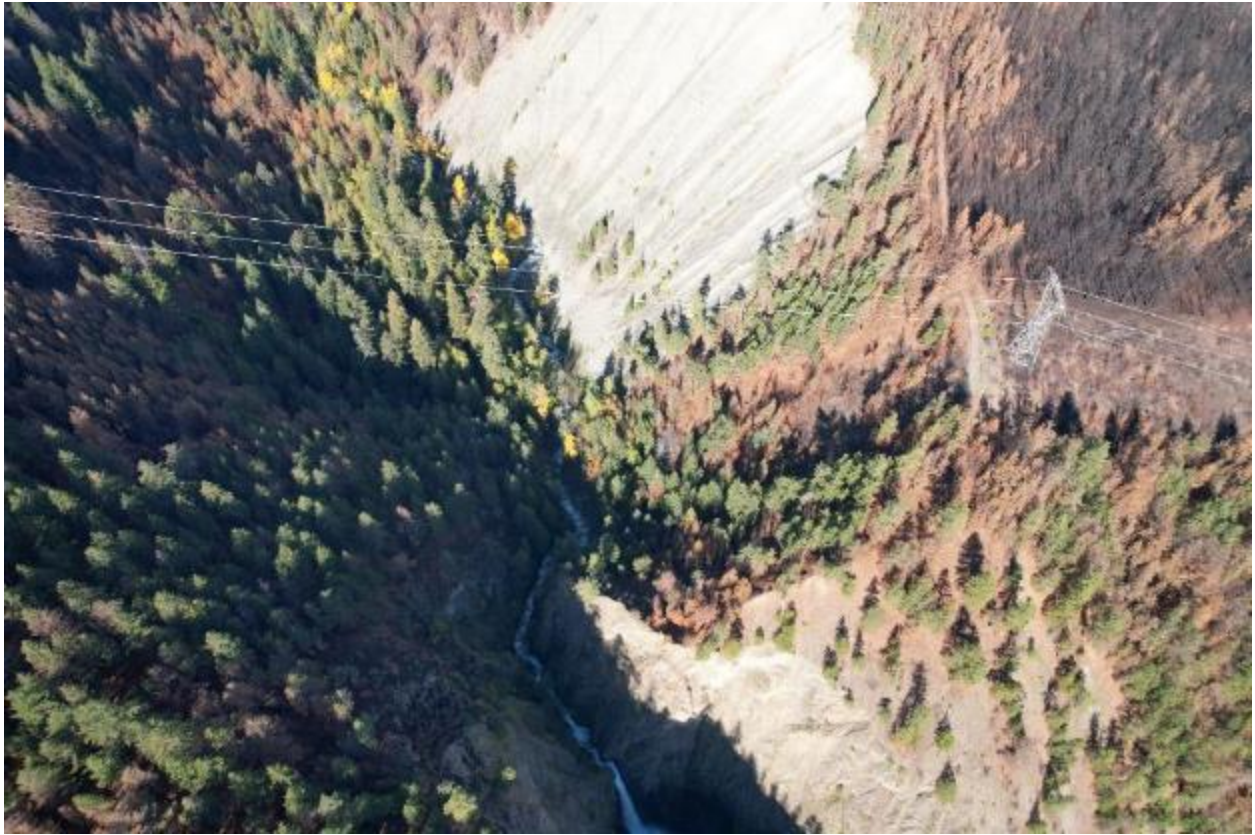
**Photo 11** Till slope upstream of bedrock canyon on Whitecap Creek.

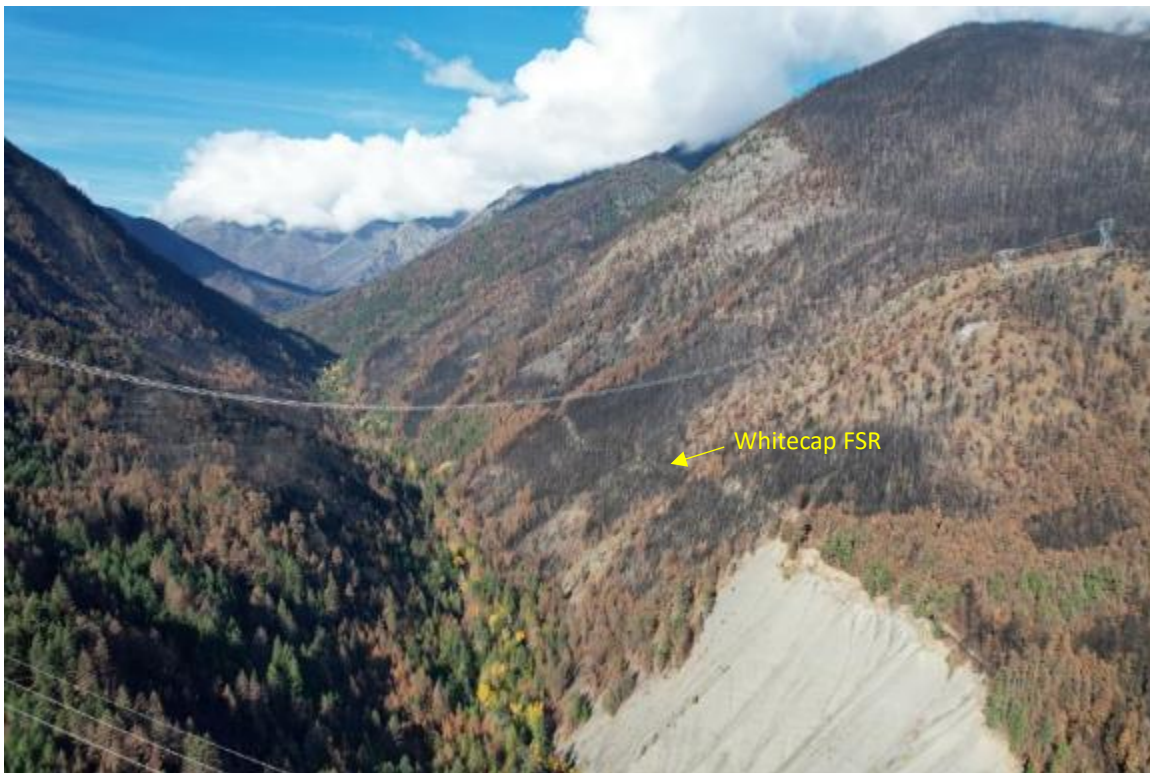
**Photo 12** Whitecap Creek watershed, looking north. Whitecap FSR is on the east side of the valley.

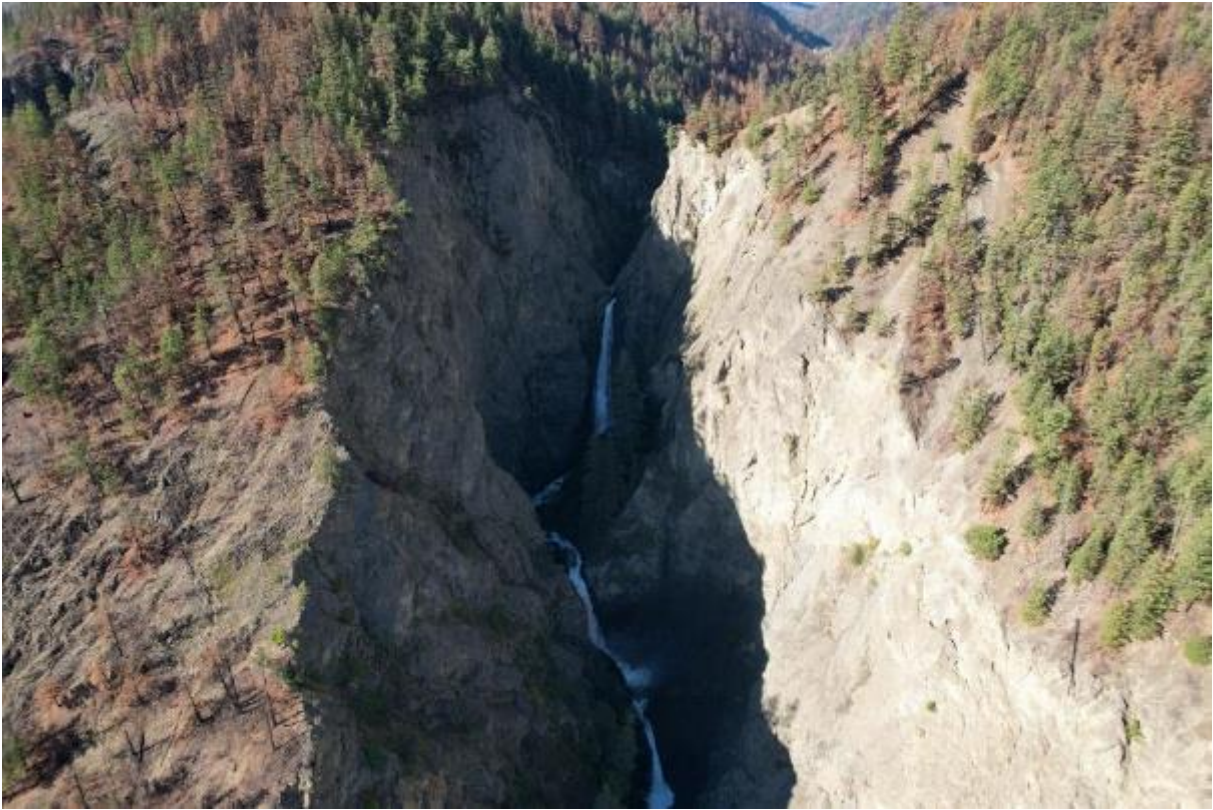
**Photo 13** Whitecap Creek falls, looking north.

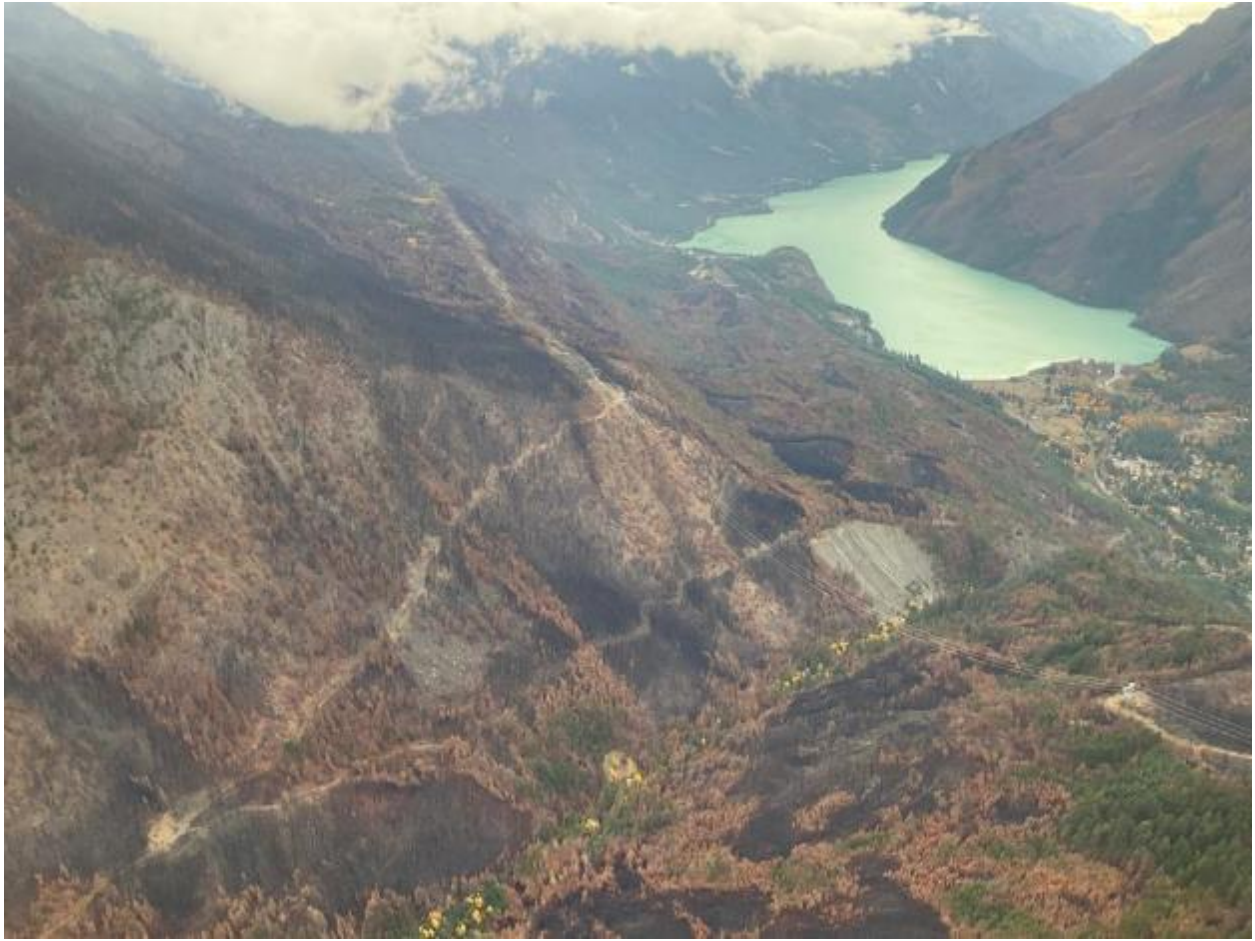
Whitecap FSR traverses the north side of the creek, with a spur road (Road 1; Photo 16) heading east above Seton Portage. A bridge over upper Whitecap Creek has been previously washed out and the road is inaccessible beyond (Photo 17). Whitecap FSR has been abandoned and has some landslide activity but has not been deactivated (Photo 18).

**Photo 16** Road 1 climbing out of the Whitecap drainage and extending to the east.

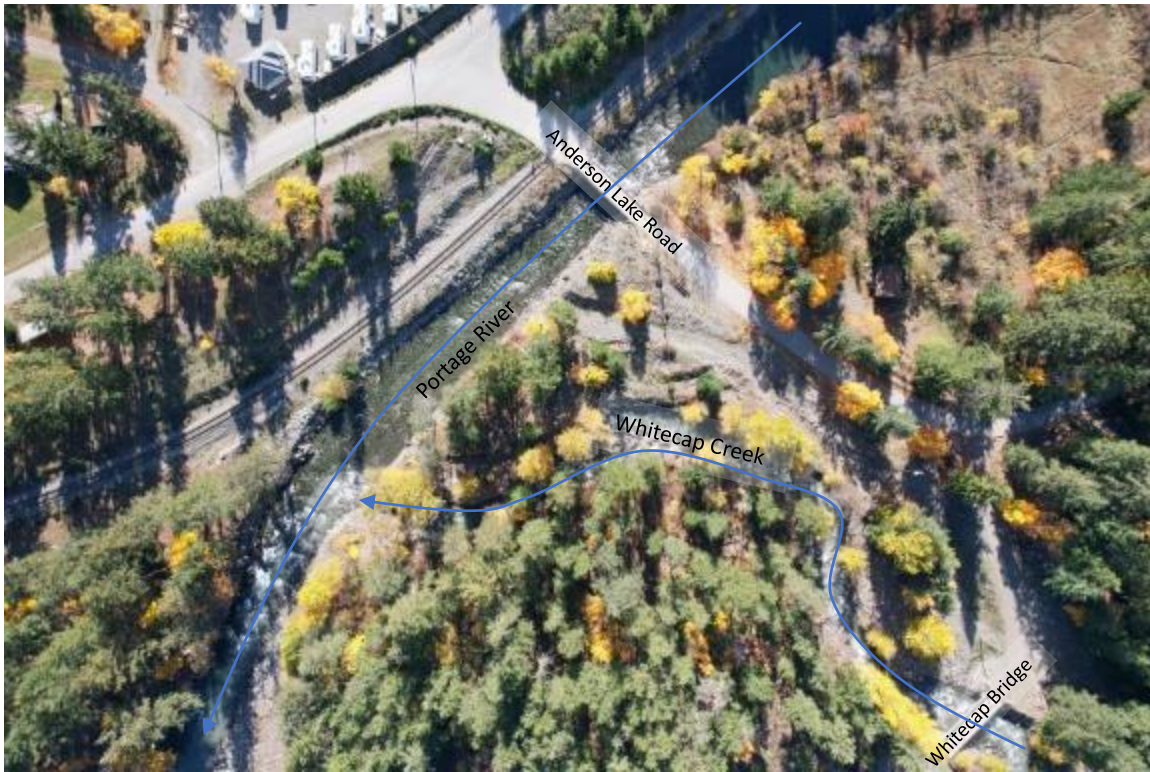
**Photo 19** Anderson Lake Road bridge at the top, Whitecap Creek bridge at the bottom, and the Whitecap-Portage River confluence.

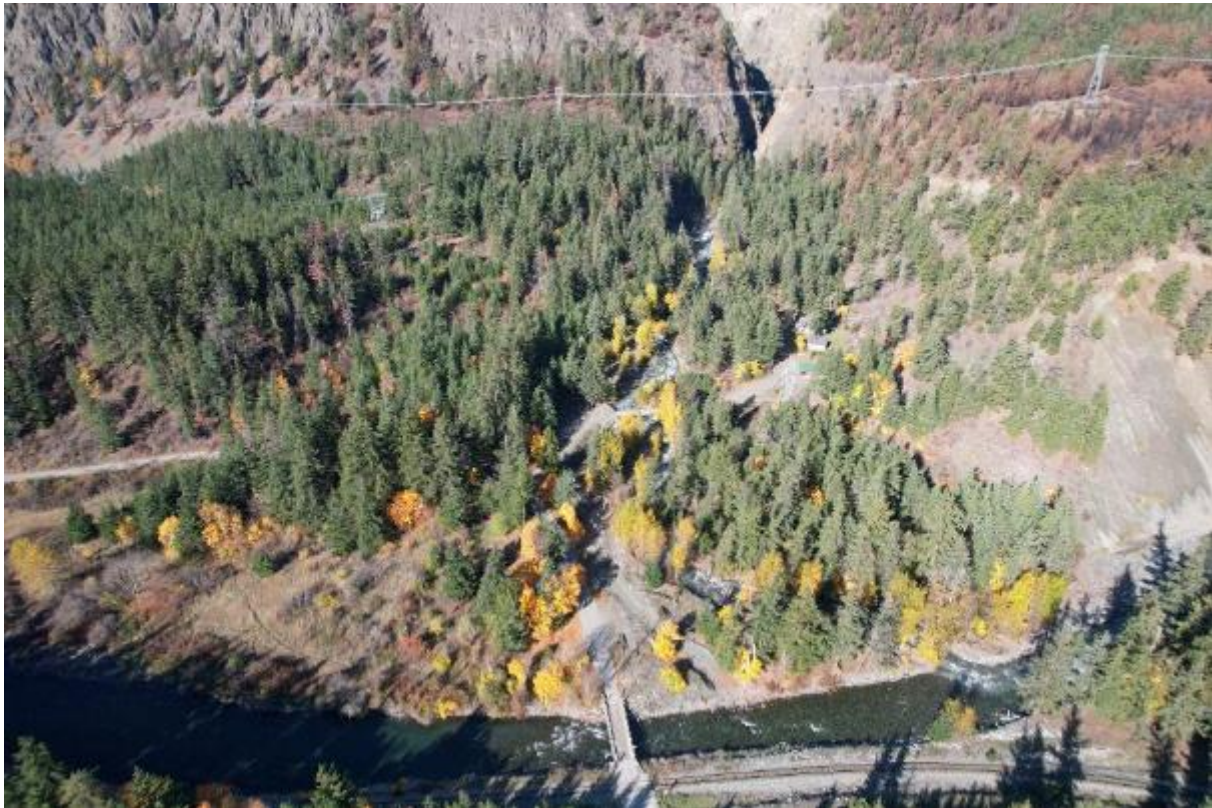
**Photo 20** Lower Whitecap Creek at the Portage River confluence.

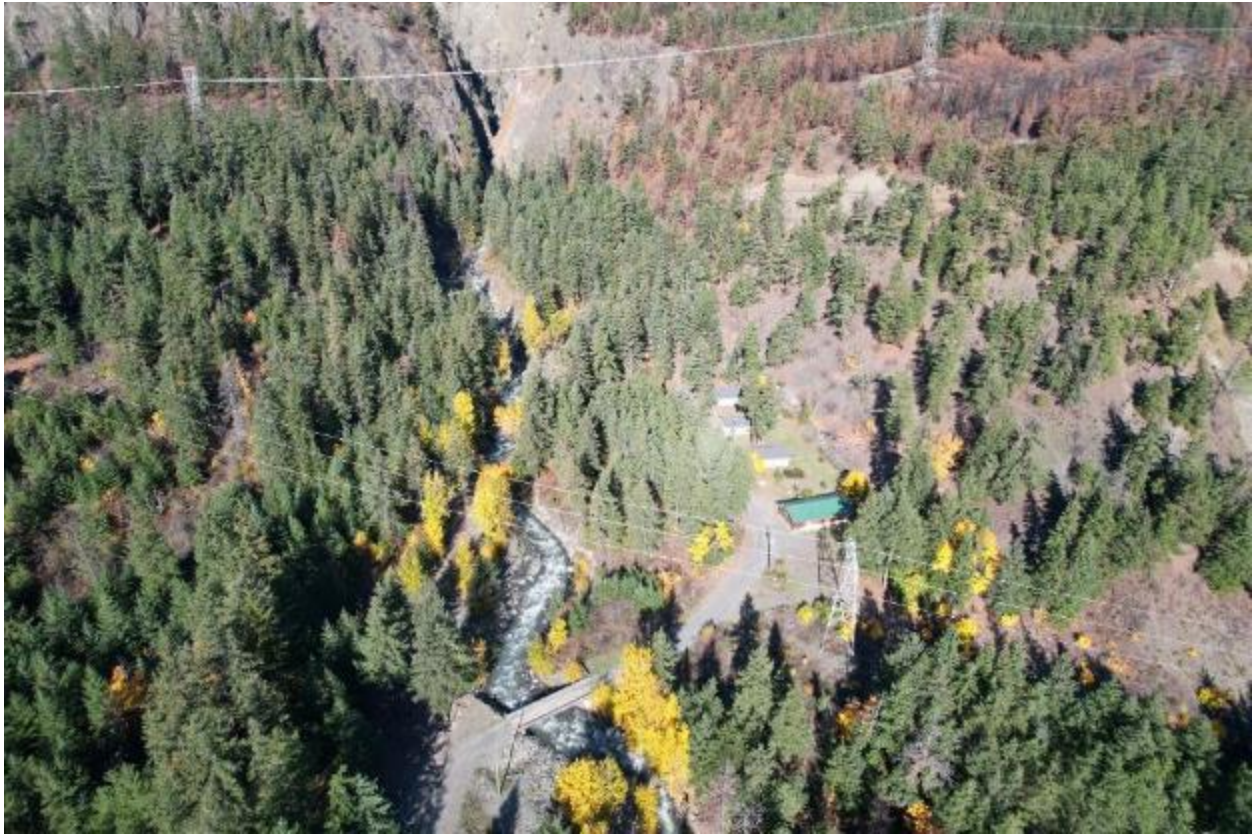
**Photo 21** Lower Whitecap Creek with the FSR bridge, cabins and office building.

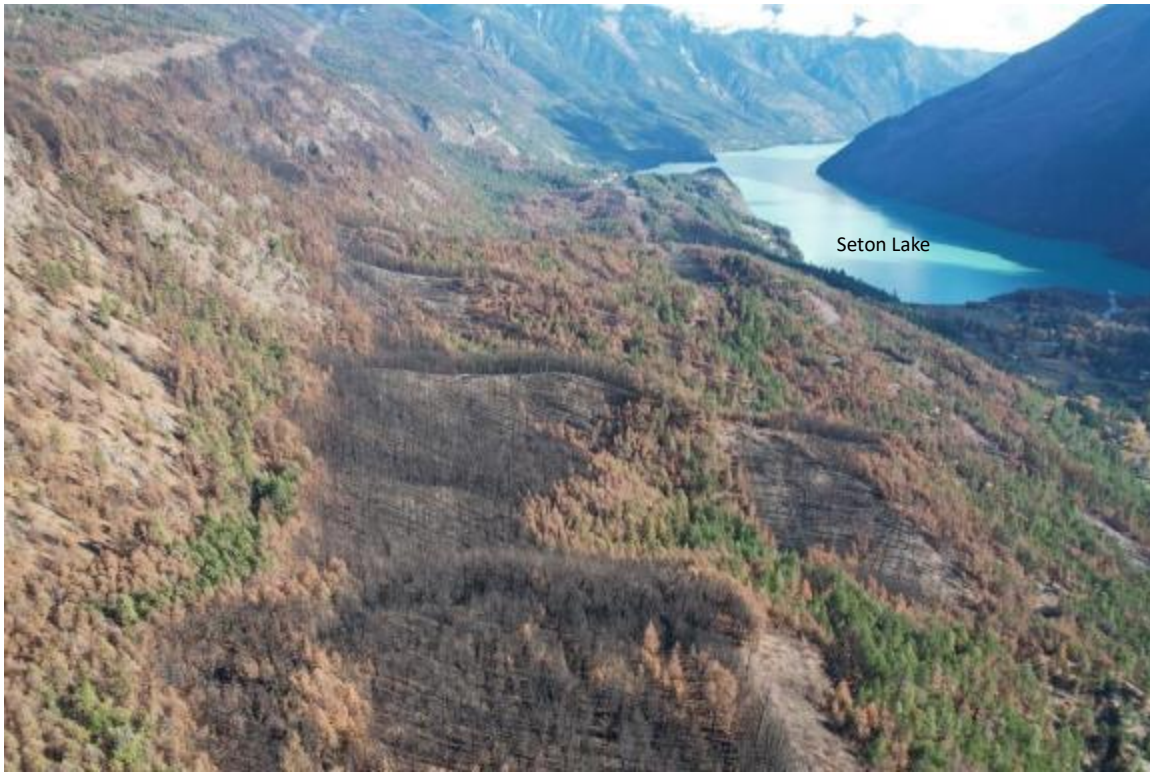
**Photo 23** Seton Portage face units, looking east. Note the steep bedrock face unit below the upper transmission line and the low gradient bench that the streams flow across in well incised low gradient draws.

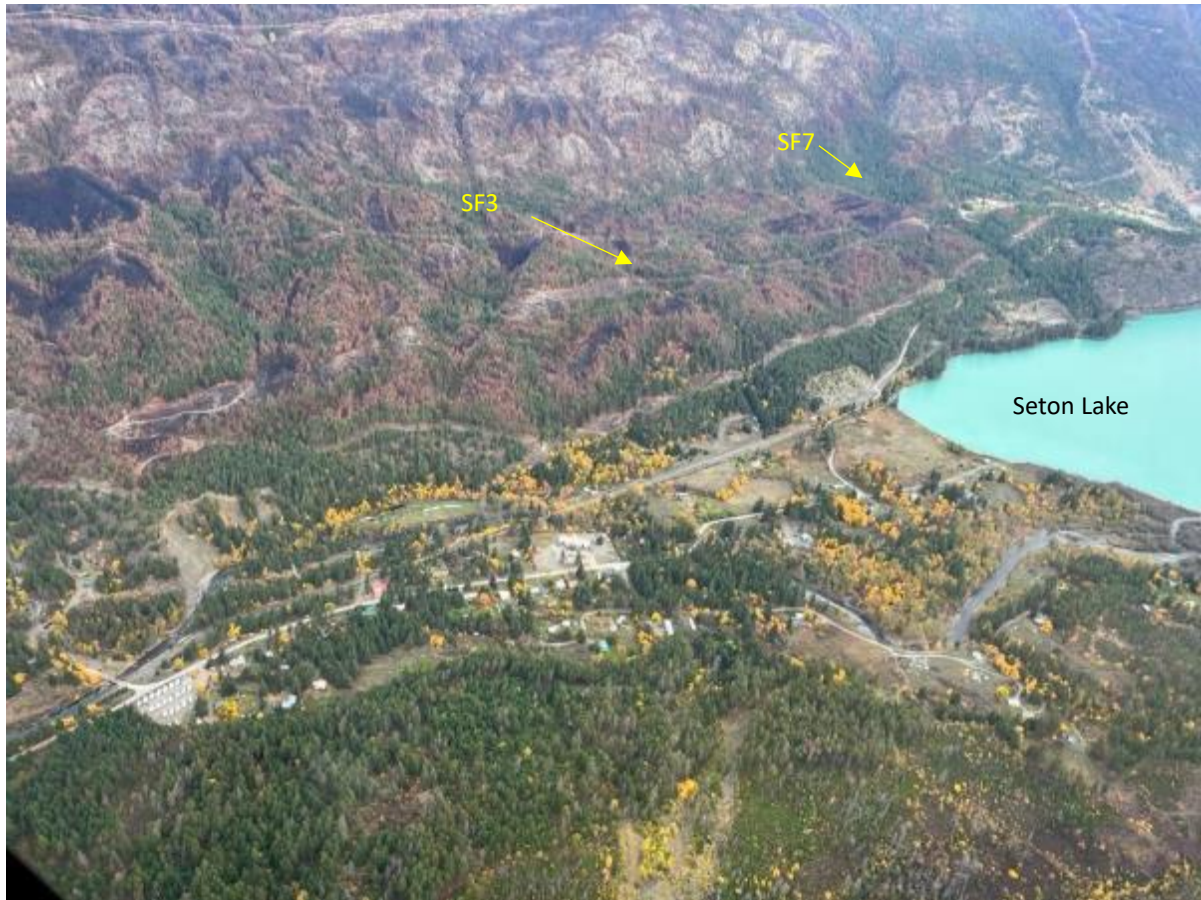
**Photo 24** Seton Portage face units, looking north.

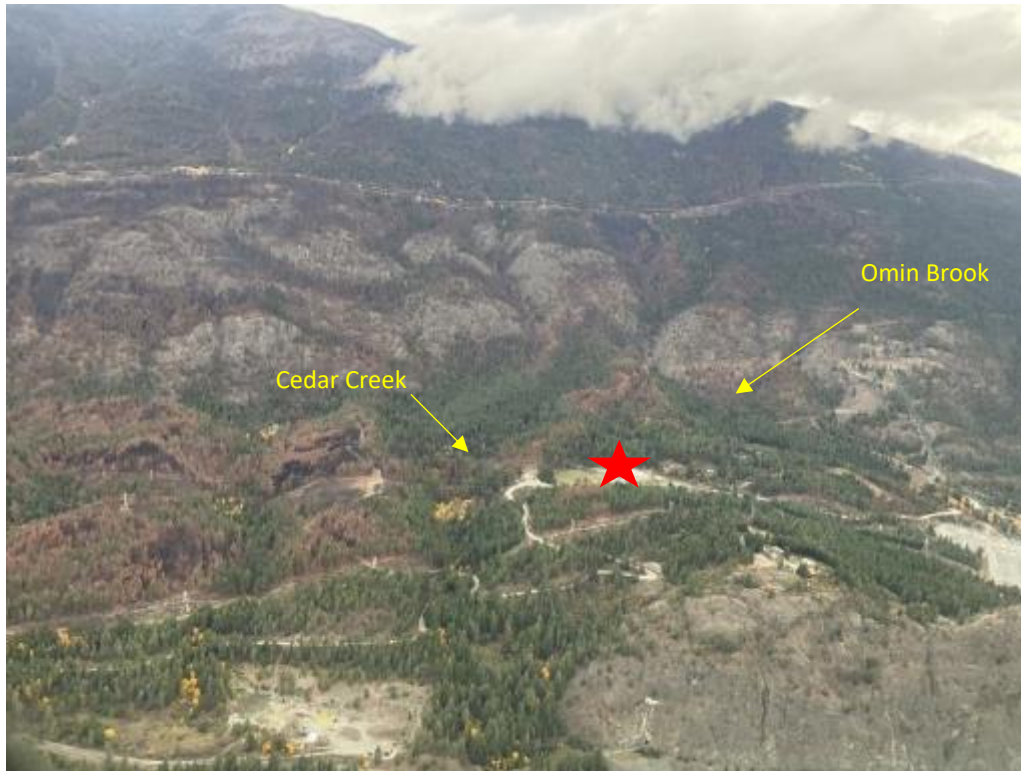
**Photo 26** Sk'il Mountain Community School (star) on the terrace between Cedar Creek and Omin Brook, looking north.

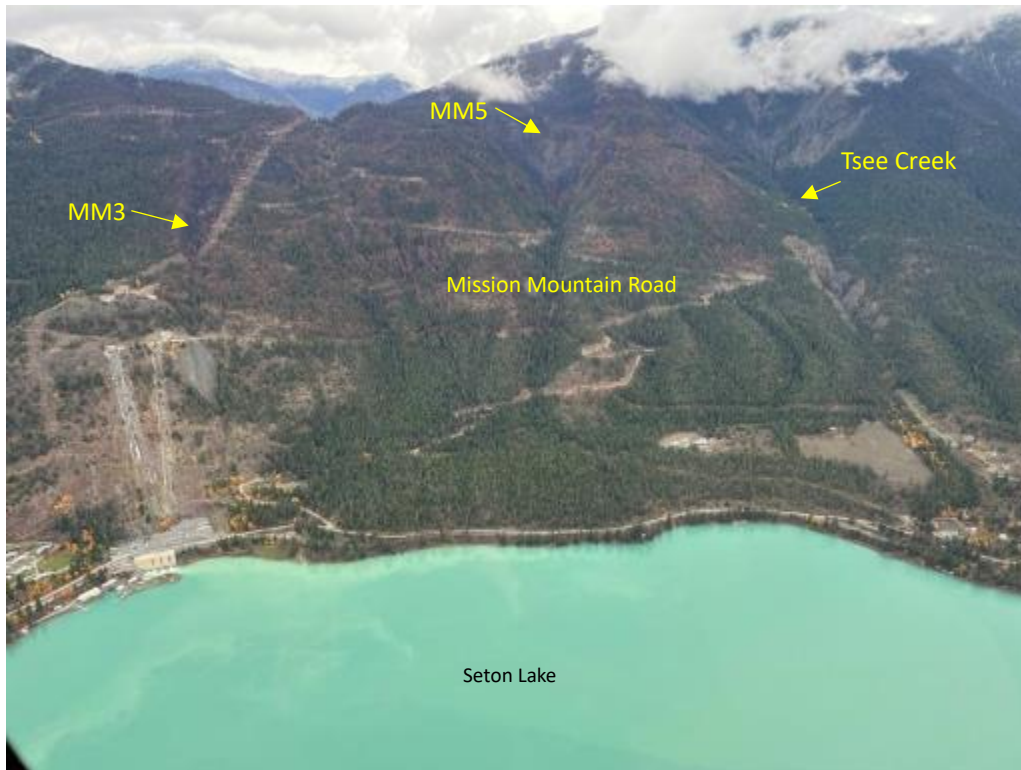
**Photo 27** South slopes of Mission Mountain Road, MM3, and MM5, looking north. Tsee Creek is on the right, and the BC Hydro BR site is on the left.

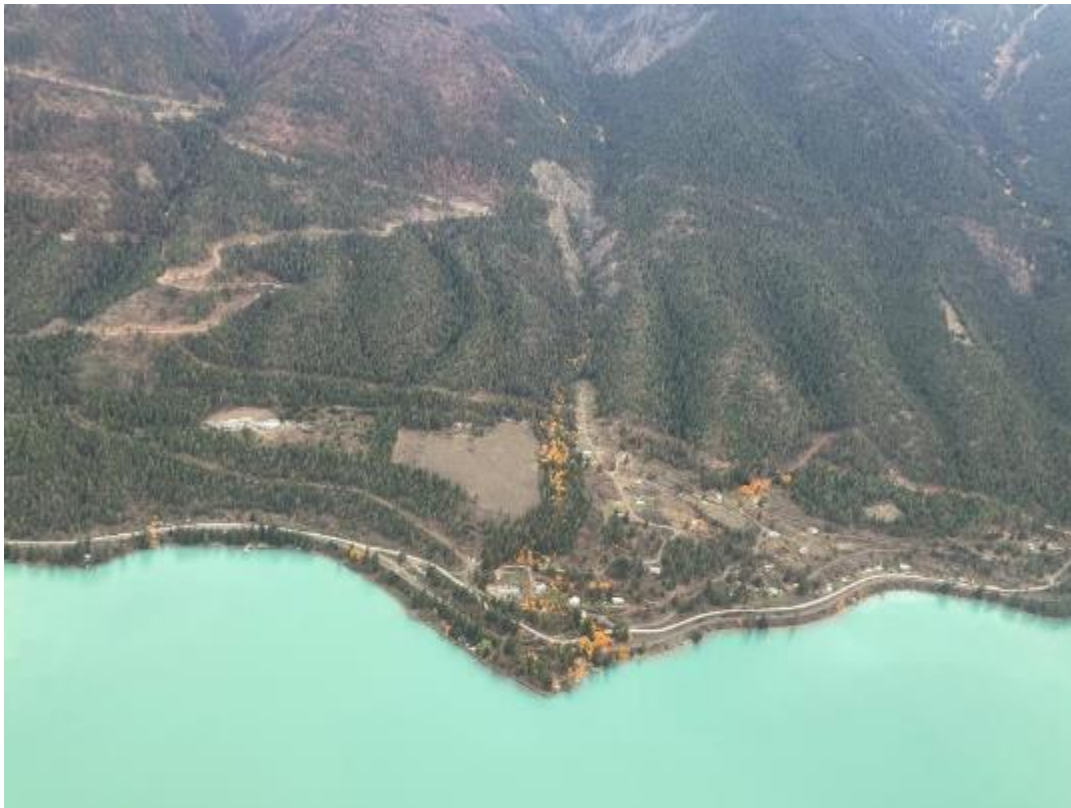
**Photo 29** Tsee Creek fan area, view looking north.

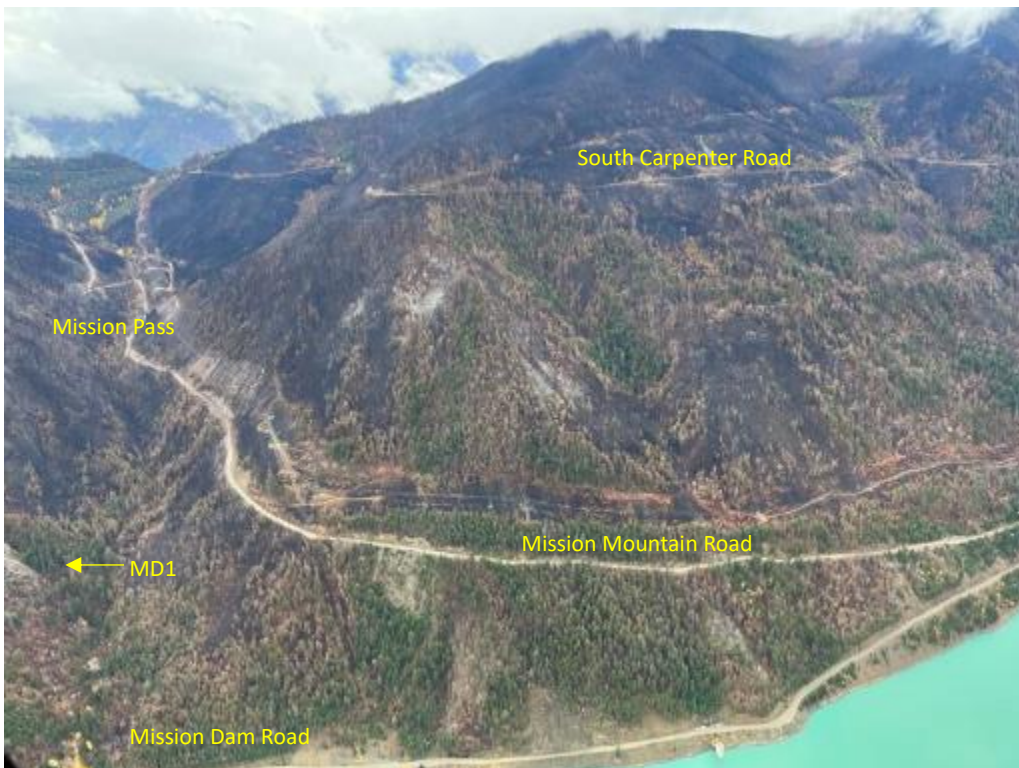
The South Carpenter FSR, also known as South Carpenter – Nosebag FSR, branches west off Mission Mountain Road at Mission Pass (Photos 31, 36). There are five small watersheds; SC1, which flows east into MD1, and SC2 to SC5, that flow north into Carpenter Lake. A cellular tower site and BCH penstock intakes are located downslope. The mountainside was predominately burned at high vegetation burn severity, reducing to low and moderate near the lakeshore and to the west at the fire boundary. One mapping error was found near SC4. The burn severity map shows unburned but downslope of the FSR was burned at high severity.

**Photo 31** North slopes of Mission Mountain Road looking south towards Mission Pass.

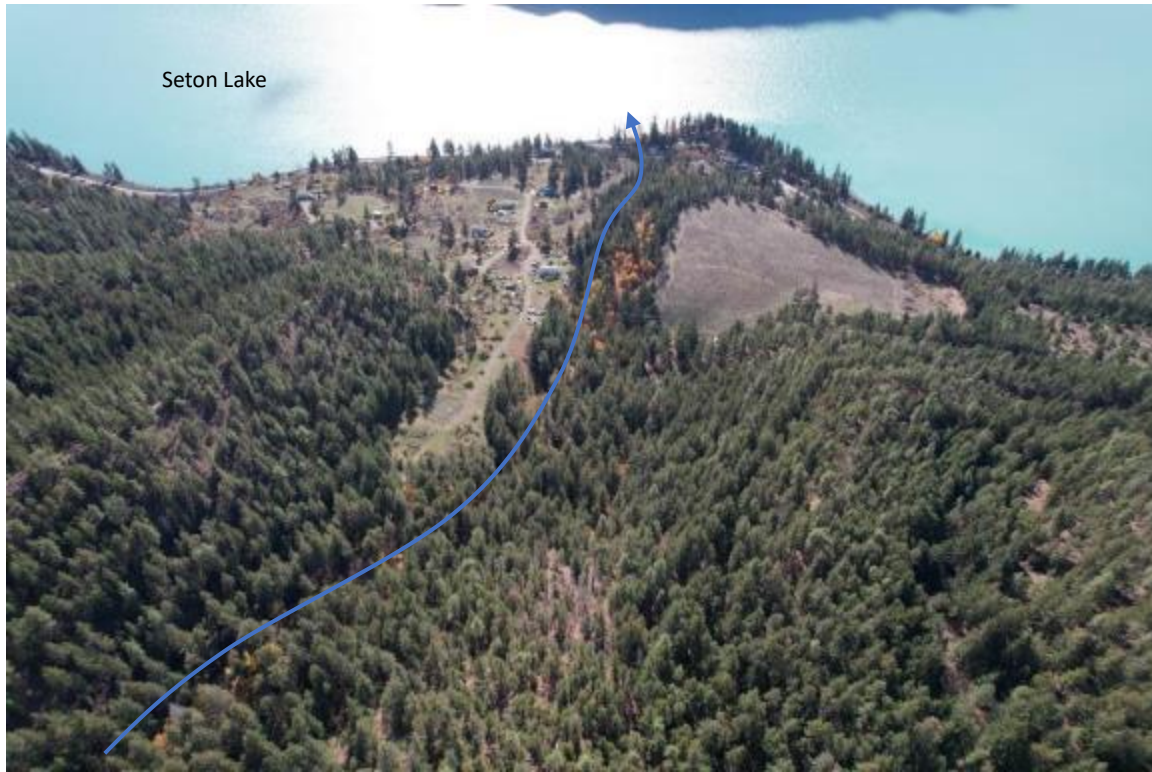
**Photo 32** Tsee Creek on the right of Shalalth, looking south.

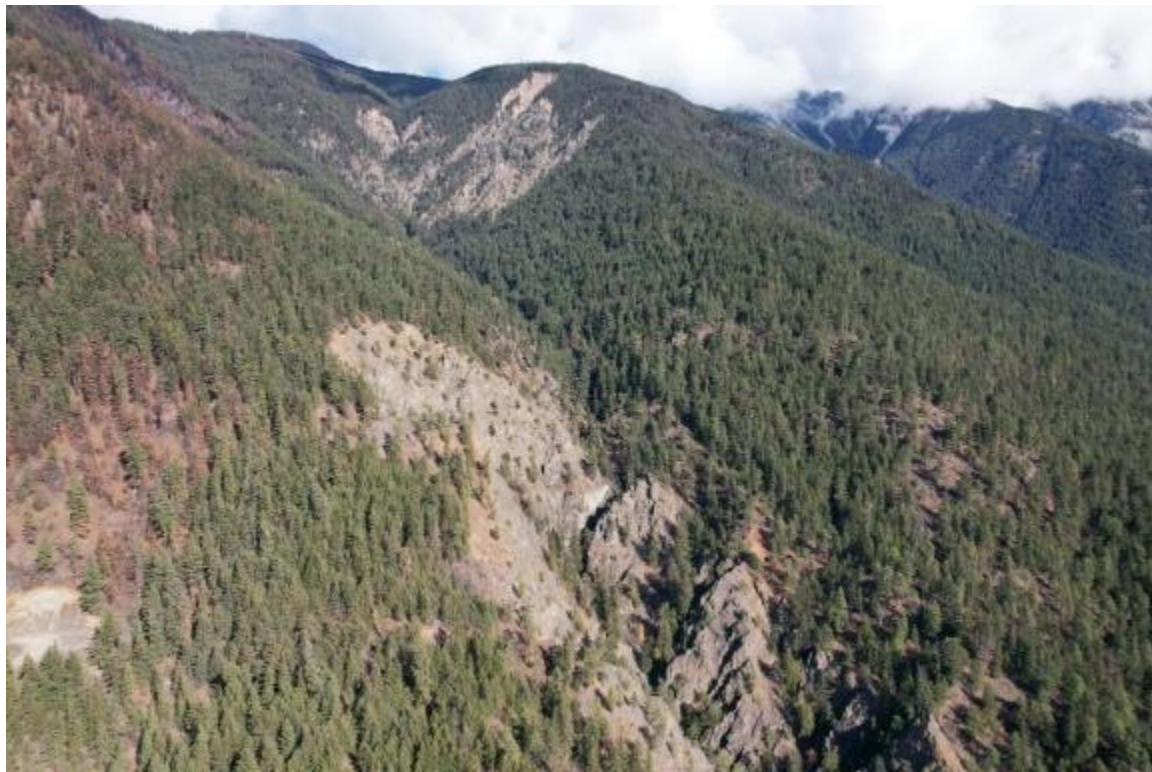
Tsee Creek has a steep, bedrock canyon that had minor bedload movement noted at the time of our field work. There is a deposit of sediment upstream of the Shalalth Road culvert and mud splattered on trees on the bank indicating past debris flow event(s) and a relatively high debris flow hazard under existing conditions (Photo 34). As the culvert was plugged during the last event, it should be considered for upgrade to account for potentially increased sediment delivery following the wildfire event.

**Photo 33** Tsee Creek watershed and bedrock canyon, looking north.

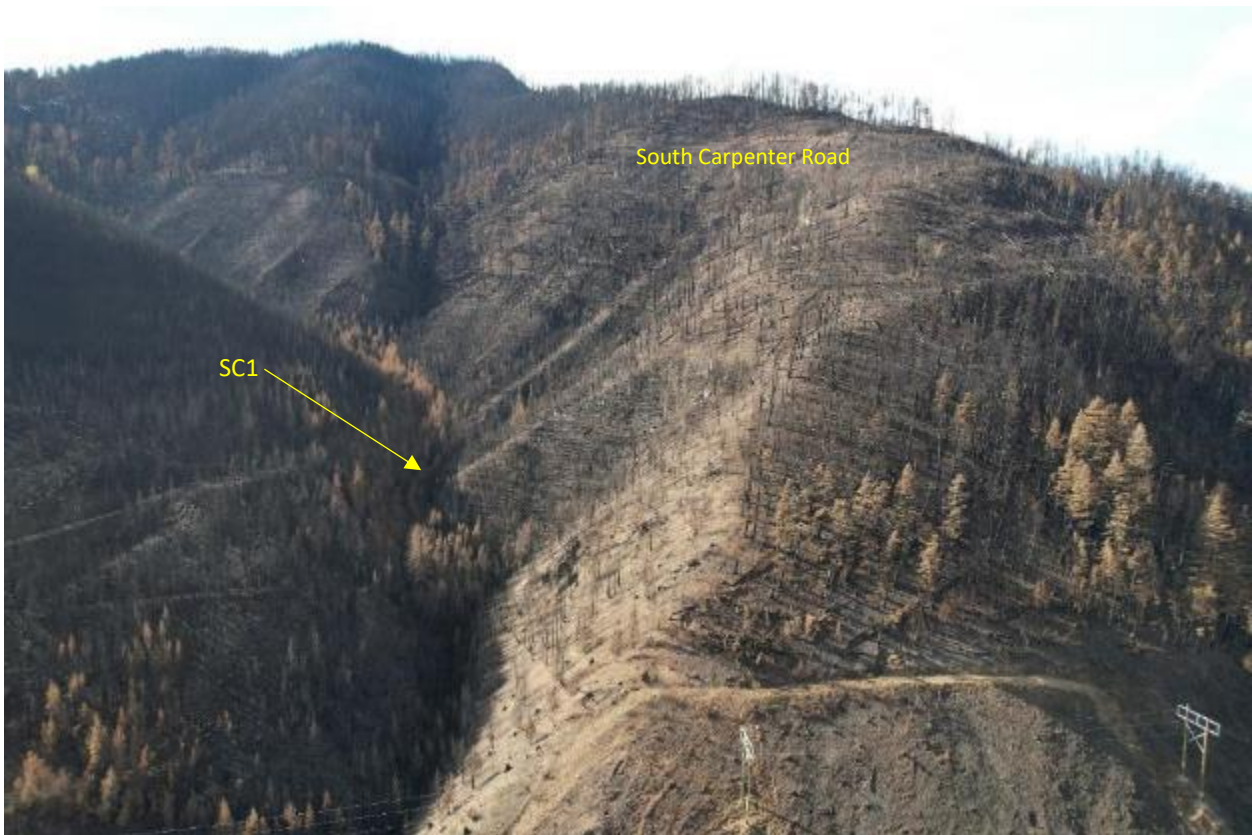
SC1 flows east into a larger watershed (MD1), which then flows north along Mission Mountain Road to Carpenter Lake (Photo 35). SC1 has an incised channel, small flow, and is burned at high vegetation burn severity (83%). The slopes consist of thick, free-draining sand and gravel with a hydrophobic upper layer. The debris flow hazard has severely increased post wildfire as 95% of the watershed was burned at moderate and high severity.

**Photo 35** South Carpenter FSR and the SC1 watershed, looking west.

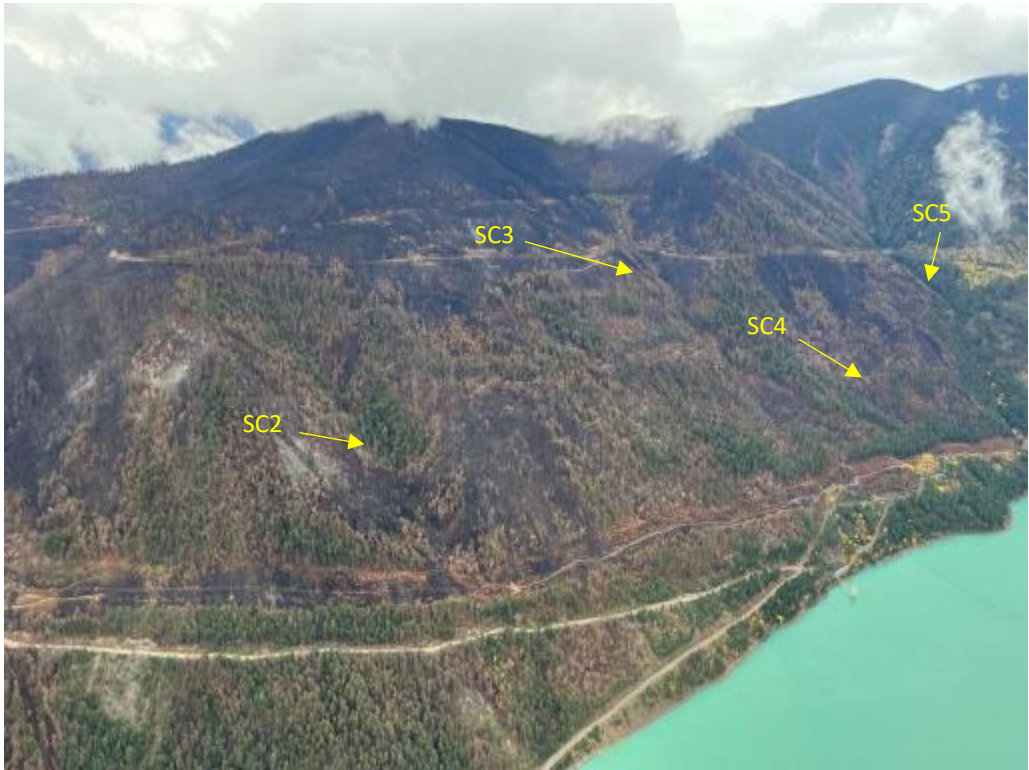
SC2, SC3, and SC4 were dry draws with no stream channel (Photo 37). There was no flow at the upper or lower crossings, but culverts were in place. The percent burned at moderate and high vegetation burn severity are 85% for SC2, 79% for SC3, and 68% for SC4. The steep, upper watersheds are highly burned and decrease in severity closer to the lakeshore.

**Photo 37** South Carpenter FSR showing SC2 to SC5 and the fire boundary on the right, looking north.

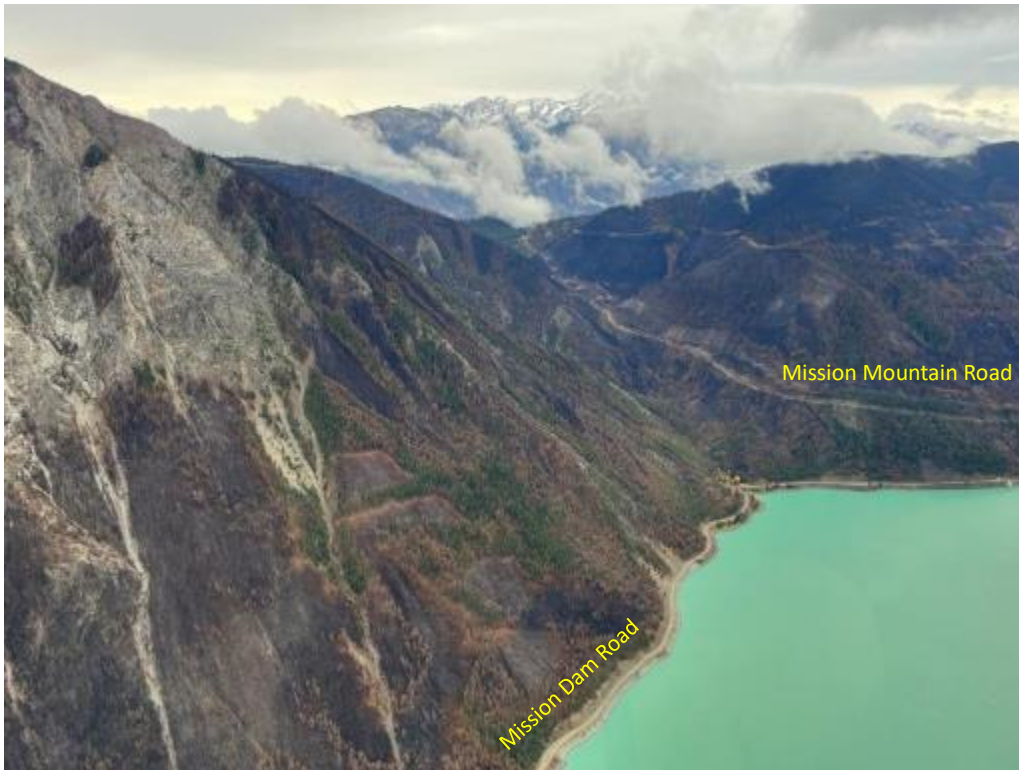
The Mission Dam Road extends from the BCH penstock intakes past the Terzaghi Dam on Carpenter Lake (Photo 38) to the Bridge River Canyon and beyond. The Terghazi Dam and Mission Dam Recreation Site are on the fire boundary at the east end of Carpenter Lake. There are 13 watersheds, MD1 to MD13, draining into Carpenter Lake and Bridge River. The slopes south of Carpenter Lake and west slopes of Mission Mountain are burned at moderate to high severity. The valley along Bridge River has varying burn severities.

**Photo 38** Mission Dam Road on the lakeshore and Mission Mountain Road, looking south.

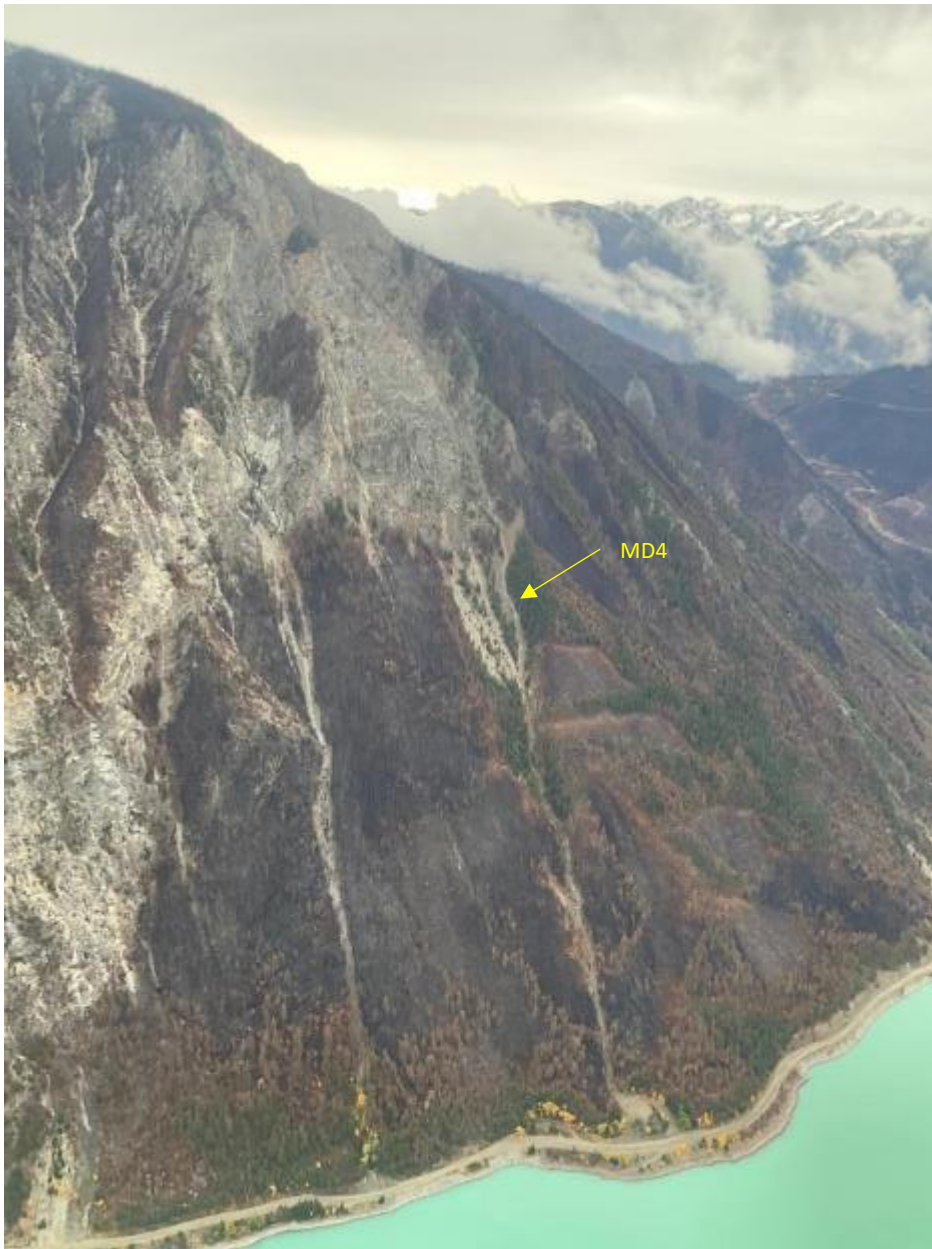
MD4 is a small watershed with a recent debris flow (Photo 40 – 41). The deposit is 5-10 m wide and >2 m deep. There were no surface flows during the field work, but water has incised through the deposit. The slopes are rocky and relatively unburned as there are few trees. The lower watershed has high vegetation burn severity (14%), including along the debris flow deposit. There is no culvert crossing Mission Dam Road. Mitigation measures should be considered above Mission Dam Road as more debris flow events and increased runoff can be expected.

**Photo 40** The upper reach of MD4, looking south.

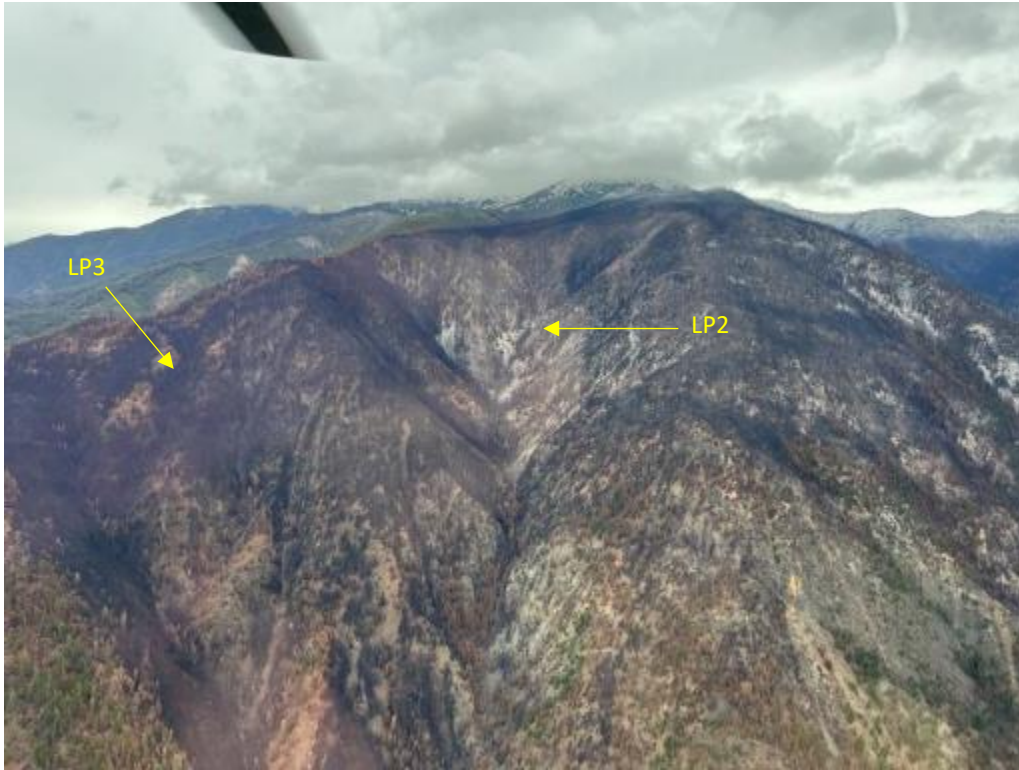
LP2 and LP3 were dry draws that likely host seasonal flows (Photo 43). Neither watershed has a defined channel at the mouth. LP2 has a moderate (47%) and high (45%) vegetation burn severity, and LP3 has high (66%) vegetation burn severity. Each draw has culvert that appears suitably sized for clearwater flows provided the inlets are maintained.

**Photo 43** LP3 (left) and LP2 (right) watersheds, looking north.
